GTE796-Stage 2  
31 March 2016

**RE: STAGE 2 CONTAMINATION ASSESSMENT at No. 3 King Street, Concord West, NSW.**

This executive summary presents a synopsis of the Stage 2 Contamination Report for the site; No.3 King Street, Concord West, NSW.

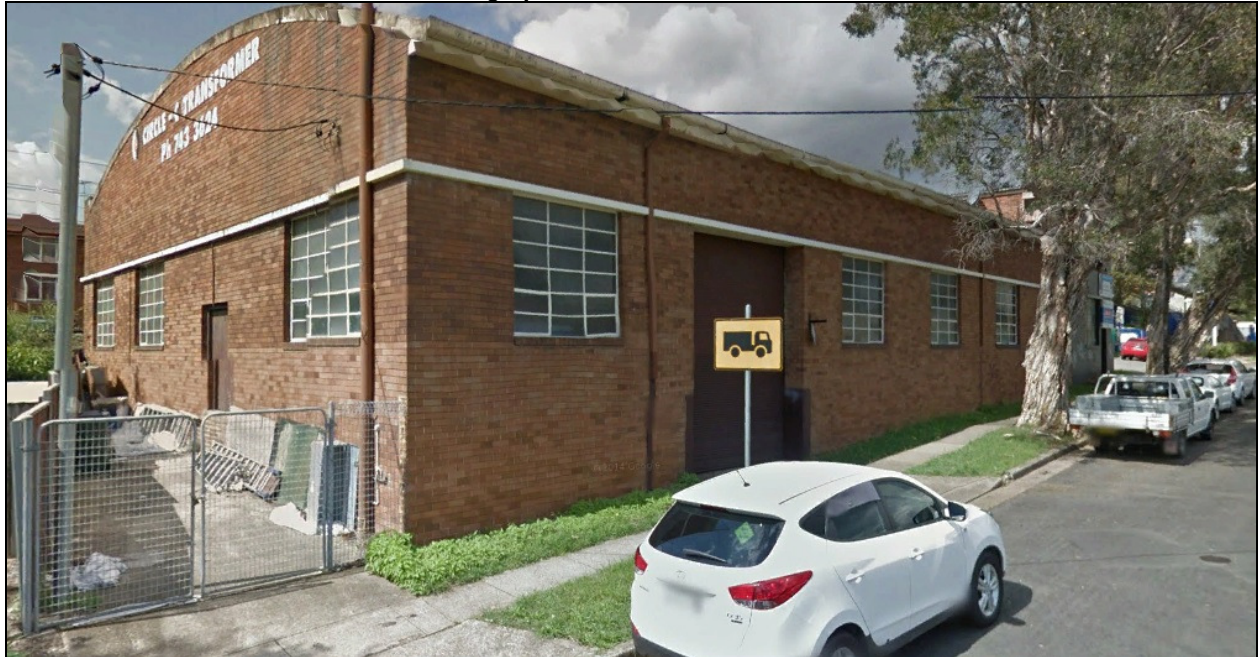
The site currently contains a brick warehouse and adjoining two storey office. The two storey part of the building is being used as a residential building, whereas the warehouse is used to hold human health supplement products.

**Photograph 1 – Industrial Warehouse**

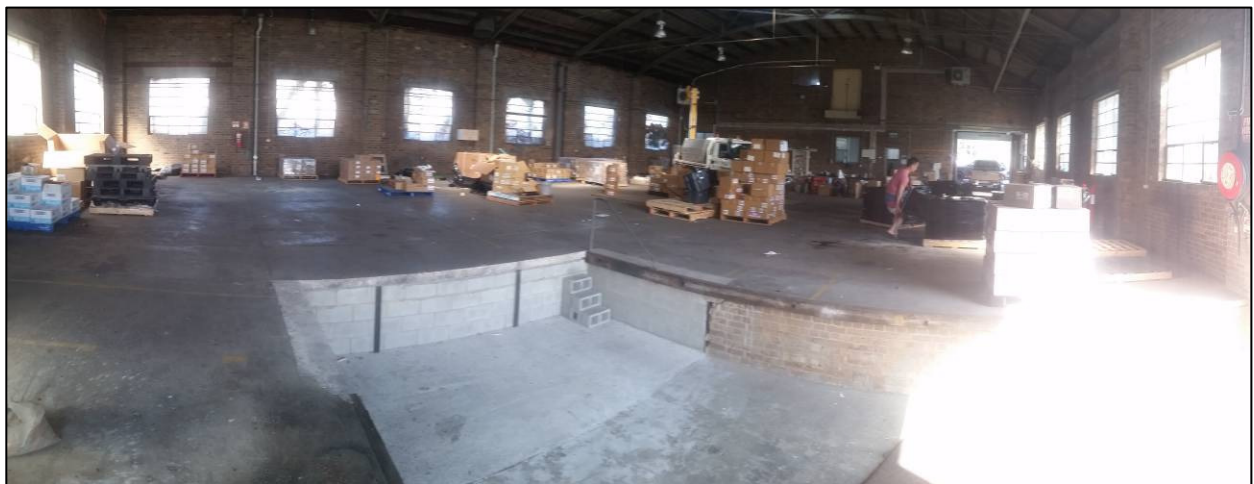
**Photograph 2 – Inside Warehouse**
