HERITAGE IMPACT STATEMENT

**WESTERN SYDNEY
UNIVERSITY
BANKSTOWN CITY
CAMPUS**

**74 RICKARD ROAD,
BANKSTOWN**

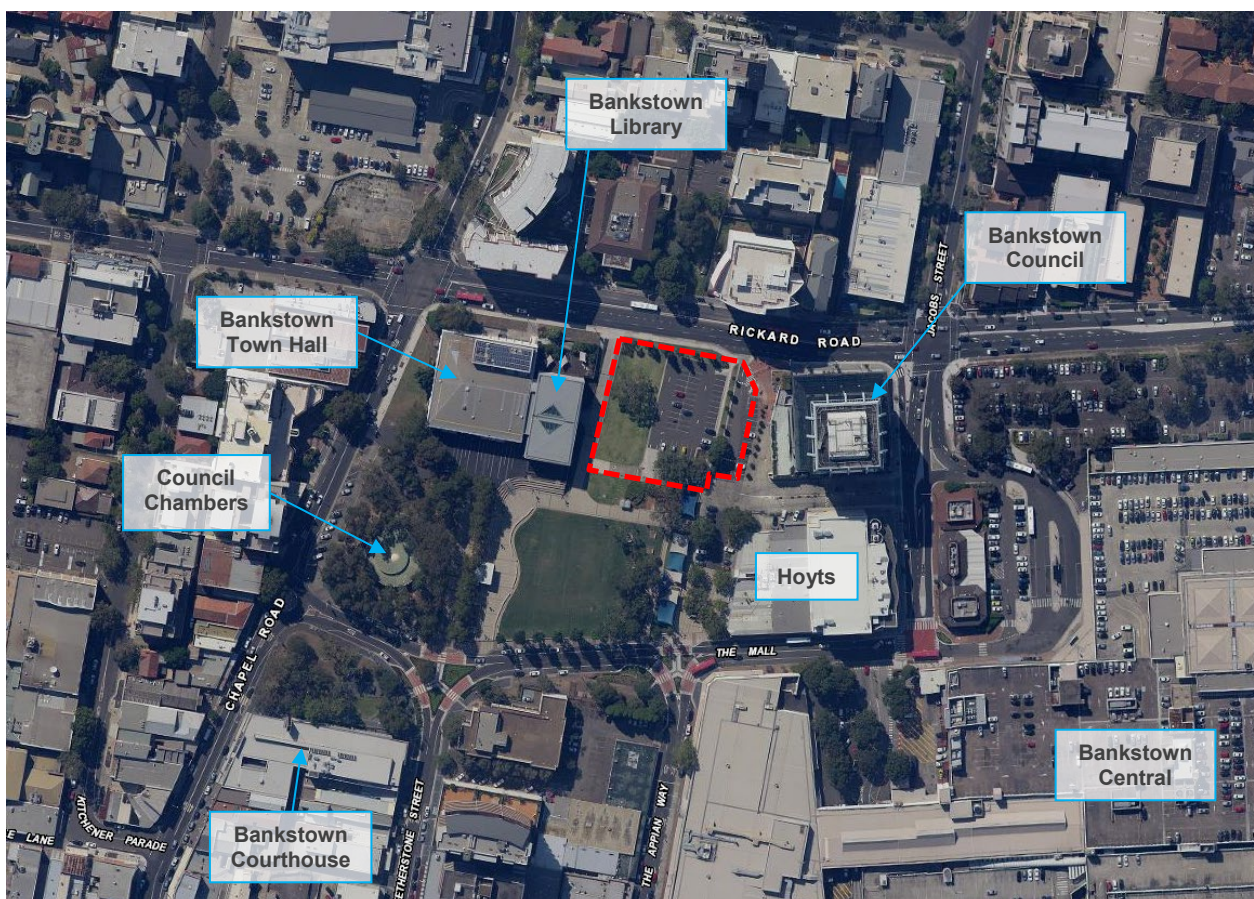
Figure 4 – Aerial view with subject site outlined in red, and surrounding building identified.

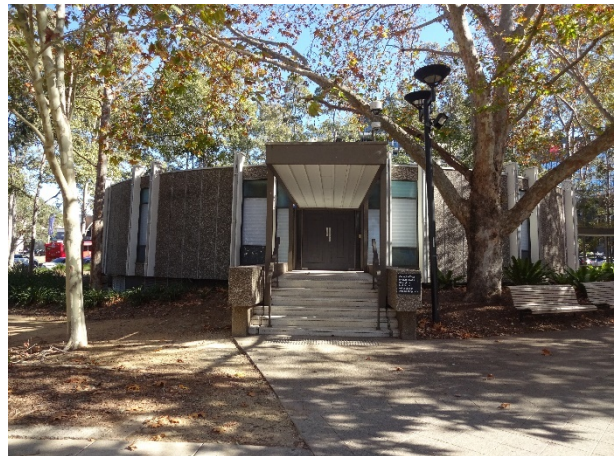
Figure 7 – View towards the south façade of the Council Chambers.

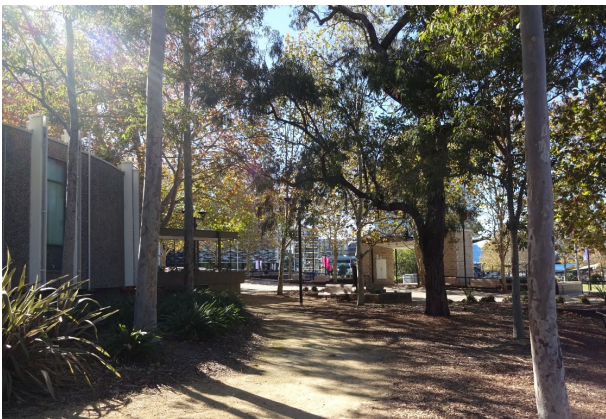
Figure 17 – View of setting around Council Chambers.

The circular Council Chambers building is small in scale, and set within an informal landscaped setting. The single level building is accessed by two bridge like porches. The main entry is on the north elevation facing the Town Hall, with the secondary entrance on the east elevation facing the former Administration Building.

The structure is designed as two concentric circles with the Chambers occupying the inner circle. This inner circle of the building has a raised ceiling with domed sky light centred above it. The central space is open with raised seating lining the room. Despite its intimate scale the Chambers has seating for 20 Councillors, Mayor, Town Clerk and senior administrative officers plus public gallery seating for between 80-160 and a press room seating six. The outer ring of the building houses a Committee Room and adjacent facilities, Mayor's Room with ensuite, and Councillors Room with kitchen.

The building has a concrete floor slab that sits on piers supported on radial beams framing into a circumferential beam. The roof framing too is a complex of radial rigid frames of steel, supported horizontally at two levels against ring beams eccentric to each other. The lower ring beam of reinforced concrete is supported by steel columns. The external walls are clad with precast exposed aggregate panels. Precast columns at regular intervals frame aluminium framed windows. The columns also house the down pipes. The roof is shallow or flat with a central raised shallow drum. Located off centre of the circle form is the domed skylight. The overall roof form is clad in ribbed copper roof sheets with lapped and folded ribs.

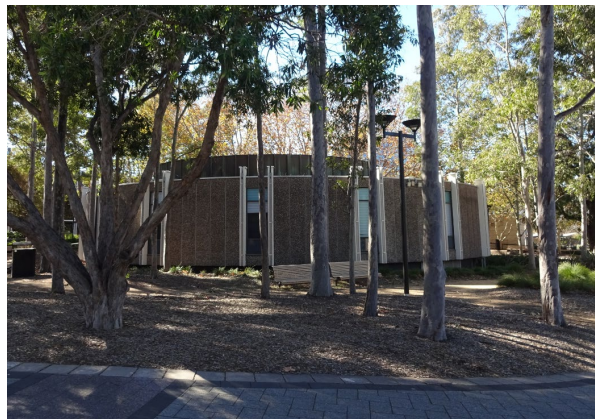
Figure 18 – View towards side elevation of Council Chambers.

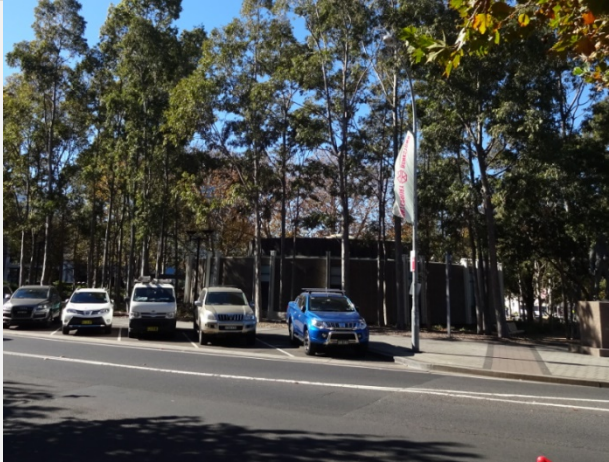
View	Significance and Impact	Image
1	This is the most encompassing view of the heritage item from the street. The proposed tower would be visible behind the item in this view however would not obscure the view. Note that other buildings are visible in the background behind the heritage item.

<p>View towards the heritage item from the south west.</p>
2	This is the most encompassing view of the entrance to the heritage item. The proposed tower would be visible behind the item in this view however would not obscure the view. Note that other buildings are visible in the background behind the heritage item.

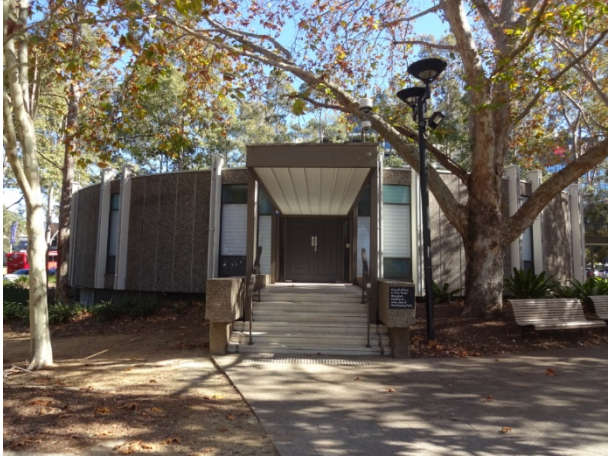
<p>View towards the heritage item from the south west.</p>
3	Views from Rickard Road to the heritage item are currently obscured by the contemporary eastern extension to the Bankstown Town Hall, the utilities building to the west of Paul Keating Park and the mature landscaping around the Council Chambers. It is not considered that this is a significant heritage view.

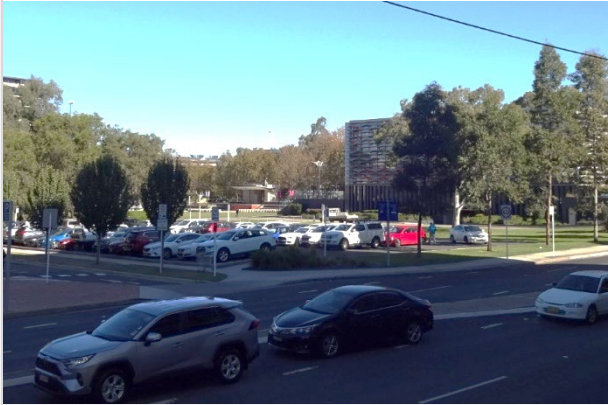
<p>View towards the heritage item from the north east (Rickard Road).</p>

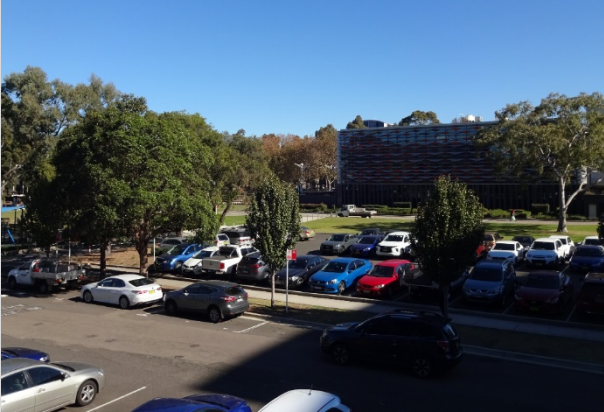
View	Significance and Impact	Image
4	<p>Views from the raised landing outside 68 Rickard Road towards the heritage item are currently obscured by the utilities building to the west of Paul Keating Park and the mature landscaping around the Council Chambers. It is not considered that this is a significant heritage view given the view is highly obscured and the viewpoint is from private property.</p>

<p>View towards the heritage item from the raised landing outside 68 Rickard Road.</p>

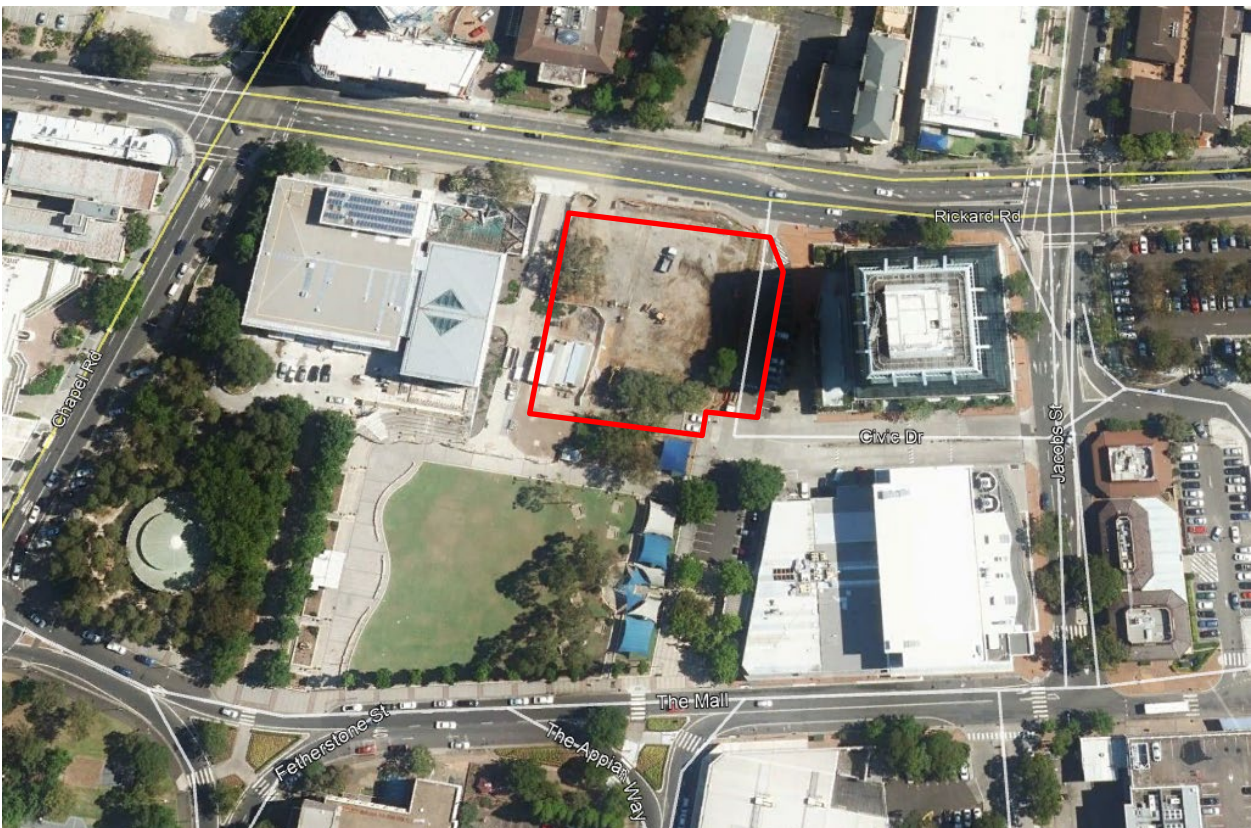
Figure 35 – 2014 aerial photograph with the subject site outlined in red. Works are underway on the subject site for new landscaping and carparking area.

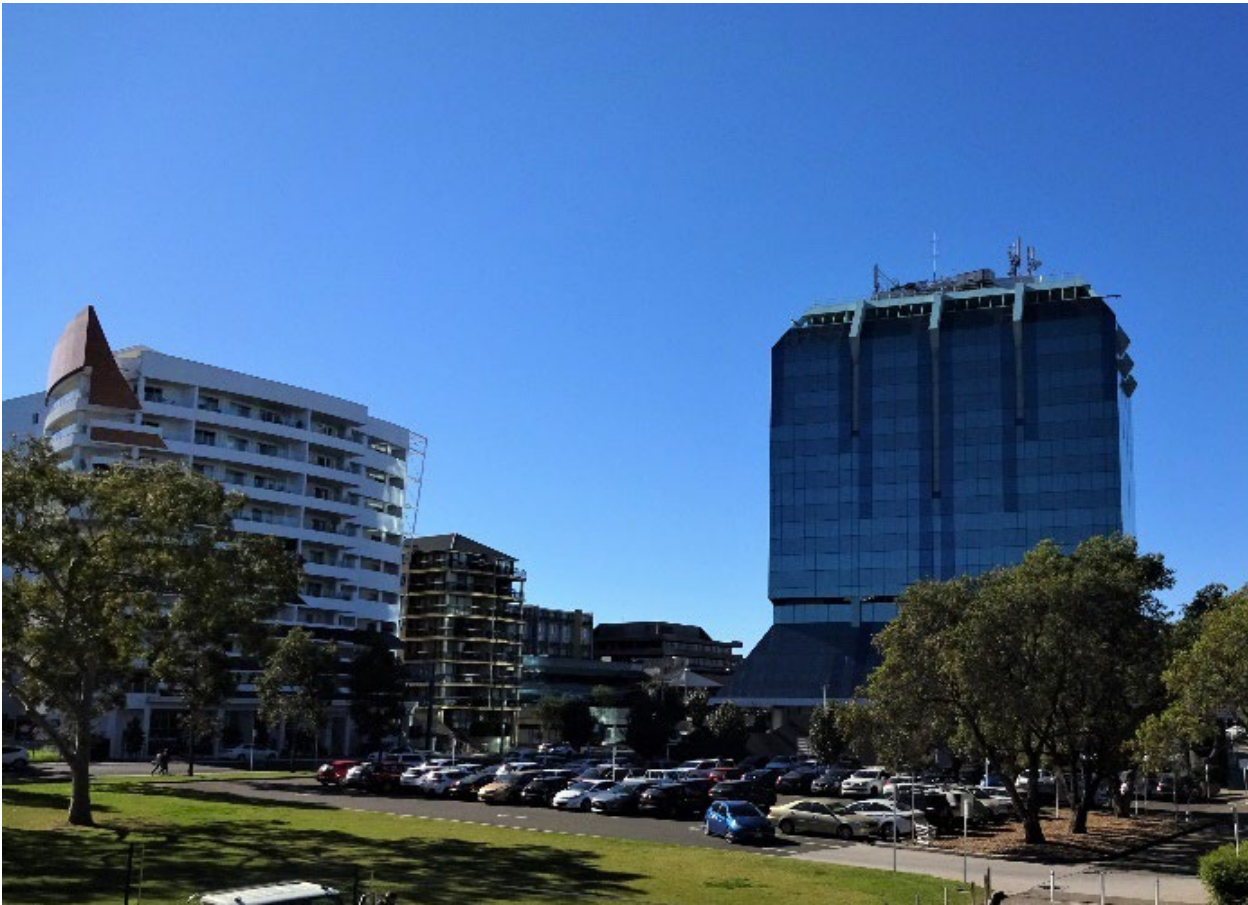
Figure 38 – Existing development visible in the broad context of the Bankstown City Centre.

- The proposed building would be visible to the rear of the Council Chambers when the latter is viewed from the intersection of Chapel Road and The Mall. However, it should be noted that the proposed building is in keeping with the character of the Bankstown City Centre and the character of existing buildings which are also visible from this vantage point (including that at 68 Rickard Road and 75 Rickard Road).

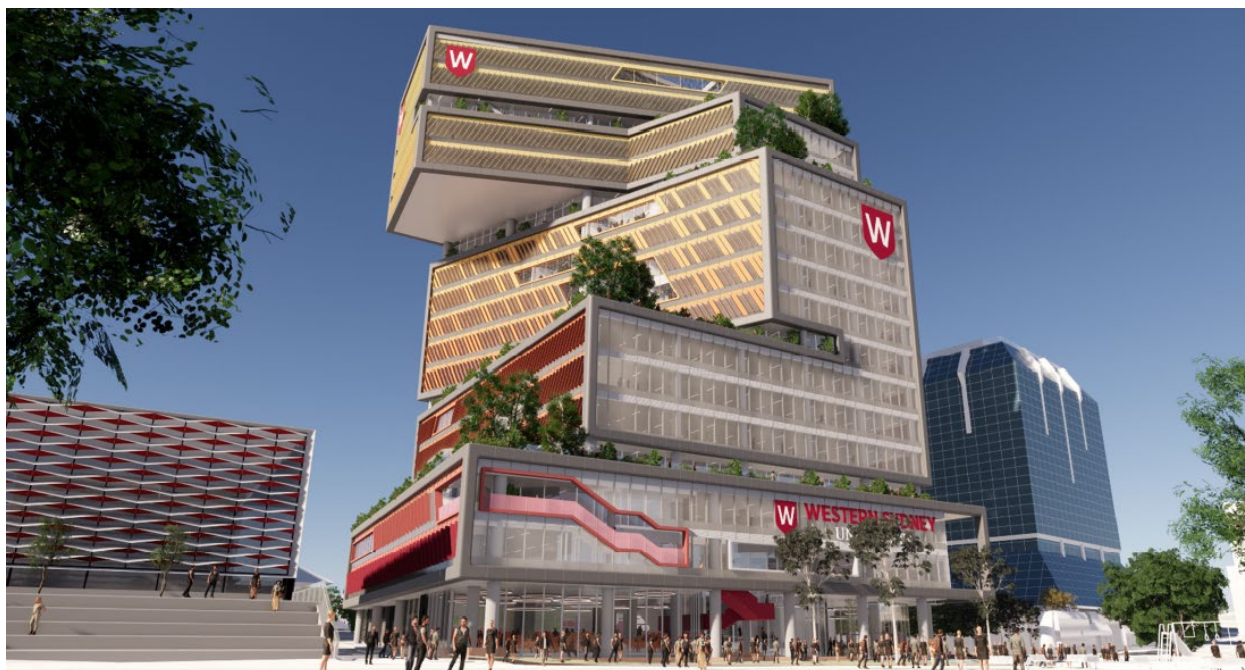
Figure 39 – Render of the south west corner of the proposed building.

- The landscaping on the ground plan is largely confined to the eastern boundary of the site. However, in addition to the above, landscaping has been incorporated throughout the building form which softens the presentation of the building in visual context of the heritage listed item. Substantial outdoors areas are created by the splay of the building forms and mature landscaping would be incorporated into the areas. Landscaping is visible on all four facades of the proposed building.
