# PLANNING PROPOSAL

## AMENDMENT TO CANADA BAY LOCAL ENVIRONMENTAL PLAN 2013

### THE CANADA BAY CLUB

3 May 2017

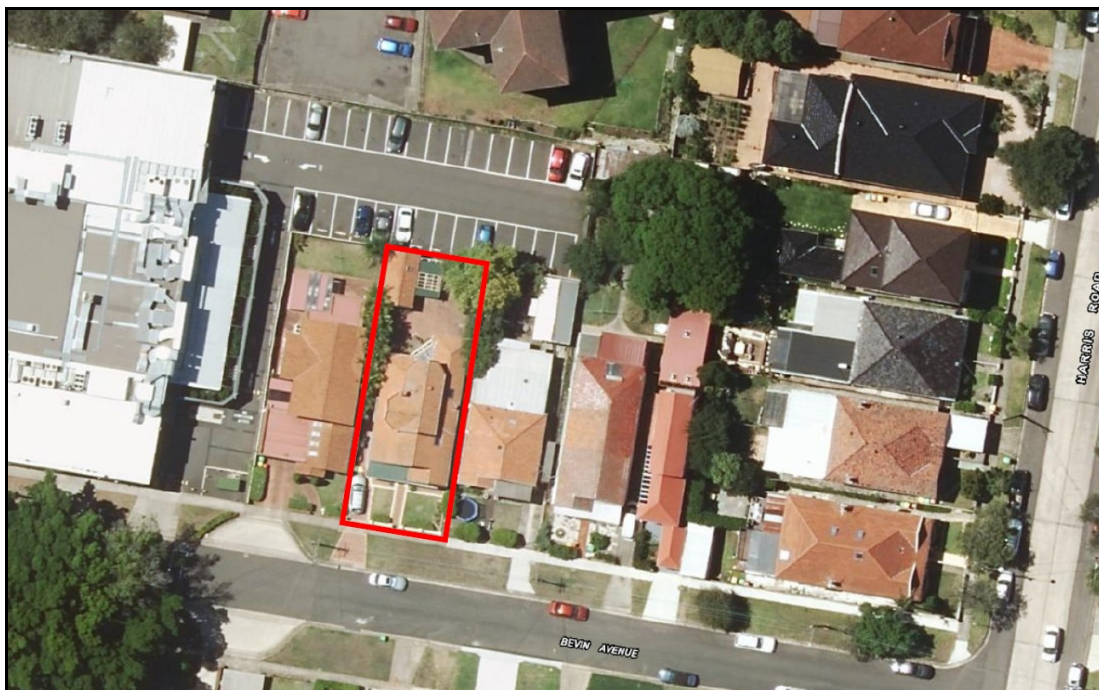
**Figure 2:** Extract from an aerial photograph showing the location of the Site. © SIX Maps

An extract from an aerial photograph of the Site is at **Figure 2**.

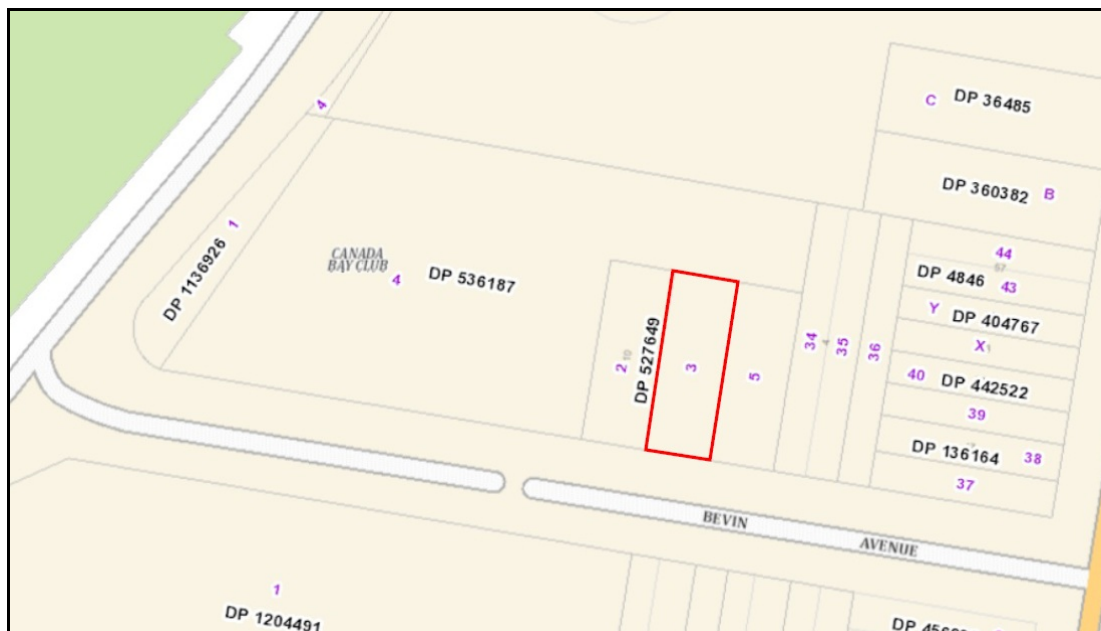
**Figure 3:** Cadastral map of the locality with the Site outlined in red. © SIX Maps

A cadastral map is at **Figure 3**.
