Remedial Action Plan  
13 Endeavour Road, Caringbah, NSW

17 September 2020

JBS&G Australia Pty Ltd

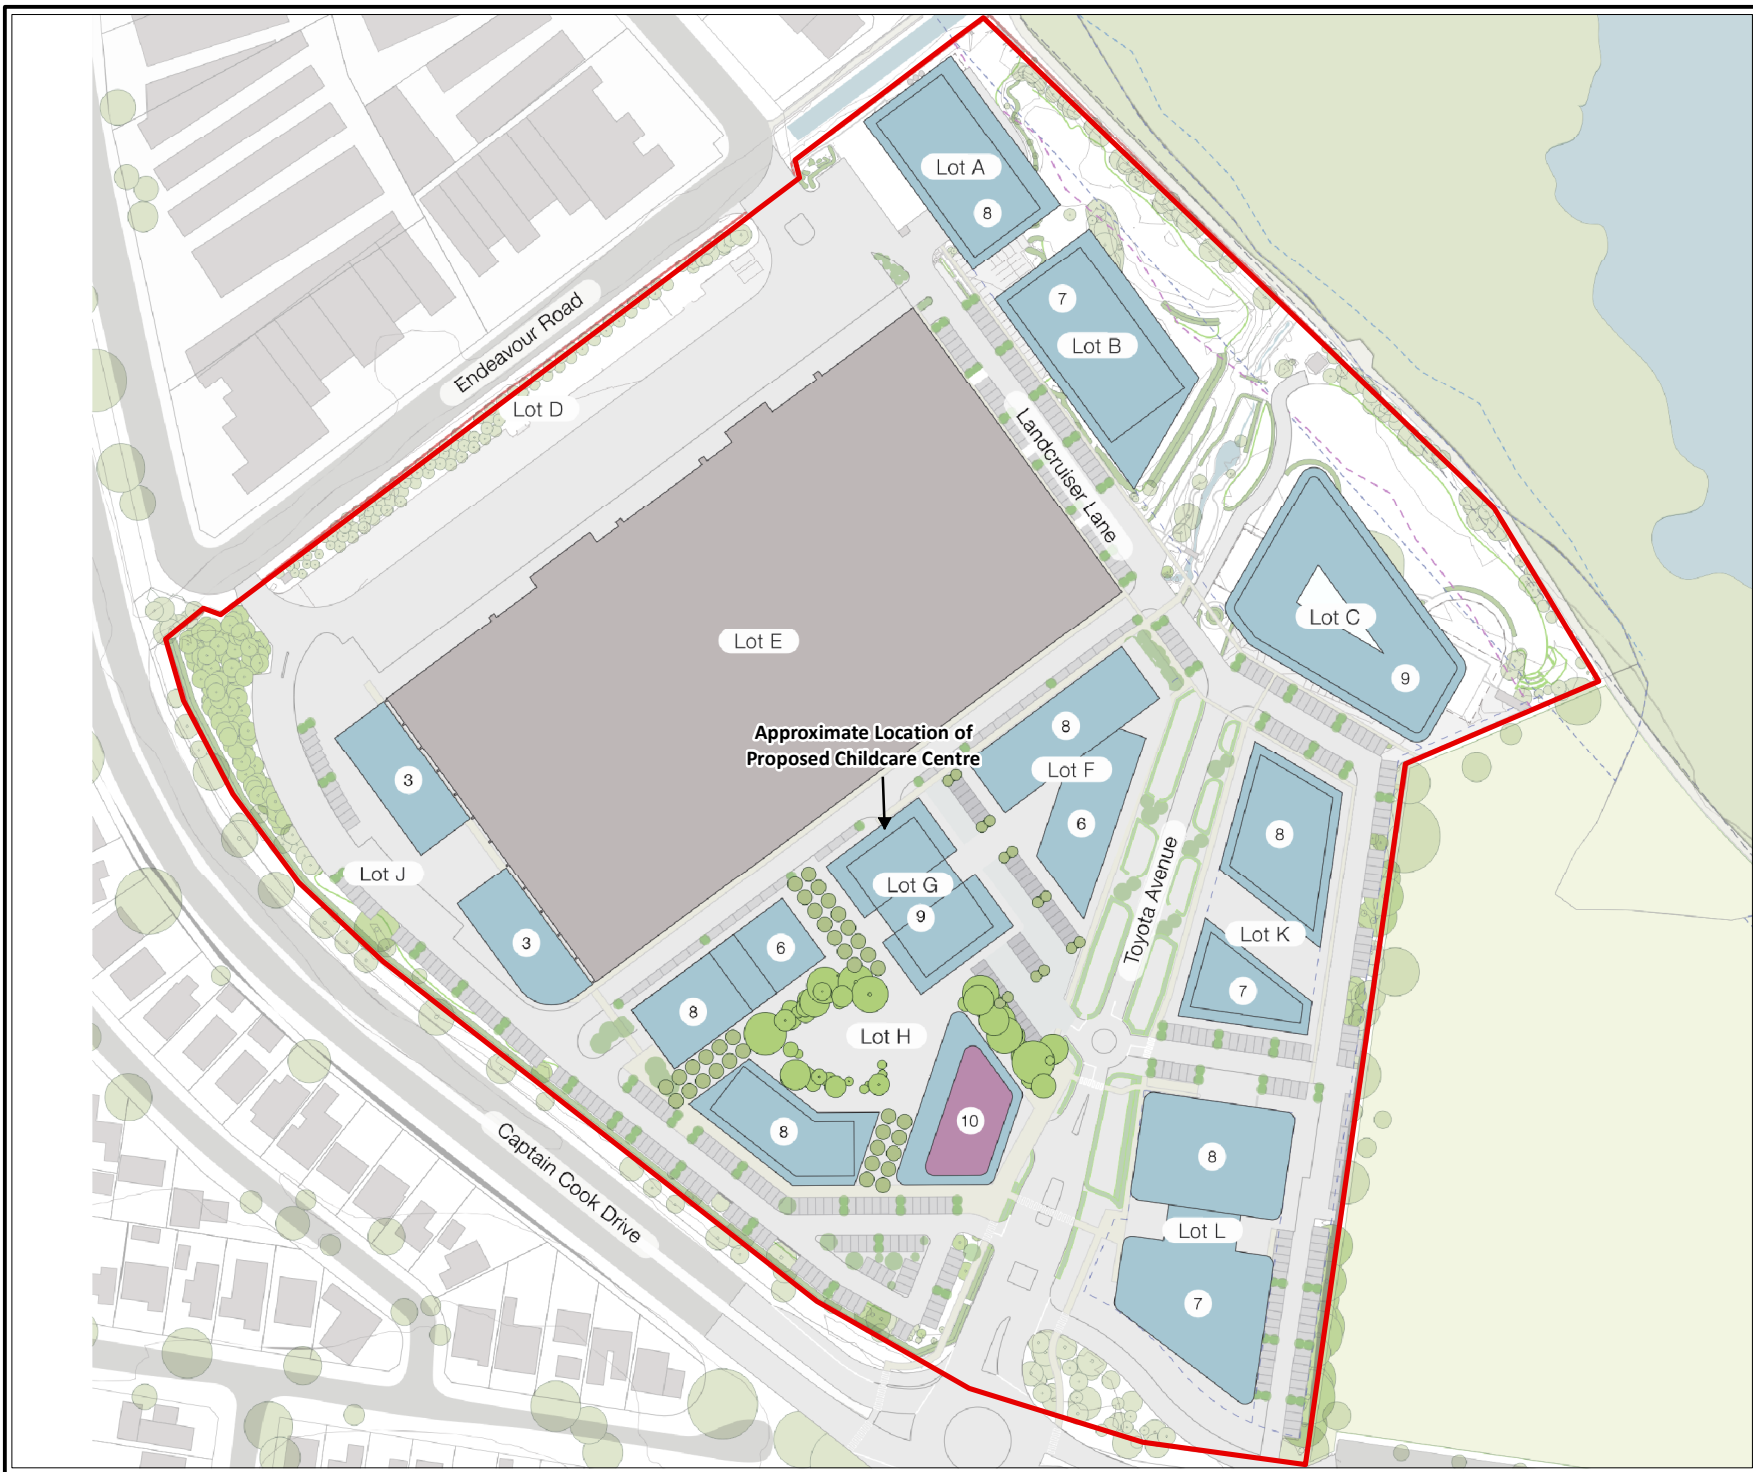
**FIGURE 3**

Coord. Sys. GDA 1994 MGA Zone 56  
**13 Endeavour Road,  
Caringbah NSW**  
**PROPOSED DEVELOPMENT**

It is proposed to retain the large existing warehouse structure present over the central and north-western portion of the site and maintain the existing internal road network. Other smaller structures will be demolished and replaced with several multi-storey buildings, typically present over the north-eastern, eastern, central and south-western portions of the site. New buildings will be constructed as 8 to 12 storey buildings, further constructed as slab on grade structures (i.e. no basements).

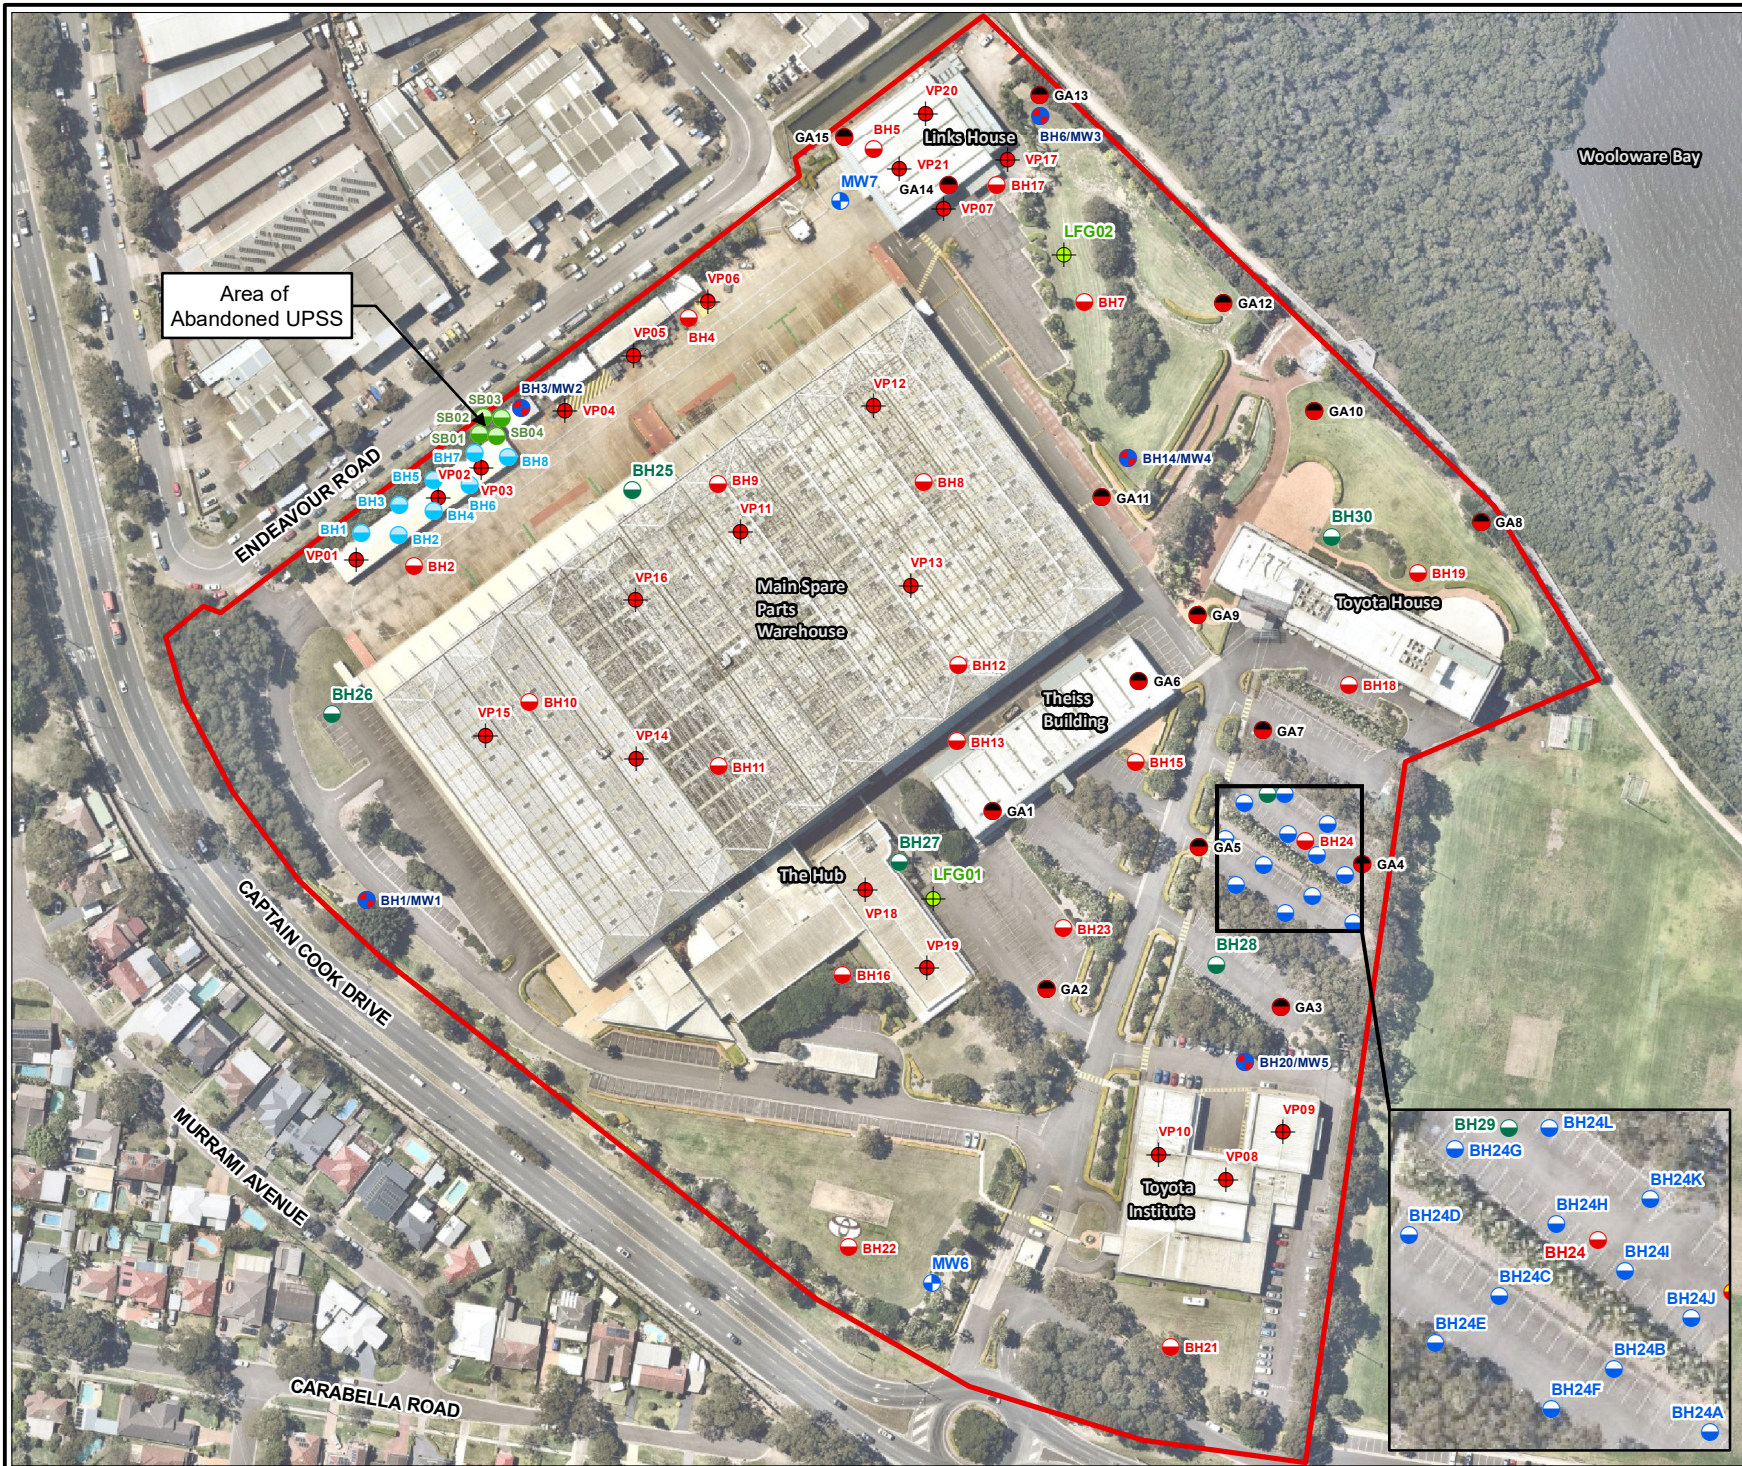
**FIGURE 4**

- Approximate Site Boundary
- Sample Locations**
  - Golder 1998
  - CES 2005
  - NA 2012
  - Borehole, AECOM 2019
  - Borehole/Groundwater, AECOM 2019
  - Borehole, JBS&G 2020a
  - Ground Gas Wells, JBS&G 2020a
  - Borehole, JBS&G 2020c
  - Groundwater, JBS&G 2020c
  - Soil Vapour, JBS&G 2020c

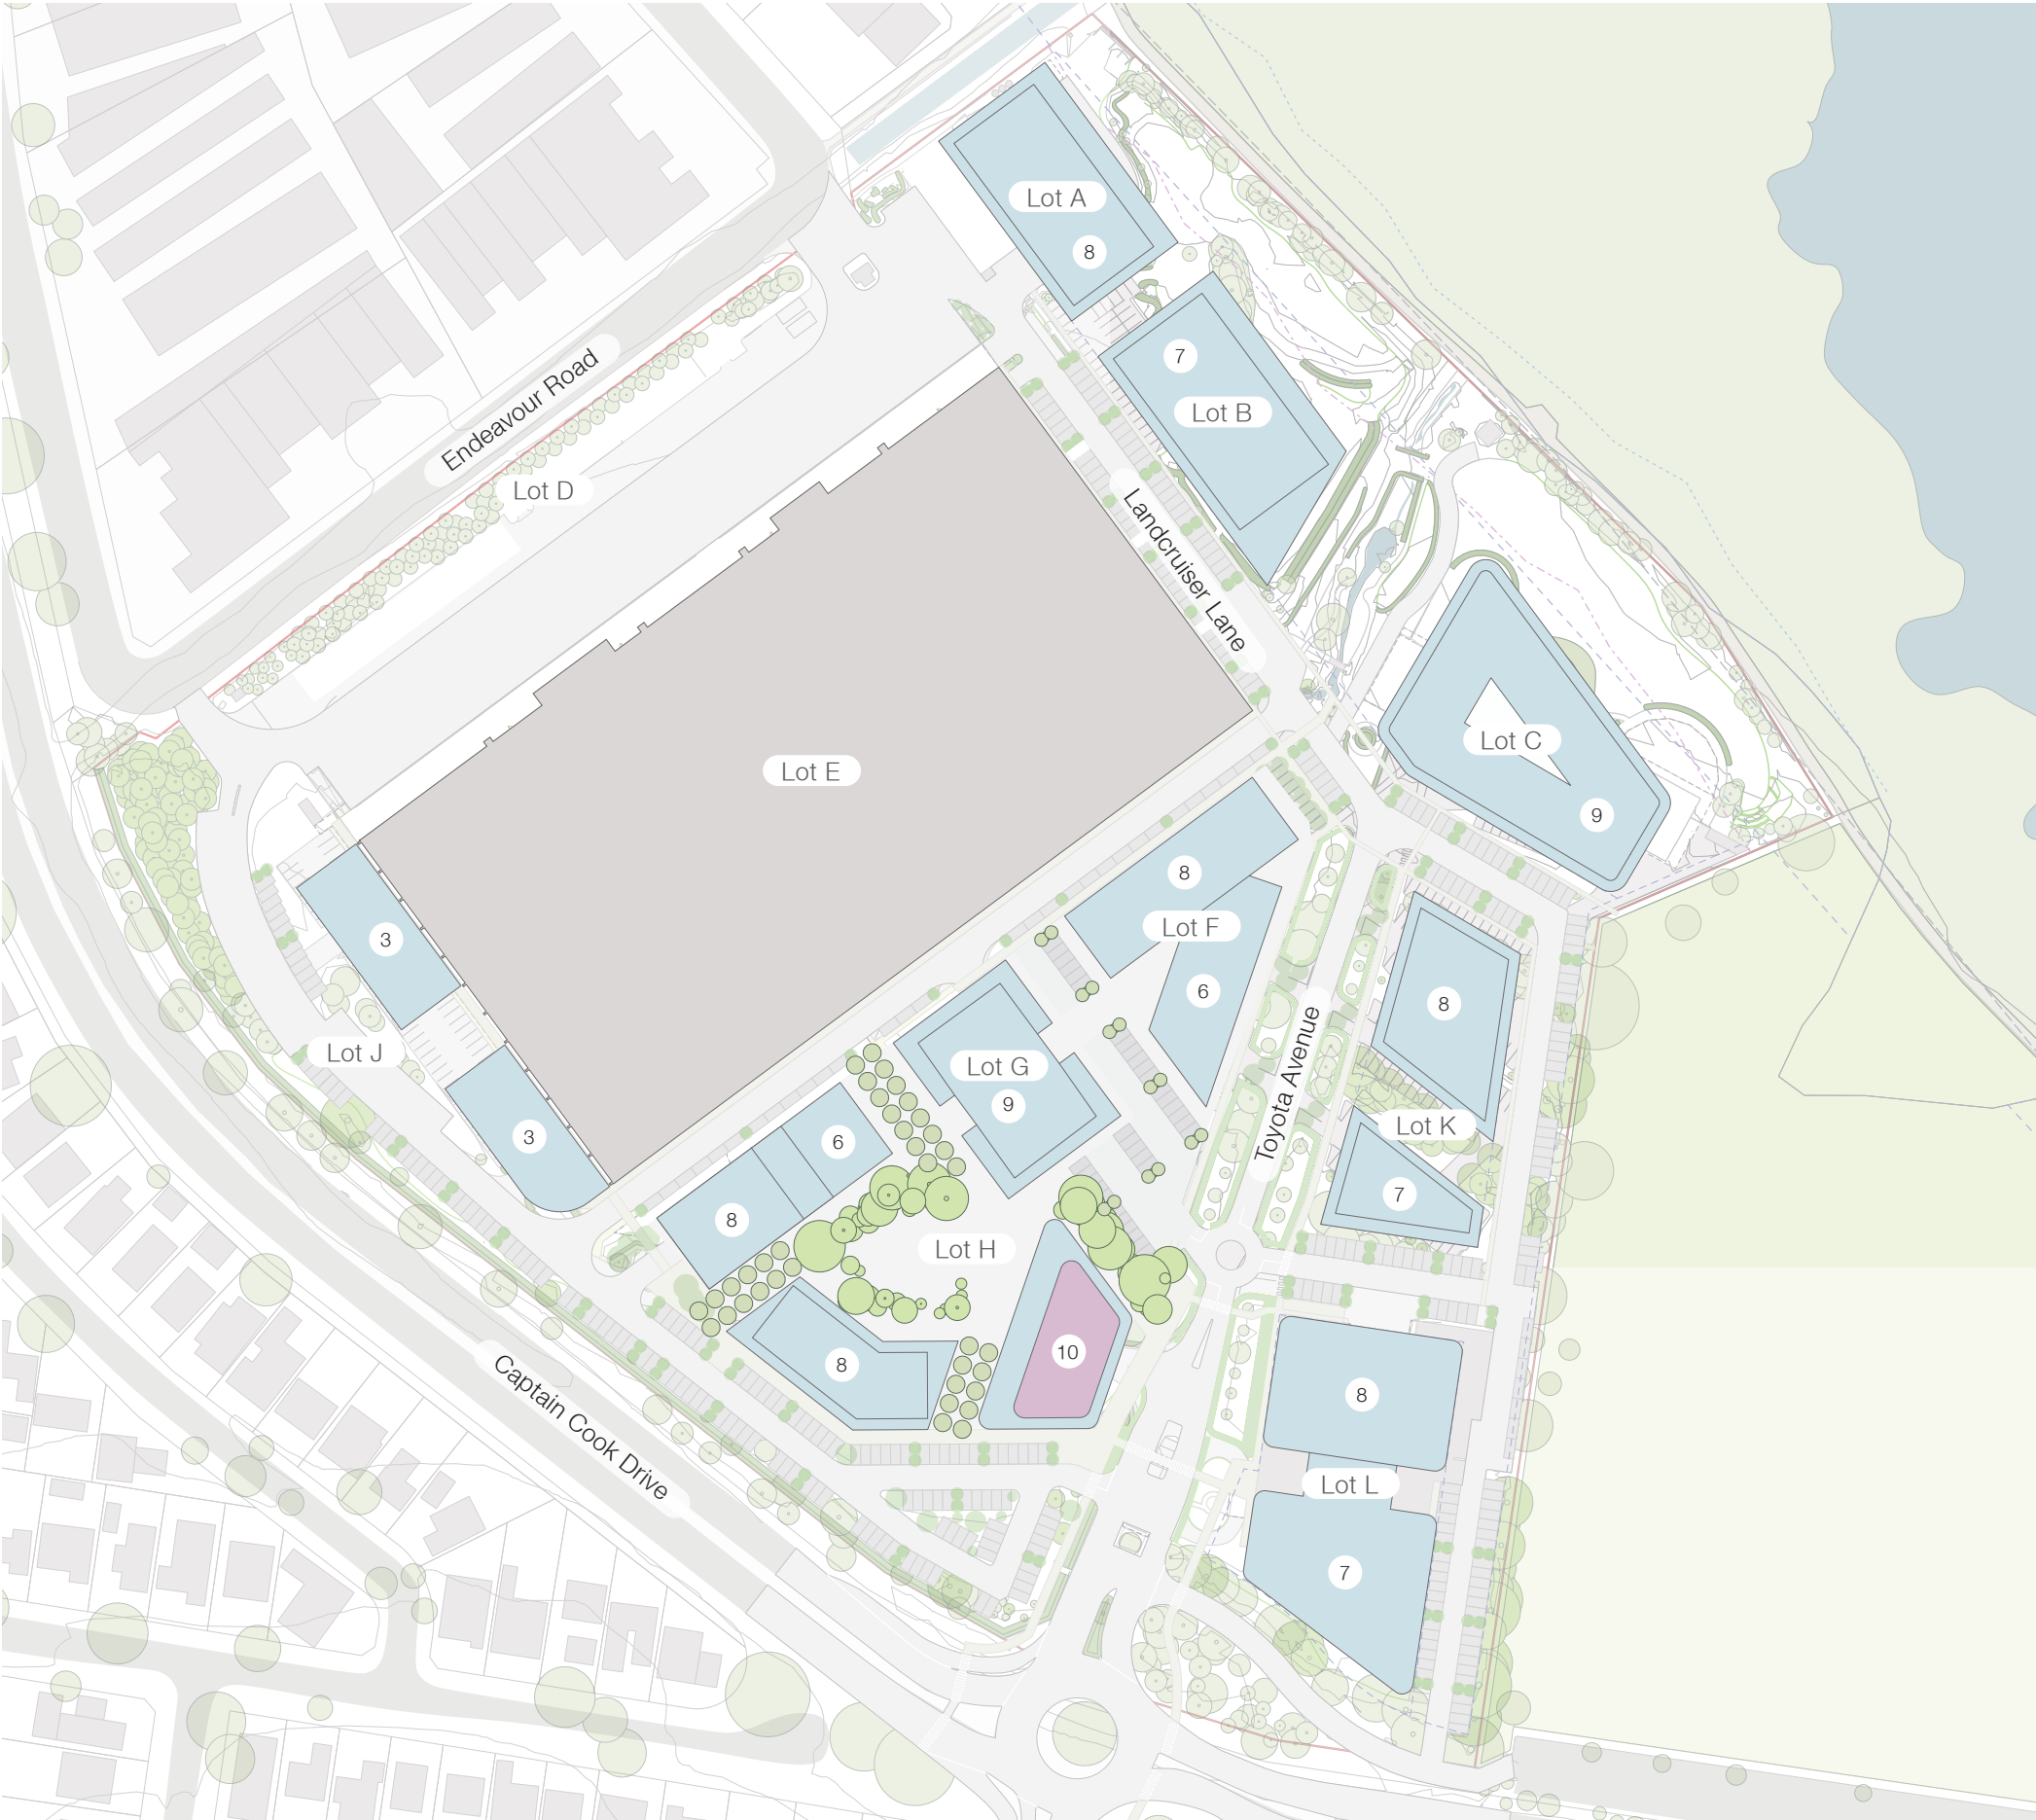
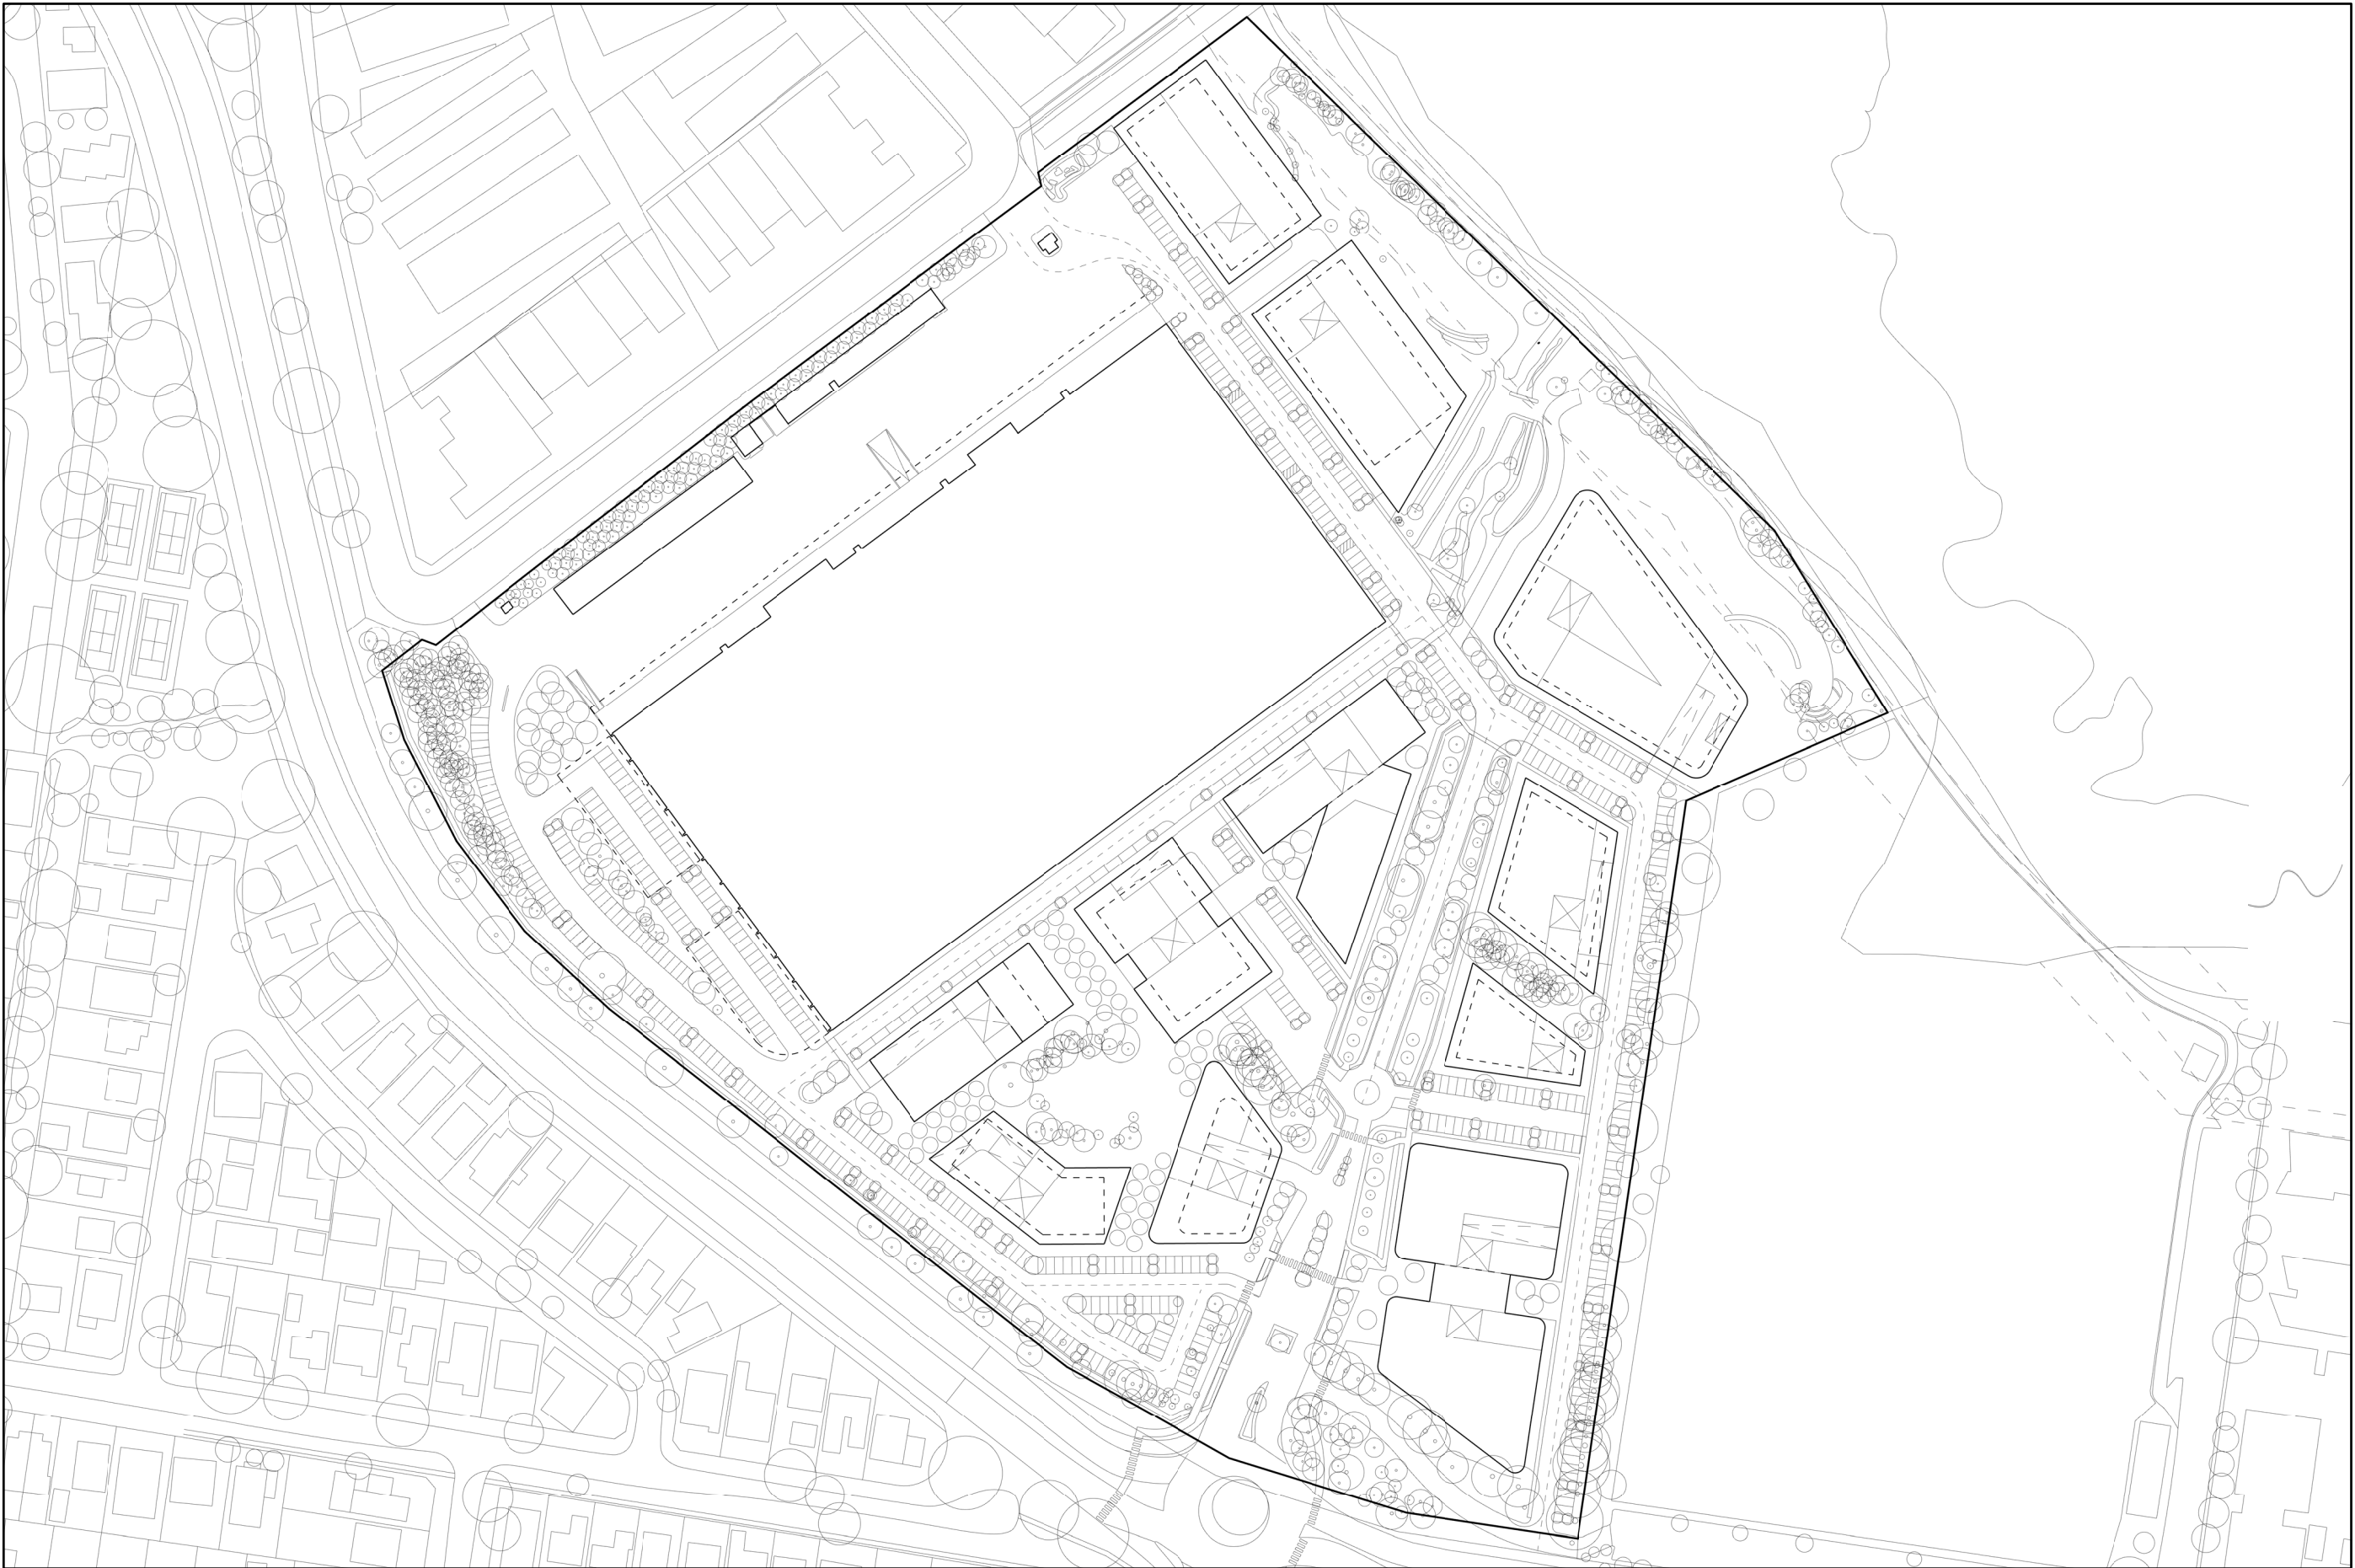
# Site Ground Floor Plan

- Development Lot
- 3m/9m DCP Built Form Street Setbacks
