**SUBJECT: Pre-DA Meeting, Council Information Request 21 – Site Contamination.**

**SUBJECT SITE: Proposed Woolworths Shopping Centre  
Lot 101 DP1028645, Corner New Illawarra and Old  
Illawarra Roads, Barden Ridge, NSW**

## **Preliminary Contamination Assessment**

Lot 101 DP1028645  
Corner New Illawarra and Old Illawarra Rds  
Barden Ridge, NSW

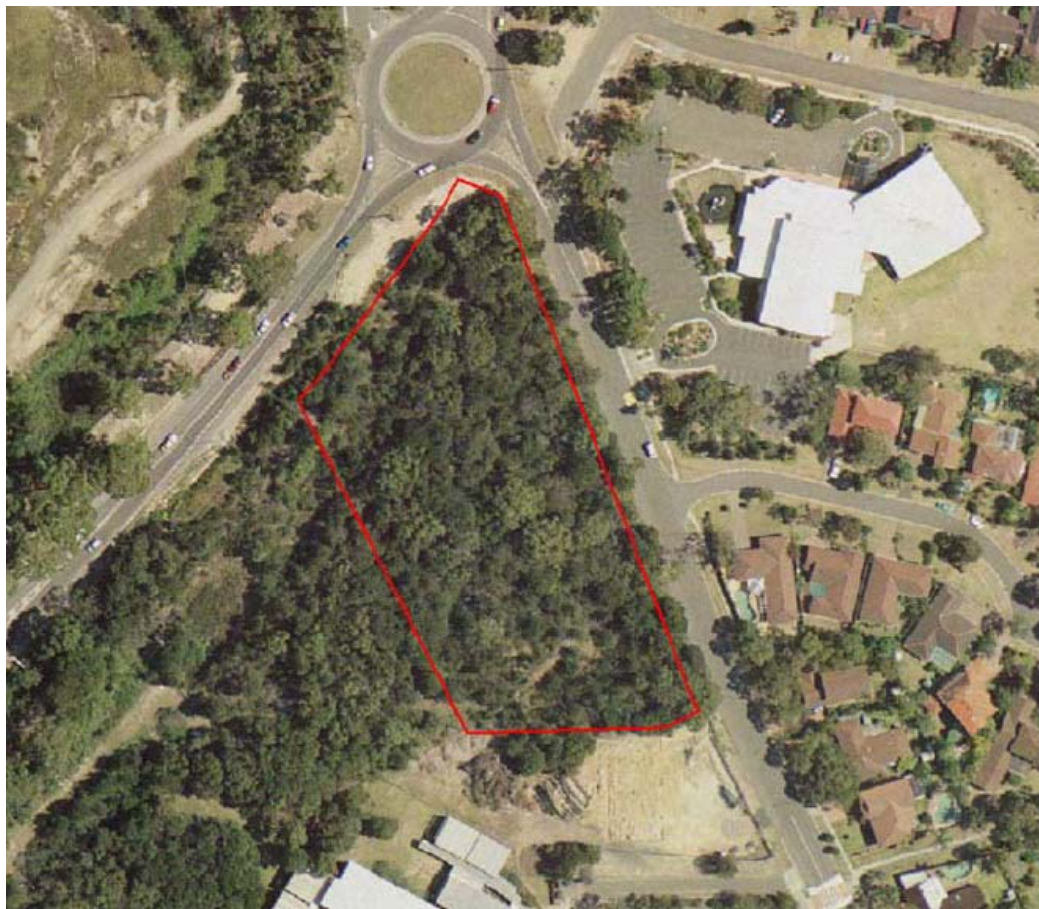
**Photo 1** – Site and surrounding areas in 2006.

Some shallow fill material is identified in the northern portion of the site, likely associated with the former road in this area. Fill material is also identified along the eastern site boundary, adjacent to Old Illawarra Rd. Remaining areas of the site consist of natural soils, with sandy soils and natural sandstone outcrops visible.
