**Lot 6 DP244030 & Lot 9 DP250425  
Diamond Beach Road, Diamond  
Beach**

**Environmental Assessment and Land  
Capability Study**

GEOTTUN01754AA-AD

30 November 2008

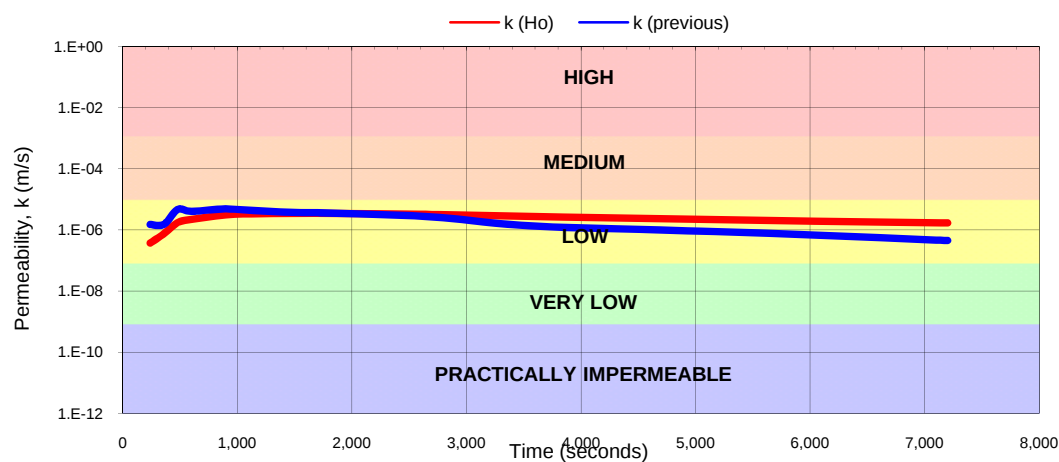
#### Permeability Calculations

#### PERMEABILITY vs ELAPSED TIME

Provision of site stormwater management may incorporate some subsurface infiltration. For the purposes of subsurface infiltration design in situ permeability testing was undertaken in boreholes BH1 to 3. Results are presented in Appendix D and summarised in Table 8.
