**REMEDICATION WORKS  
FORMER SANITARY WASTE FACILITY  
SERENITY WAY, VACY**

**Prepared for Dungog Shire Council**

**Prepared by RCA Australia**

**June 2016**

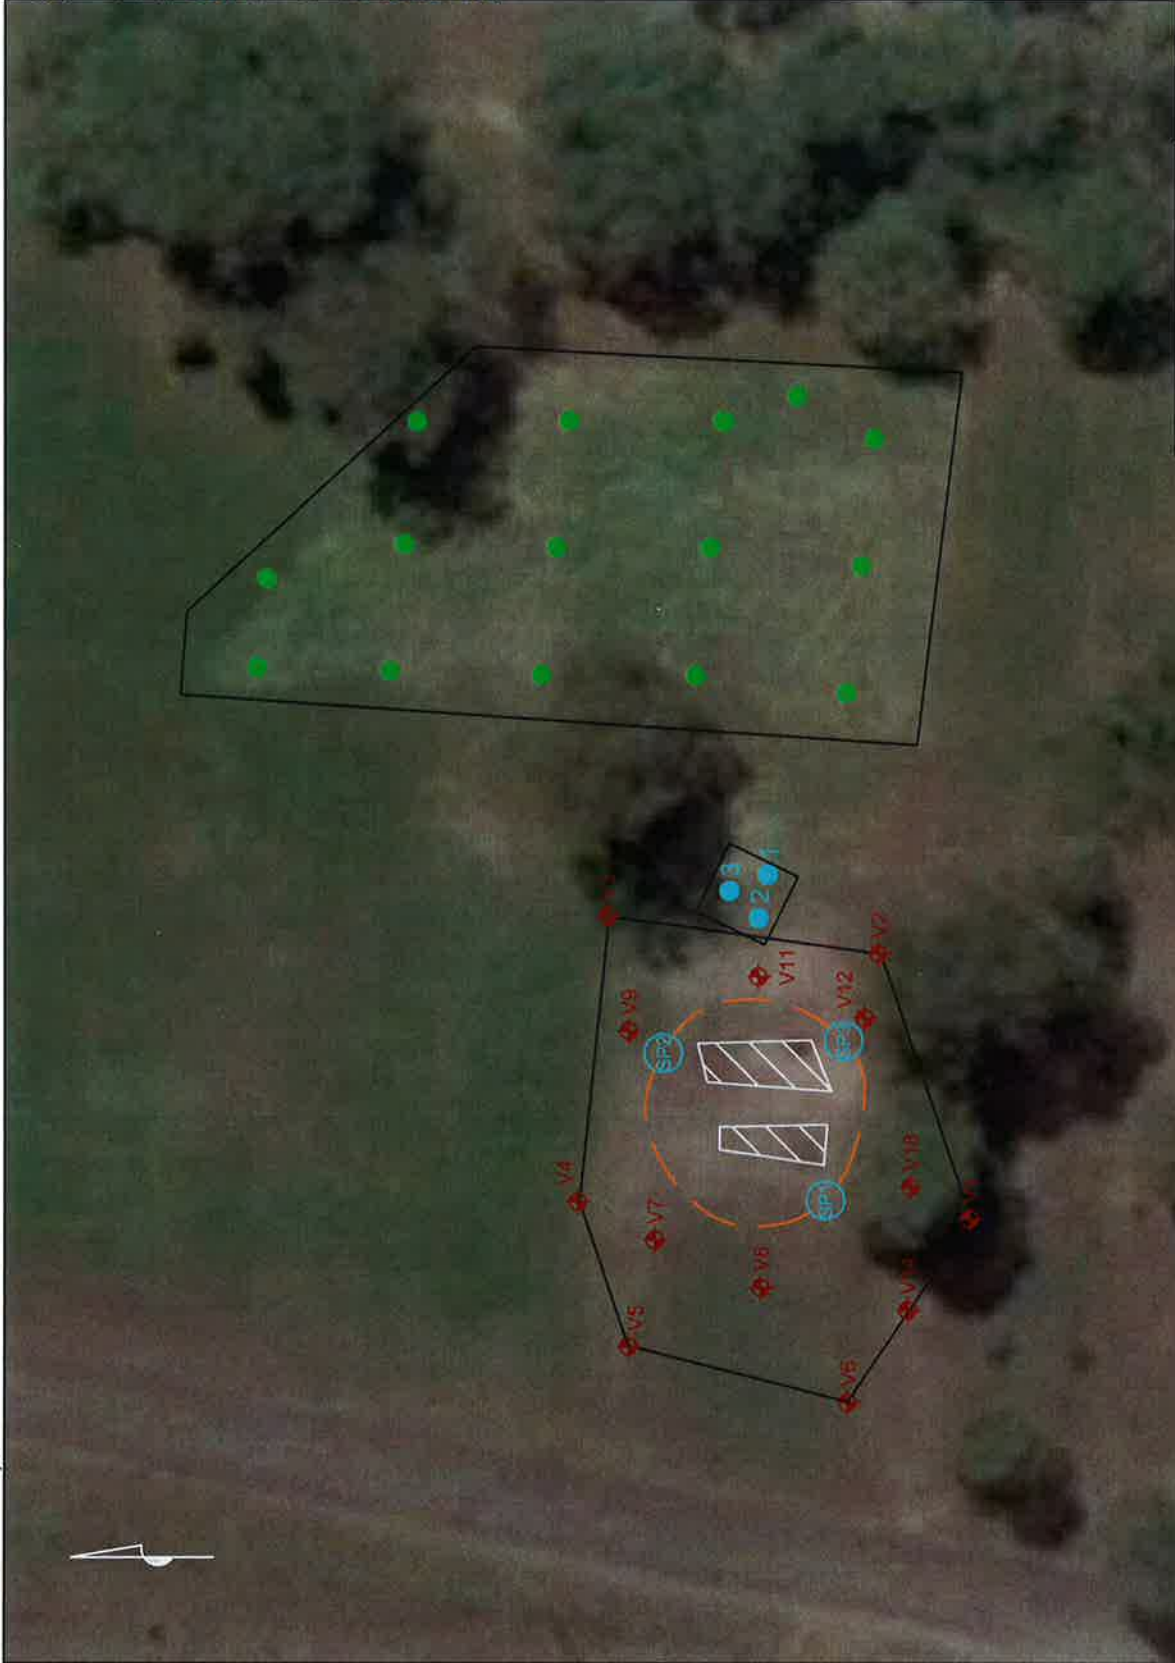
SITE LAYOUT AND LOCATION PLAN  
SERENITY WAY  
VACY

**Drawing 1, Appendix A** shows approximate locations of remediation areas and sampling locations.

Delineation of the tar impacted area is considered to have been achieved with the exception of the north western extent of the area. Delineation samples for each respective direction and depth of the impacted area are summarised in **Table 2** and shown on **Drawing 1, Appendix A**.

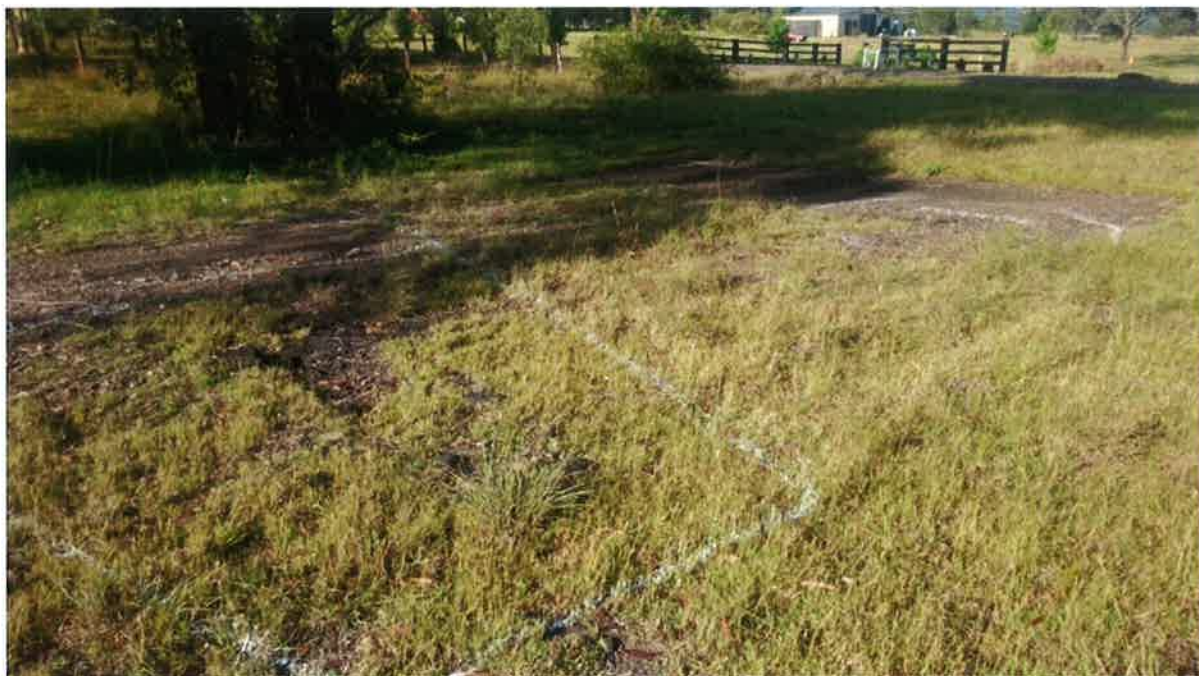
**PHOTOGRAPH 1**    *Tar impacted area marked for removal*

- A site inspection. This site inspection was used to identify impacted areas and mark out these areas which the backhoe was to excavate (**Photograph 1, Appendix B**).

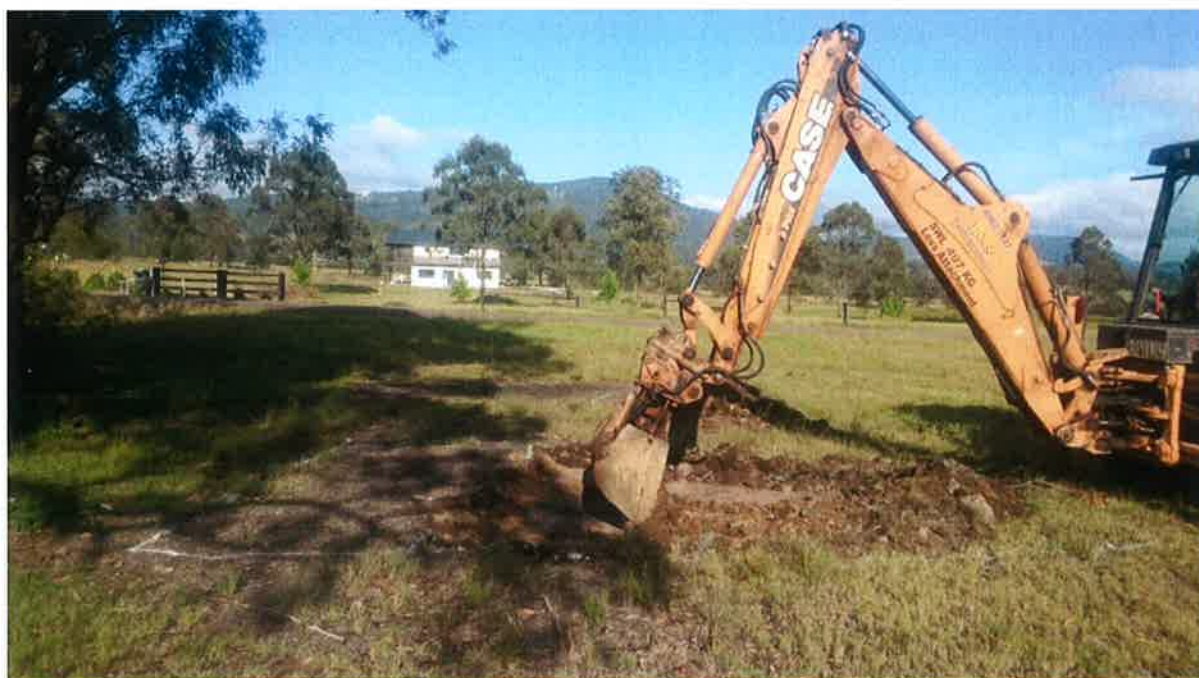
**PHOTOGRAPH 2**    *Scraping of tar impacted area by backhoe*

- Tar material visually identified on the ground surface and underlying soils to 0.4m below the surface were scraped/excavated (**Photograph 2, Appendix B**) and removed off site to an appropriately licensed waste handling facility. The volume of impacted materials removed from site was approximately 10m<sup>3</sup>.

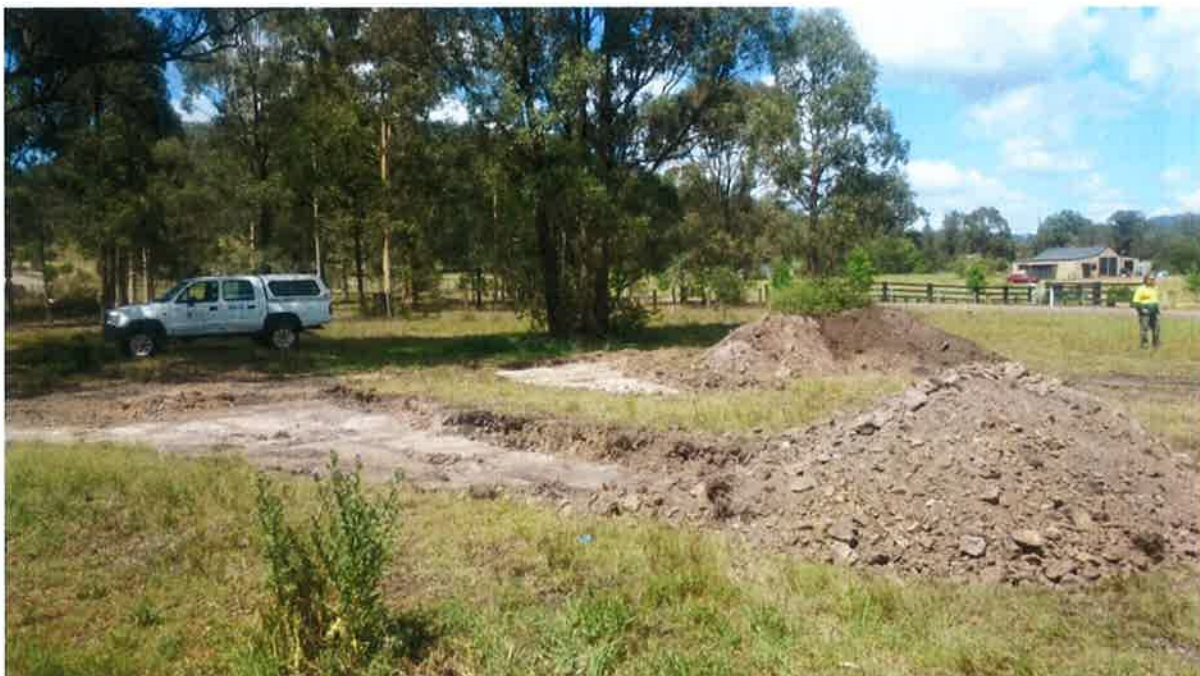
**PHOTOGRAPH 3**      *Completed (scraped) tar impacted area showing stockpiles*

- Further tar impacted materials were observed during these works which were not removed from site due to the vehicle used for removal reaching its load capacity. Some of this material was pushed up into small soil stockpiles adjacent to the scraped areas and the remainder was left *in situ* (**Photographs 3 and 4, Appendix B**). In addition, further tar impacted materials were encountered which correlated to a gravel hardstand area in the south west of the site.

RCA considers that the site is suitable for residential use following the removal of stockpiled gravel material and with implementation of the management protocol. If the items in the protocol cannot be implemented, additional remediation may be required.

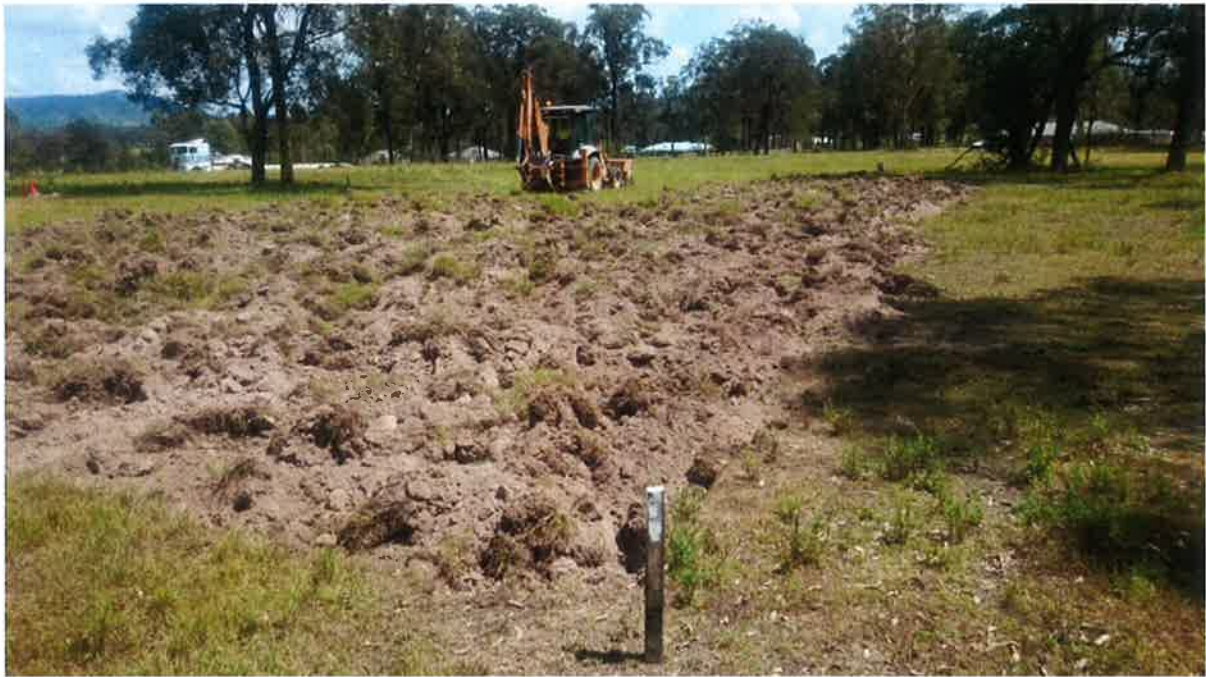
**PHOTOGRAPH 5**      *'Turned' former night soil disposal area*

- The former night soil disposal area, approximately 1,700m<sup>2</sup> in size, was 'ripped' to a depth of 0.4m with the aid of a backhoe (**Photograph 5, Appendix B**).
- An area 4m x 4m in the vicinity of sample location TP15 was excavated to a depth of approximately 0.6m and placed within an adjacent treatment area prepared by RCA measuring approximately 25m<sup>2</sup> in size consisting of a hydrated lime pad to prevent microbial transport into the subsoil (**Photograph 6, Appendix B**). The materials transferred to this area were then allowed sufficient time for material drying and microbial die-off to occur. The materials excavated were based on visual and olfactory evidence encountered in the field.
