Stockton Rifle Range Site Environmental Management Plan

For: Department of Defence

Project Name:	Stockton Rifle Range - Site Environmental Management Plan
Project Number:	3001625.004
Report for:	Department of Defence

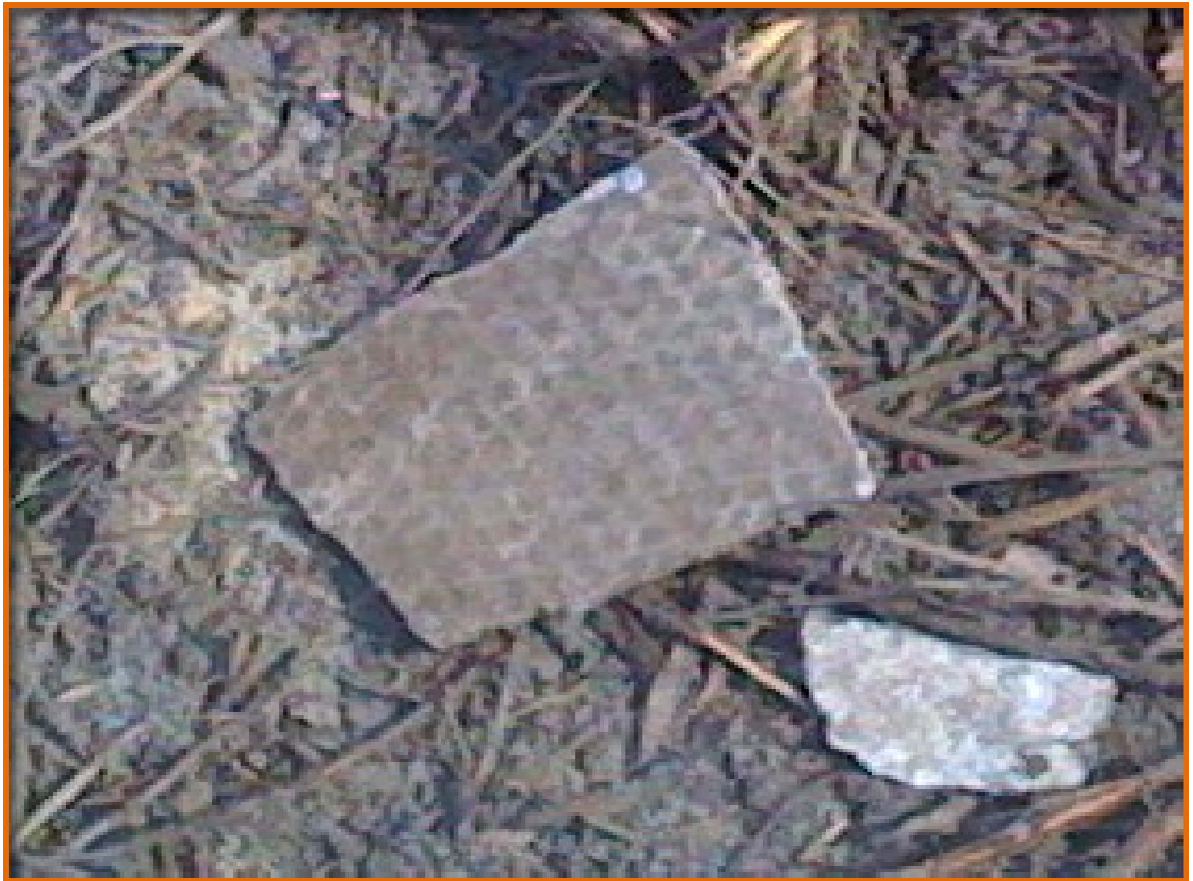
Photo 1: ACM fragment

- RAC 5, Potential Asbestos Containing Material (ACM) in Heavily Vegetated Area – An AS1 licensed contractor hand-picked ACM fragments (**Photo 1, Appendix B**) within and adjacent to 'accessible' areas. An Occupational Hygienist then inspected the ACM removal 'Stages' and provided an Asbestos Clearance Certificate. Where identified ACM could not be removed by hand, these areas were excavated. The estimated surface area of RAC5 was 170,000m².

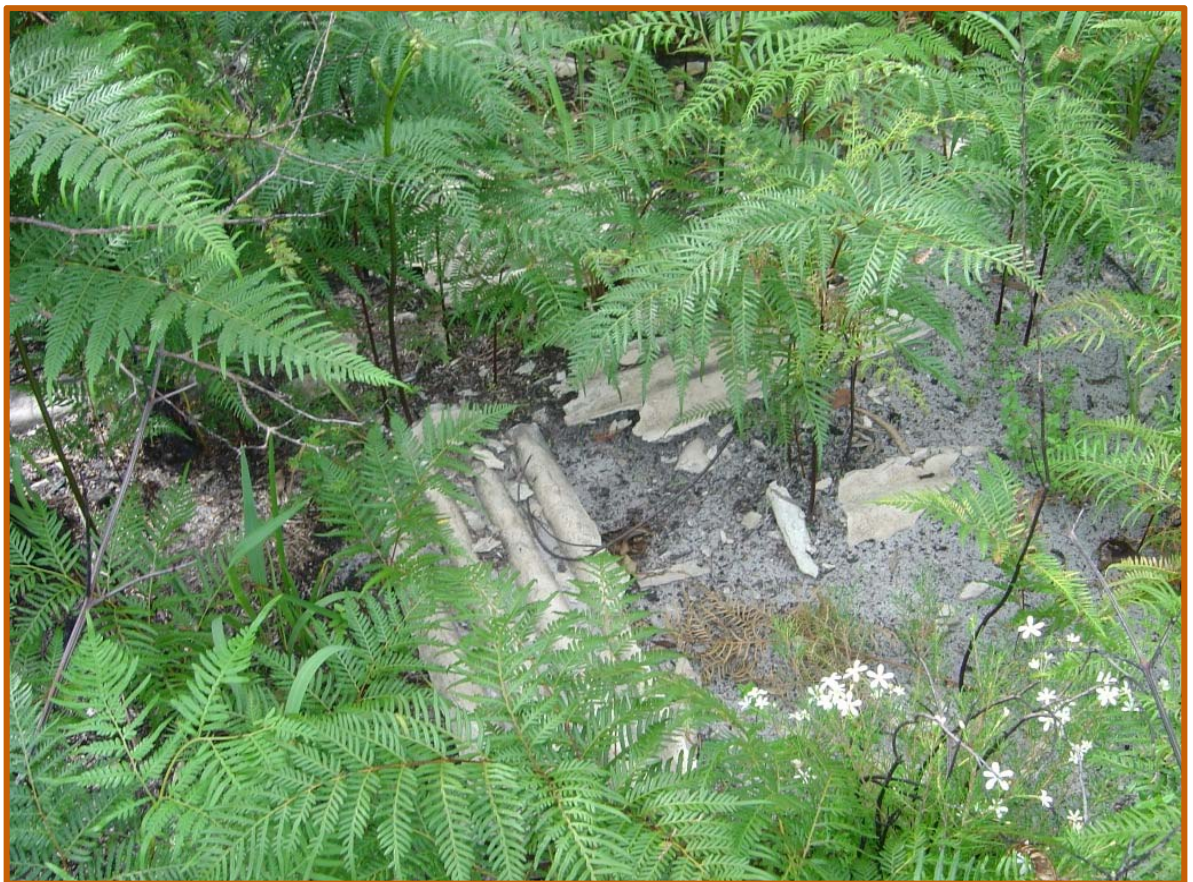
Photo 2: ACM sheeting - Previously encountered within the Northern Heavily Vegetated Area

- Northern Heavily Vegetated area – The northern portion of the site is vegetated by Sand Apple-Blackbutt Forest. Demolition waste, including sheet metal and cement fibre sheets containing asbestos (**Photos 2 and 3, Appendix B**), was noted throughout the accessible portions of this area (approximately 50,000m²). Asbestos fibres were not detected in the surface soils. A Polycyclic Aromatic Hydrocarbon (PAH) contamination hotspot (D4-1) was also identified in this area.

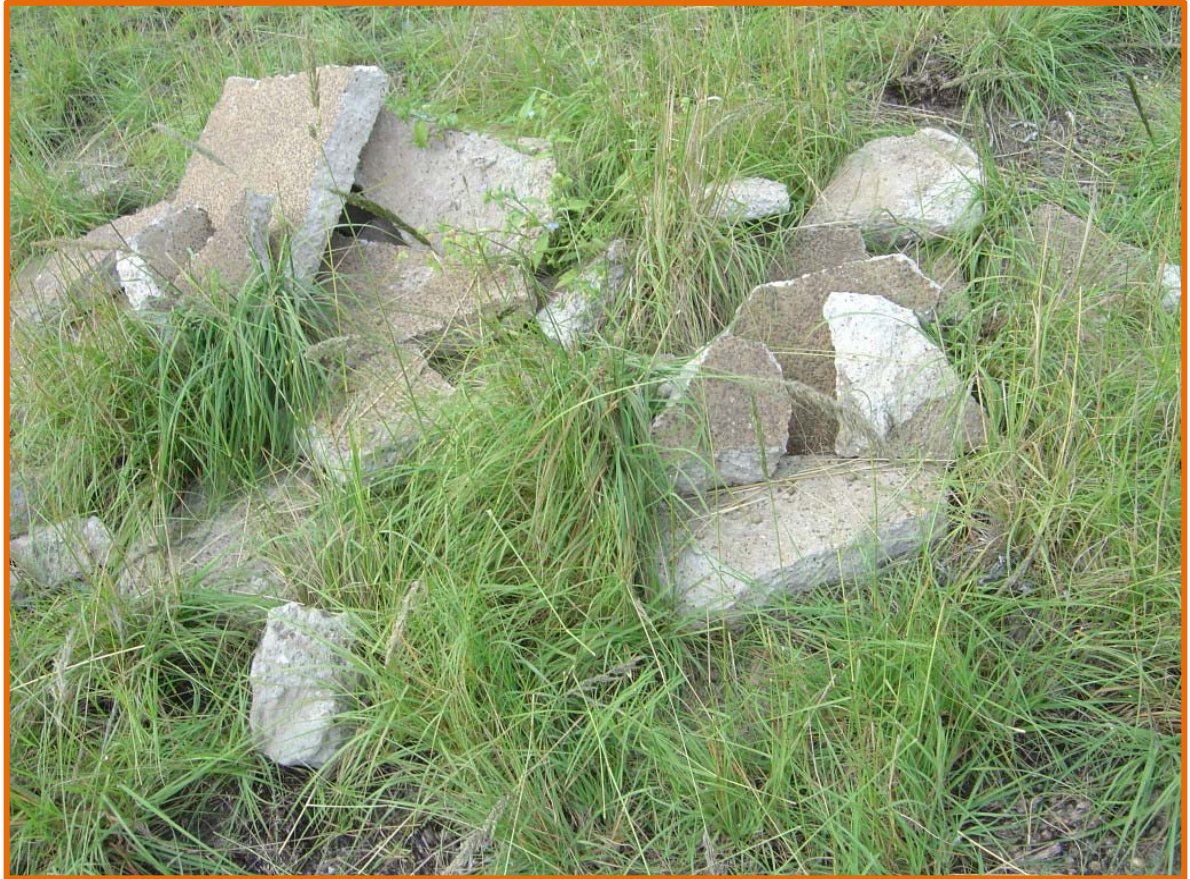
Photo 3: Building and Demolition Waste - Previously encountered in the Northern Heavily Vegetated Area

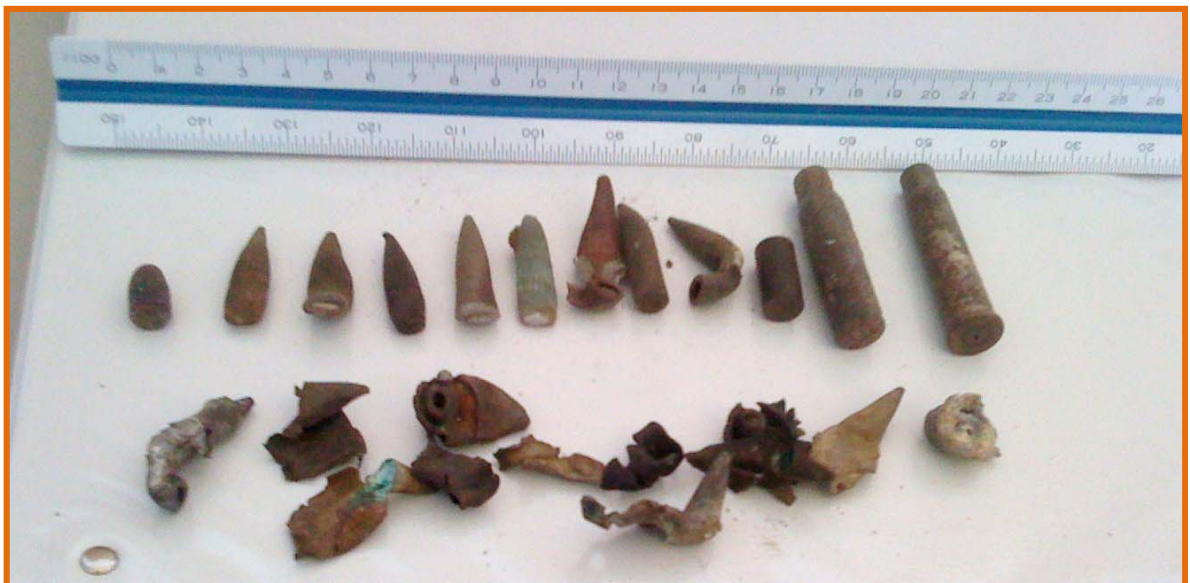
Photo 4: Examples of Rifle Range waste encountered onsite

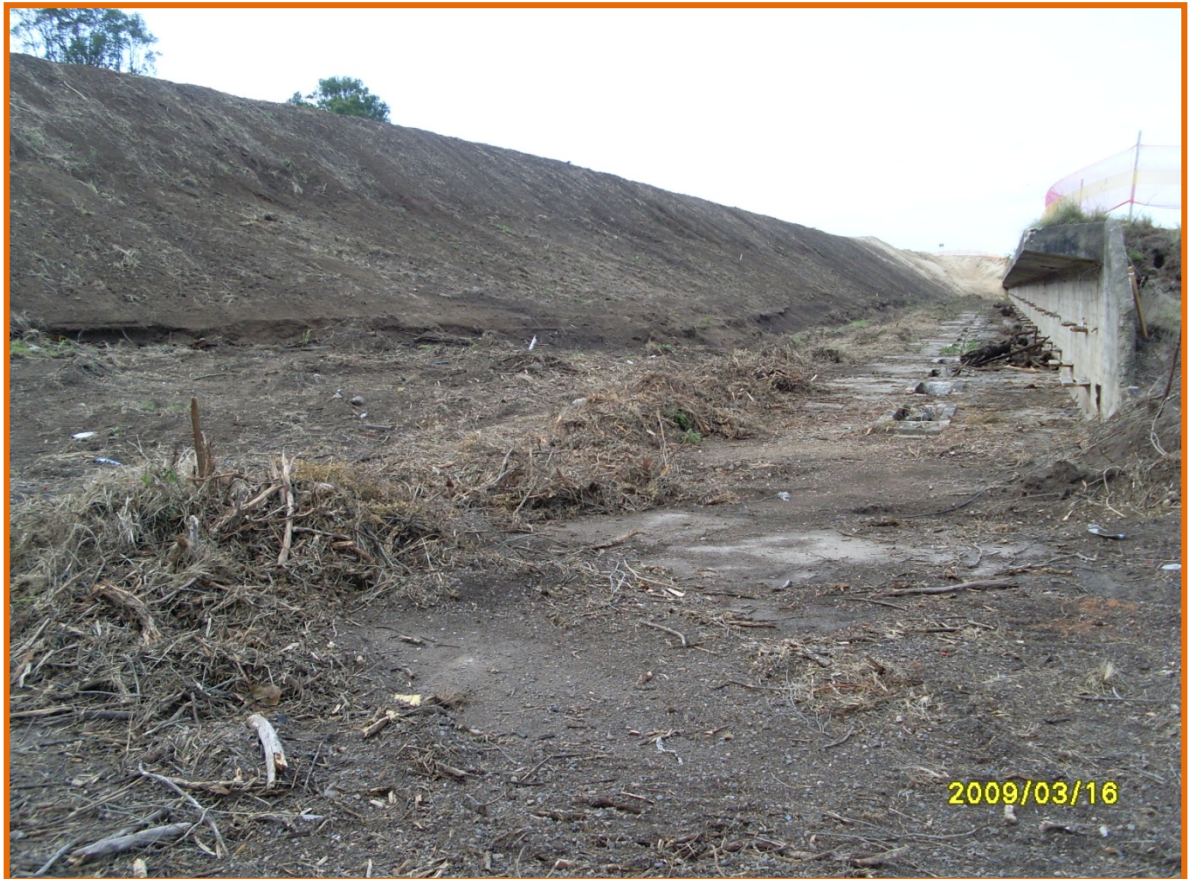
Photo 5: Target Mantle - Prior to being filled with the former Firing Mound material

The Target Mantle concrete structure was retained (**Photo 5, Appendix B**) and filled by on-site soils removed from the former Firing Mounds and sandy soils from other on-site areas. A plan showing the cross-section of the backfilled trench and recontoured Stop Butt is provided in **Figure 4** in **Appendix A**.

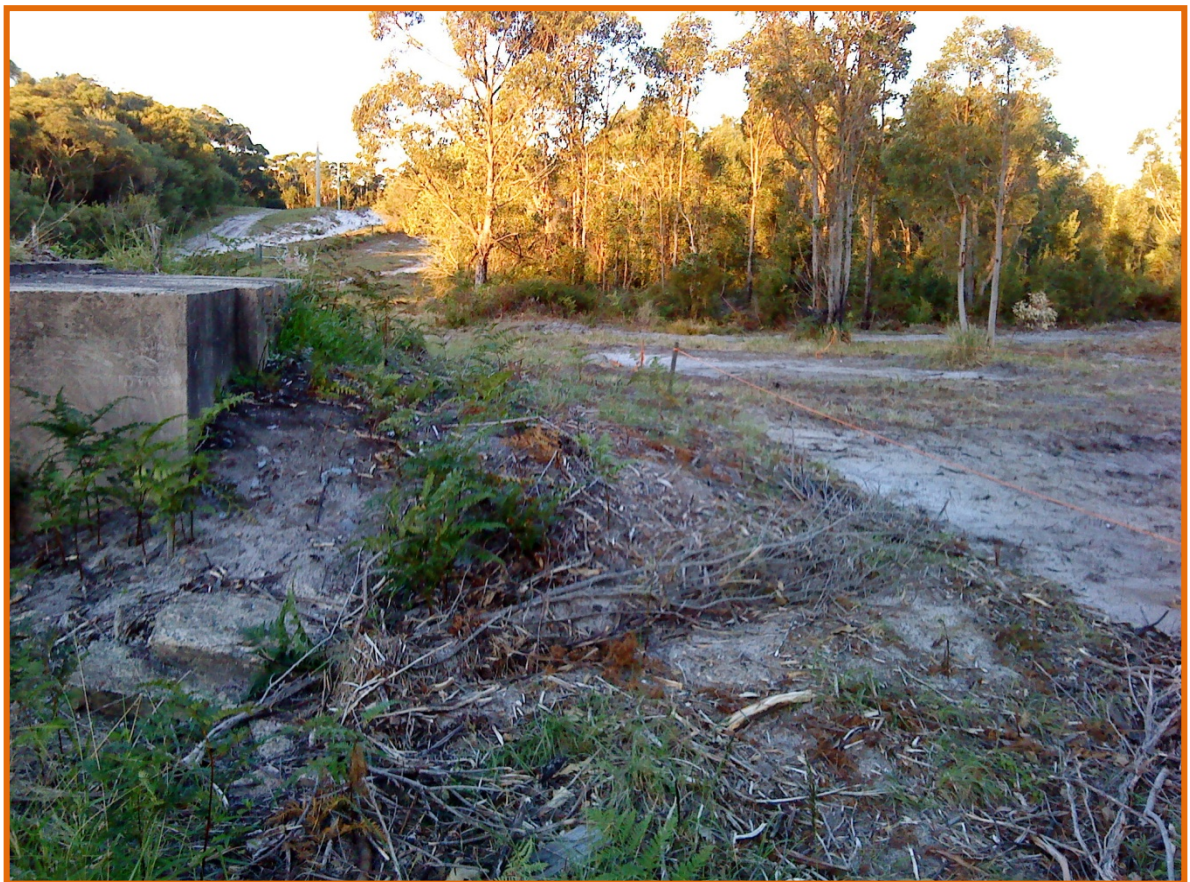
Photo 6: Fill surrounding Gun Emplacements within the Links Anti-Aircraft Battery.
