## **Stage 1 Contamination Assessment**

**For Proposed Rezoning of Part Lot 4 DP 834254,  
510 Beach Road, Berry**

SEEC Reference 15000106-CA-01

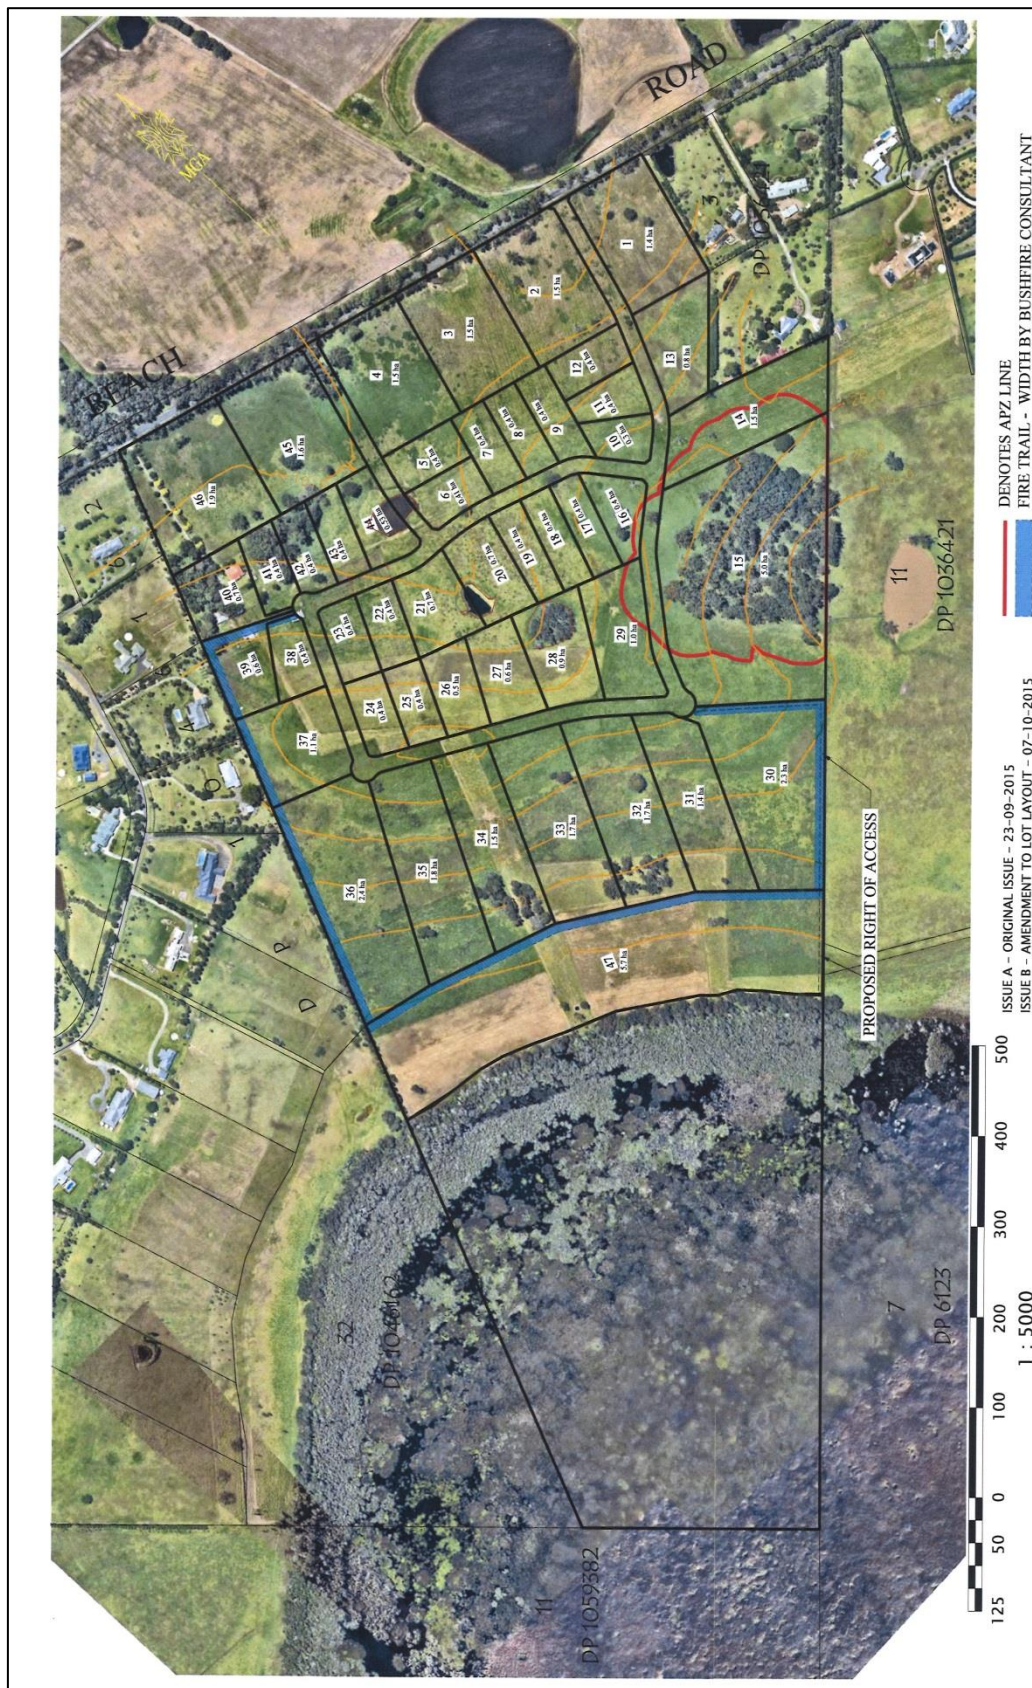
Figure 2 - Conceptual Subdivision

It is proposed to re-zone the land to Zone R5 to permit its subdivision into (conceptually) 46 rural residential lots of between 0.3 ha and 5 ha. There would be a residual lot (Lot 47) that would be zoned E3 and be dedicated to National Parks.

Two new access roads would connect all lots to Beach Road. A conceptual subdivision plan has been prepared by John M. Daly & Associates Pty Ltd, **Figure 2**.

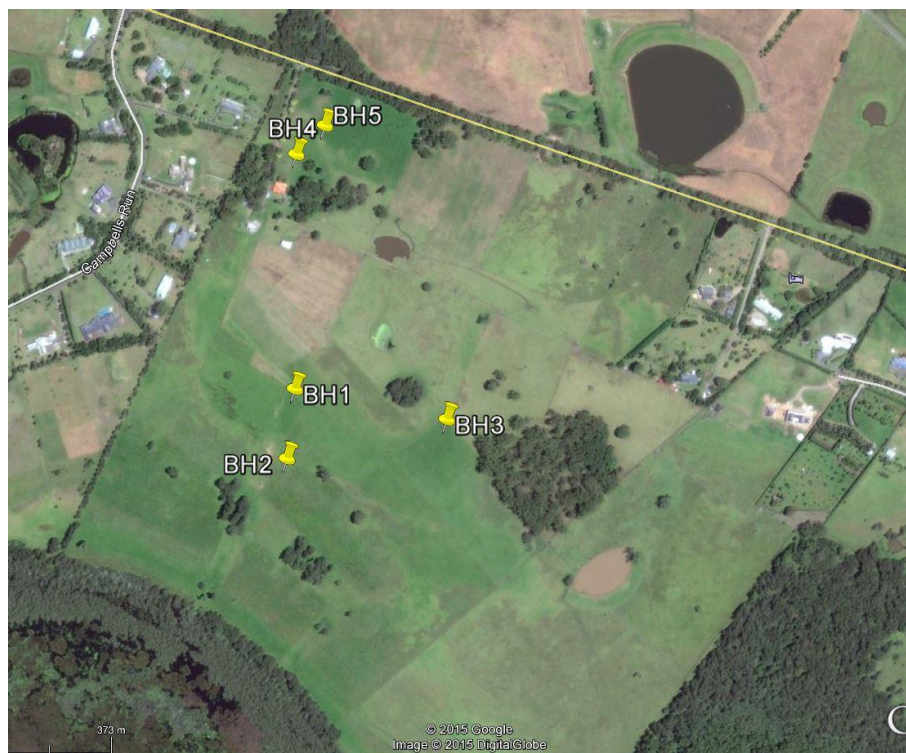
**Figure 4 - Soil Core Locations**

A site-specific soil investigation was undertaken by SEEC. A series of soil bores were taken where shown in Figure 4. The results of that investigation suggest the extent of the Shoalhaven Soil Landscape in the northwest of the site is smaller than mapped; the Coolangatta Soil Landscape was present in this area too. Lands in the south will not be developed and so were not investigated. All soil cores were taken on the Coolangatta Soil Landscape. The following soil profiles were observed:

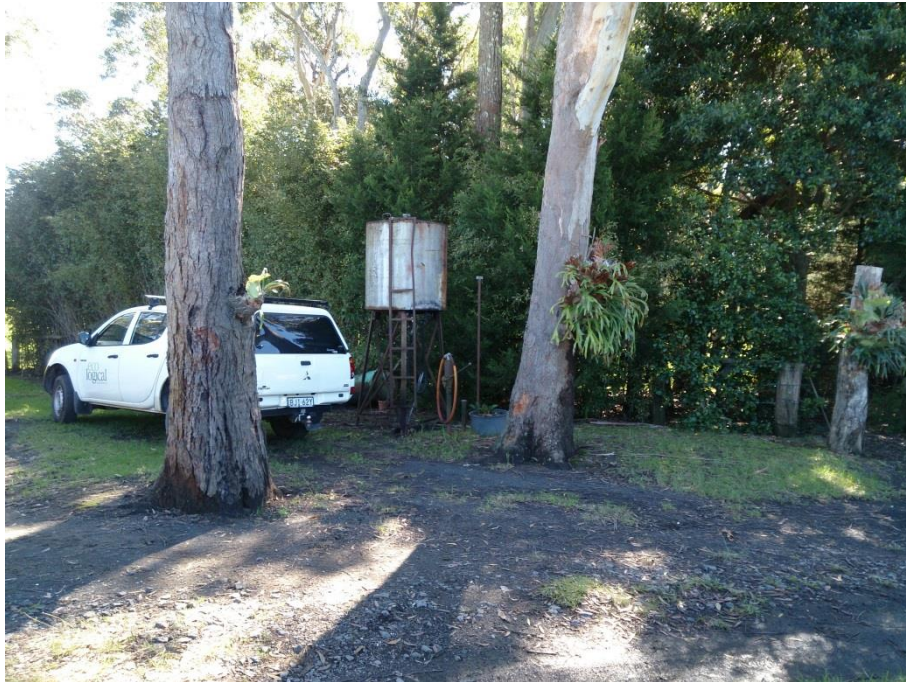
Figure 5 – Raised diesel tank. Older, buried, tank is beneath

One of the machinery sheds (the western one) has adjacent to it a raised fuel tank containing diesel (**Figure 5**). Under that tank is a disused diesel tank buried in the ground.

- The area surrounding and downslope of the two diesel tanks. This area is likely to be contaminated with diesel fuel, either as a result of spillage or leakage. The contamination could have plumed downslope and could be contained in the subsoil.
- The footprint of the homestead. This area is likely to have been treated for white ants and so could have residual organochlorine pesticides in the near-surface soil.
- The areas located immediately outside of the entrances to the machinery sheds. These areas could be contaminated by fuel or chemical spills from within the sheds. Chemical use on the farm has, however, been minimal.

Further soil investigation (a Stage 2 Assessment) is required at the locations identified in Section 7.2.3 to determine the level and extent of any potential contamination. The investigation must be carried out by a qualified consultant with access to suitable sampling/measuring equipment and soil testing must be carried out by a NATA registered laboratory.

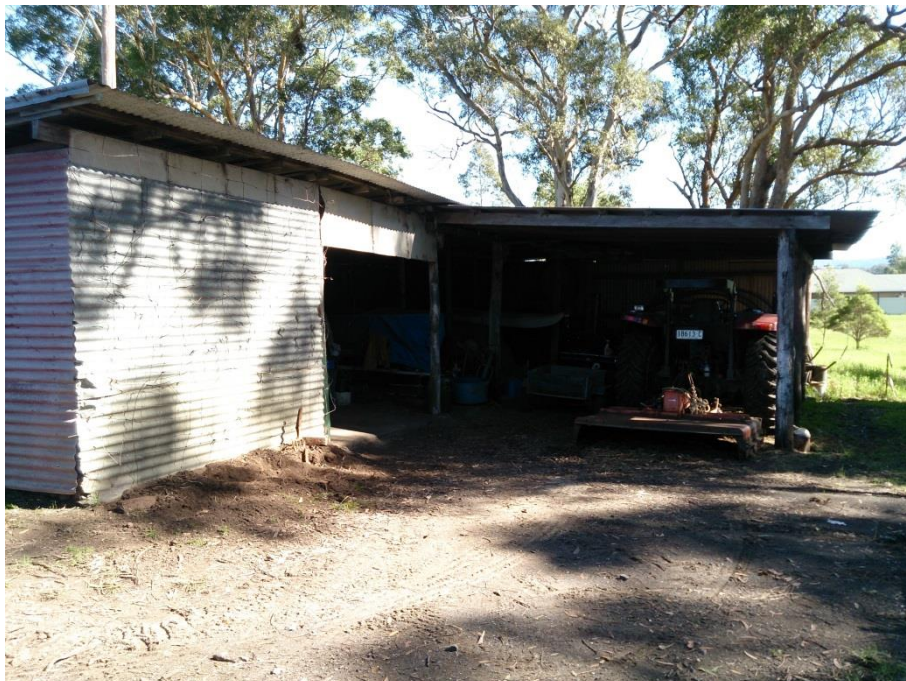
Figure 6 – Western Machinery Shed

The machinery sheds and garage all have concrete floors, except for the “car port” adjacent to the western shed (**Figure 6**). Small volumes of oils and fuels have been, and are, kept in the sheds.

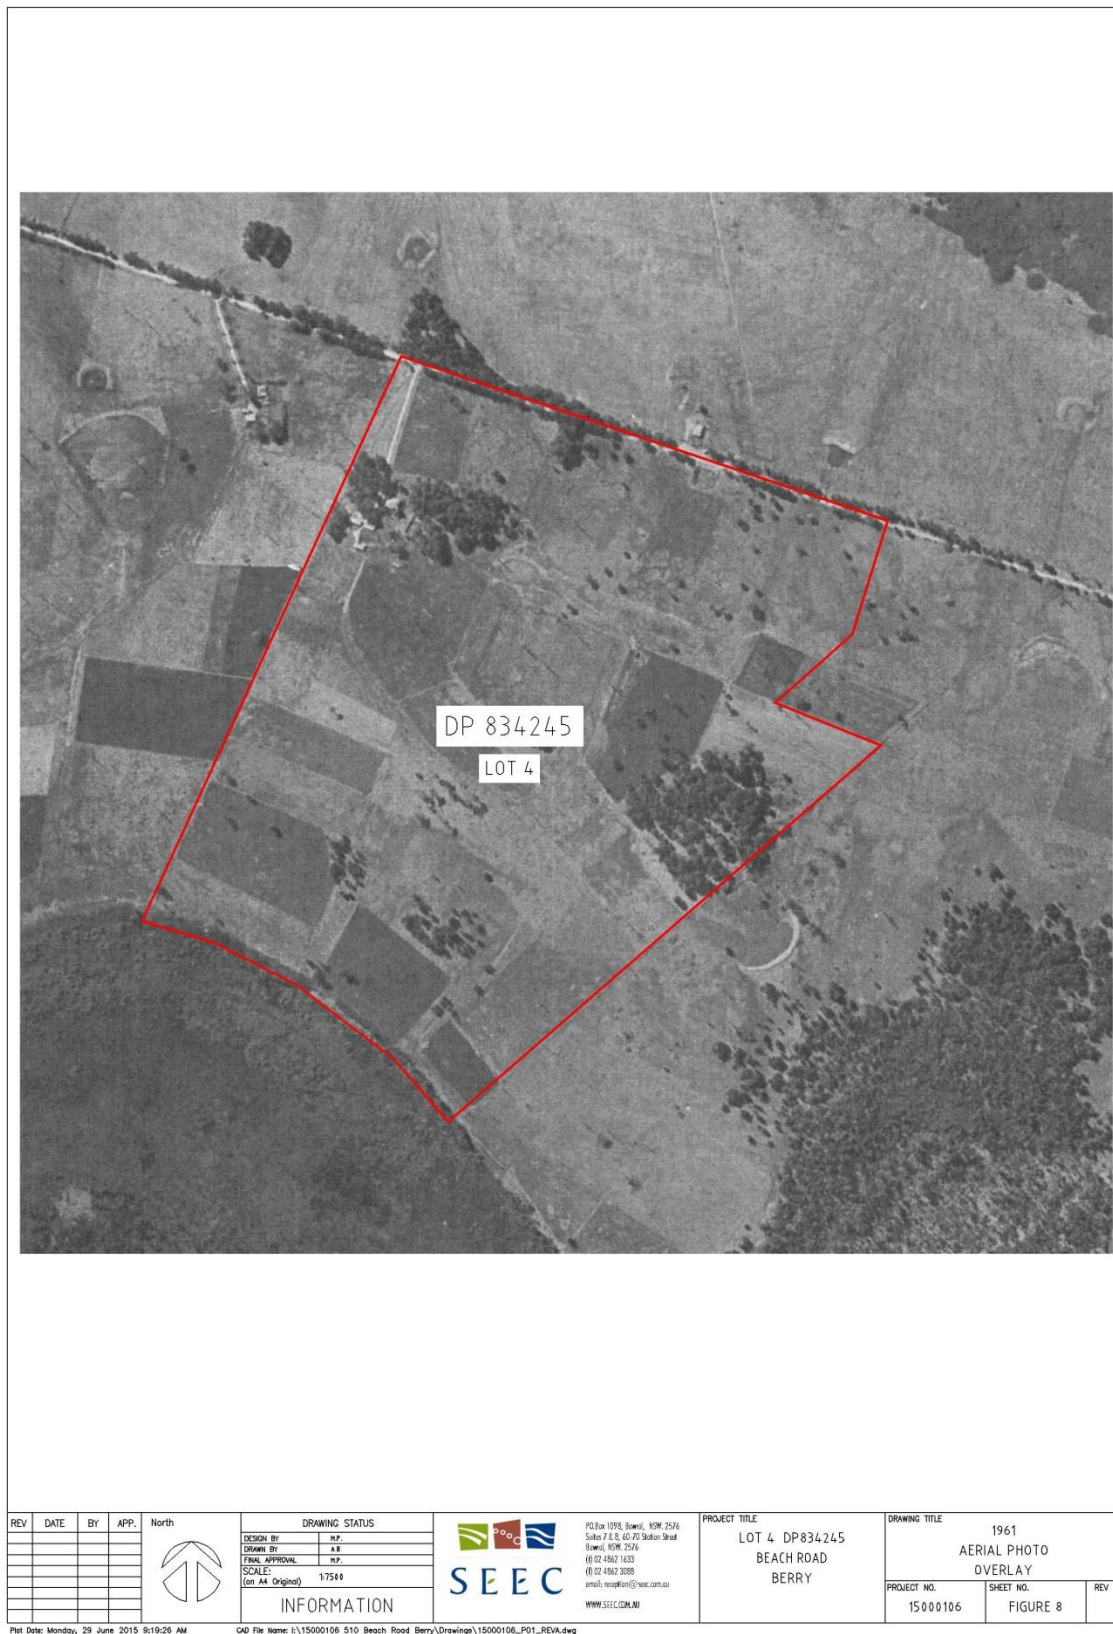
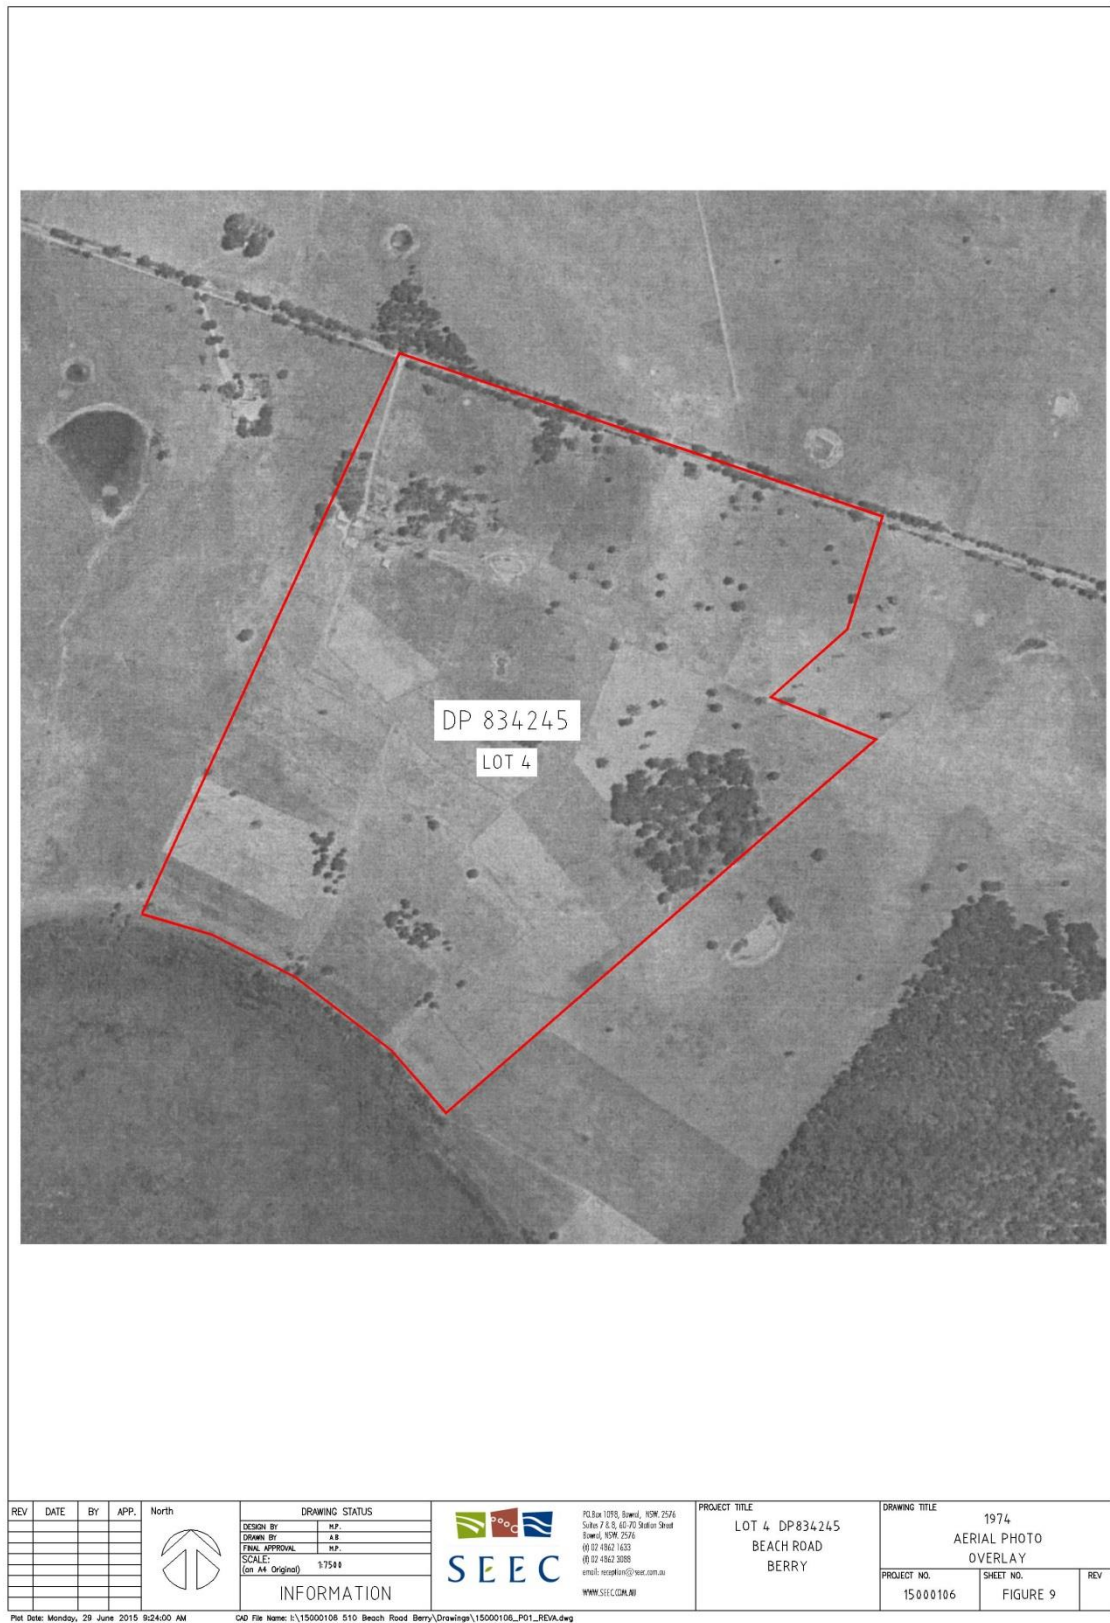
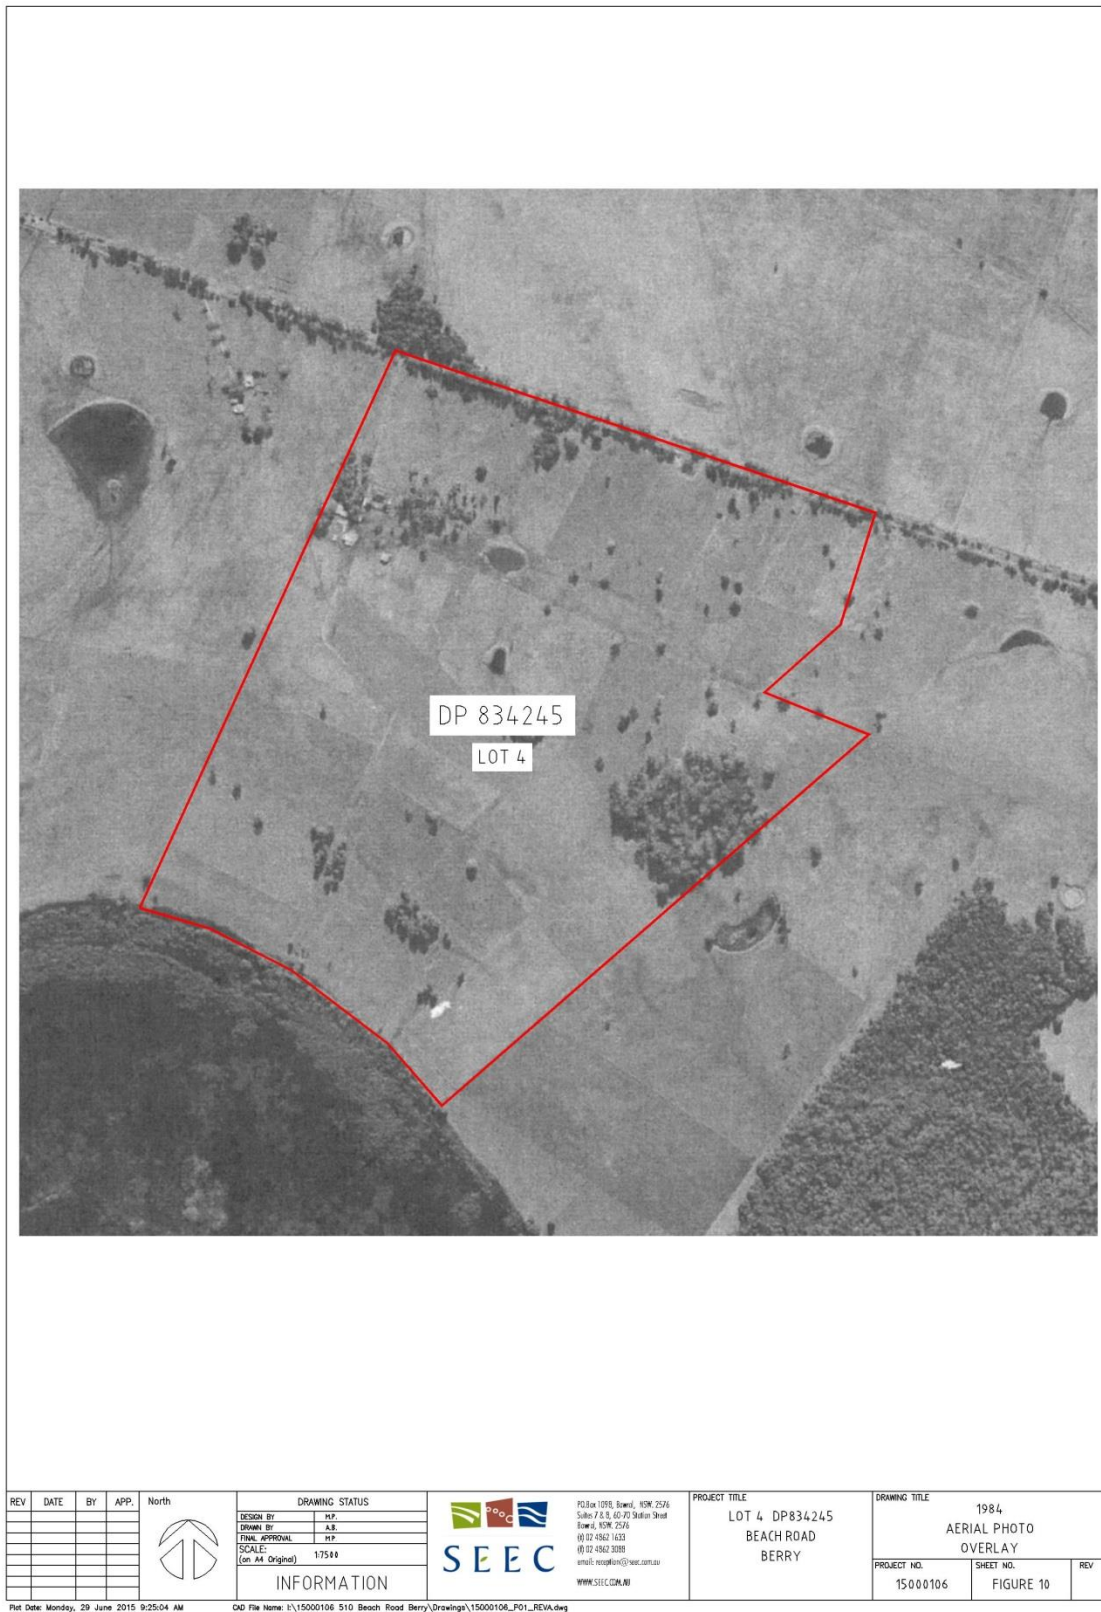
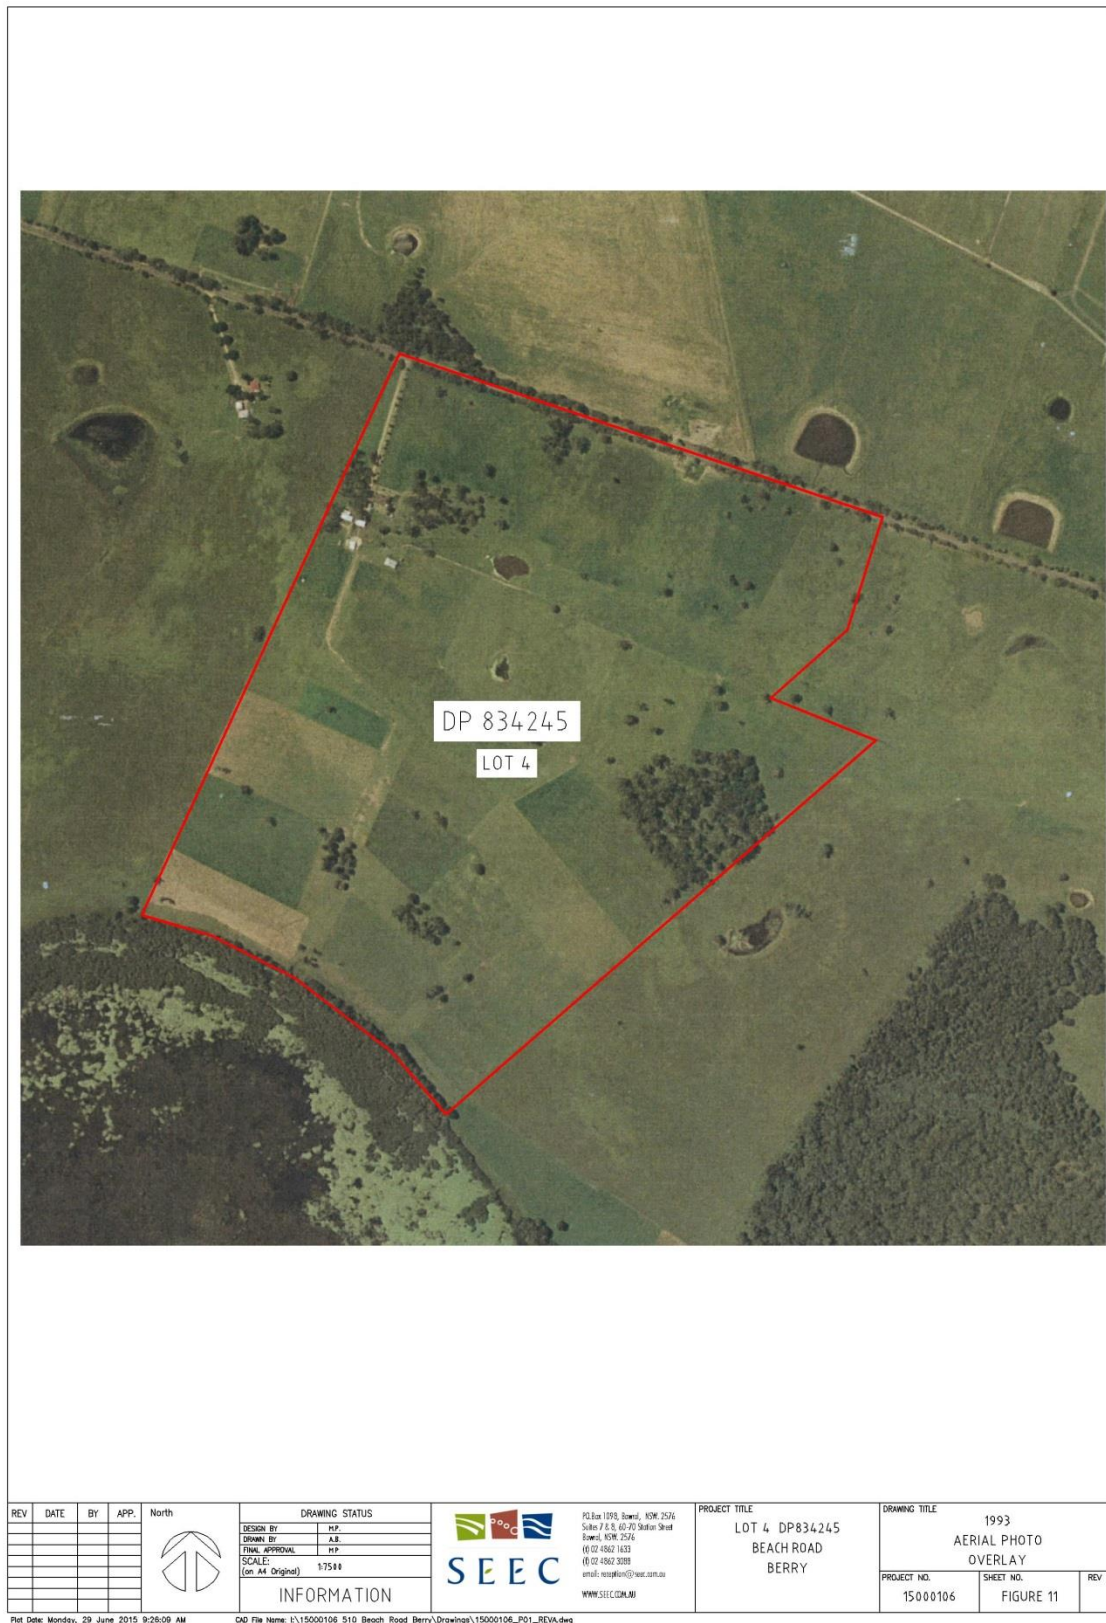
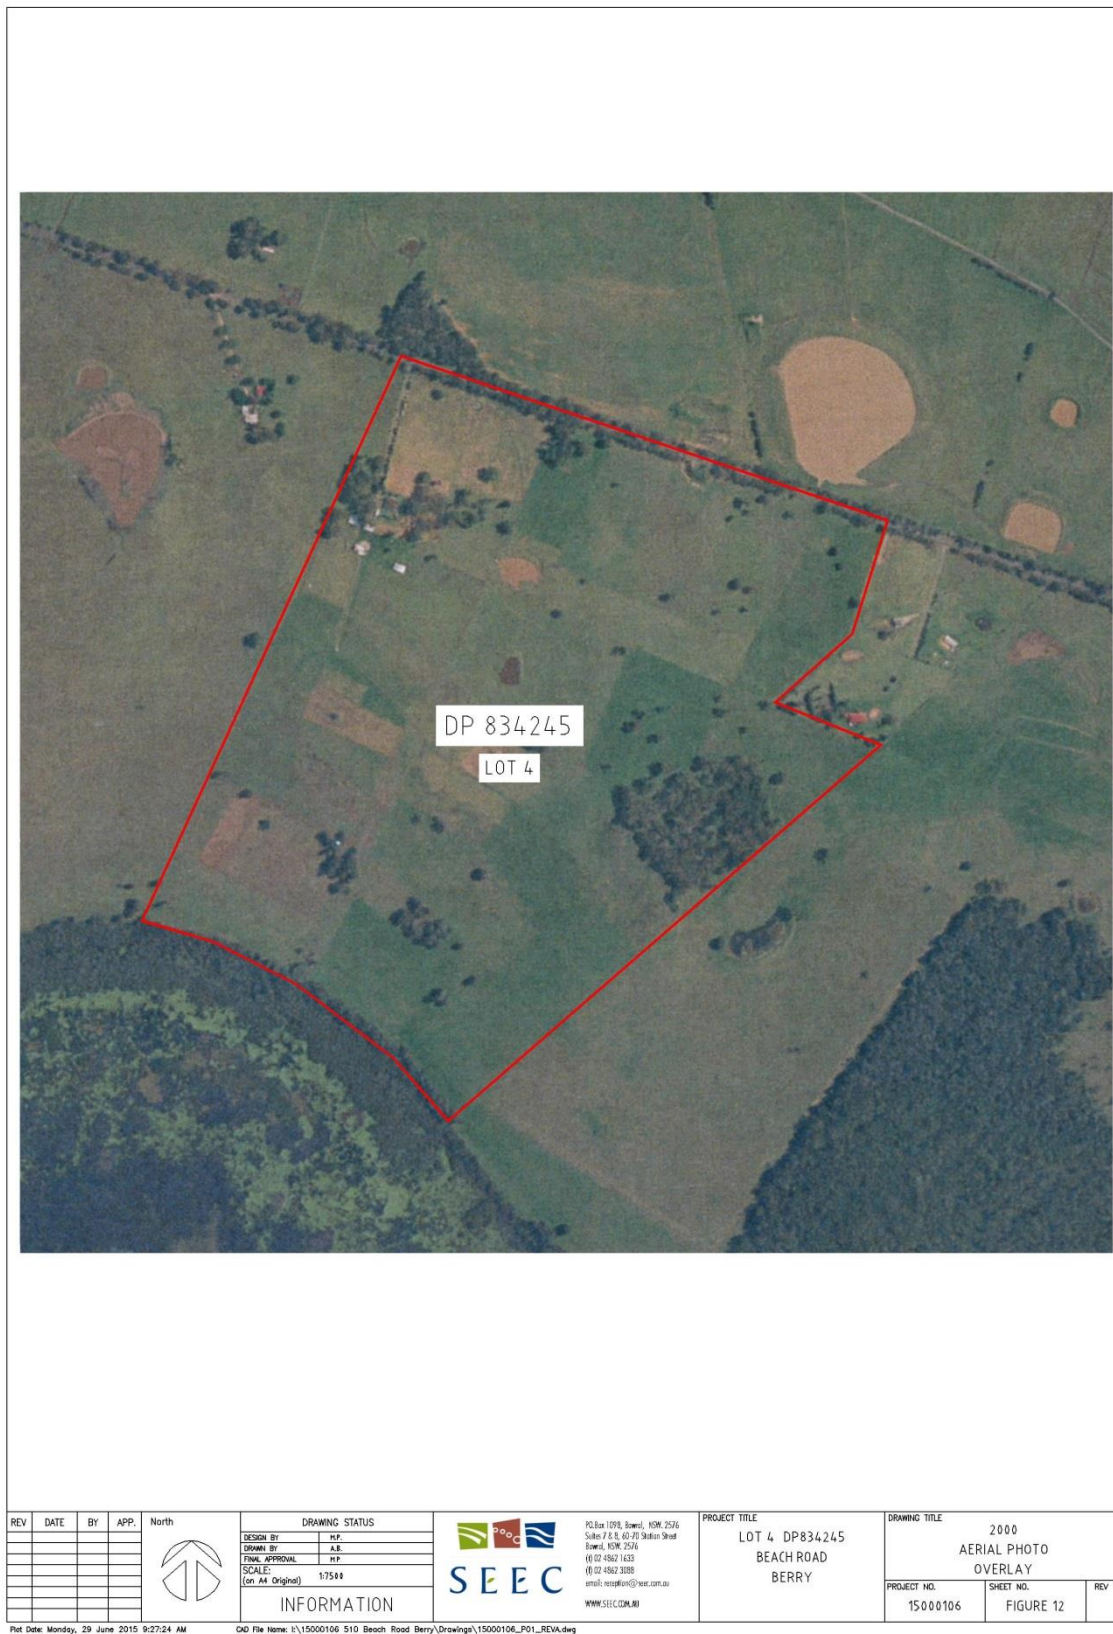
**Figures 7 to 12** contain extracts from aerial photographs taken in 1949, 1961, 1974, 1984, 1993 and 2000. These photographs were supplied by the NSW Government: *Land and Property Information* (a division of the Department of Finance and Services). Figures 13 and 14 are more recent images from Google Earth.

Inspection of these photographs reveals there has been little, if any, change to the land over the entire period. The homestead and some of its outbuildings are seen in 1949 with some additional outbuildings built by 1961, including the one associated with two diesel tanks (Section 5.5). Since 1961 the buildings appear to have remained essentially unchanged. The agricultural land appears to be unchanged over the entire period investigated.

Until approximately 2002 the surrounding lands to the west and east were similar agricultural properties to the site (e.g. Figures 7 to 12). Between 2000 and 2005 lands to the west were rezoned to RU5 and subdivided into rural residential properties, as were lands adjacent to the north east part of the site. Lands south of the site are Coomonderry Swamp, which is a SEPP 14 wetland and lands to the north (across beach Road) are part of a sand quarry site. There are no past or present adjoining land uses that were, or are, potentially contaminating.
