# Planning Proposal

Amendment to KLEP 2011  
to Rezone Land

### Phase 1 Contamination Assessment & Preliminary Geotechnical Assessment

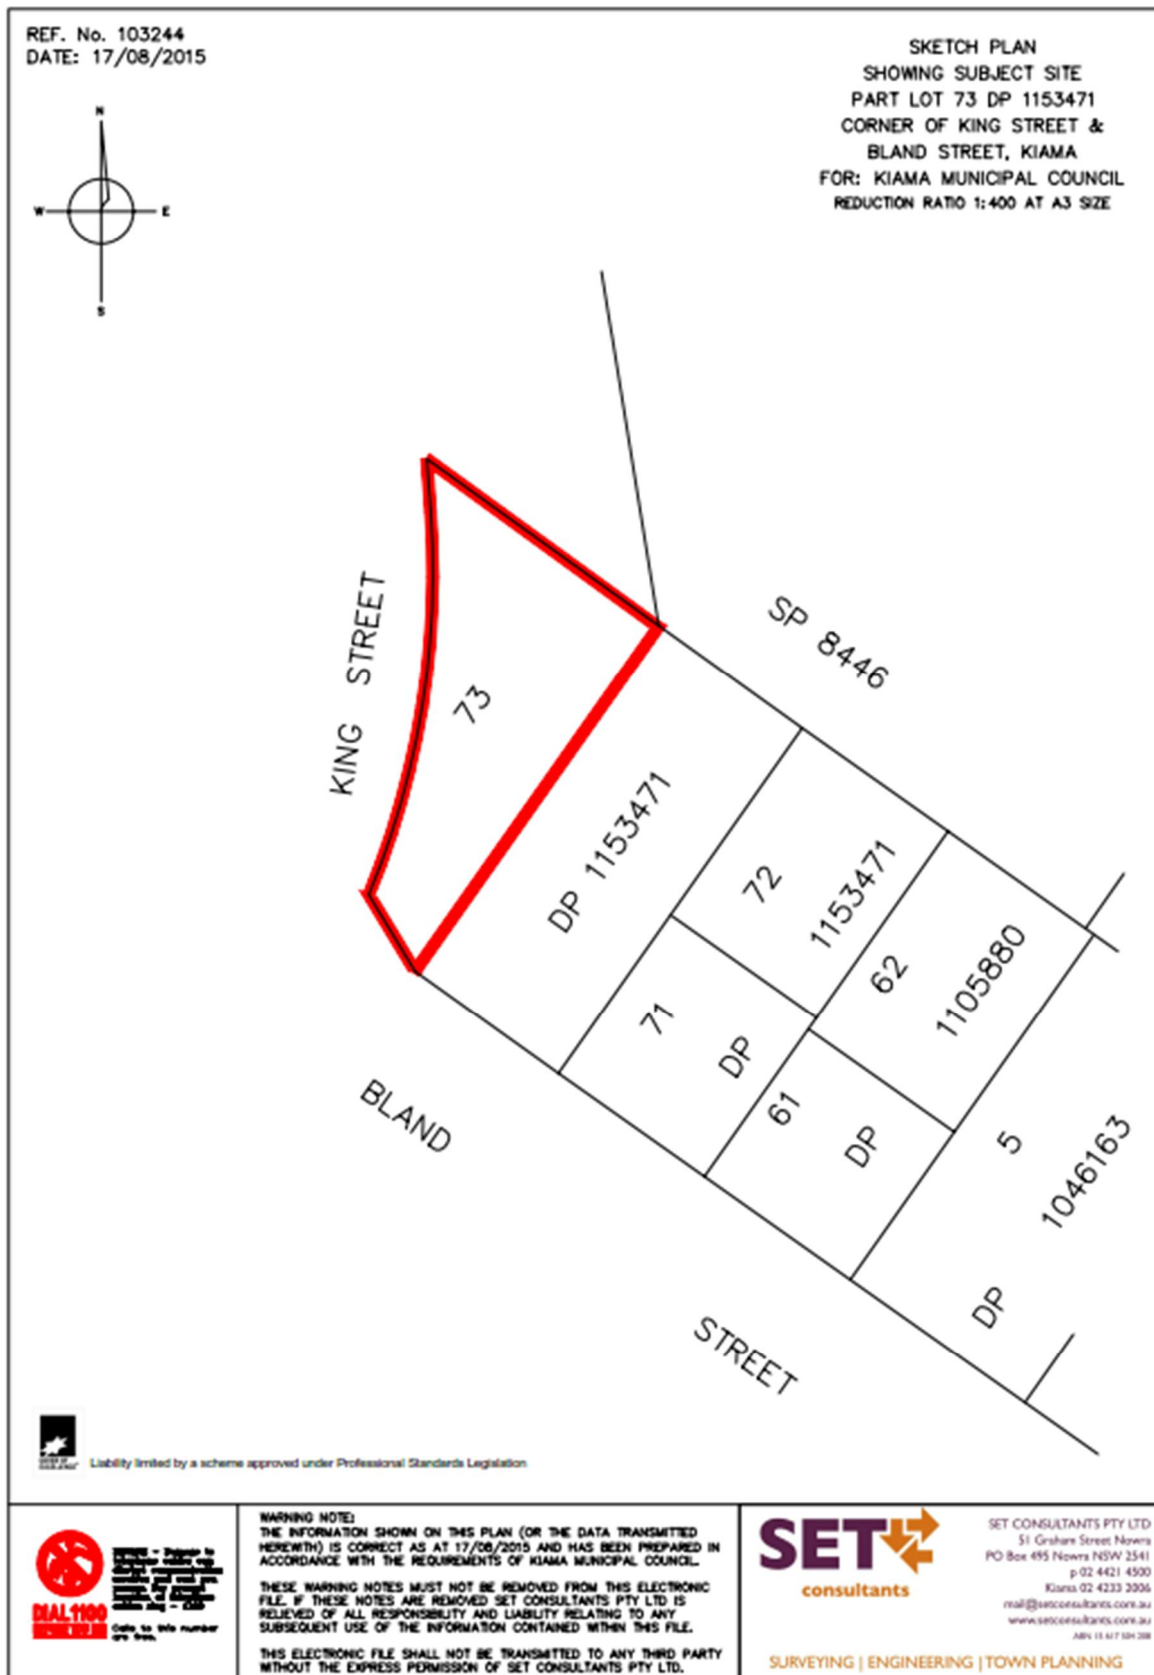
#### 4.1 Land the subject of the Planning Proposal

The following images illustrate the current land use zoning and proposed land use zoning amendments to the Kiama LEP 2011 for the subject site and are indicative only. Changes to the Principal Development Standards are outlined in Section 2. These changes will be mapped after the gateway determination. The maps below are reproduced in Appendix 3 on the paper size noted on the scale. Aerial photographs of the sites are also included in the Appendix 3.

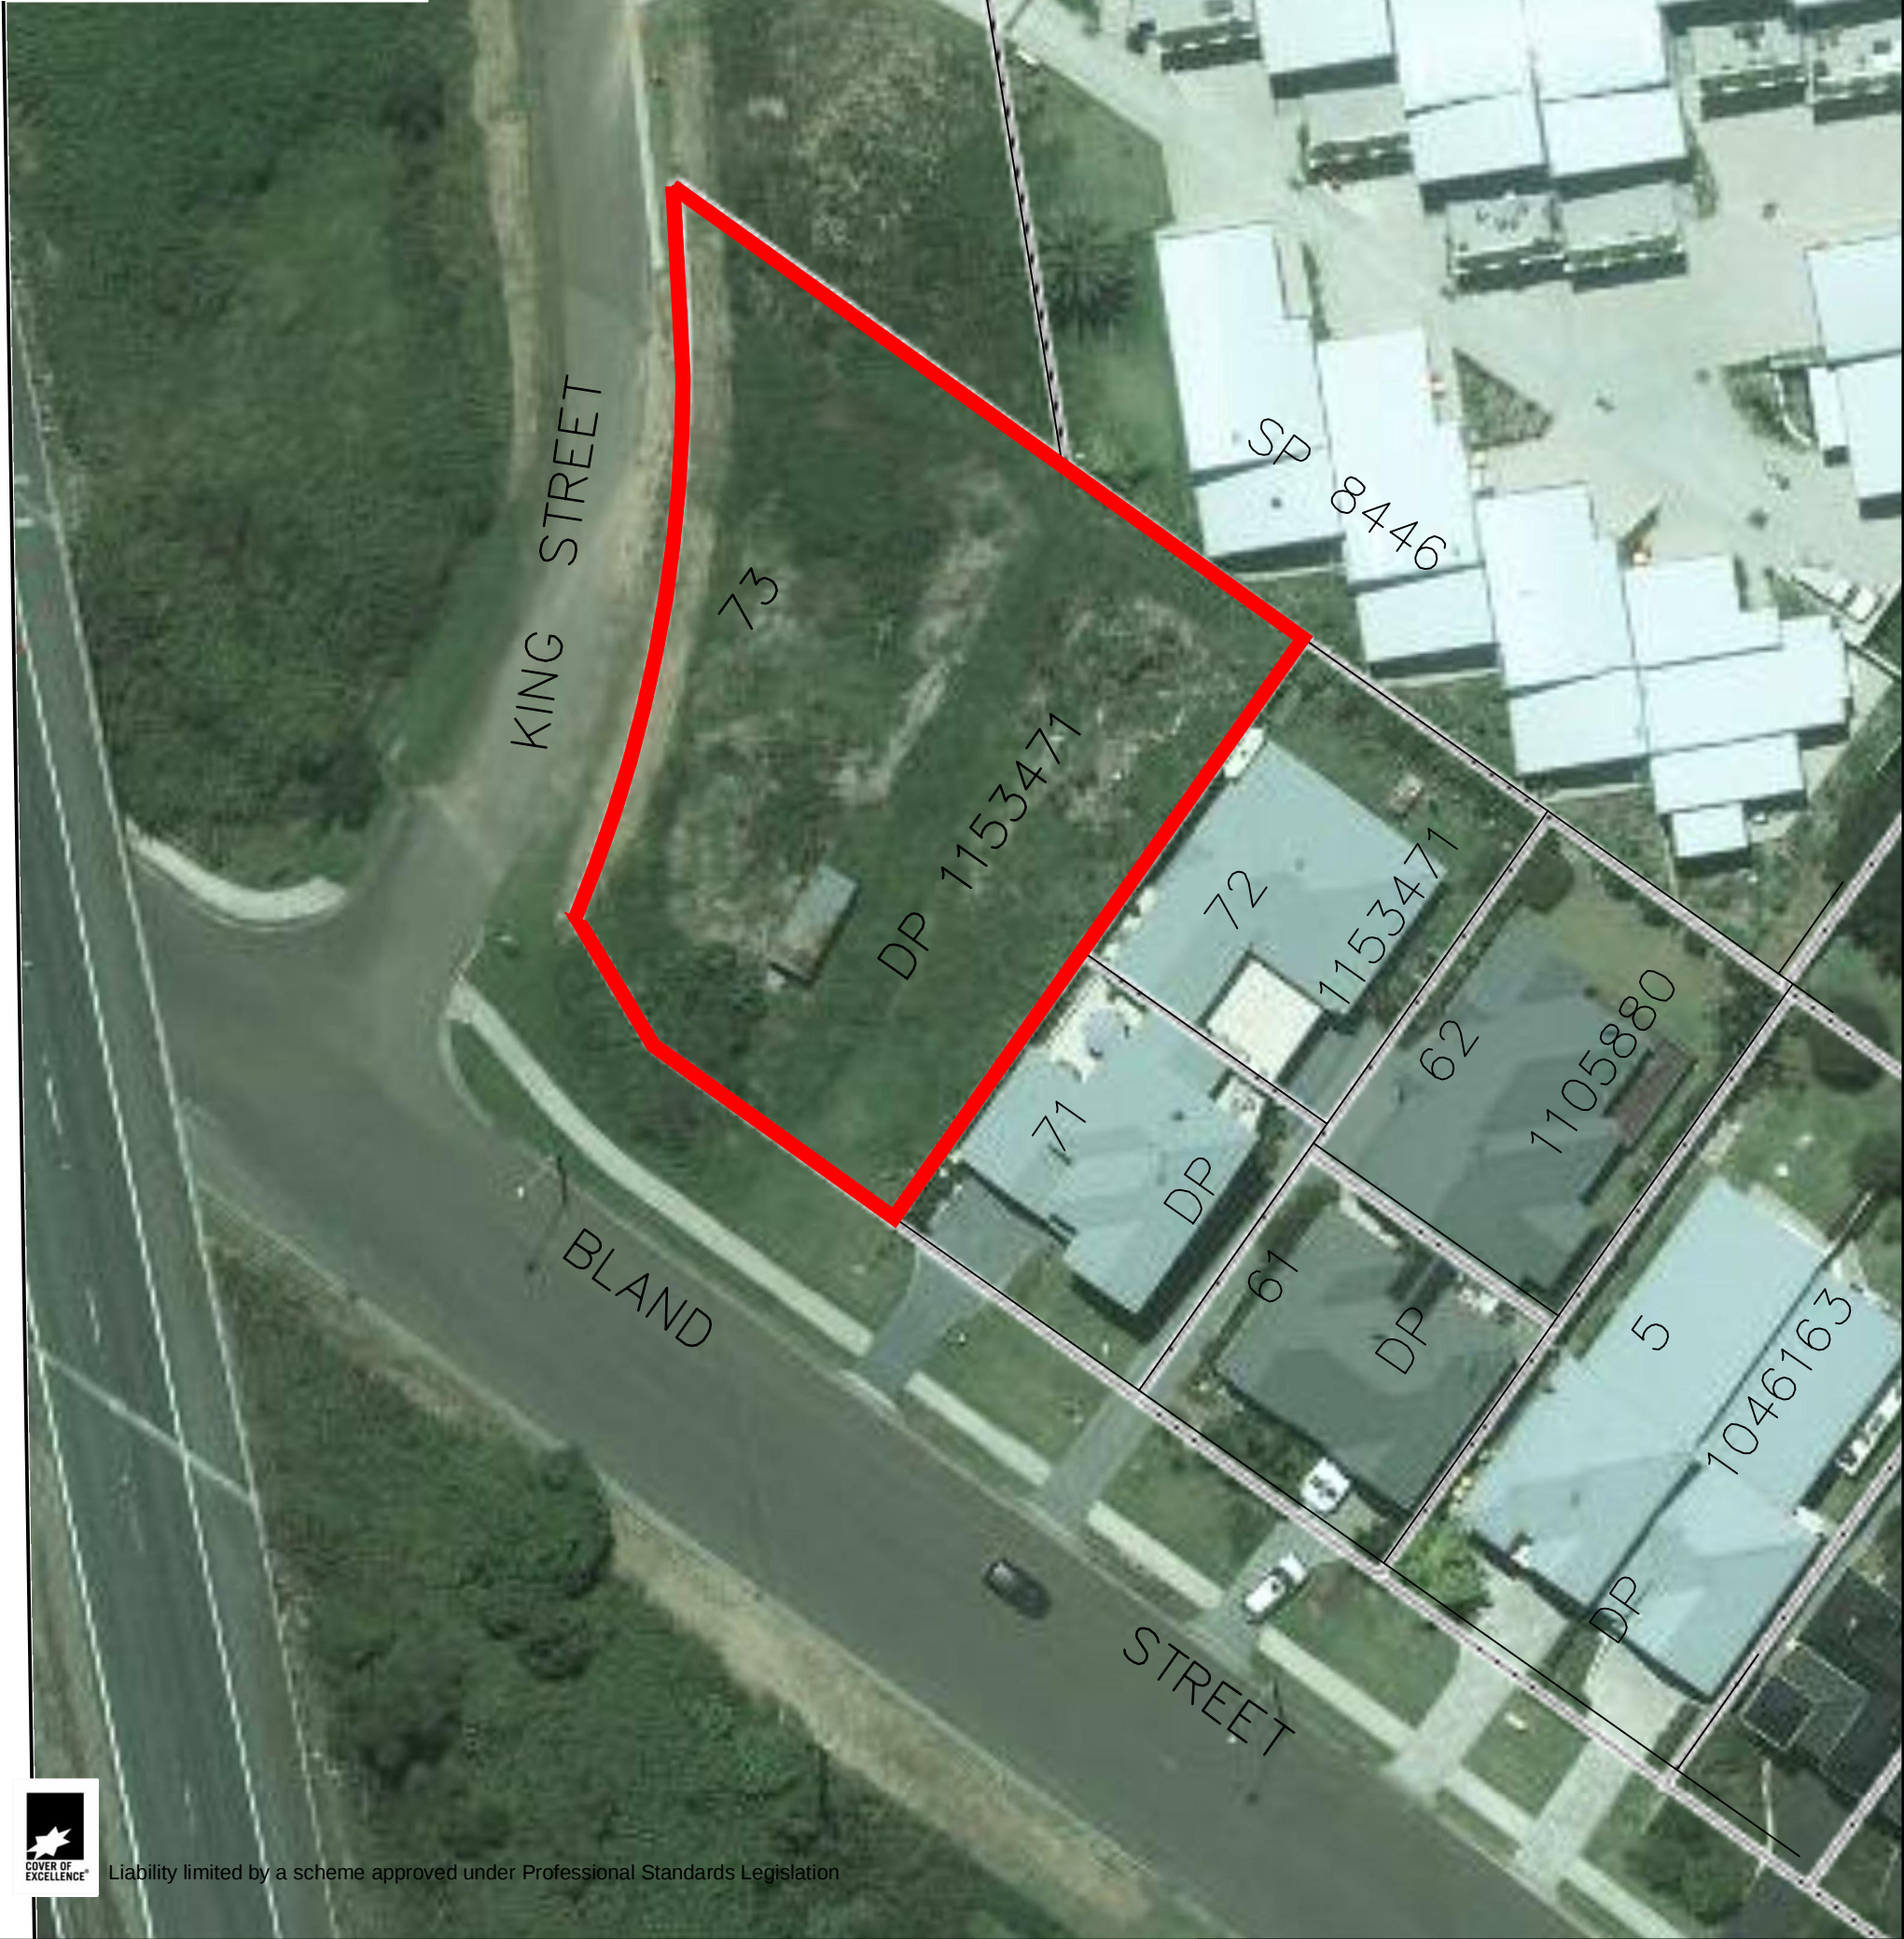
SKETCH PLAN SHOWING  
AERIAL MAP OVER SUBJECT SITE  
ENTIRE LOT 73 DP 1153471  
CORNER OF KING STREET &  
BLAND STREET, KIAMA  
FOR: KIAMA MUNICIPAL COUNCIL  
REDUCTION RATIO 1:400 AT A3 SIZE
