STAGE 1 PRELIMINARY SITE INVESTIGATION (PSI)

**HENRY PARKES DRIVE
LOT 442 DEPOSITED PLAN 1201831
KIAMA DOWNS, NSW, 2533**

Prepared For: **INDESCO**
Project Number: **ENRSW0144**
Date: **January 2020**

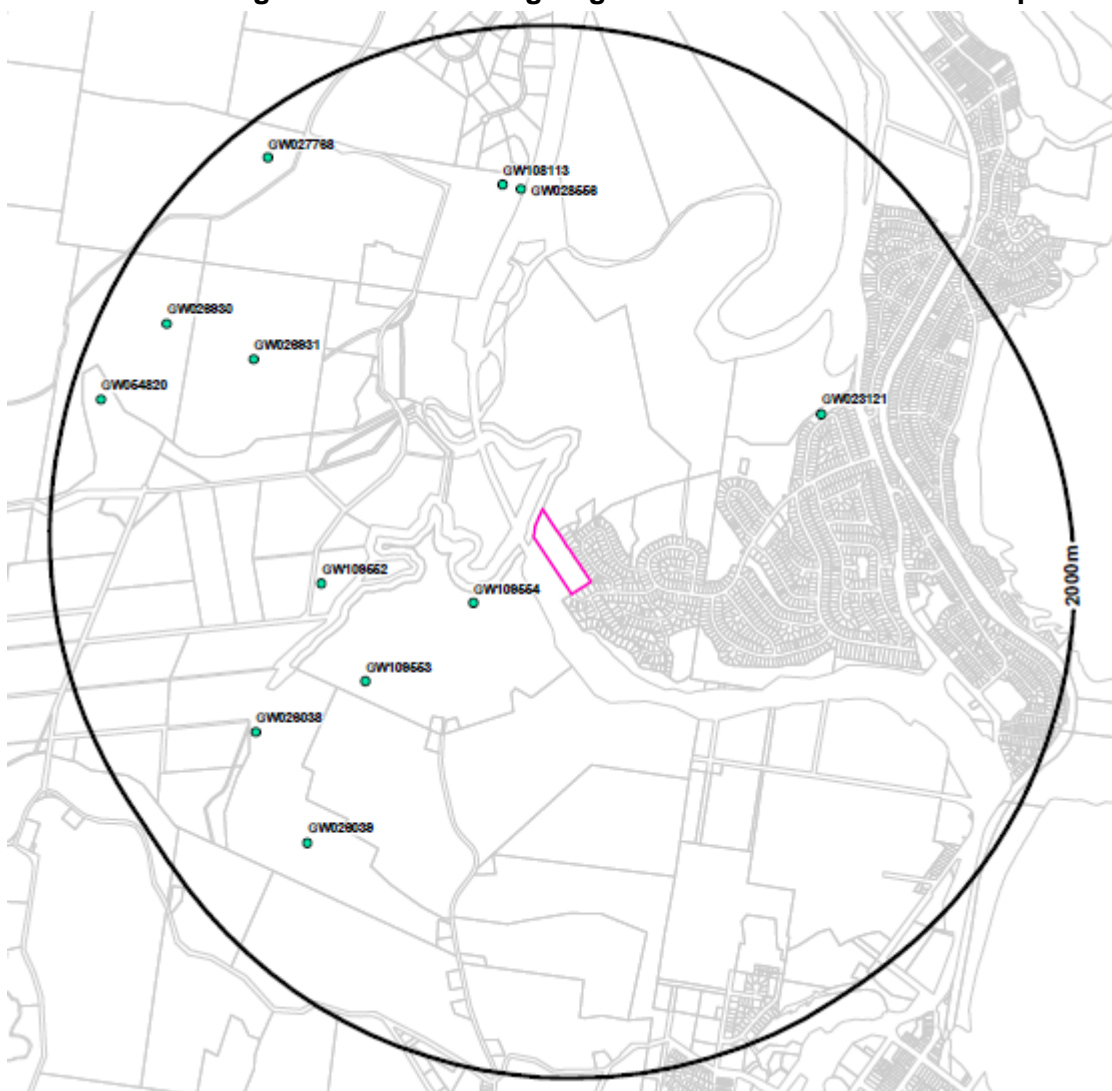
Figure 2: Surrounding Registered Groundwater Bore Map

Review of the NSW Department of Industry's registered bore database identified multiple registered groundwater bores within a 1km radius of the Site. However, no bores are located down gradient of the Site. Hence, Site activities are considered unlikely to impact existing groundwater users in the area.

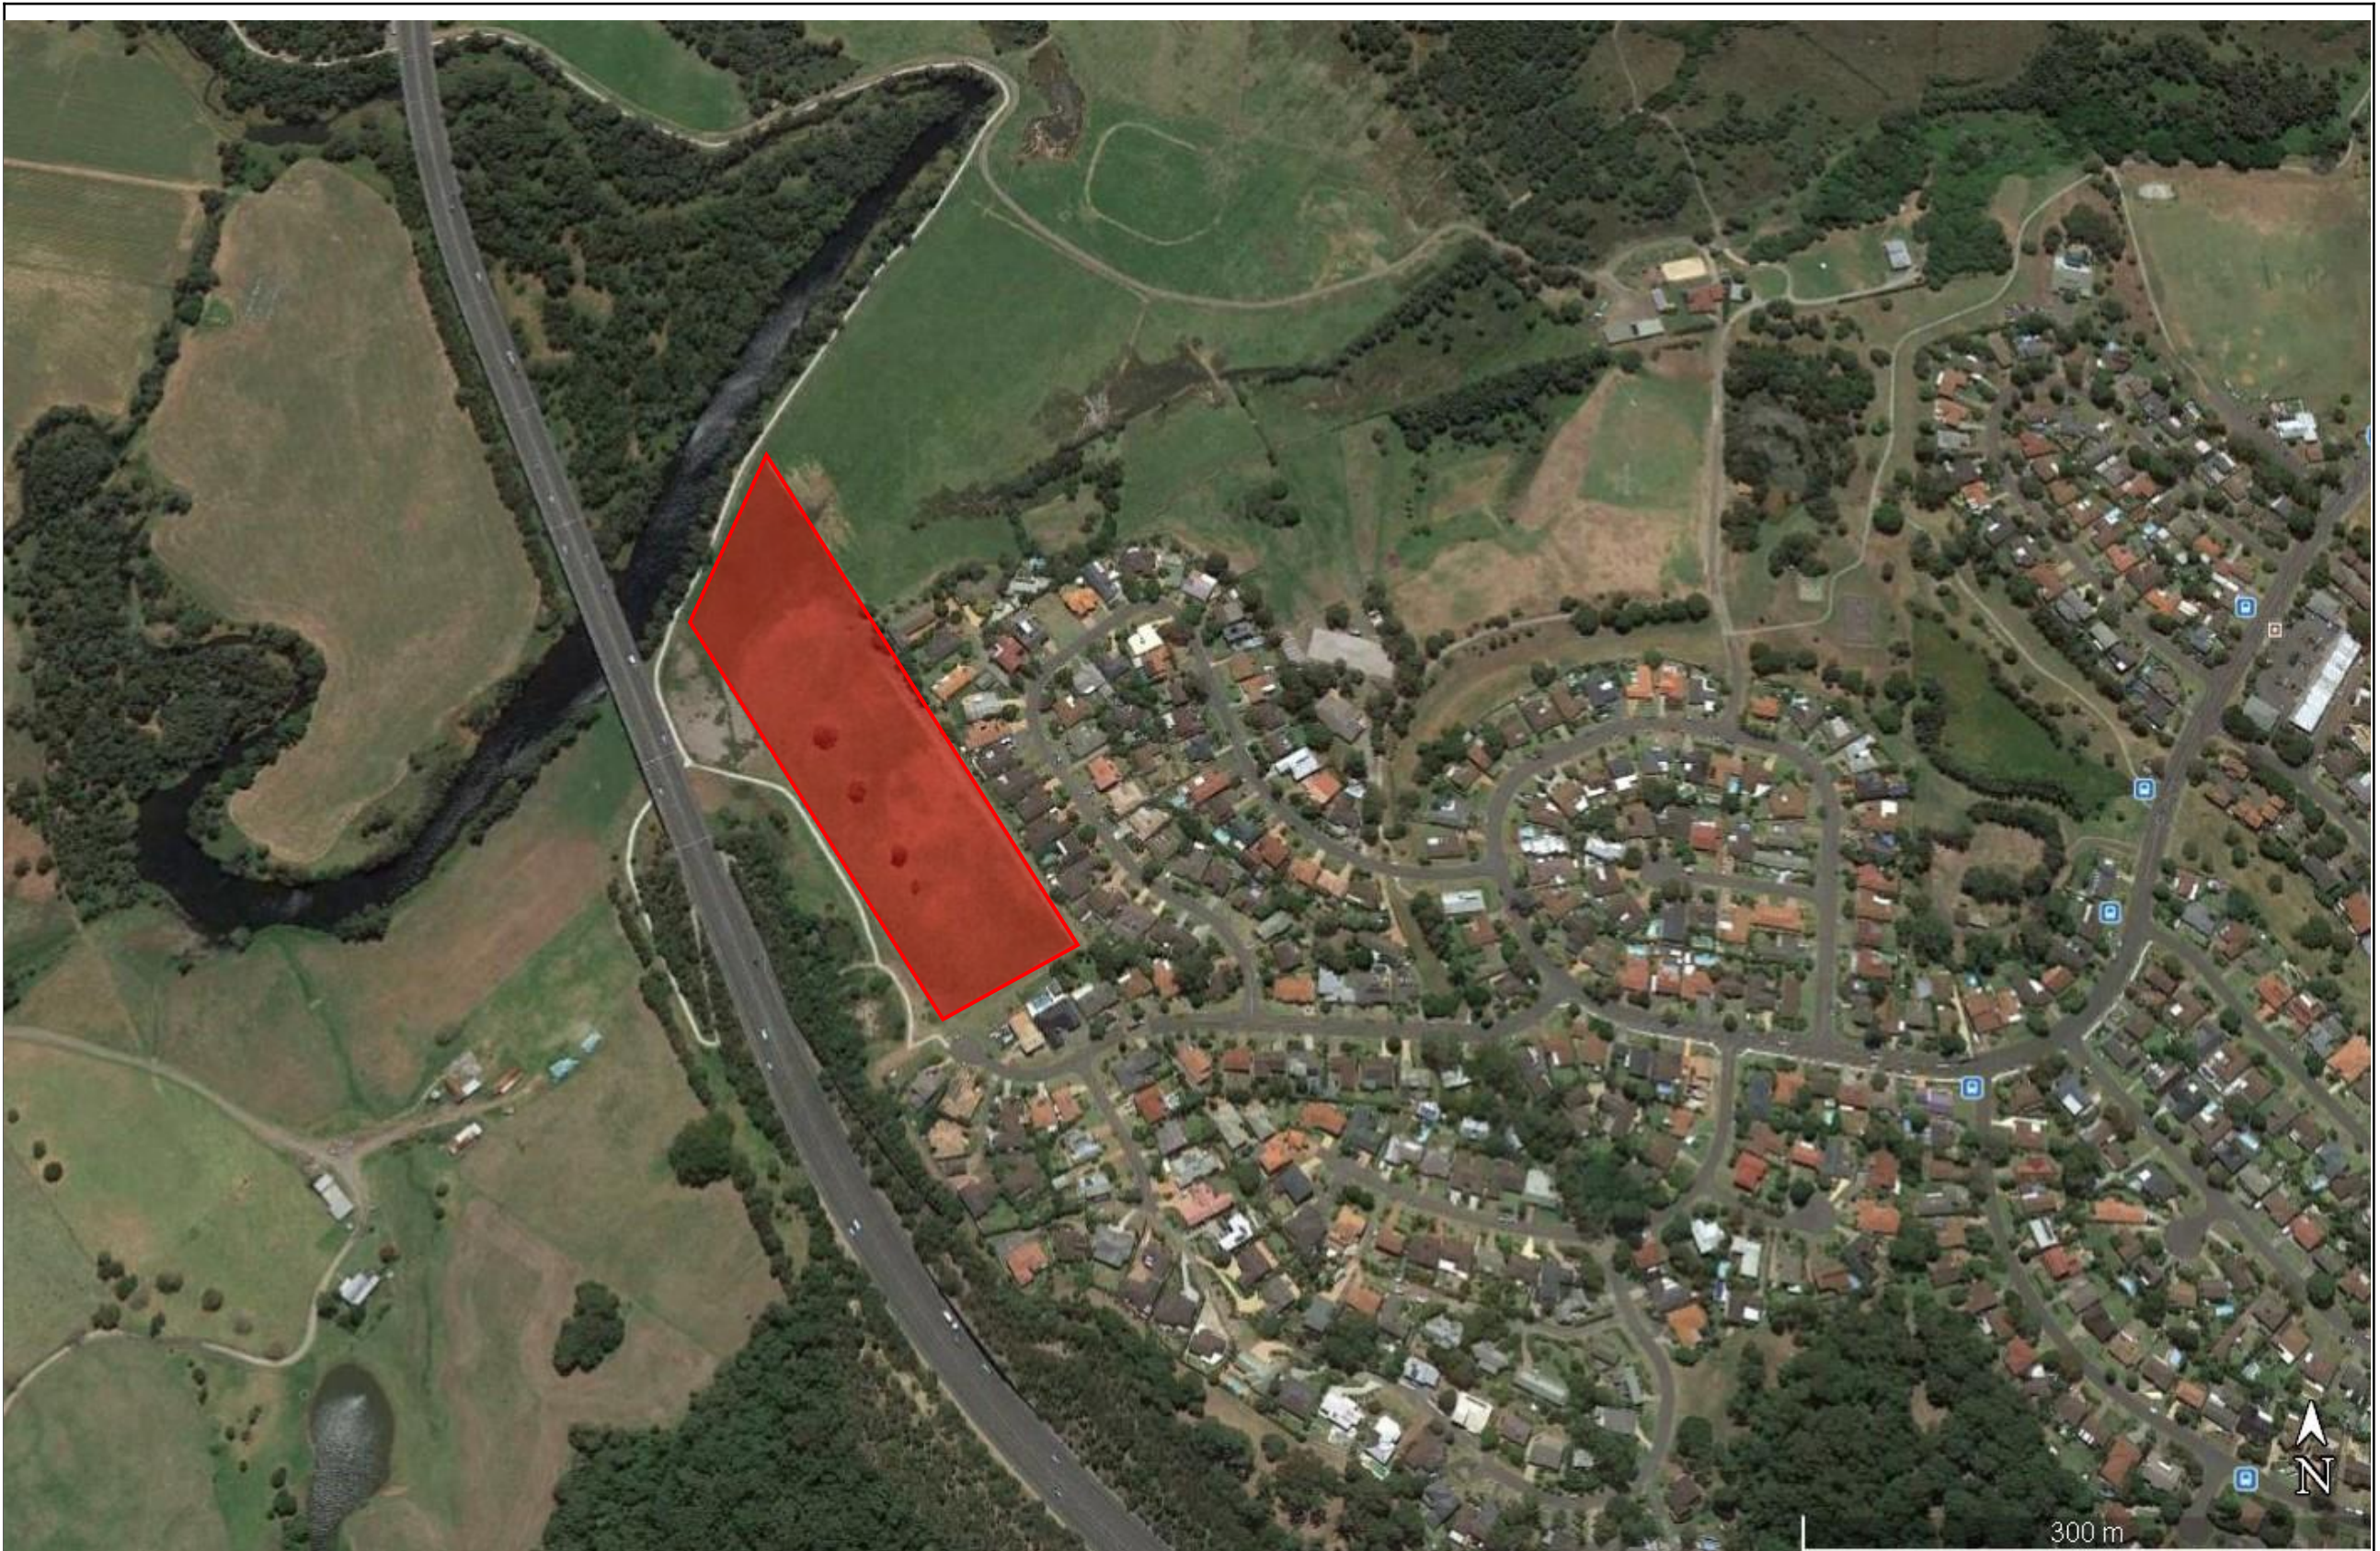
Client:	INDESCO	Drawn:	PL	Figure:	5
Project:	ENRSW0144	Source:	Google maps	Date:	21/01/2020
Location:	Henry Parkes Drive	Scale:	See Figure	Title:	Site Plan
		Status:	Rev 1

The following points outline the Site layout and activities identified at the time of this investigation. A Site layout plan is provided in **Figure 3** with a photographic record of Site conditions tabled in **Appendix C** (both appended at the end of this report). In general, the Site remained undeveloped

with no major vegetation. No structures/infrastructure or access tracks or were present at the Site. Based on the layout of the Site, no areas of environmental concern (AEC's) were identified.

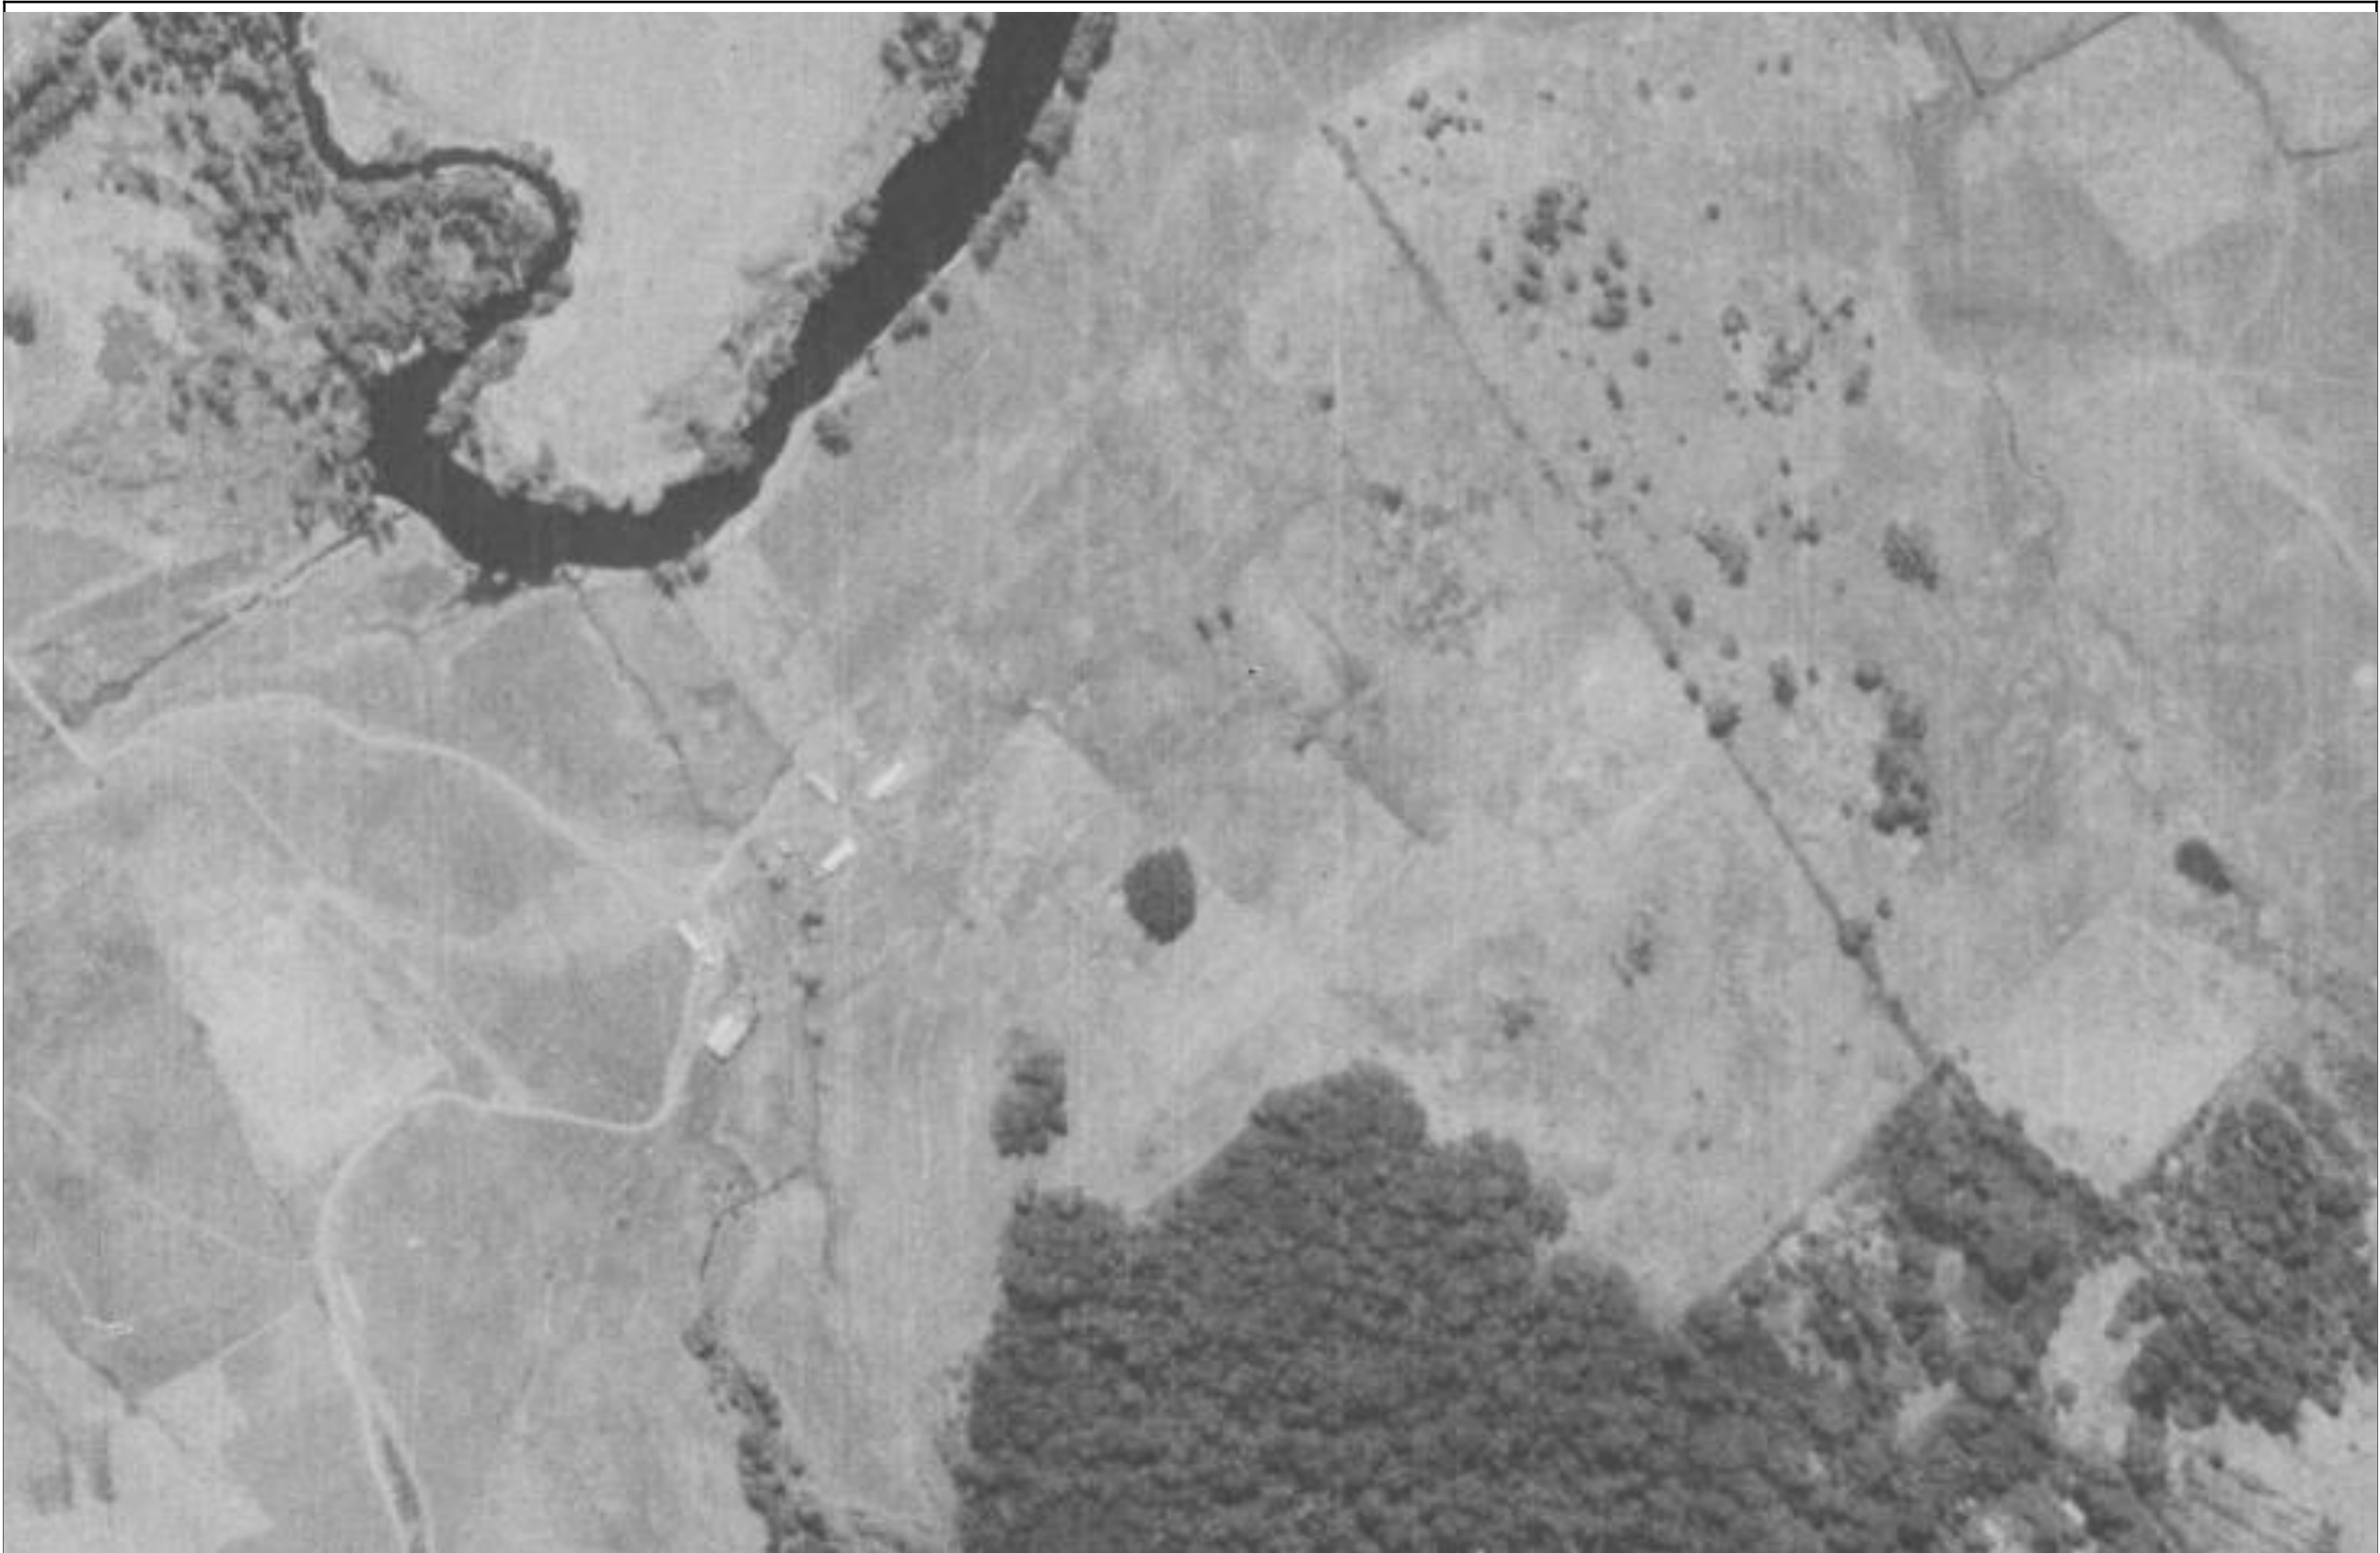
Client:	INDESCO	Drawn:	PL	Figure:	5
Project:	ENRSW0144	Source:	Google maps	Date:	21/01/2020
Location:	Henry Parkes Drive	Scale:	See Figure	Title:	Historical Imagery: 1963
		Status:	Rev 1

Year	Description of Site condition and surrounding land use
1963	Site and surrounding areas comprised of grassy, undeveloped land. Scattered trees, evidence of fence lines.
1974	No significant change since the 1963 imagery.
1984	No significant change since the 1974 imagery.
2005	Princes Hwy, significant residential development surrounding Site to east and south. Site area remains clear of any visible infrastructure.
2018	No significant change since 2005, excepting bike path along the western boundary, evident from approx. 2012. Relatively consistent with current day aerial photography.

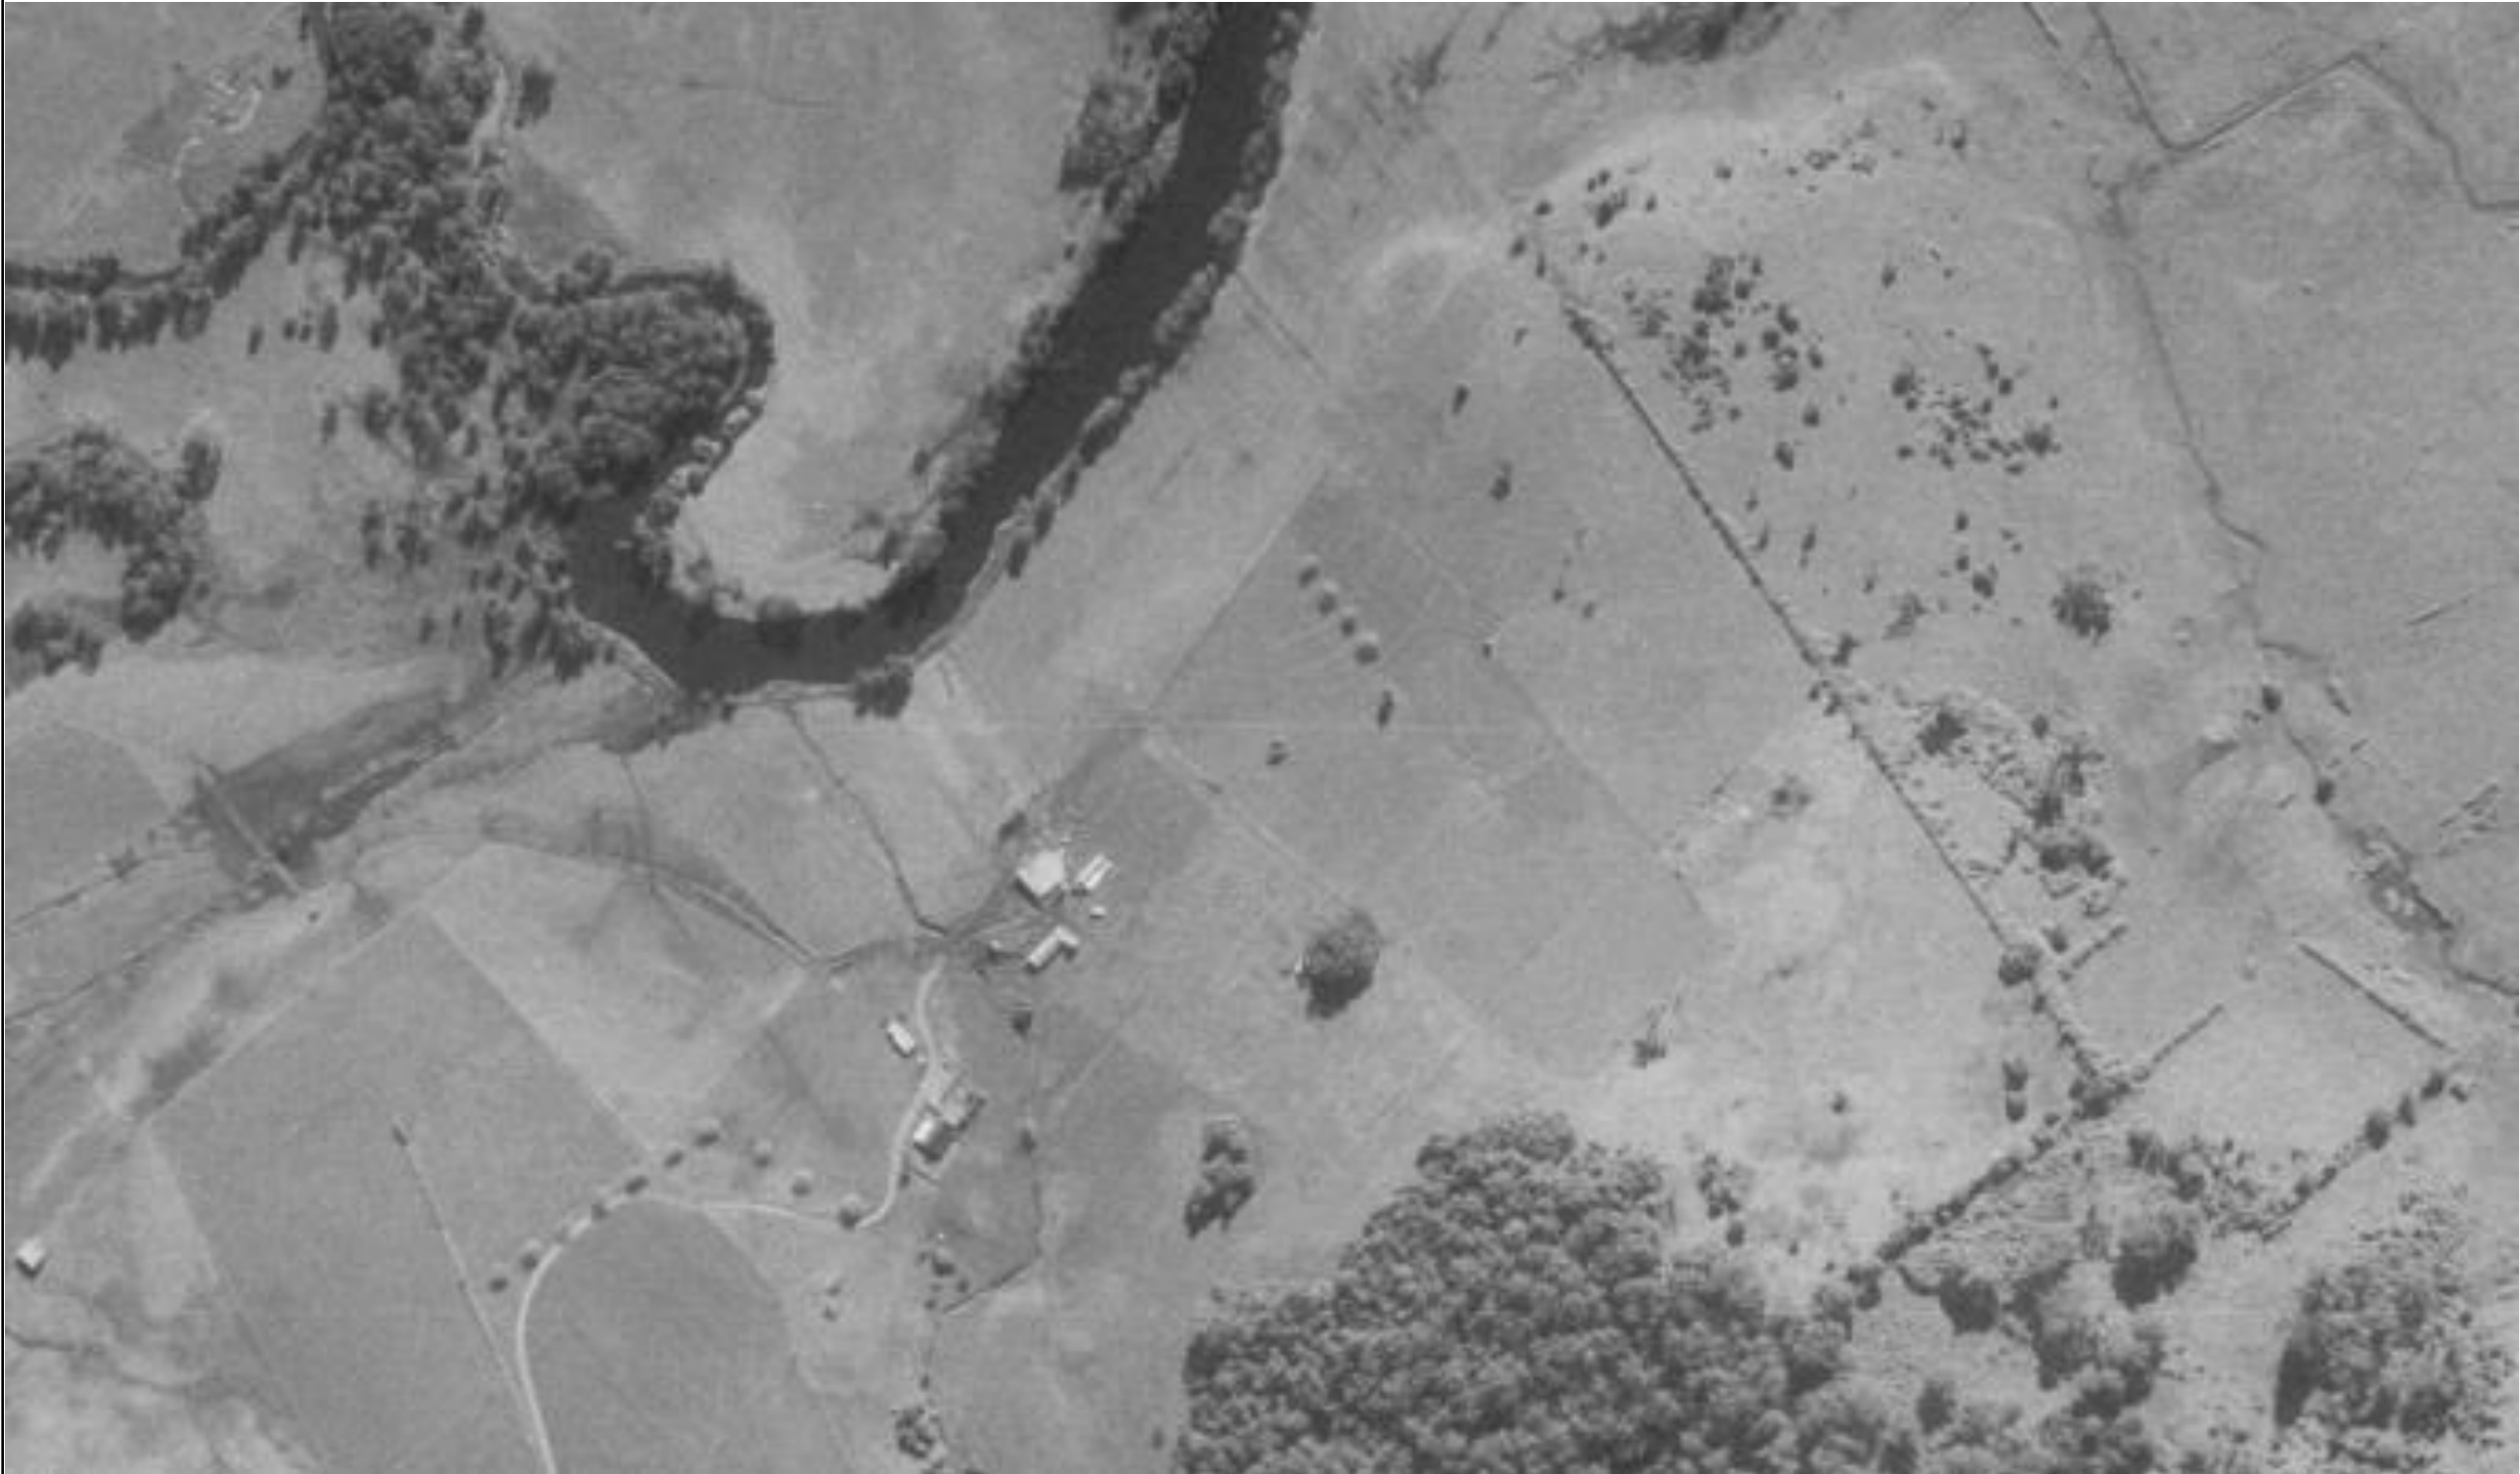
Client:	INDESCO	Drawn:	PL	Figure:	6
Project:	ENRSW0144	Source:	Google maps	Date:	21/01/2020
Location:	Henry Parkes Drive	Scale:	See Figure	Title:	Historical Imagery 1974
		Status:	Rev 1

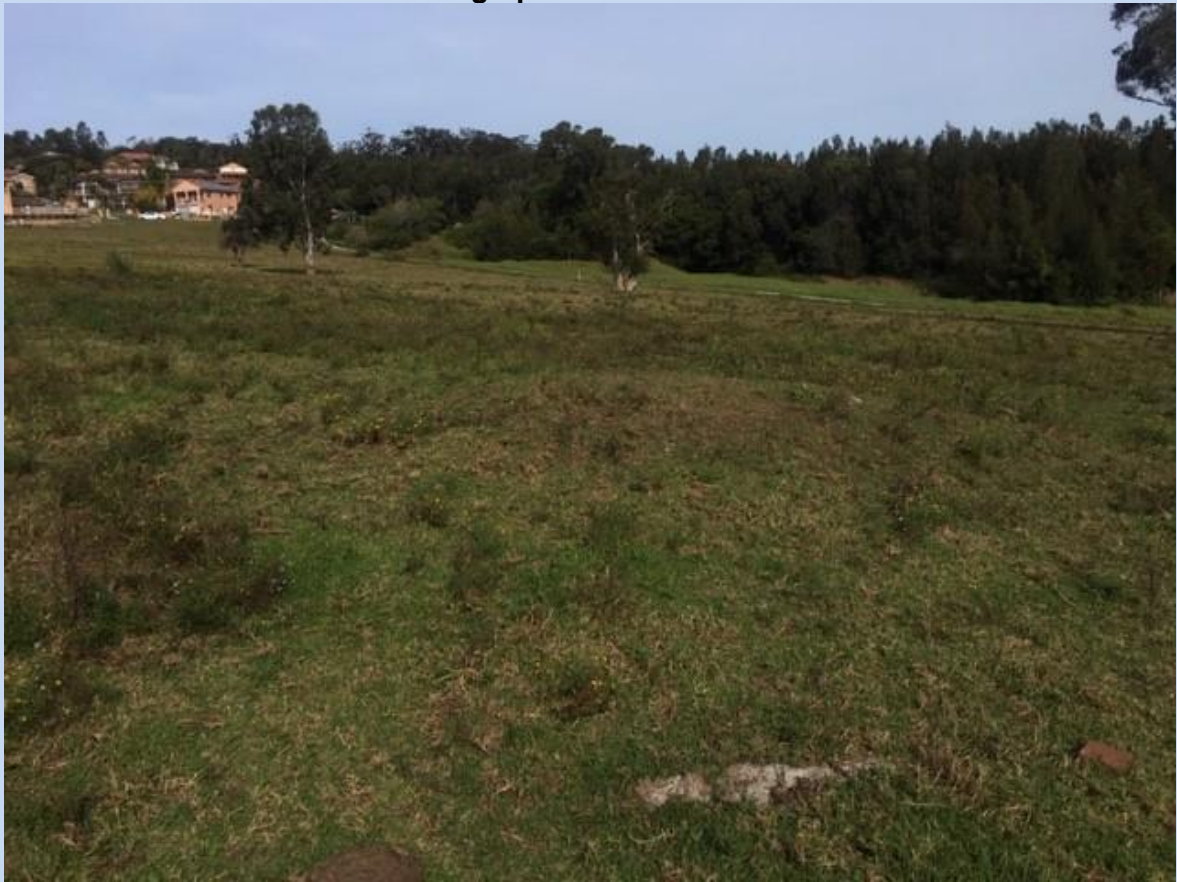
Photograph 1: Site Condition

The inspection consisted of a Site walk over to confirm the Site boundaries, access, layout, surface conditions, land use, buildings, potential for Above ground Storage Tanks (AST) and Underground Storage Tanks (UST), and a preliminary assessment for uncontrolled Fill and waste storage, as summarised below. In general, the observed Site layout was consistent with the current aerial photographs. At the time of the inspection, the site remained undeveloped consisting of open grassland.

Given the undeveloped nature of the Site and observed Site conditions there is 'low' potential for the presence of significant ground contamination at the Site. No areas of Fill were observed across the Site. No visual or olfactory evidence of contamination was observed on the surface of this material.
