Preliminary contamination investigation

Proposed Animal Shelter Development, 301 Golf Links Road, Condobolin NSW

Summary report

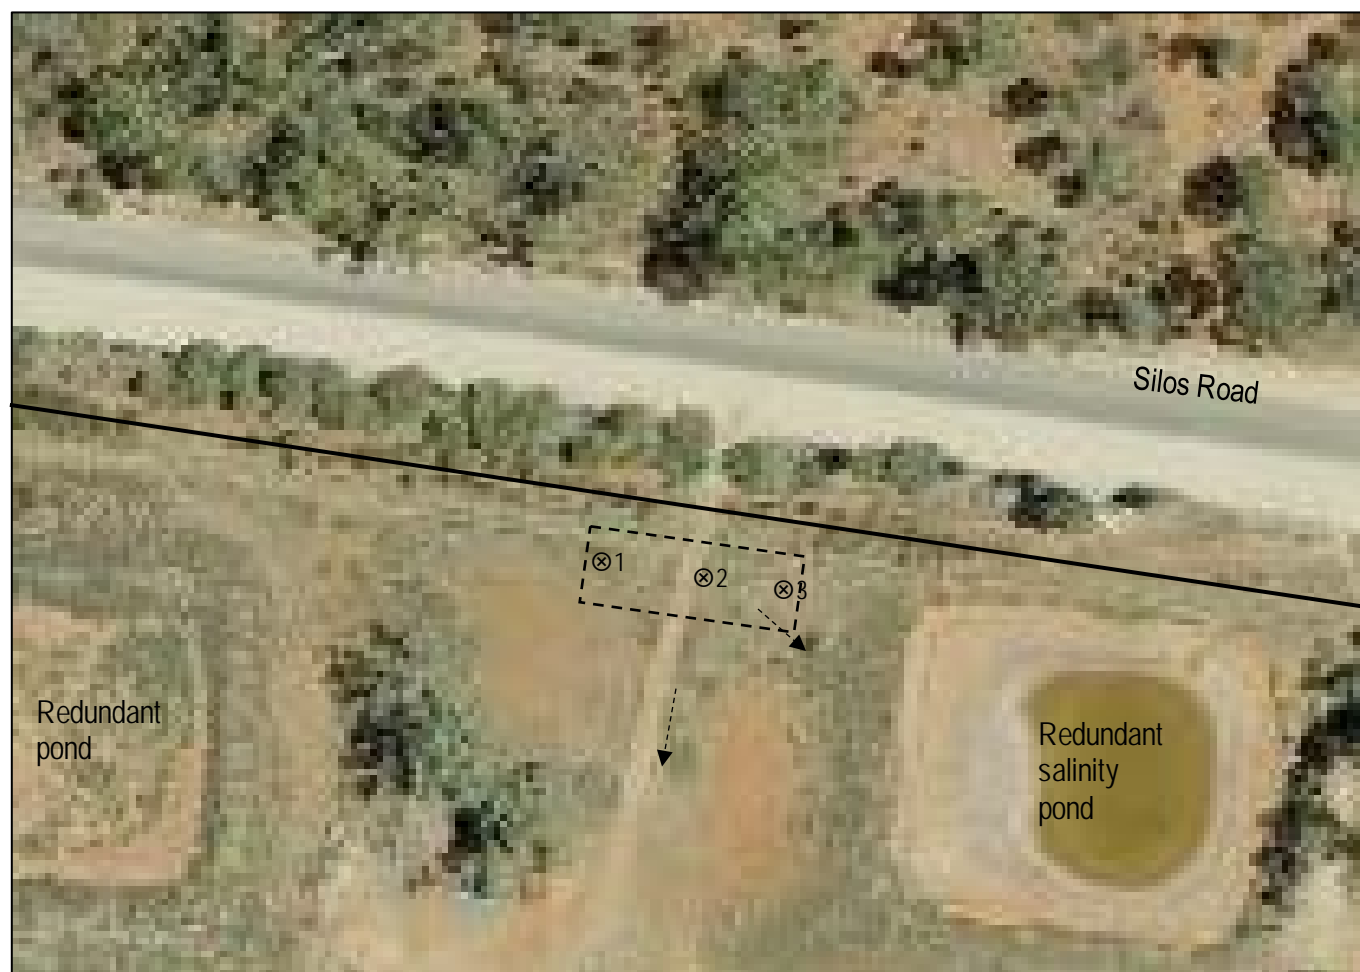
LSC2
100
3,200mg/kg
-
-

LSC3
100
-
7.125 dS/m
100 cfu/100ml

Soil samples LSC1 and LSC2 contained levels of total nitrogen at 4,500mg/kg and 3,200mg/kg which is greater than the adopted threshold of 857mg/kg. High levels of nitrogen have the potential to leach into waterways. The levels present have potential to cause off-site impacts.

E. coli was detected in one soil sample. The presence of *E. coli* has the potential to impact on human health.

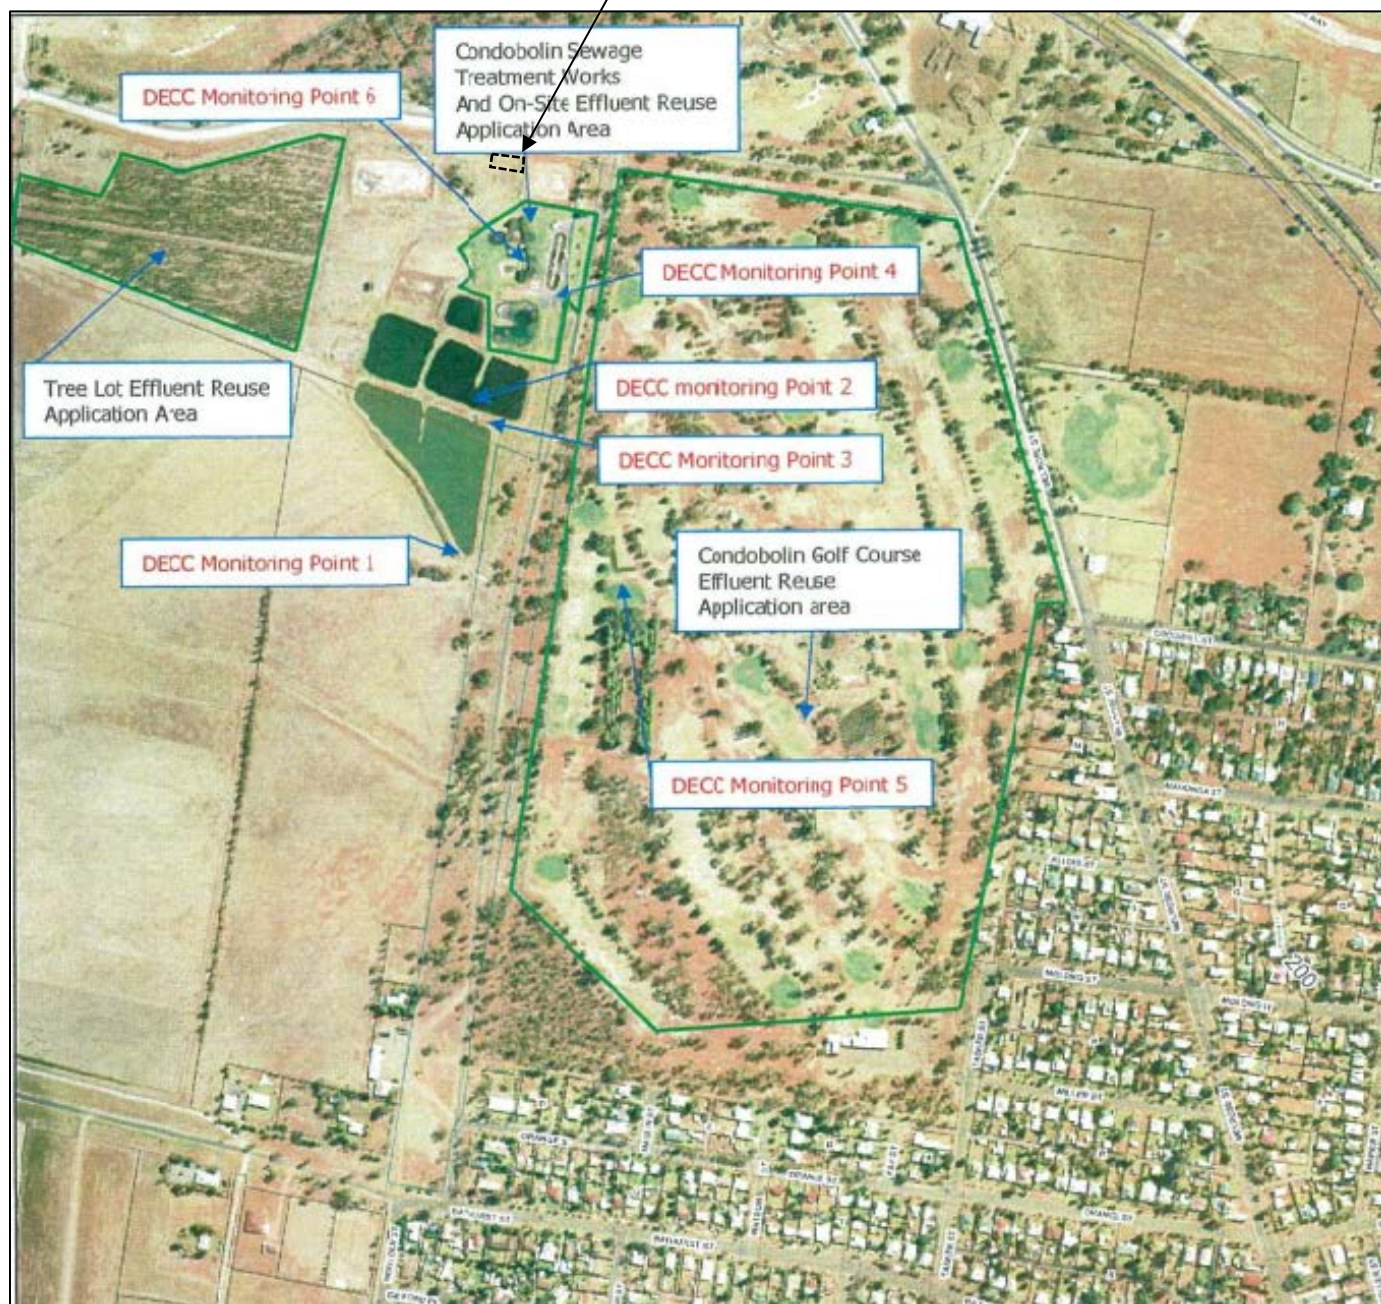
Figure 4. Condobolin Sewage Treatment Works
Reuse Application Areas

The STP discharges water from the final maturation pond towards the south. The discharge point is located approximately 200m south of the investigation area (Figure 4).

Treated effluent is utilised for irrigation at the Condobolin Sewage Treatment Plant and Condobolin Golf Course. Condobolin Golf Course is located 150m west of the investigation area. Reuse at the Condobolin Sewage Treatment plant is spray and drip irrigation to the tree lot located 170m west of the investigation area and Condobolin Sewage Treatment plant located 50m south. Effluent application to land is regulated by the NSW EPA under licence 4480.

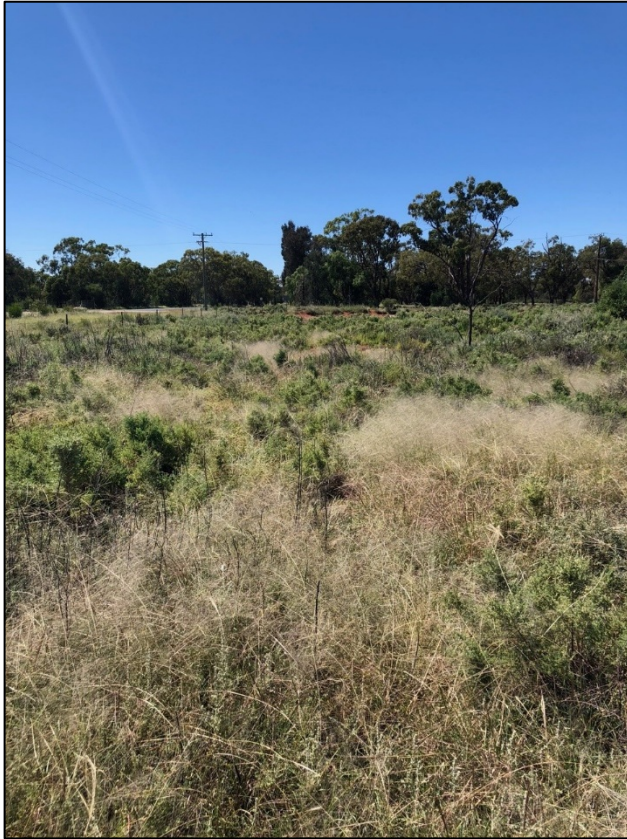
Looking east towards redundant salinity pond

A redundant salinity pond is located west of the site. The pond is not known to have been utilised and water within the pond is runoff.

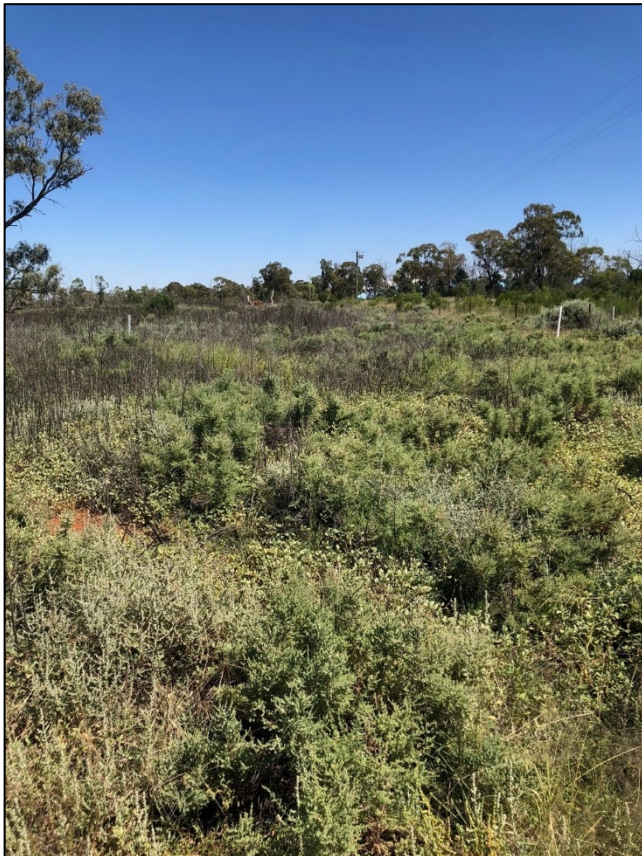
Looking west
