***PRELIMINARY GEOTECHNICAL ASSESSMENT***

***PROPOSED RESIDENTIAL SUBDIVISION***

***LOTS 93 TO 96, DP 753194***

***Project 39519 – Rev 1***

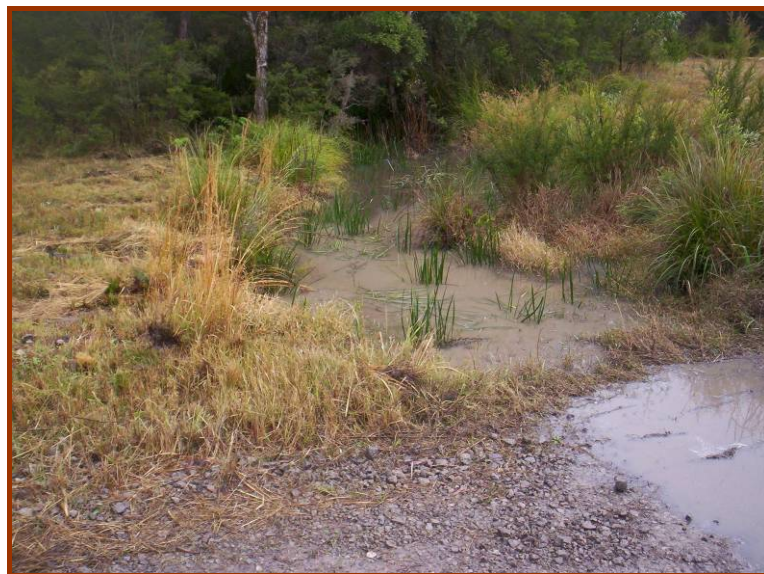
***Photo 1 – Flowing creek within gully at transmission easement (looking north Lot 96)***

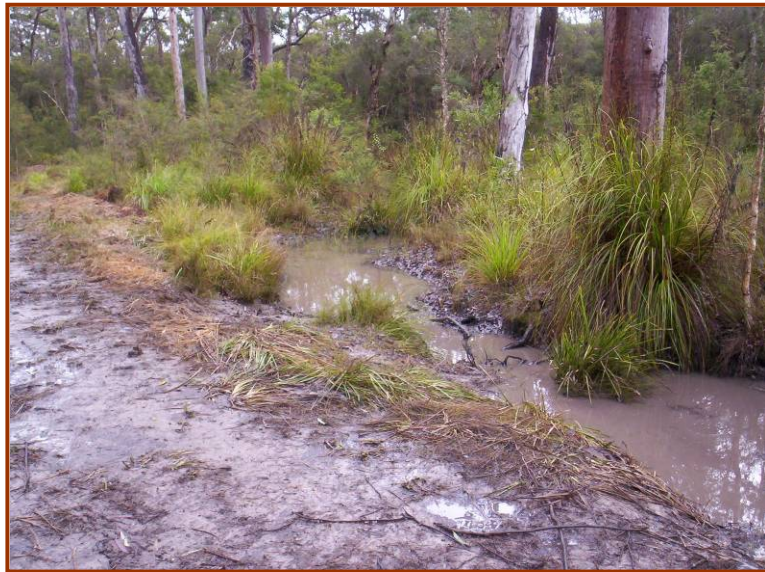
**Photo 2 – Creek within gully (looking north-west Lot 95)**

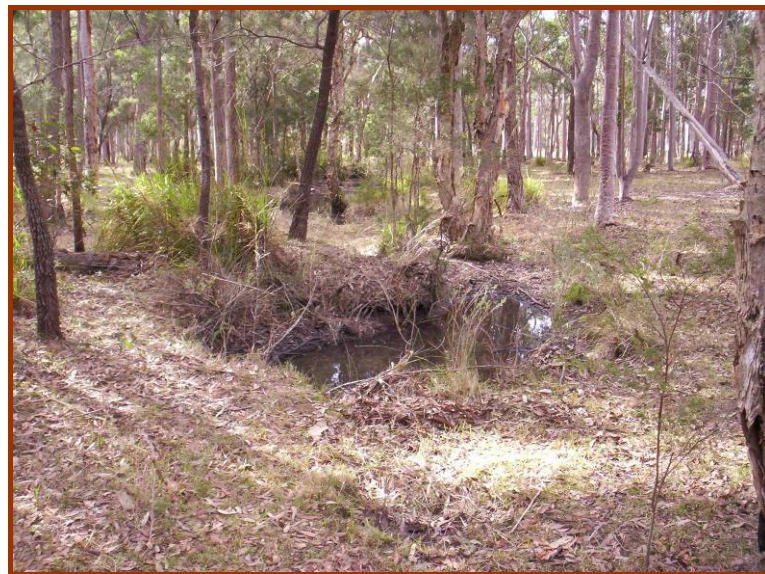
**Photo 3 – Ponds within minor gully (looking east Lot 93)**

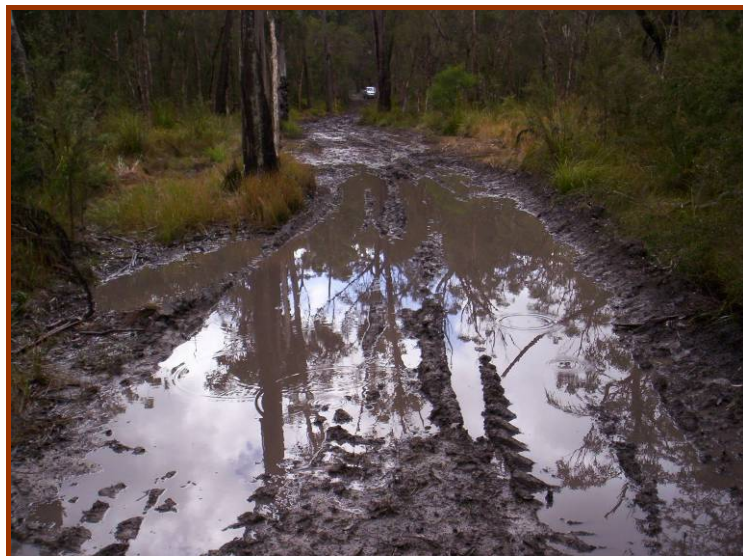
- Main gully - extending 50 m to 100 m from the gully's centreline in some areas (typically within areas with paperbark trees) (Photo 4);
- Cleared area within Lot 94, which has formerly been ploughed / ripped for cropping (Photo 5);
- Unsealed access tracks and localised unsealed cleared areas of the site which comprise minimal vegetation cover (including site boundaries which had recently been cleared for fencing).

***Photo 4 – Boggy ground within gully (looking north-east Lot 95)***

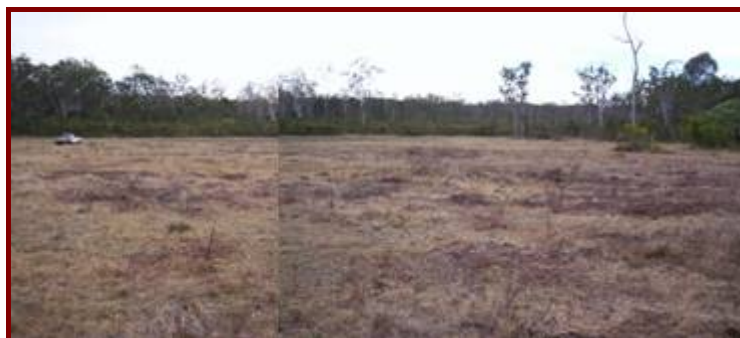
***Photo 5 – Formerly ploughed / ripped area (Looking east Lot 94)***

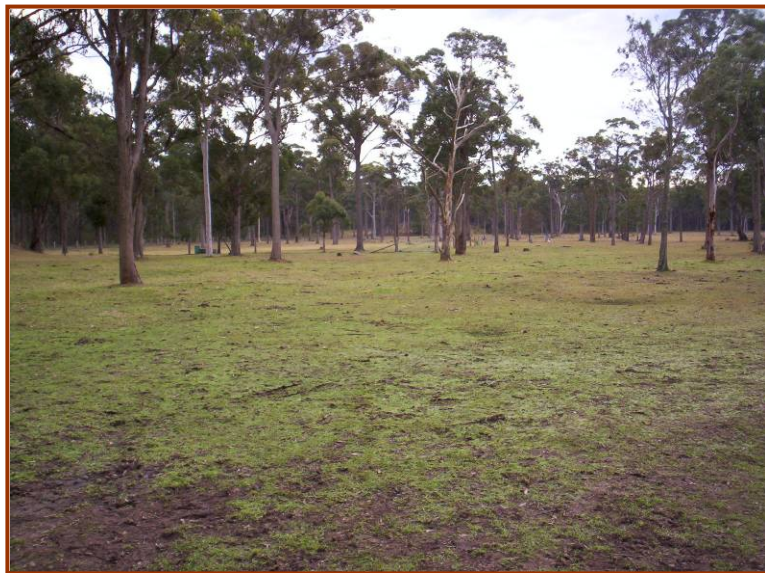
***Photo 6 – Semi-cleared area within Lot 93 (looking north)***

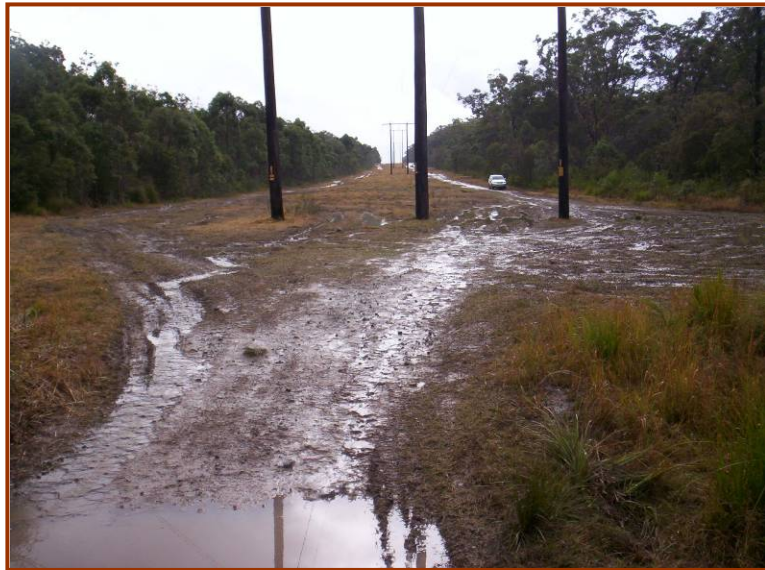
Minor soil erosion was observed within some gullies and in areas of sparse vegetation (Photo 7).

***Photo 7 – Minor soil erosion within transmission easement (looking north-east Lot 96)***

Provision of an adequate vegetation cover would aid in preventing large scale erosion at the site. It should also be noted that erosive soils are readily amenable to standard mitigation measures such as silt fences, revegetation / reshaping batters, drainage structures (catch drains), sediment traps and sedimentation basins during and following construction.

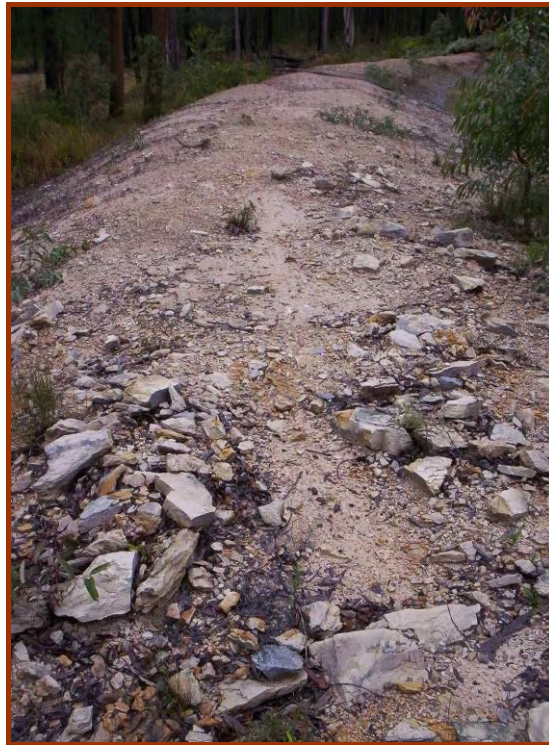
Dam walls typically appeared to be constructed from clays and siltstone materials (Photo 8), likely to be cut / fill, with embankment heights of up to 2 m. Waters within farm dams at the time of inspection ranged from relatively clear within dams closer to site gullies (Photo 9), to turbid within the larger dams in the southern portion of the site (Photo 10). Minor soil erosion was also observed in some of the dam embankments, especially where vegetation was sparse.

***Photo 8 – Clays/siltstone within dam wall (looking east Lot 95)***

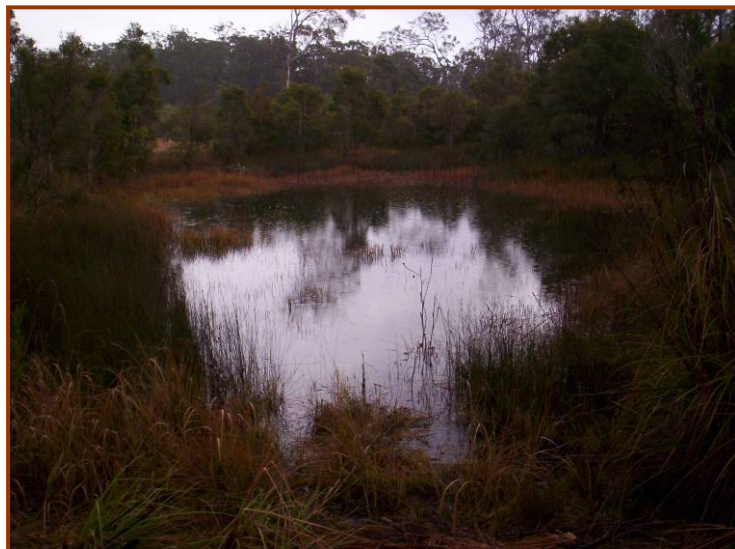
***Photo 9 – Dam within gully (looking north-west Lot 94)***

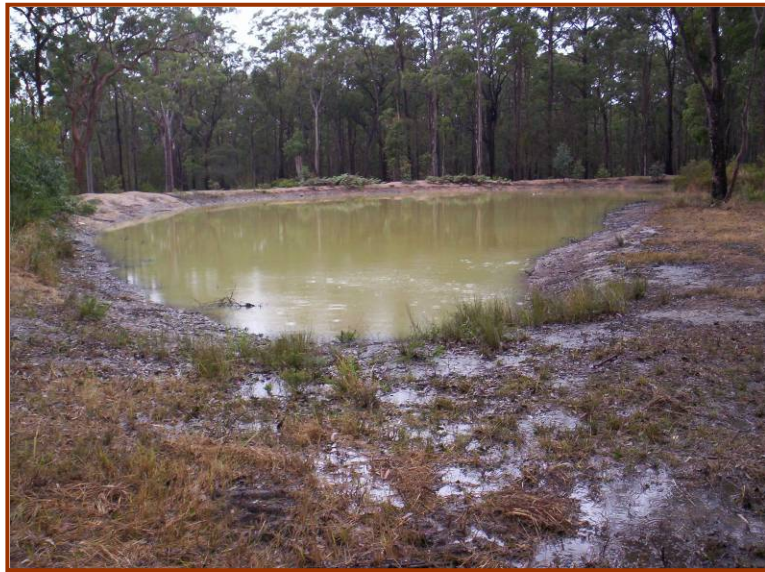
***Photo 10 – Turbid dam (looking north-east Lot 95)***

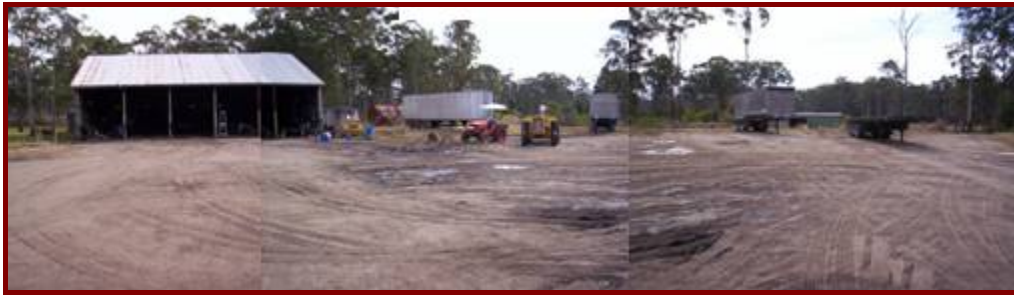
- Fill hardstand located to the east of the workshop/shed within Lot 94. The fill was observed to comprise various inclusions such as bricks, concrete, ceramic tiles, gravel, plastic, metal, rubbish in a clay matrix. Hydrocarbon staining and hydrocarbon odour was observed at the ground surface in the vicinity of the fill pad and workshop (Photo 11);

***Photo 11 – Fill pad adjacent to workshop / shed within Lot 94 (looking north)***

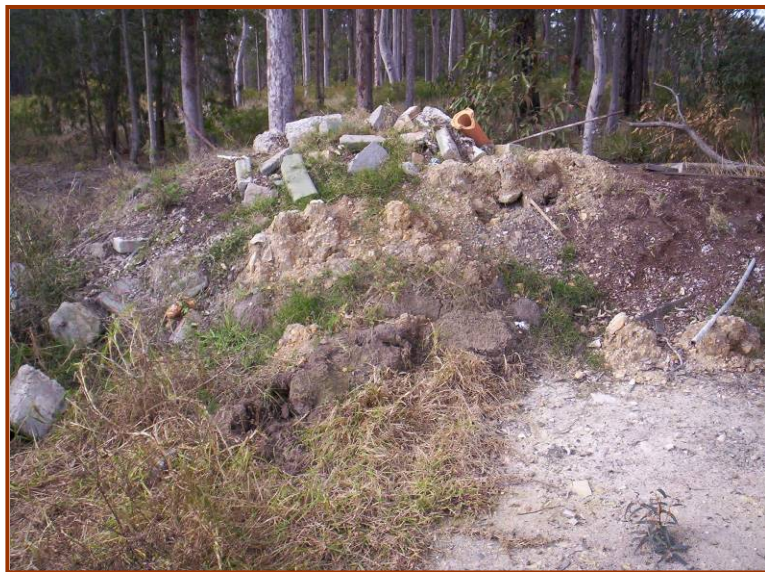
- Fill stockpiles adjacent to the fill pad within Lot 94. The fill stockpiles were observed to contain clays, gravel and sand fill with some concrete, piping and metal inclusions (Photo 12);

***Photo 12 – Fill stockpile adjacent fill pad (looking east Lot 94)***

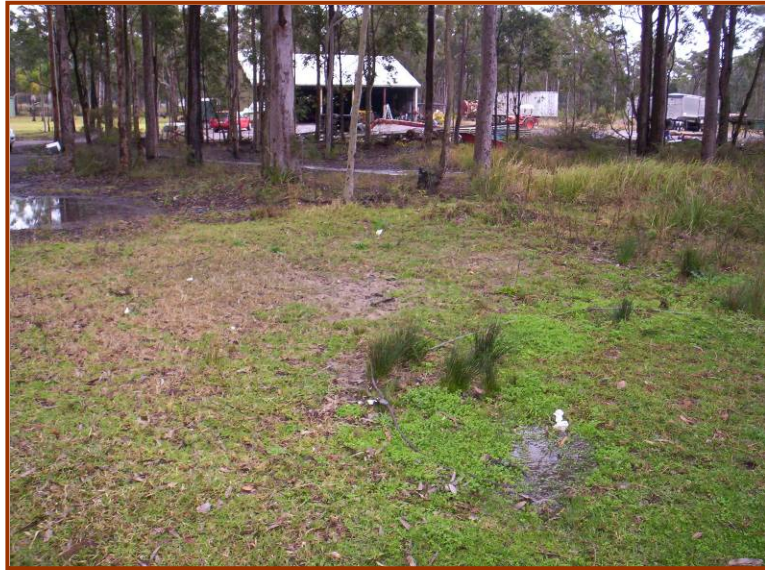
**Photo 13 – Surface fill to south-east of fill pad (looking north-west Lot 94)**

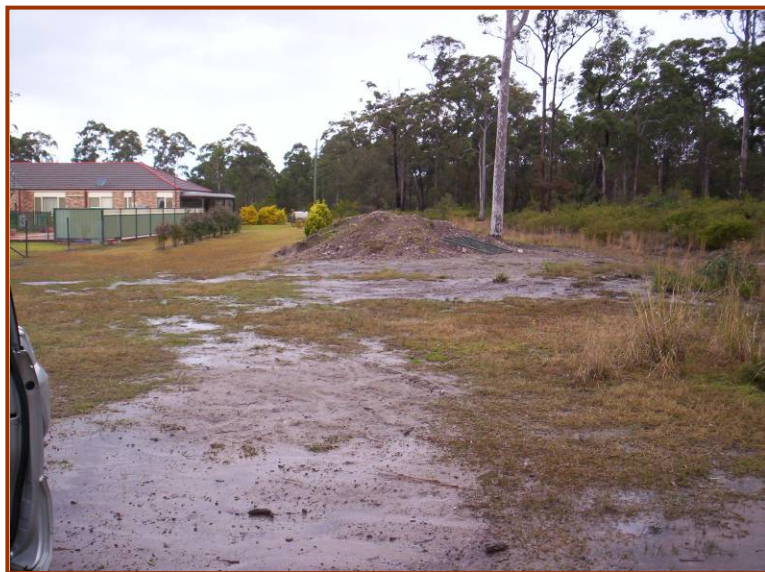
**Photo 14 – Stockpile comprising weathered siltstone (looking south-west Lot 95)**

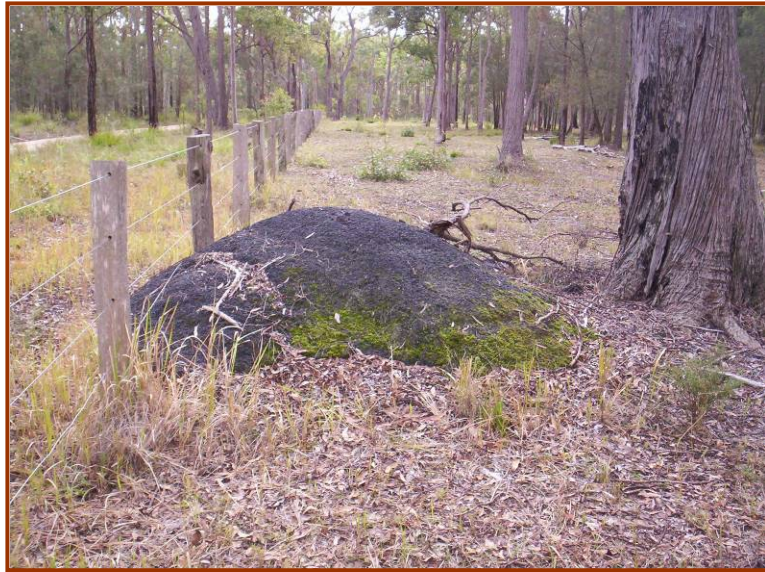
- Fill stockpile comprising hardened bitumen adjacent to the western boundary of Lot 93 (Photo 15);

**Photo 15 – Stockpile of bitumen (looking north Lot 93)**

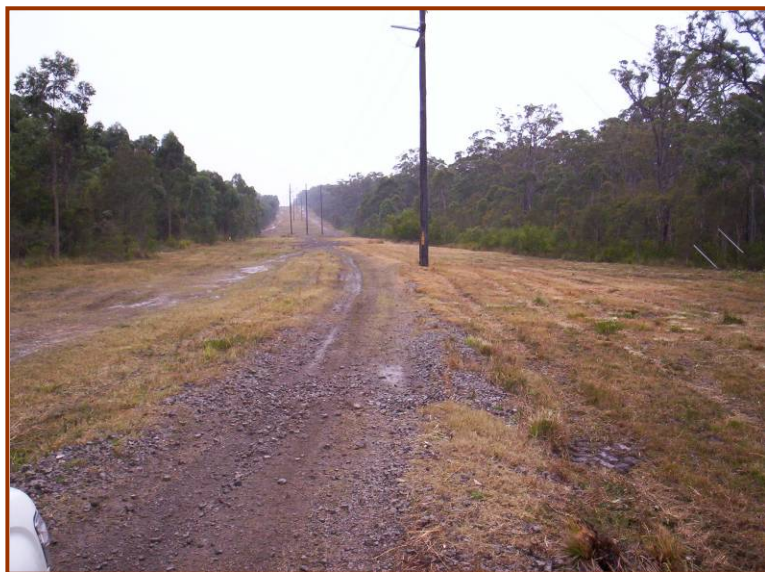
- Surficial fill placed along the transmission easement in the south-east corner of the site, generally comprising granular slag and gravel fill (Photo 16);
- Granular filling used to construct internal access roads to residences within Lots 93 to 95.

**Photo 16 – Surficial filling along transmission easement (looking north-east Lot 96)**
