## Preliminary site investigation of Lot 10 DP 1218866, Murrumbateman, NSW

Report title
Preliminary site investigation of Lot 10 DP 1218866, Murrumbateman, NSW

## Executive summary

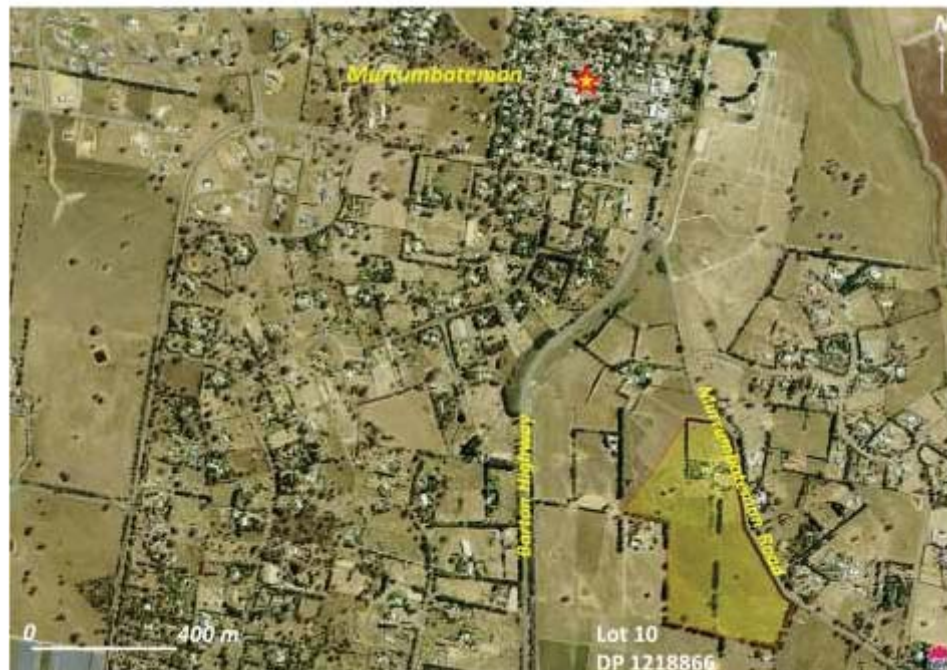
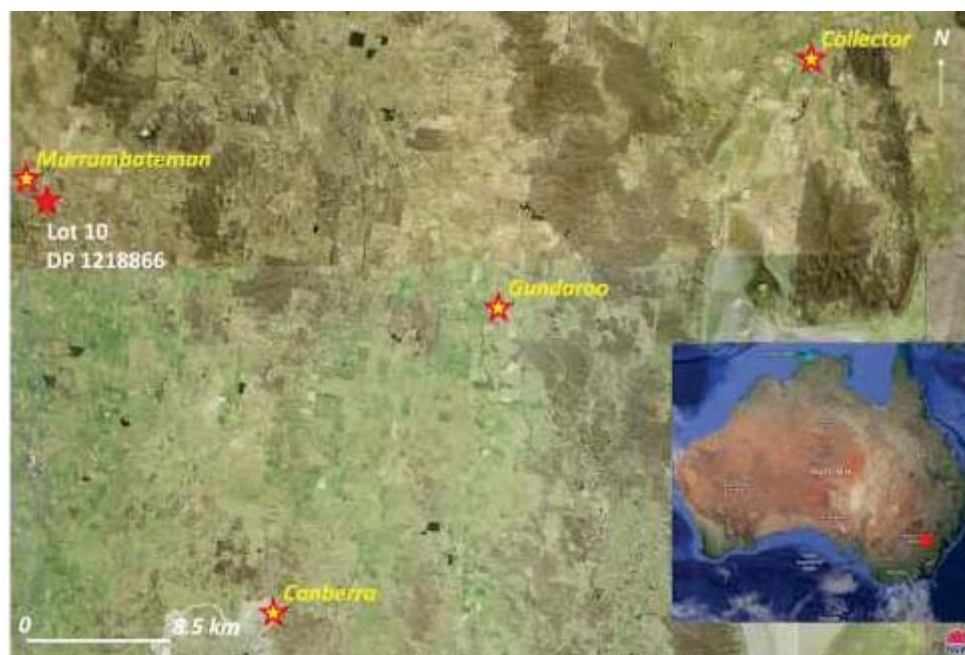
Figure 1. Location of the Site relative to (a) Murrumbateman; and (b) NSW

Murrang Earth Sciences was engaged to undertake preliminary assessment of contamination—commonly referred to as a Preliminary site investigation — at the 18.6 ha Lot 10, DP 1218866 (the Site), Murrumbateman (Figure 1). It is proposed that the Site be subdivided into nine, 2 ha lots (Appendix A), with Murrang Earth Sciences engaged to undertake a Preliminary site investigation to meet development application requirements for this subdivision. The preliminary site investigation presented herein is a largely desktop-based assessment.

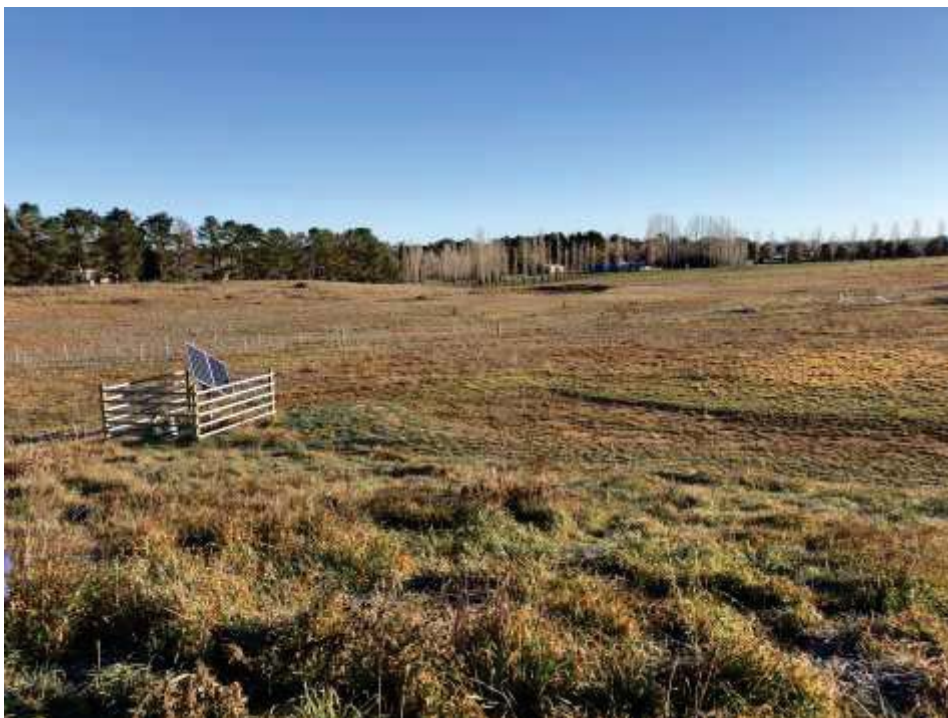
A bore was constructed to replace this first bore, approximately two years ago (Figure 2). It is located approximately 100 m west of the Glen Lea residence, and has a depth of 40 m. This water is fresher than the original bore. Ken noted that a bore was initially sunk to 200 m approximately 120 m south-east of this new bore without hitting water, before drilling was moved to where the current water bore now occurs. A tributary of Murrumbateman Creek rises in the southern parts of the Site, with this a medium by which any contamination which occurs on the Site might be transported from it. The tributary is considered to not have the potential to transport contamination to the Site, due to the lack of watercourse above the southern area.

Figure 2. A solar panel providing energy to the bore located on the western Side of the Glen Lea Residence

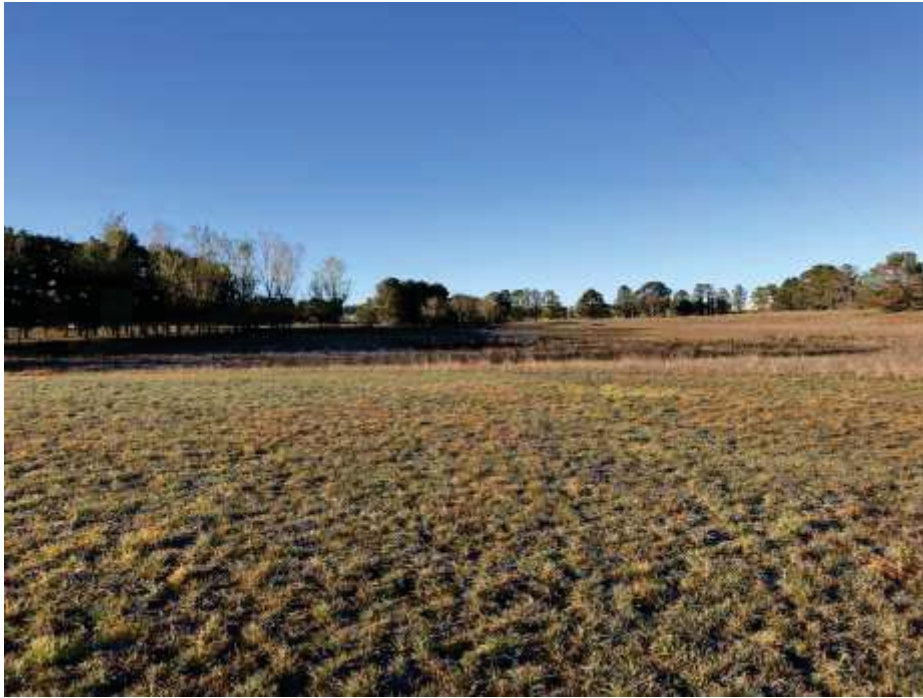
The Site was largely comprised of empty and grassed paddocks (Figure 3). Trees occurred in rows around the property's boundary, with the fenced paddocks otherwise well grassed. No indications of any rubbish, including barrels, fences, or any other farm equipment, were noted across the Site. A neighbour on the Site's southern boundary stores farm equipment including old barrels on the property boundary, however no indications of leaks, staining, or odours were noted. Ken noted that noxious weeds on the property are actively

Figure 3. Empty paddocks located in the southern portion of the Site, looking south. The trees in the left, right, and background of the photograph indicate the Site boundary

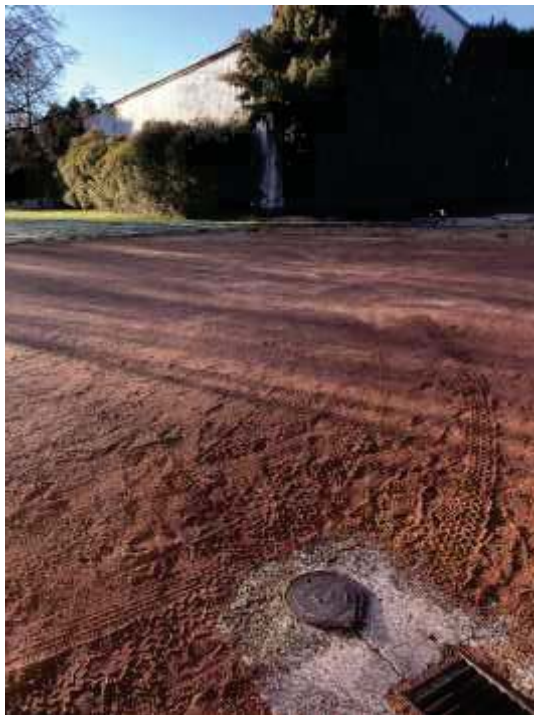
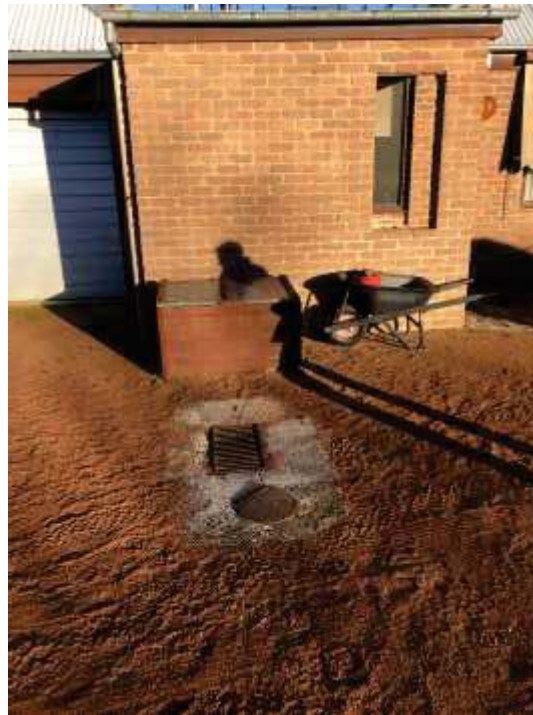
A UPSS used for the storage of diesel is located within Lot 3 of the proposed development (Figure 4). This 15,000 L tank has been refuelled only once in its existence and was used to fuel a diesel furnace within the Glen Lea residence. The furnace was used to heat the house. The tank is thought to be located 0.5 to 0.75 m

Figure 4. Underground petroleum storage system cover on the eastern side of the current Glen Lea residence looking (a) east; and (b) west

below the ground surface, and within 5 m of the centre of the eastern side of the house. The tank itself is steel and was concreted into the ground. Ken checks the tank for water as an indication of any leaks using ullage paste, with no indications of leaks. The diesel furnace has not been run for at least 20 years, due to the high cost of fuel, and around 1000 L of diesel is thought to remain within the tank.

Murrang Earth Sciences considers the underground petroleum storage system within Lot 3 to present a hazard to both human health and the environment due to its:

- location in a UPSS sensitive area, where is located within the vicinity of both a drinking water catchment and groundwater wells used to source drinking water;
- the tanks age;
- the lack of independent monitoring of the tank and surrounds for indications of leaks; and
- the tank containing diesel, which contains contaminants including phenols, polycyclic aromatic hydrocarbons, and total recoverable hydrocarbons known to be a hazard to human health and the environment.

Both Murrang Earth Sciences and the New South Wales Environment Protection Authority recommends the tank be removed and a validation assessment of the remaining excavation be undertaken. The underground petroleum storage system is considered to not be an area of environmental concern, unless the UPSS remains at the Site.

Murrang Earth Sciences recommends the Underground Petroleum Storage System be extracted from the Site. Contaminants of potential concern including:

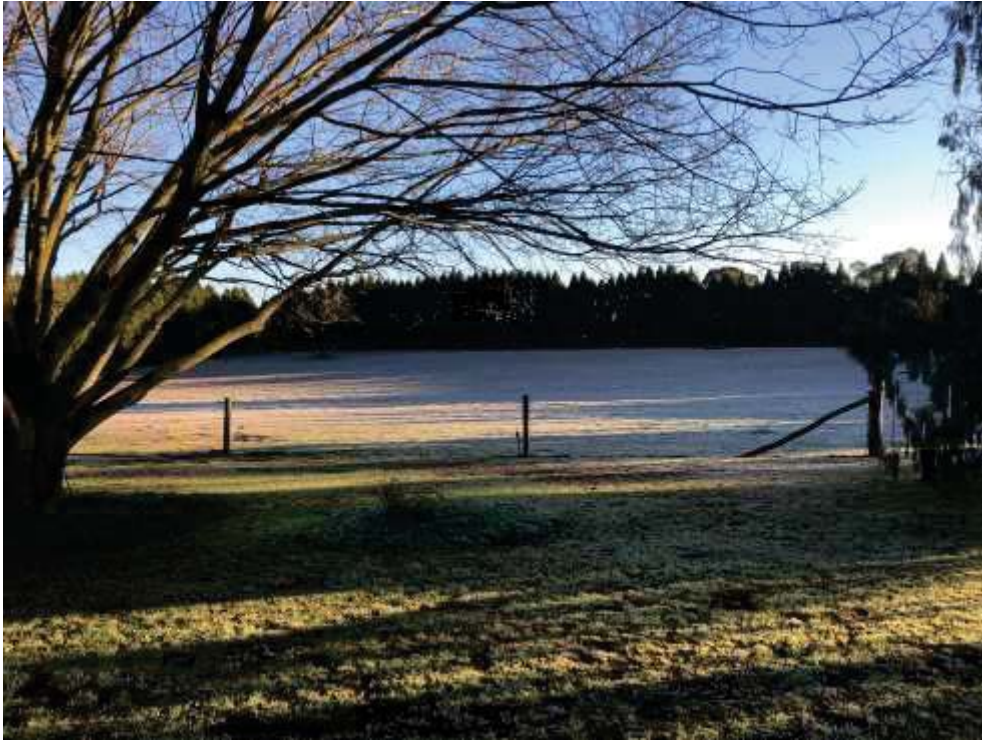
Figure 5. Trees planted in the 1980s, looking towards the eastern boundary of the Site from the Glen Lea residence
