## **GEOTECHNICAL INVESTIGATION REPORT**

### **Victoria Road and Faversham Street (Site 2) Marrickville NSW 2204**

**Report No. GS5611/1A**

**22<sup>nd</sup> January 2014**

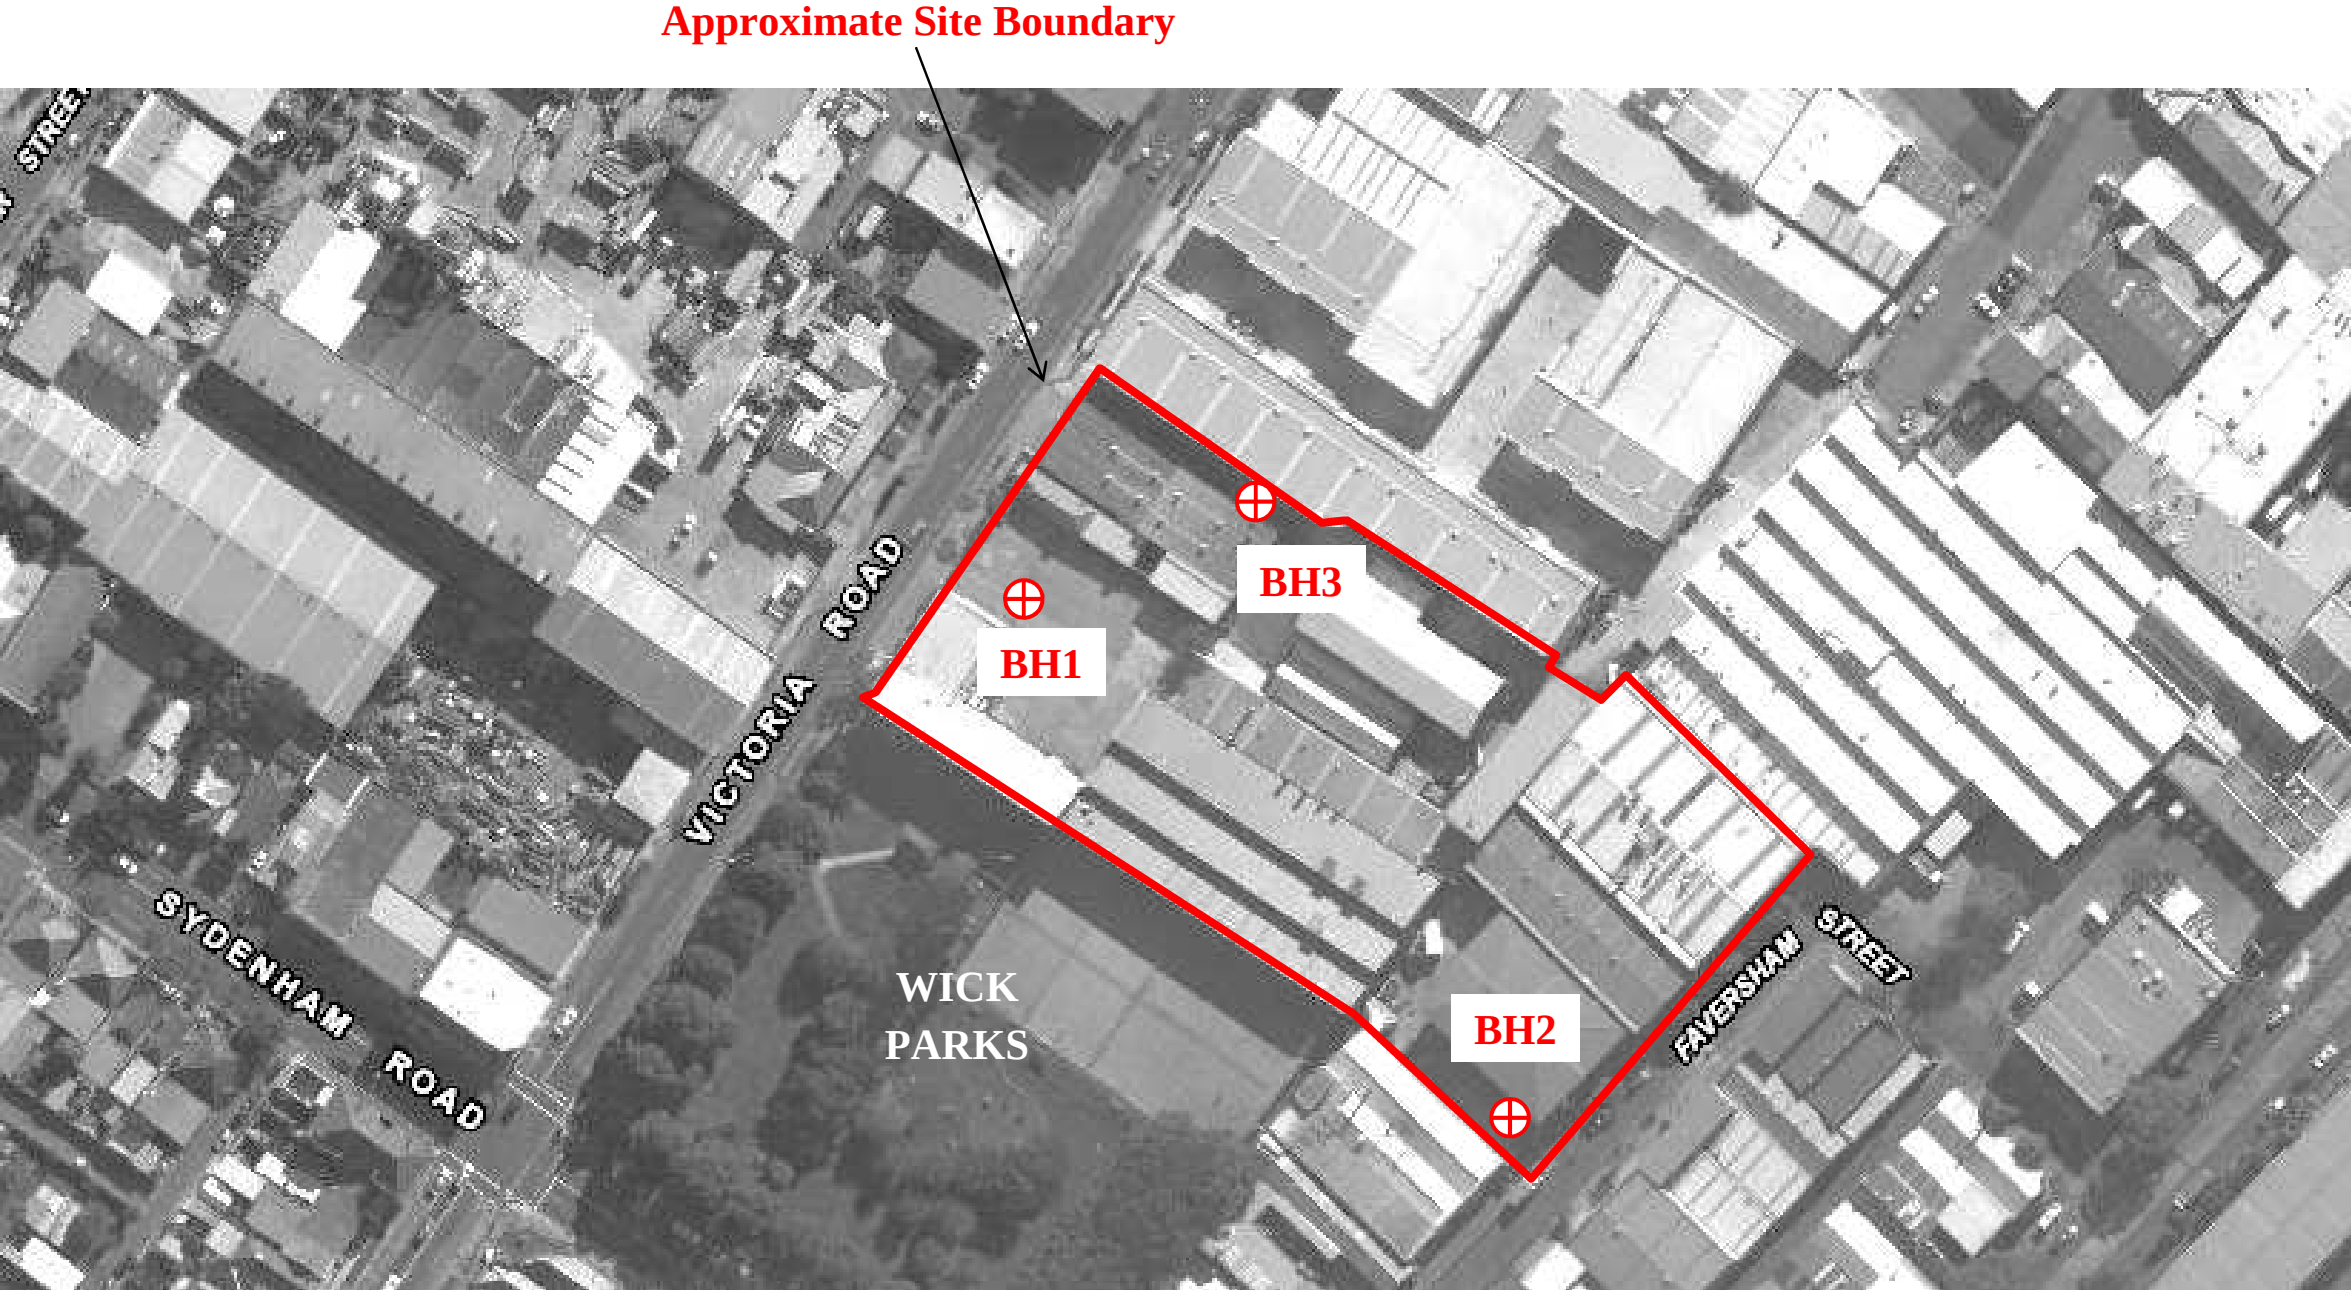
## **SITE PLAN (FIGURE 1)**

Legend:      ⊕ Approximate locations of boreholes drilled on 15<sup>th</sup> and 17<sup>th</sup> October 2013 by Aargus

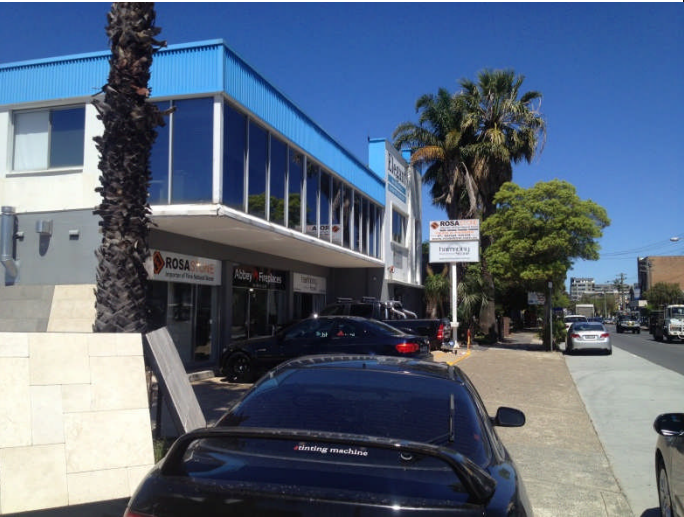
| <p><b>Photograph 1</b><br/>View of the north-western boundary of the site along the Victoria Road.</p> | <p><b>Photograph 2</b><br/>View of the existing buildings within the south-western area and entrance to the carpark from the Victoria Road.</p> | <p><b>Photograph 3</b><br/>View of the car park area and entrance to the site from Victoria Road.</p> | <p><b>Photograph 4</b><br/>View of the existing building at the western corner and adjacent carpark area within the site.</p> |

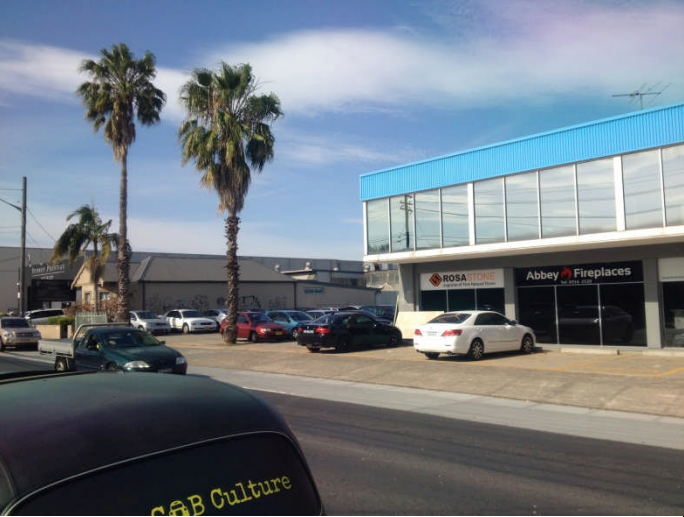
| <p><b>Photograph 5</b><br/>View of the site from Victoria Road towards the north-east.</p> | <p><b>Photograph 6</b><br/>View of the existing buildings and carpark within the southern corner of the site towards the north-east.</p> | <p><b>Photograph 7</b><br/>View of the existing building and carpark within the southern corner of the site towards the south-east.</p> | <p><b>Photograph 8</b><br/>View of the existing building within the eastern corner of the site towards the north-east.</p> |
