# **ACID SULPHATE SOILS ASSESSMENT**

**182, 184, 188, 190 & 190A Victoria  
Road &  
18-26 & 28 Faversham Street,  
Marrickville NSW**

**E & D Danias Pty Ltd**

**8<sup>th</sup> May 2014**

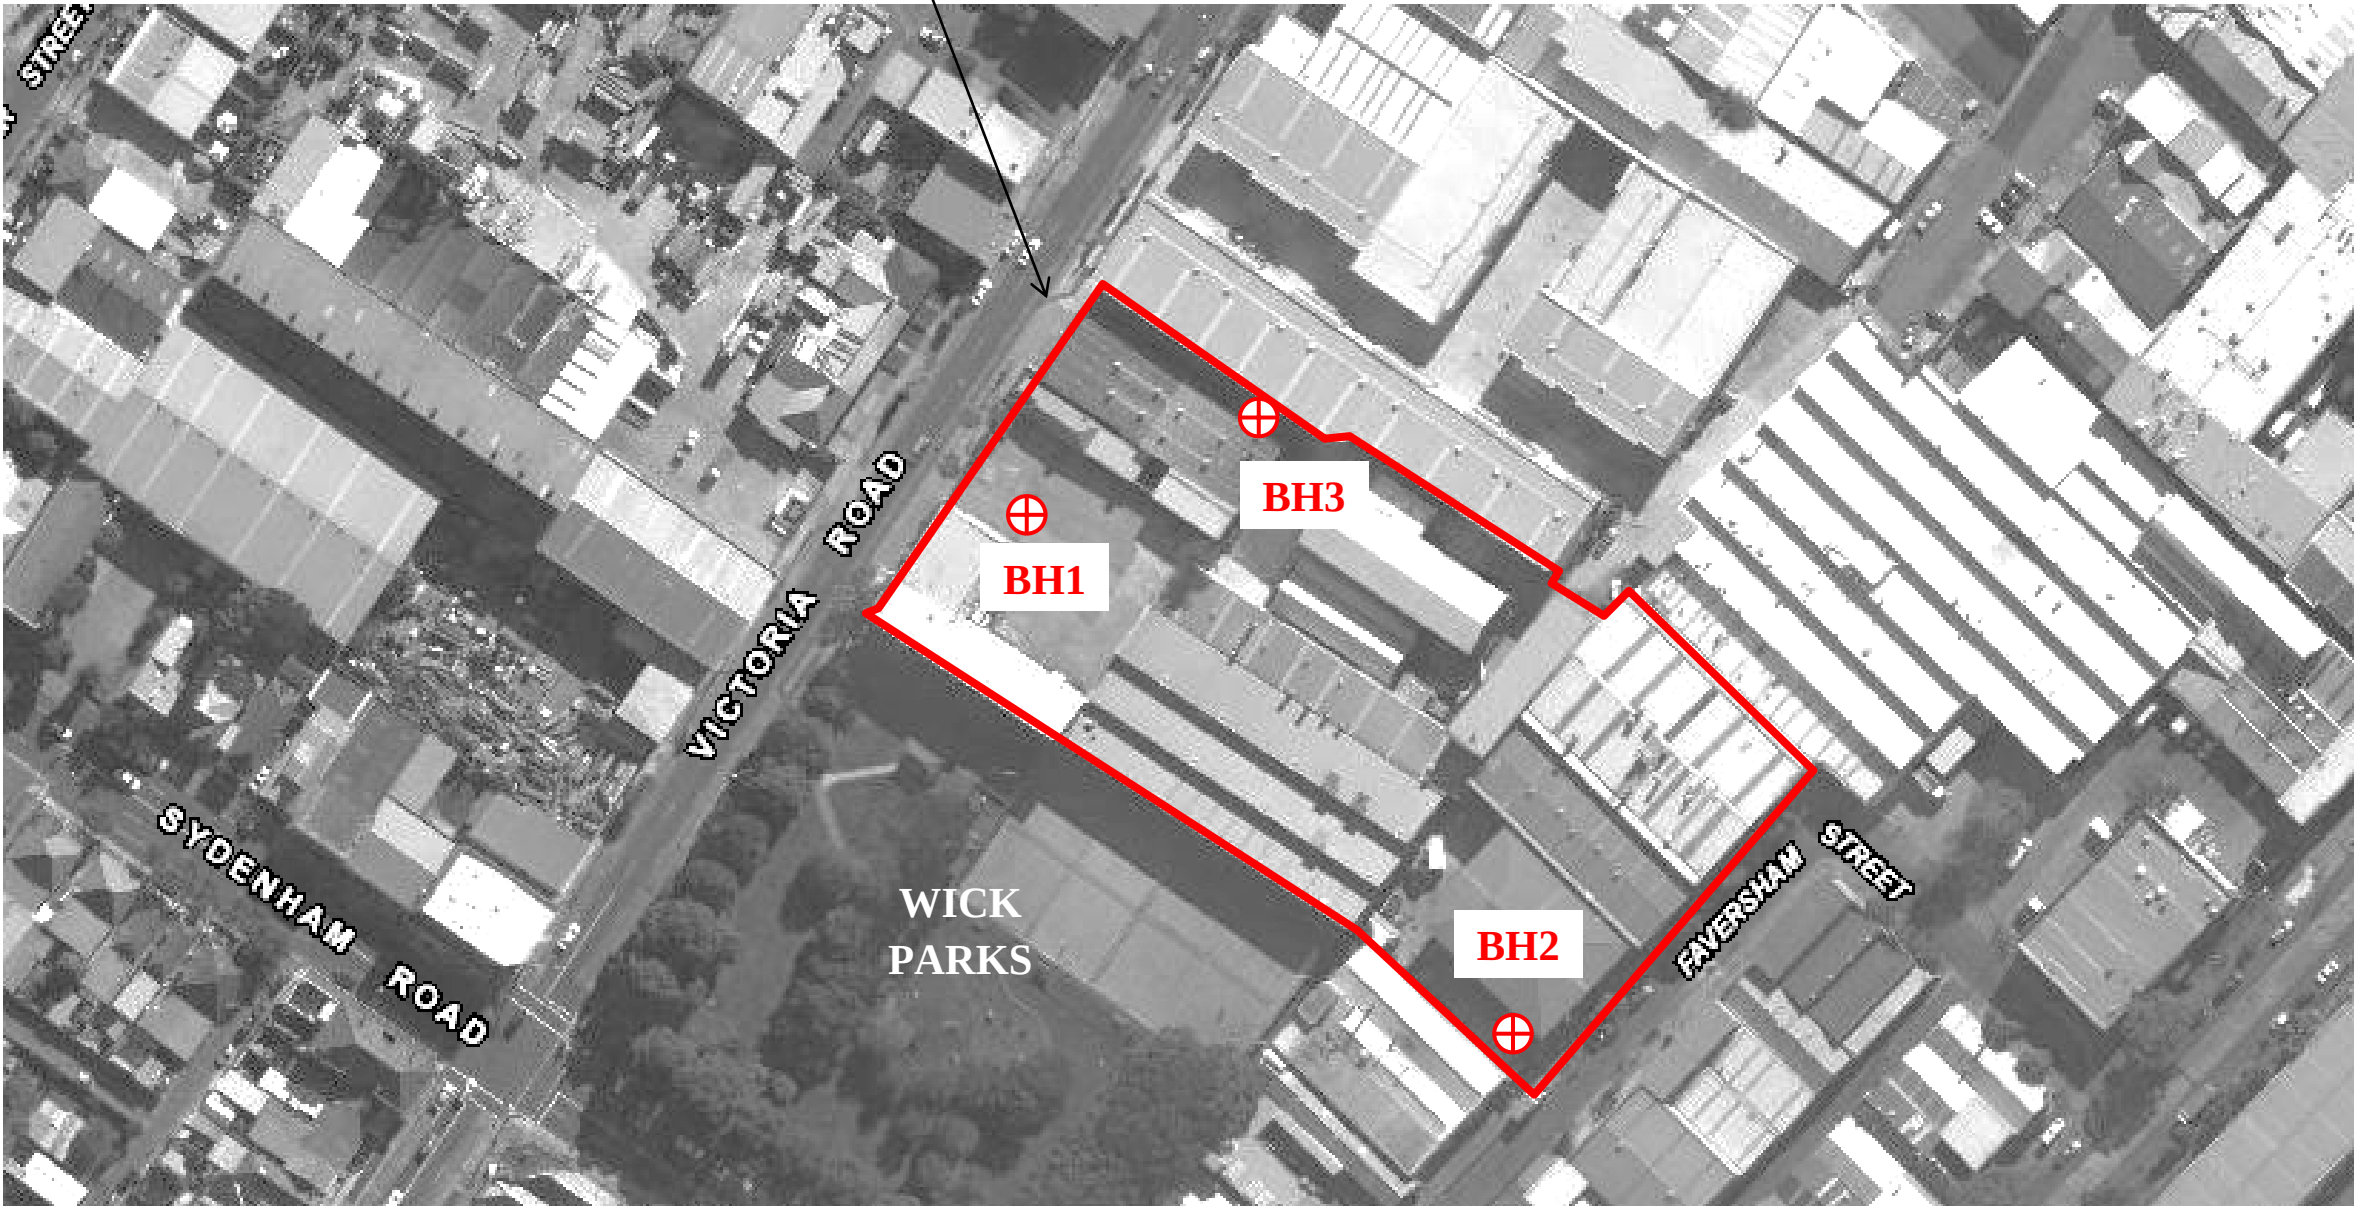
A soil sampling and analysis program was used to consolidate the nature and degree of Acid Sulphate Soils present in the surface and subsurface geology. Samples were collected from three (3) boreholes (BH1 to BH3) drilled within the site. The boreholes were drilled to depths between 4.3m & 8.0m below ground level (BGL), that being refusal in bedrock, with samples collected at varying depths depending on the soil profile (the borehole locations are presented in Figure 2 – Site Plan in Appendix A).
