# OPTIMA DEVELOPMENTS PTY LTD

**REZONING (RZ/15/2009) OF LOT 23 DP 1159704, No 76 BERKELEY ROAD, FOUNTAINDALE.**

# **Whitehead & Associates**

### **Revised Wastewater Management Report**

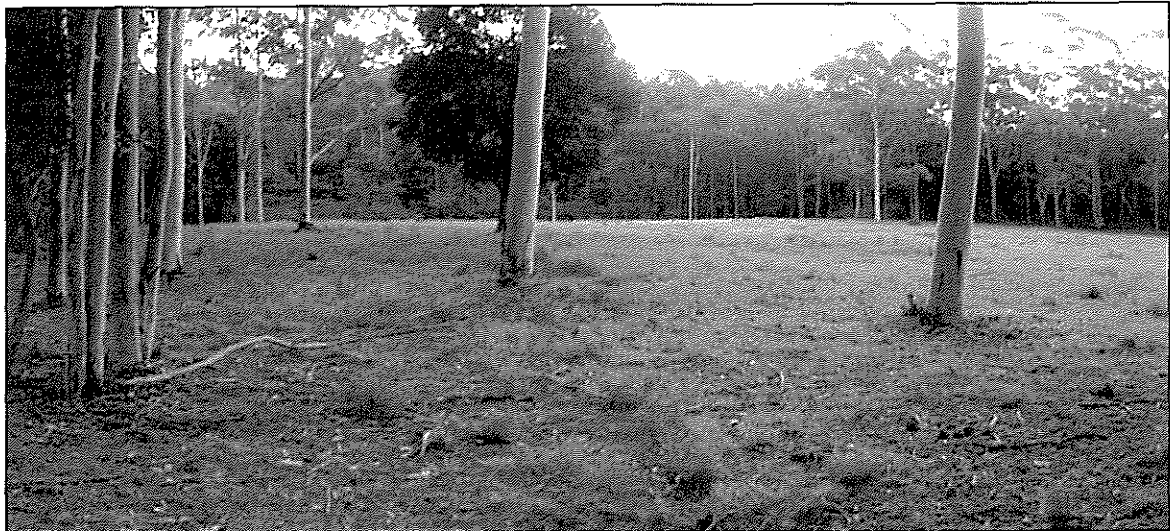
The site generally appeared to comprise a mix of grass vegetated paddocks, dense bushland (trees and shrubs) and some medium dense bushland regrowth. No evidence of existing or former buildings/structures, or an intensive agriculture (orchards/market gardens) were observed at the site. The cleared areas, within both the north-east and south-west portions of the site, were fenced and used for grazing. Portions of the site, beyond the fenced areas, appeared to comprise medium dense to dense bushland. There was no evidence of any fly tipped stockpiles.

**Figure 2 – Photograph of north-east portion of the site.**

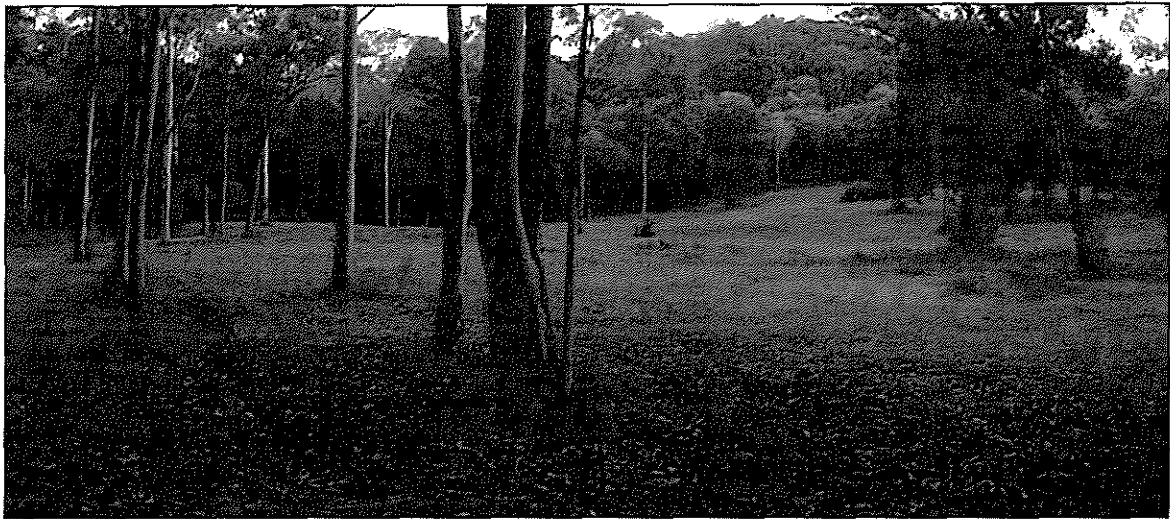
**Figure 3 – Photograph of south-west portion of the site.**

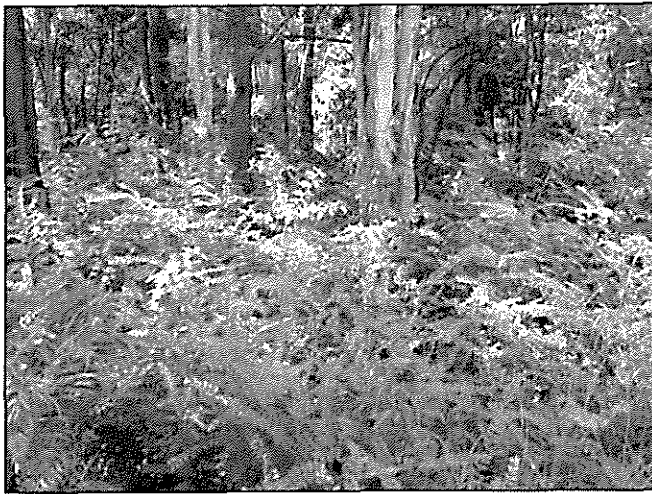
Figure 4 – Photograph of vegetation along the western boundary of the site.
