## **GEOTECHNICAL INVESTIGATION REPORT**

**Malco Site (Site 3)  
Rich Street  
Marrickville NSW**

**Report No. GS5544/2A**

**20<sup>th</sup> December 2013**

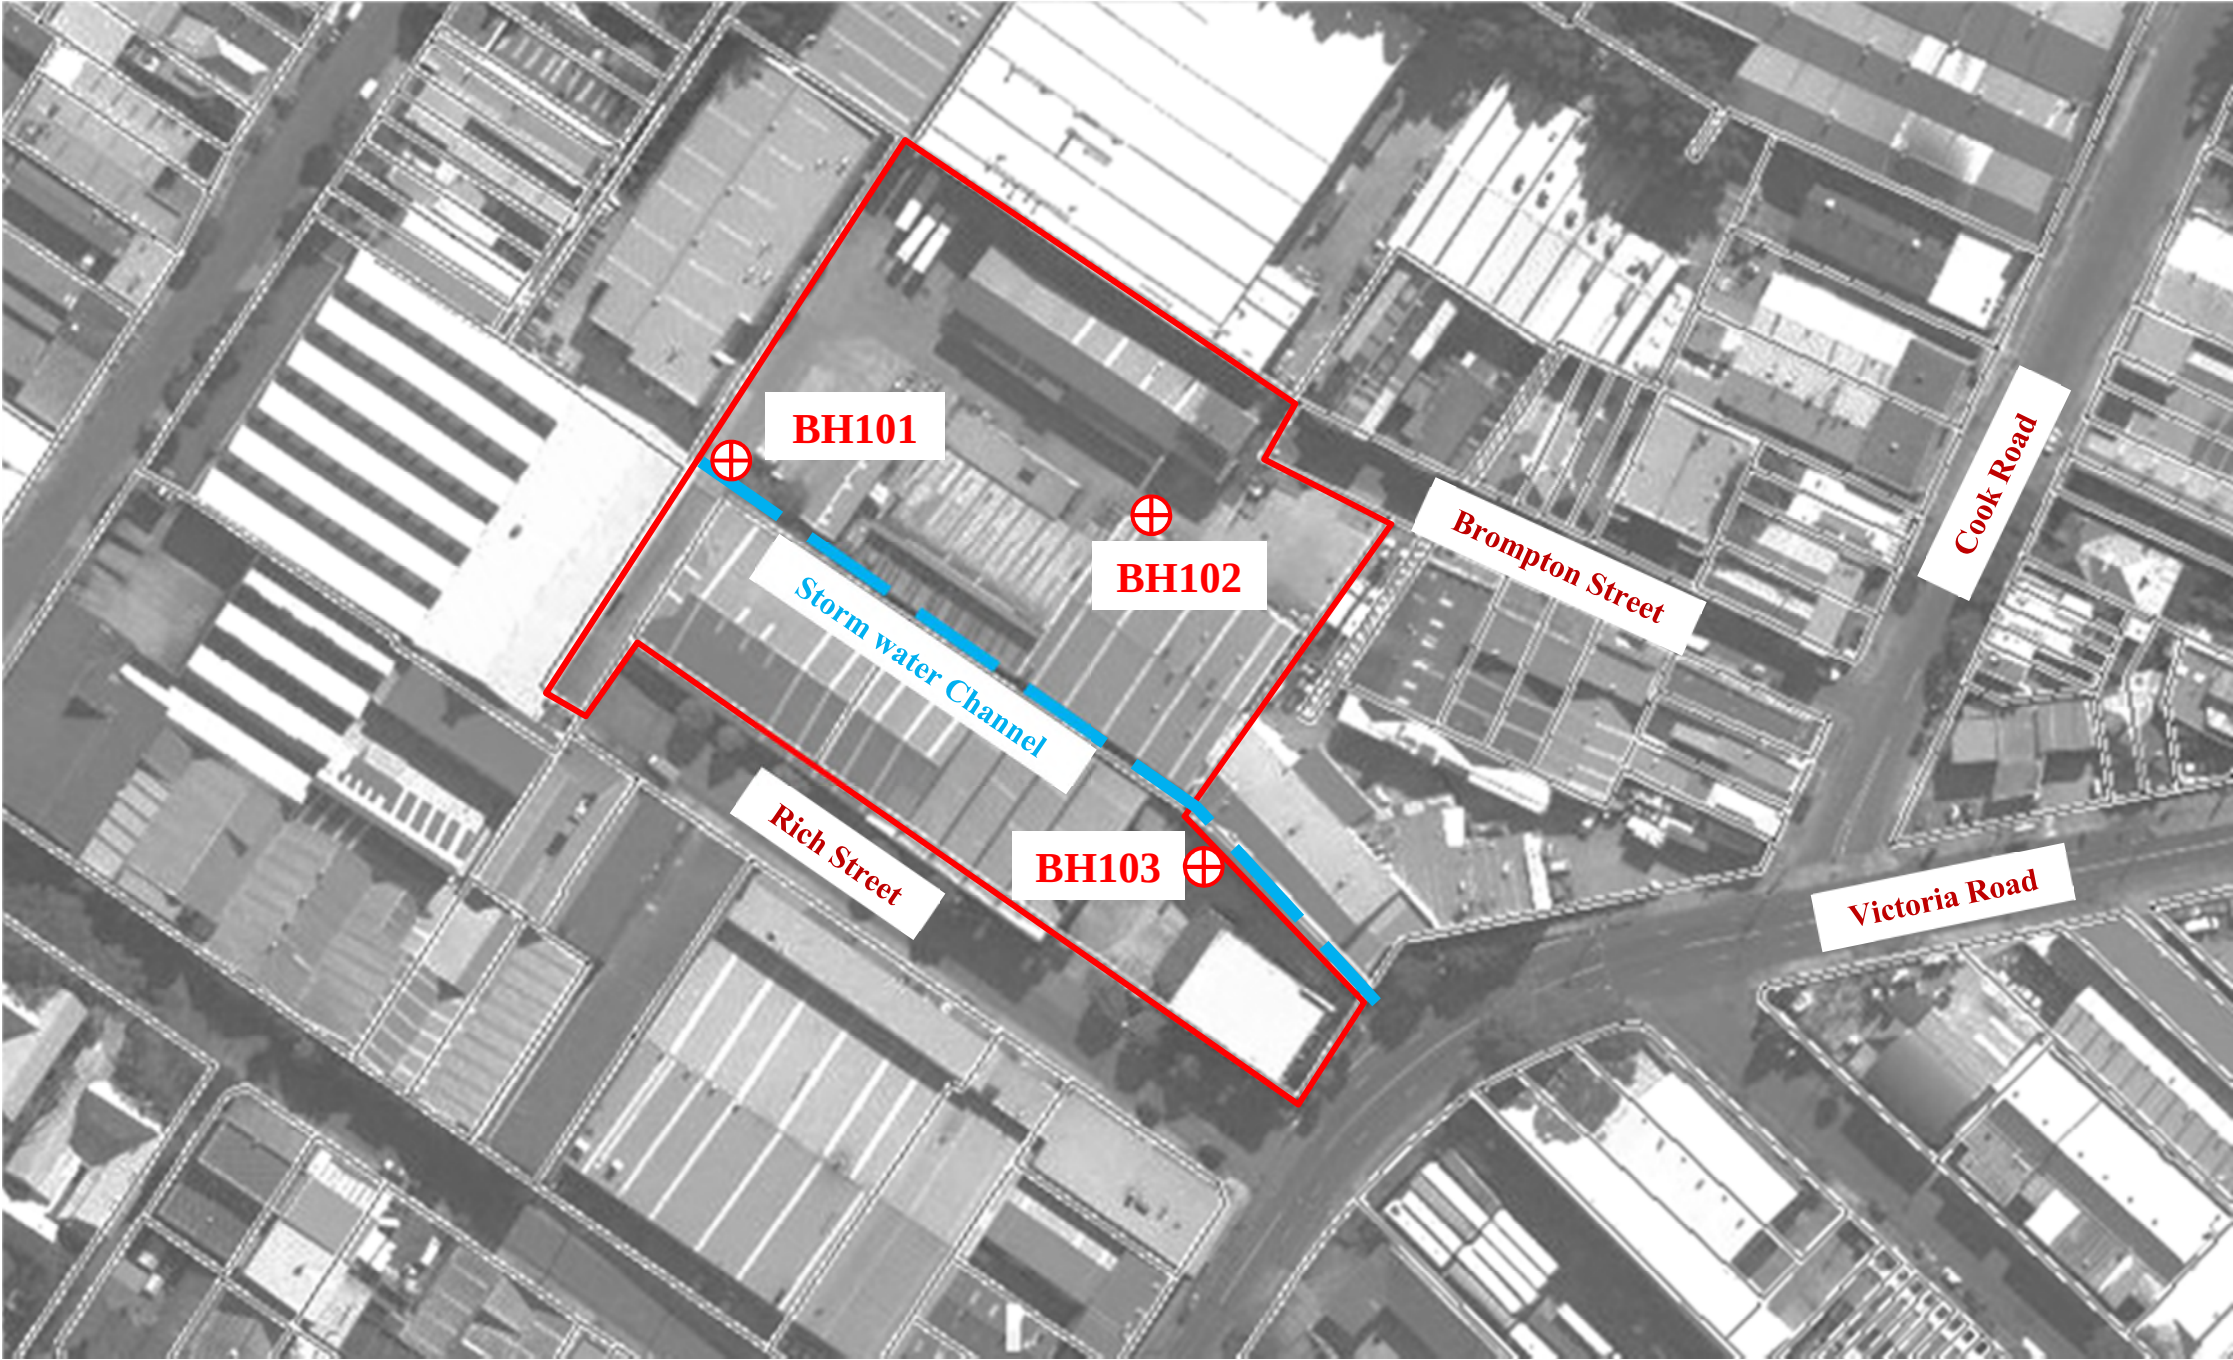
## **SITE PLAN (FIGURE 1)**

Legend: ⊕ Approximate locations of the boreholes drilled on 12<sup>th</sup> and 13<sup>th</sup> September 2013 by Aargus
