# Victoria Road, Marrickville Planning Proposal

Heritage Report

Report to JBA Urban on behalf of  
Danias Holdings  
July 2016

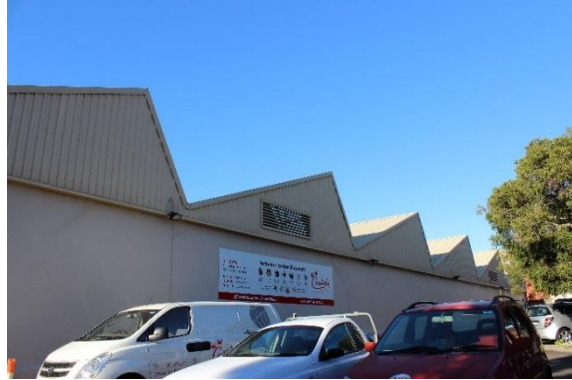
The building is a saw-tooth roofed structure with the original asbestos sheeting reclad with metal. Riveted metal roof trusses support the saw-tooth roof which has windows set on an angle rather than the more common vertical setting.<sup>15</sup> Although the form is original, the external fabric has been replaced.

**Figure 12: View of façade on Shepherd Street, south east aspect**

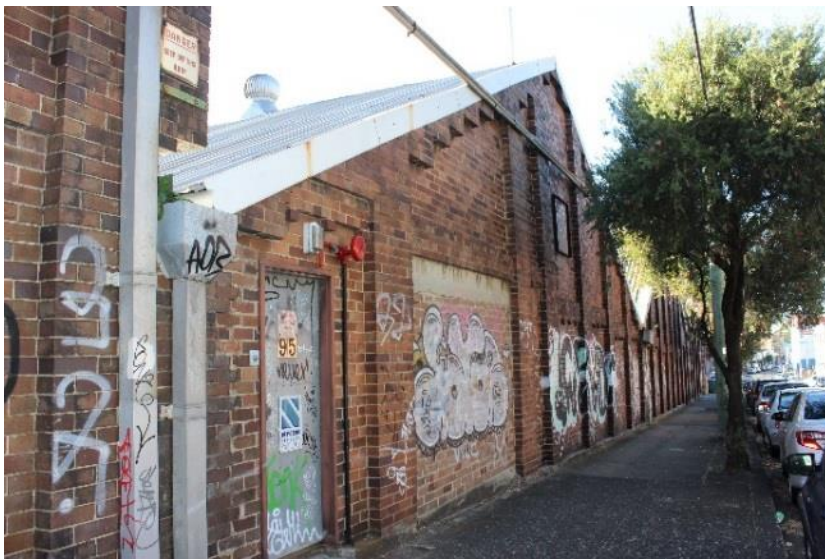
There is a potential rebuild on the corner of Shepherd and Chapel Street. More modern bricks have been used on Chapel Street on the north west side. Some infill on the Chapel Street frontage, possibly for previous air-conditioning units.

**Figure 13: View of façade on Chapel Street, south west aspect**

Detailed heritage assessment would clarify the address of the façade listing in relation to the modern property boundaries. Further assessment would also identify the heritage values of this item and considerations for any future development proposals. This report concurs with the findings and recommendations of the 2013 heritage report (Graham Brooks and Associates) and that the façade should be retained in future developments.

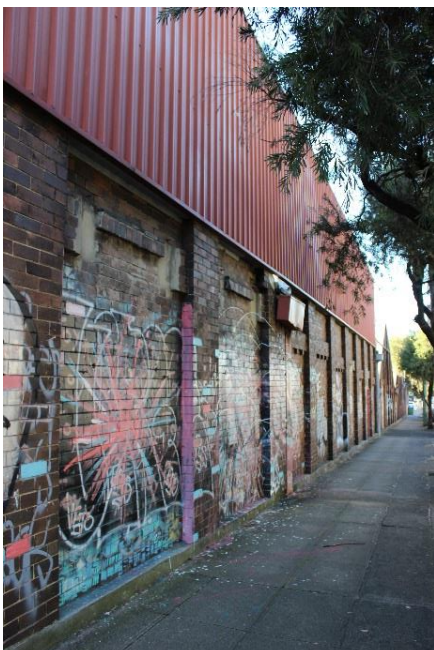
**Figure 14: Detail of Chapel Street façade, south west aspect**

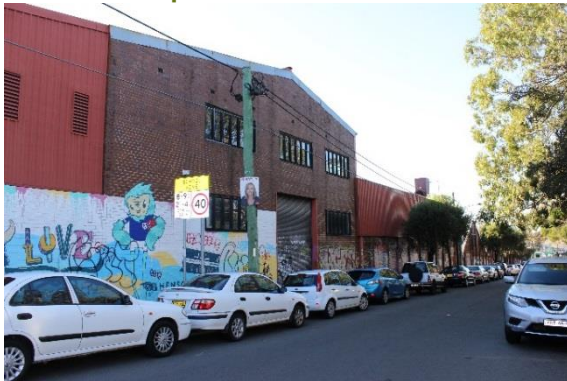
**Figure 15: View of façade on Chapel Street, north east aspect**

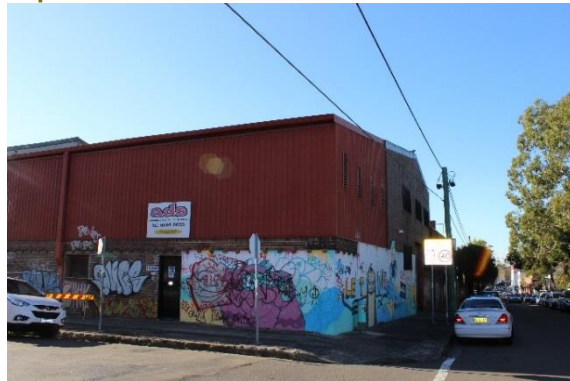
**Figure 16: View of corner of building, east aspect**

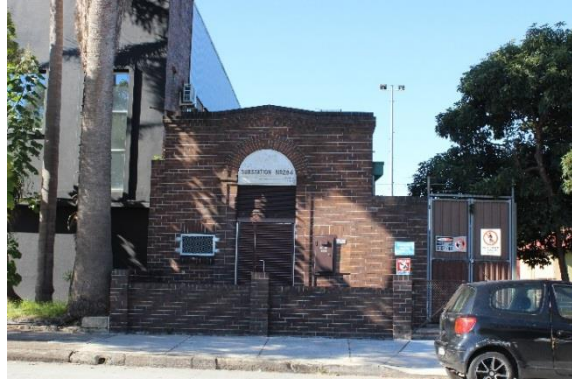
The substation is brick built with two original windows that have been filled in, and a single front entrance. It is made of purple/orange brick that was prominent in brick buildings in the area. It appears on the 1943 aerial, but most likely pre-dates this and is early twentieth century when electricity was spreading to this region of Sydney. Above the door the inscription 'M.C of S. Electricity Dept. Substation No. 284' is given in a brick arch. A brick fence fronts the property and a palm is planted to the north of the lot boundary. It is in good condition, retaining the majority of the original

**Figure 22: View of building, east aspect**

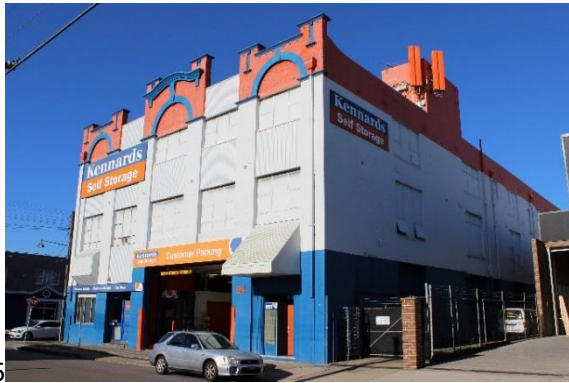
The Kennards building is a three-storey brick warehouse with detailed parapet dating to the early 1900s. The fenestration is original on the upper two levels, but not on the ground floor. It has been modified with aluminium window frames, possibly in the 1980s. The ornate parapet walls are probably original but have been modified in between with a pebblecrete finish. A similar parapet example is the Milroy and Simmons building located in Petersham. Its architectural style stands out from the other buildings in the area. The building exterior is in fair-good condition.

**Figure 23: View of side of building on Chapel Street, south aspect**

The building exterior has been modified but could be restored to enhance aesthetic qualities. More detailed heritage assessment would identify the values of this item. The building lends itself to renovation and adaptive reuse in future development.

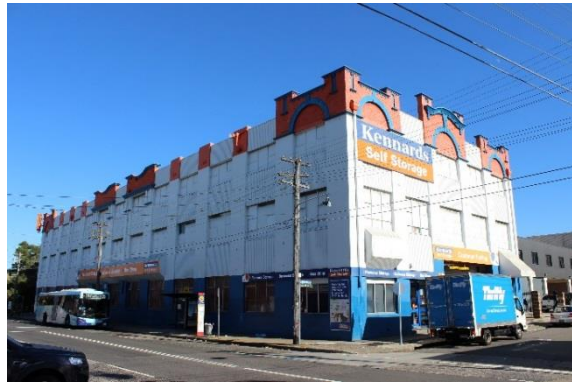
**Figure 24: View of front and side of building, south west aspect**

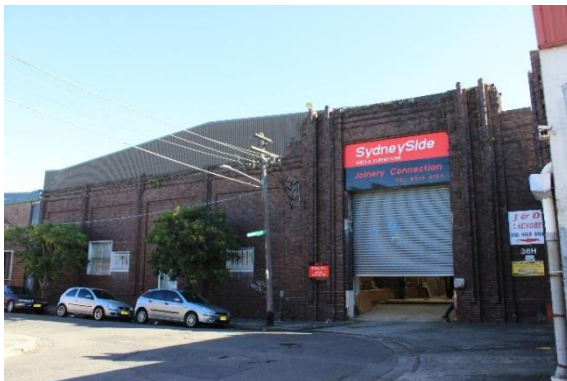
The building is a brick workshop with a detailed brick façade art deco warehouse type detailing, which dates to c. 1915-1940. The brick is purple shale, and the rear wall has been rebuilt. It has a metal and timber framed roof, with metal cladding near the top of the walls. Vertical brick fin walls divide the façade. The façade has moulded bricks and is a distinguished industrial architecture style. The windows appear to be original and the building is in fair-good condition. The adjacent façade on Hans Place was most likely part of the same construction period.

**Figure 25: View of façade on Faversham Street, north west aspect**

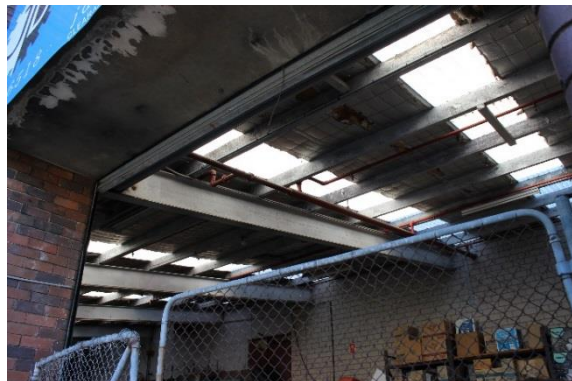
**Figure 26: View of interior of Hans Place, north aspect**

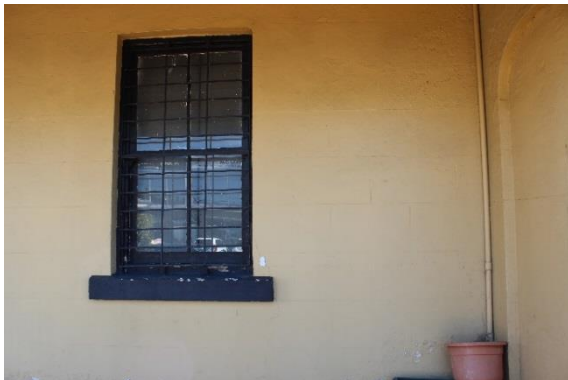
Numbers 175-177 have sash windows that appear to be original but in poor condition. Number 171-173 have had the sash windows replaced. The front external walls have plaster render mimicking stone for 173-177, and 171 has a pebblecrete finish. The front doors and galvanised iron roof have been replaced to the street facing side. The tile roof of number 171 is not original. The veranda posts are possibly original. There are two chimneys still intact. An arch wing wall separates each cottage. The veranda has a curved convex roof, and there are iron underfloor vents. The porch is rendered brick. Number 171 has the name 'Wincanton' on the front. The front gardens are not intact and the buildings have no external mouldings or decorative detail.

**Figure 40: View of window of cottage, west aspect**

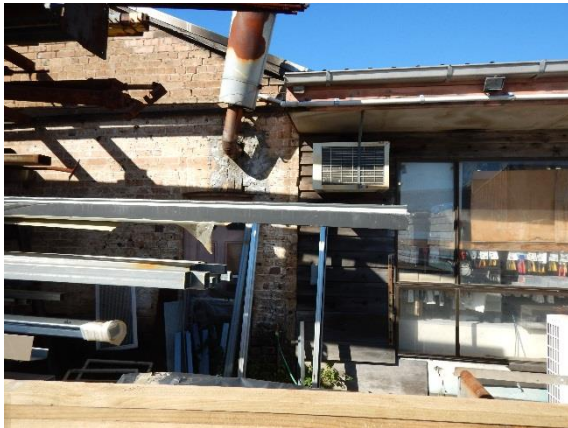
Figure 42: View of rear of cottage 177 showing southern extension

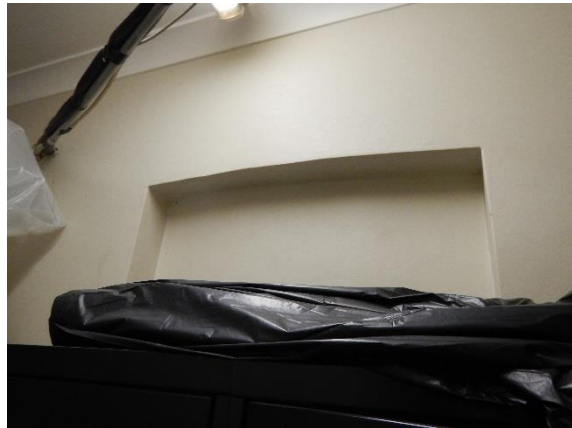
Figure 51: View of boarded up window at rear of cottage 173

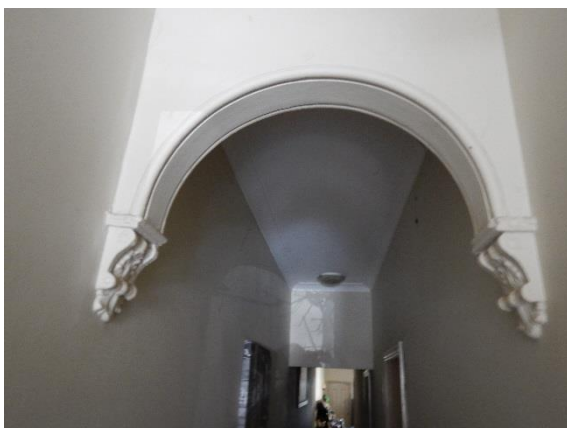
Cottage 29 has retained the original layout to the front with an extension to the rear. The wooden door and window frames are non-original and the windows and doors have been replaced. The original pedestal arch at the front entrance retains its original mouldings and corbels. A boarded up fireplace remains in the front room. The floorboards are non-original.

**Figure 64: View of original pedestal arch with mouldings in cottage 29**

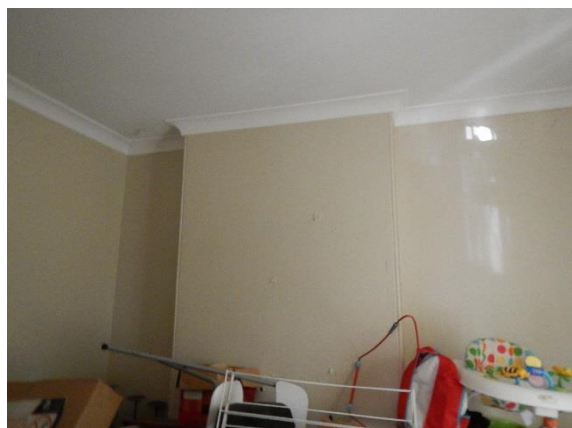
**Figure 65: View of boarded up fireplace in cottage 29**

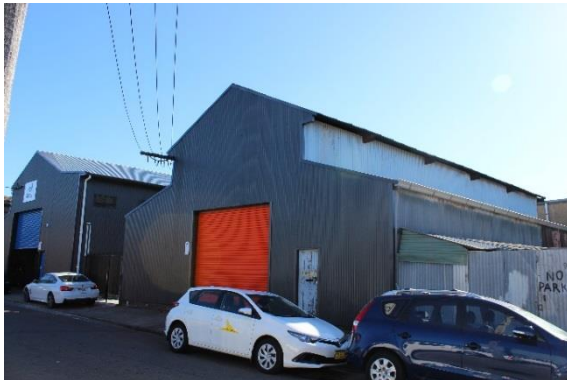
The Brompton Street tin sheds are two timber a-frame structures and were likely originally associated with light industry. The building has dry press shale brick footings, and some asbestos roof sheeting remains. Both sheds currently have a roller door at the front. Both sheds appear in the 1943 aerial, and were part of the early twentieth century industrial development in the area. The shed cladding has very recently been replaced. They are similar to other a-frame sheds that were present when the area was highly industrial. The buildings are in fair condition as most of the original exterior fabric has been removed.

**Figure 66: View of front of buildings, north west aspect**

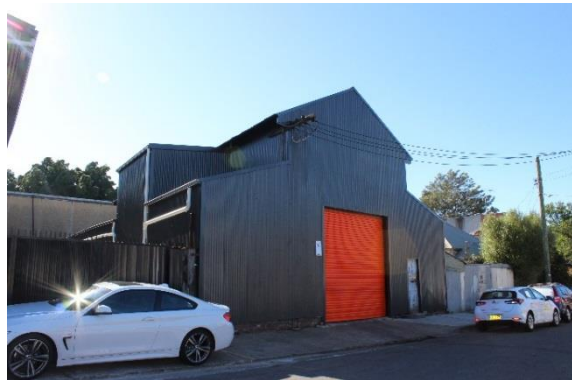
Until recently the Brompton Street sheds had rusted cladding which resulted in an appearance of heritage aesthetic. The façade has recently been reclad and this character is now lost. Although the buildings may have originally added to the 'historic character' of the area, they do not meet the criteria for heritage listing. Other examples of a-frame sheds, such as the ones at Sydenham Railway Station are better and more intact examples of this type of architecture.

**Figure 67: View of front of building, north east aspect**
