## **GEOTECHNICAL INVESTIGATION REPORT**

### **Victoria Road and Faversham Street (Site 2) Marrickville NSW 2204**

**Report No. GS5611/1A**

**22<sup>nd</sup> January 2014**

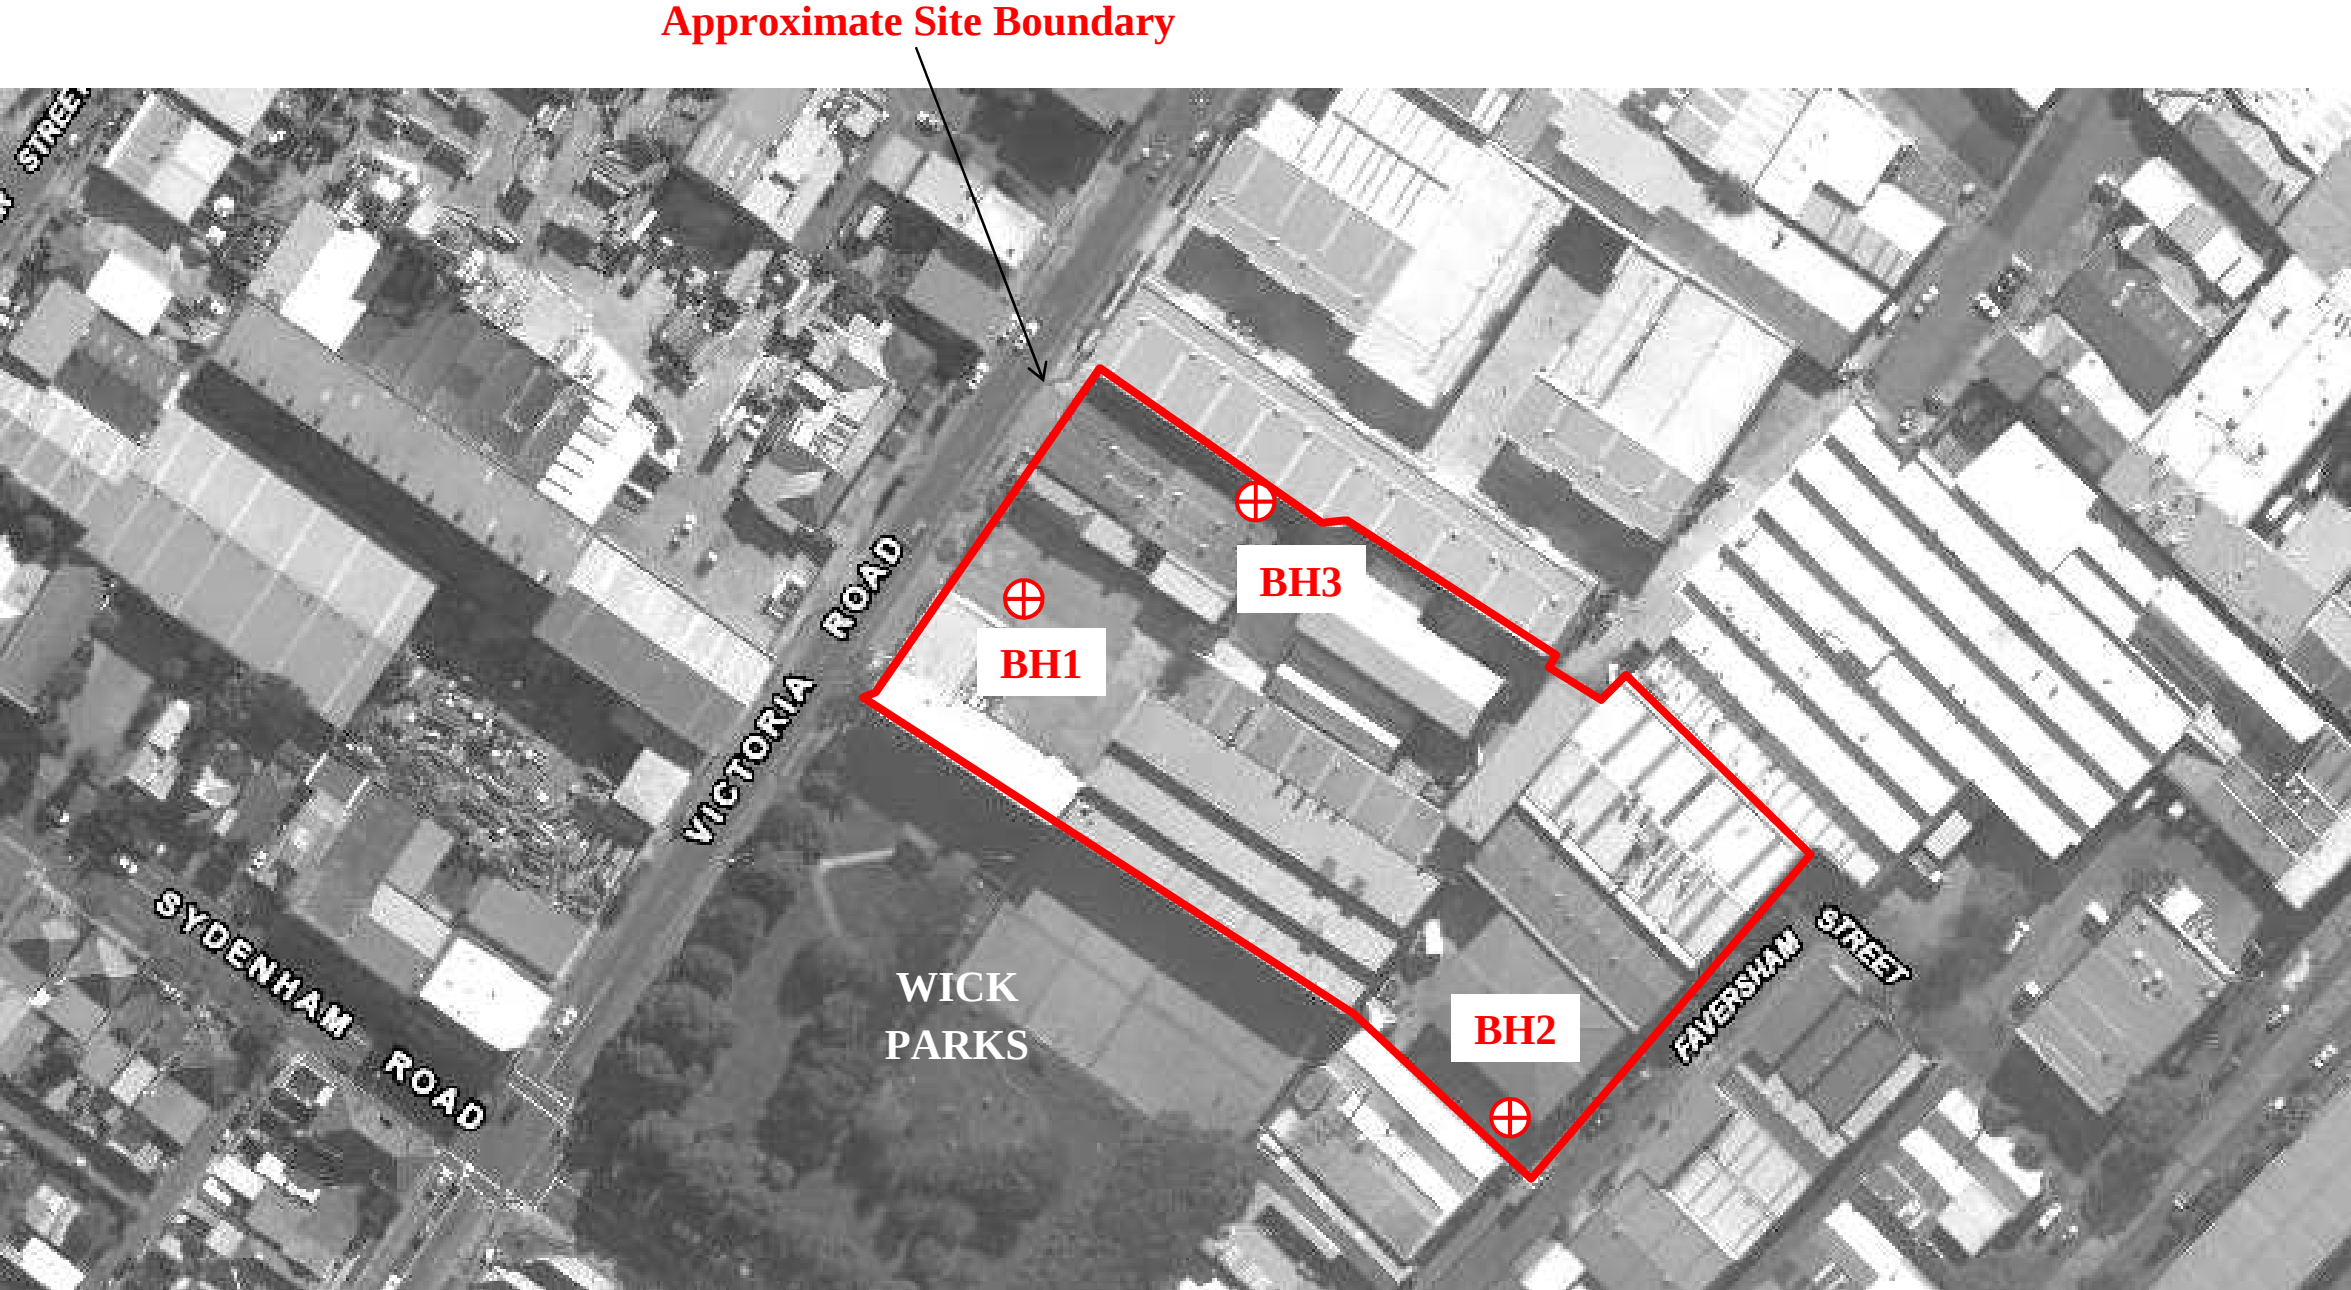
**SITE PLAN (FIGURE 1)**

Legend: ⊕ Approximate locations of boreholes drilled on 15<sup>th</sup> and 17<sup>th</sup> October 2013 by Aargus

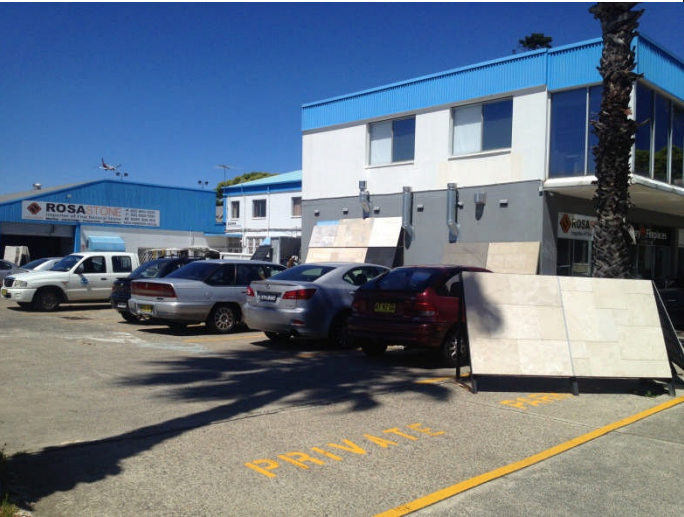
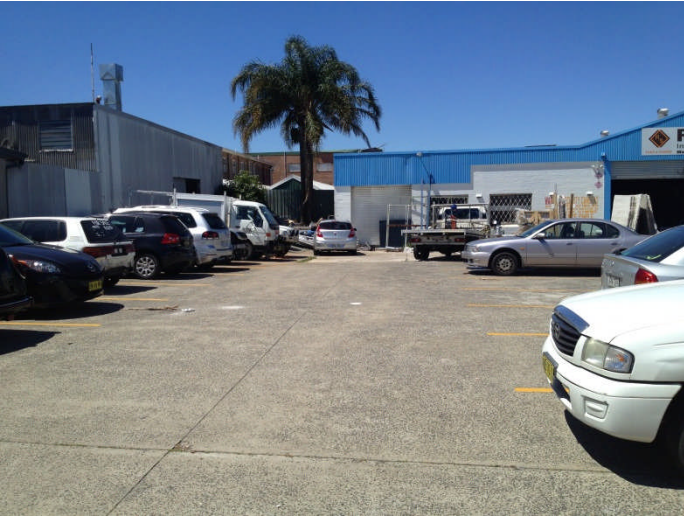
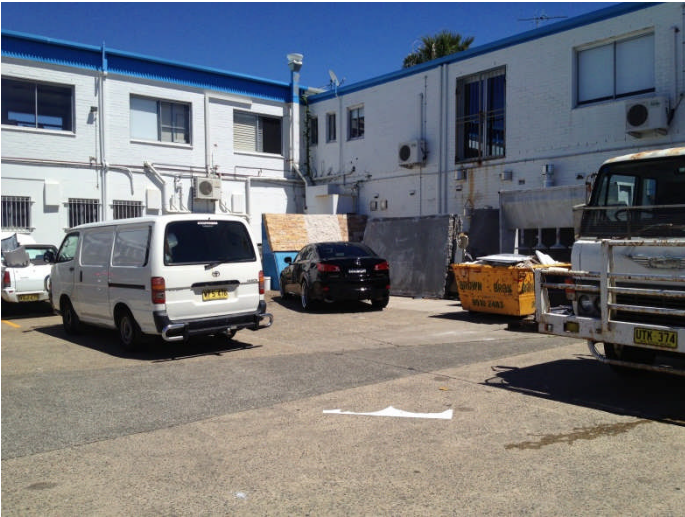
## SITE PHOTOGRAPHS (FIGURE 2)

| <p><b>Photograph 1</b><br/>View of the north-western boundary of the site along the Victoria Road.</p> | <p><b>Photograph 2</b><br/>View of the existing buildings within the south-western area and entrance to the carpark from the Victoria Road.</p> | <p><b>Photograph 3</b><br/>View of the car park area and entrance to the site from Victoria Road.</p> | <p><b>Photograph 4</b><br/>View of the existing building at the western corner and adjacent carpark area within the site.</p> |

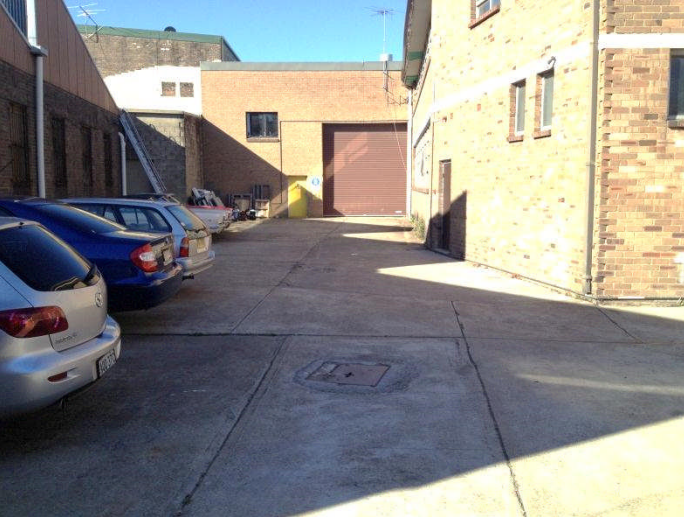
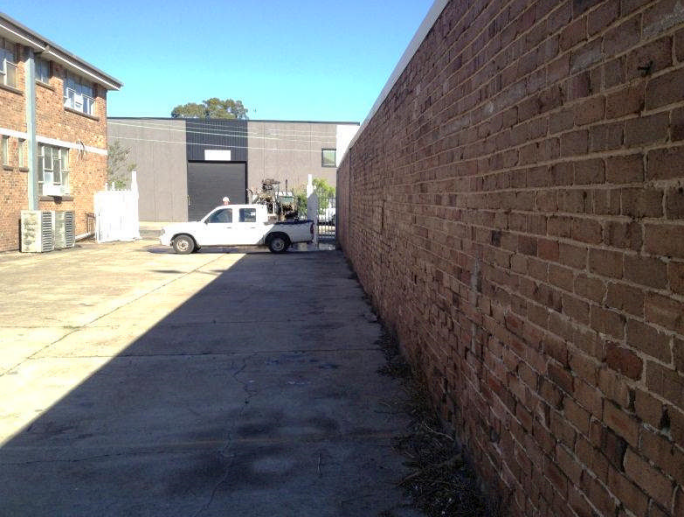
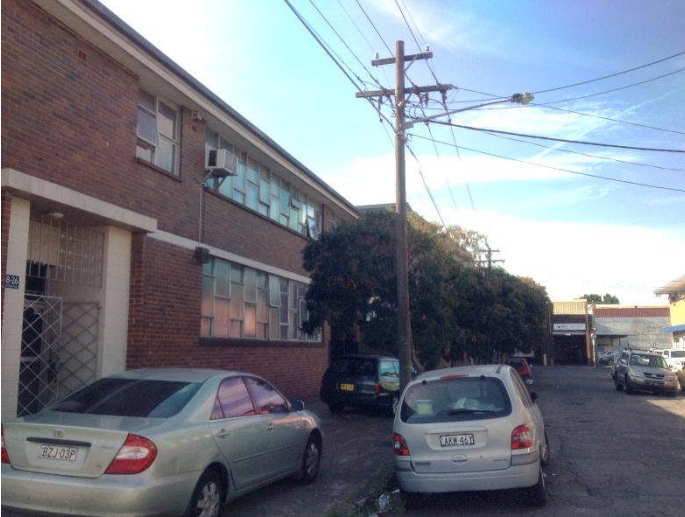
Figure 2 – Site Photographs

| <p><b>Photograph 5</b><br/>View of the site from Victoria Road towards the north-east.</p> | <p><b>Photograph 6</b><br/>View of the existing buildings and carpark within the southern corner of the site towards the north-east.</p> | <p><b>Photograph 7</b><br/>View of the existing building and carpark within the southern corner of the site towards the south-east.</p> | <p><b>Photograph 8</b><br/>View of the existing building within the eastern corner of the site towards the north-east.</p> |
