# **ACID SULPHATE SOILS ASSESSMENT**

**182, 184, 188, 190 & 190A Victoria  
Road &  
18-26 & 28 Faversham Street,  
Marrickville NSW**

**E & D Danias Pty Ltd**

**8<sup>th</sup> May 2014**

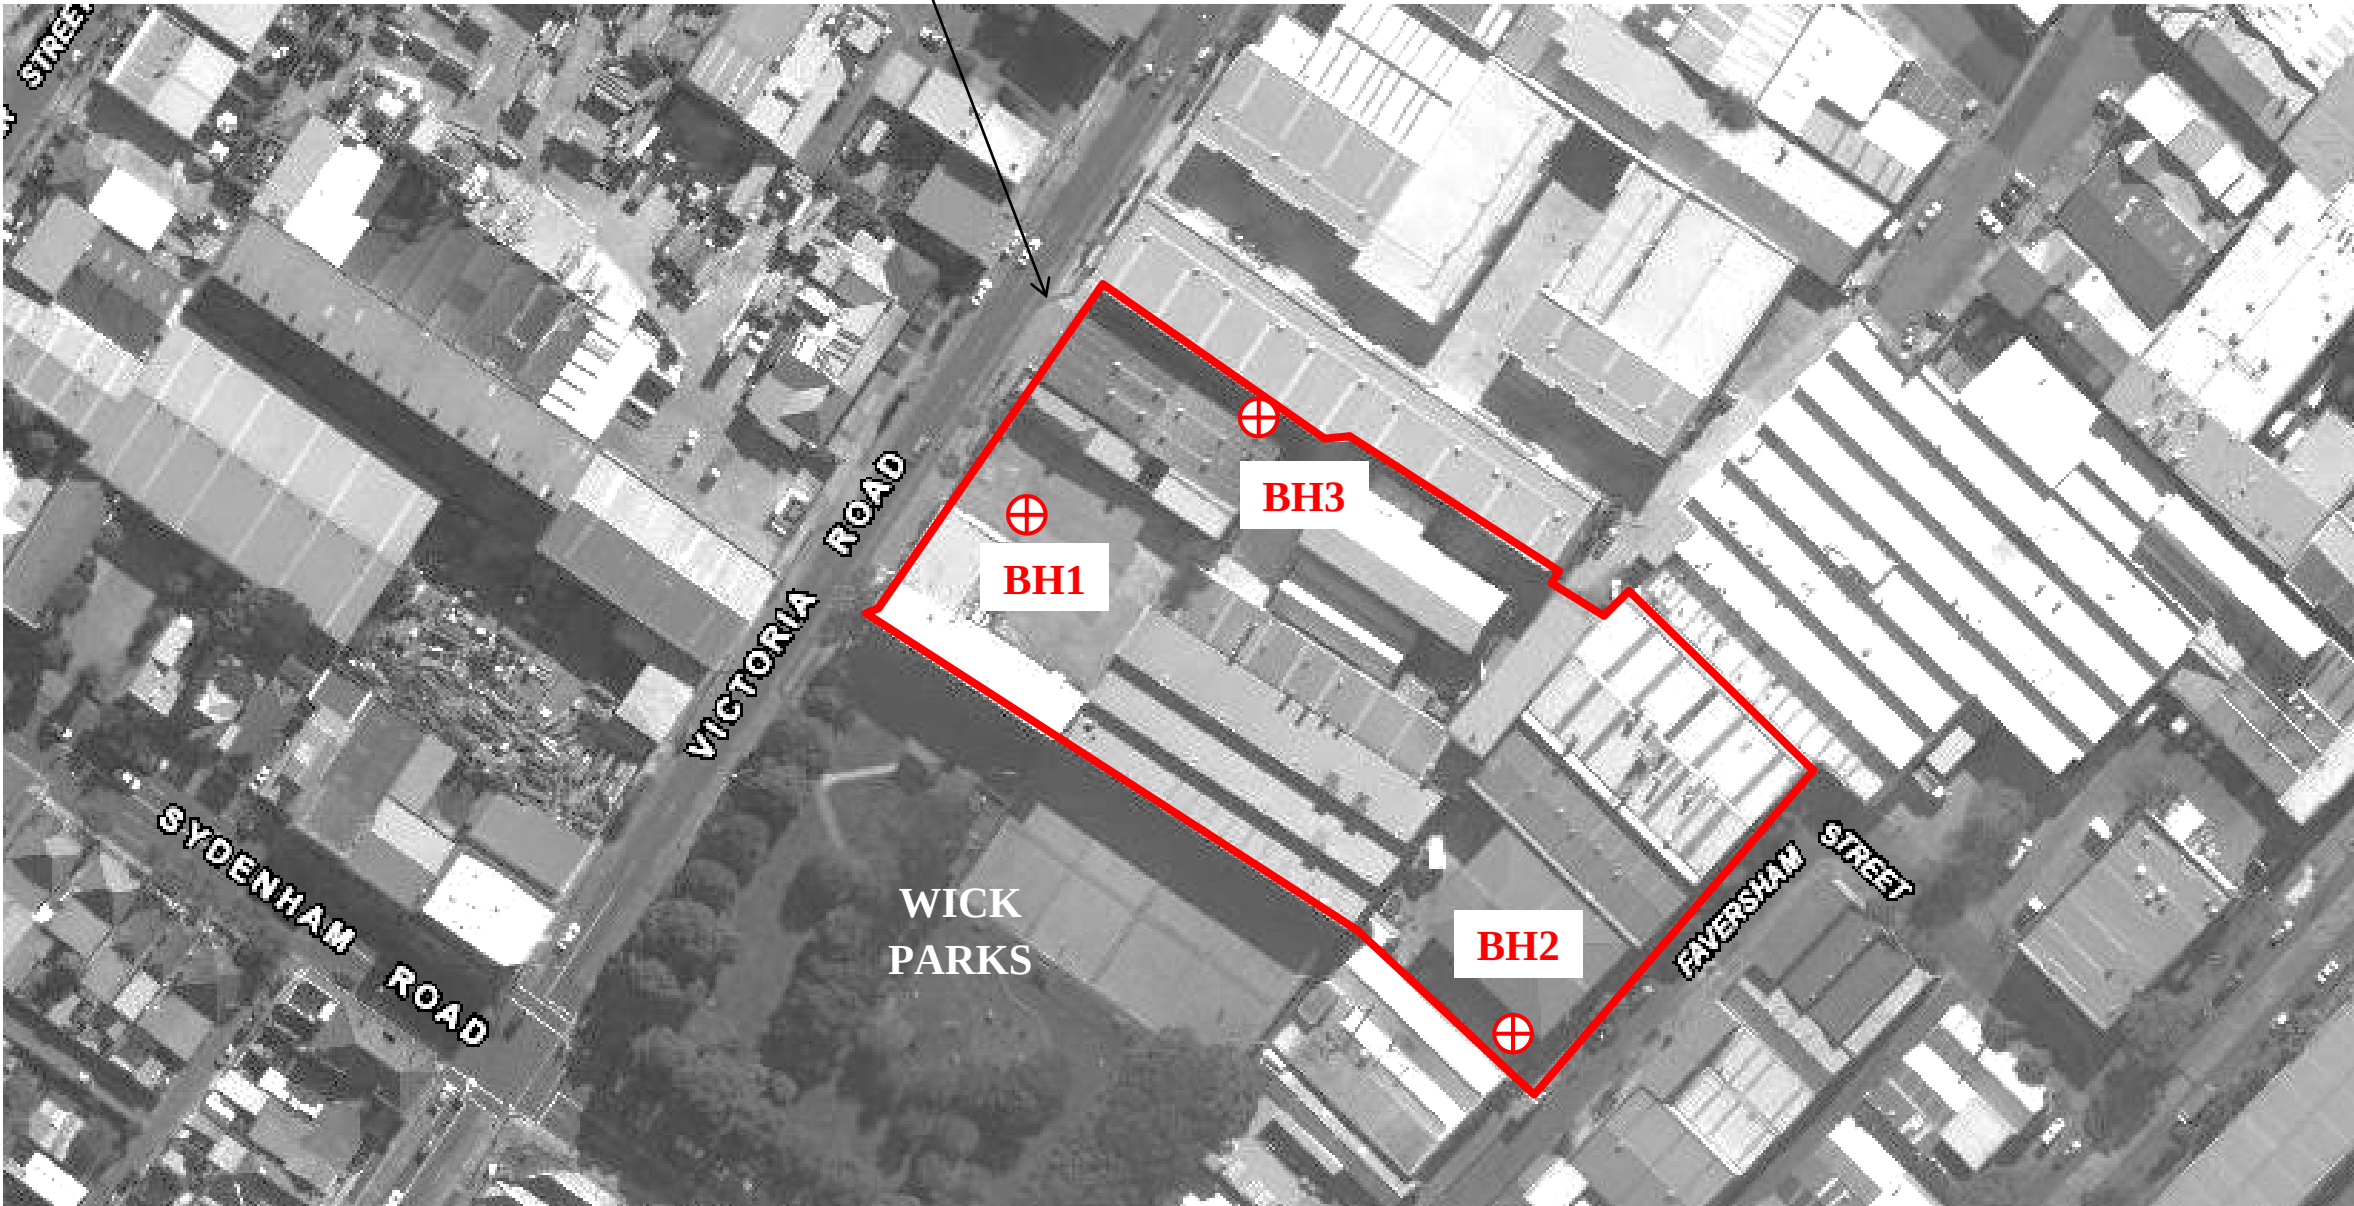
Approximate Site Boundary

A soil sampling and analysis program was used to consolidate the nature and degree of Acid Sulphate Soils present in the surface and subsurface geology. Samples were collected from three (3) boreholes (BH1 to BH3) drilled within the site. The boreholes were drilled to depths between 4.3m & 8.0m below ground level (BGL), that being refusal in bedrock, with samples collected at varying depths depending on the soil profile (the borehole locations are presented in Figure 2 – Site Plan in Appendix A).
