## **GEOTECHNICAL INVESTIGATION REPORT**

**Malco Site (Site 3)  
Rich Street  
Marrickville NSW**

**Report No. GS5544/2A**

**20<sup>th</sup> December 2013**

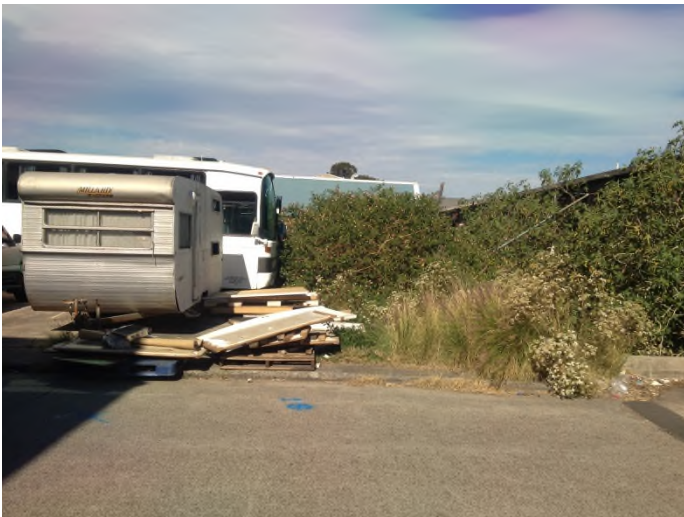
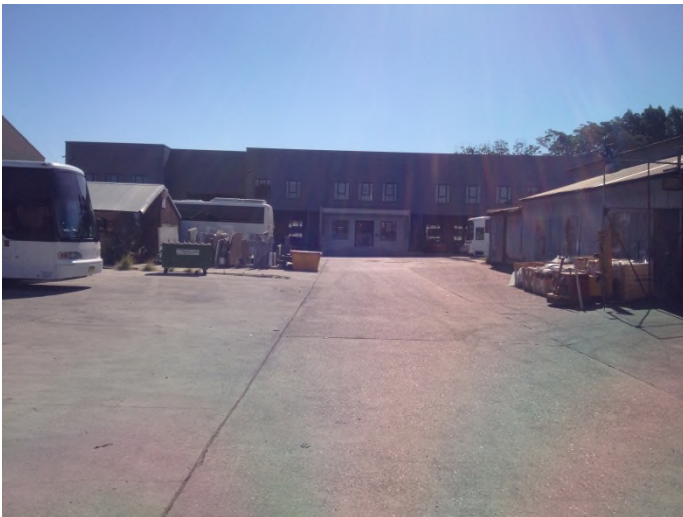
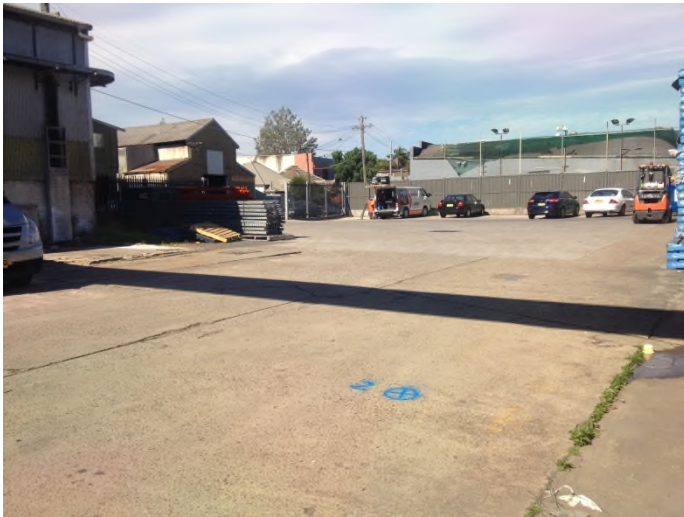
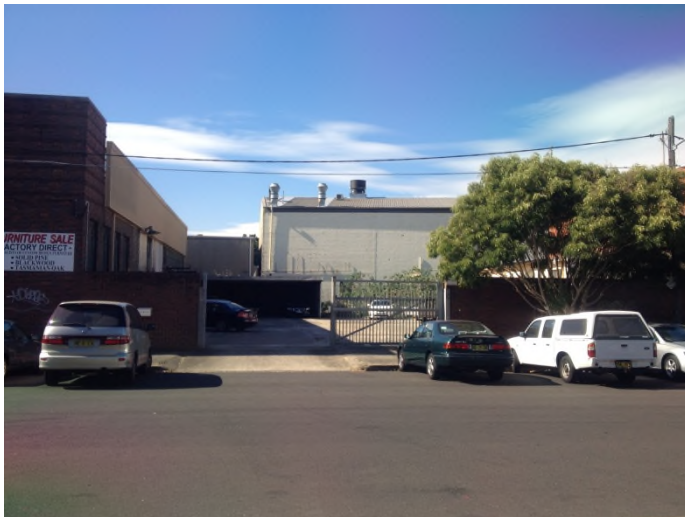
| <p><b>Photograph 1</b><br/>View from the western boundary of the site, adjacent to the location of borehole BH101, towards the east.</p> | <p><b>Photograph 2</b><br/>View of the open hardstand area in the middle of the site towards the north-west.</p> | <p><b>Photograph 3</b><br/>View of the location of borehole BH102 and the carpark adjacent to the Brompton Street entrance towards the east.</p> | <p><b>Photograph 4</b><br/>View of the entrance from Rich Street and the existing building within the southern part of the site.</p> |

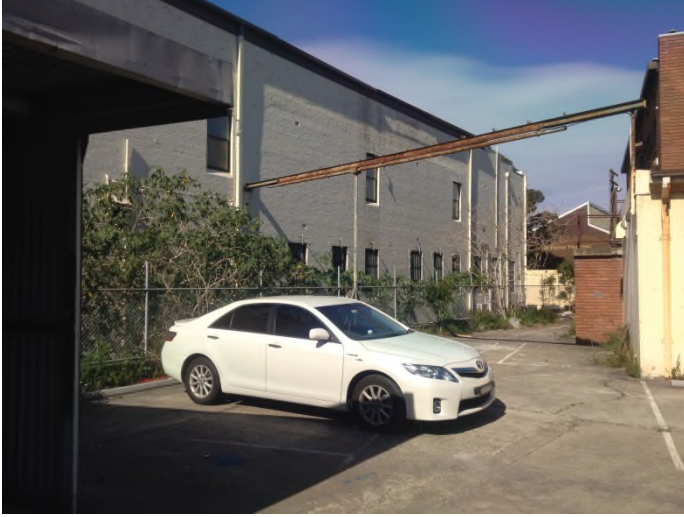
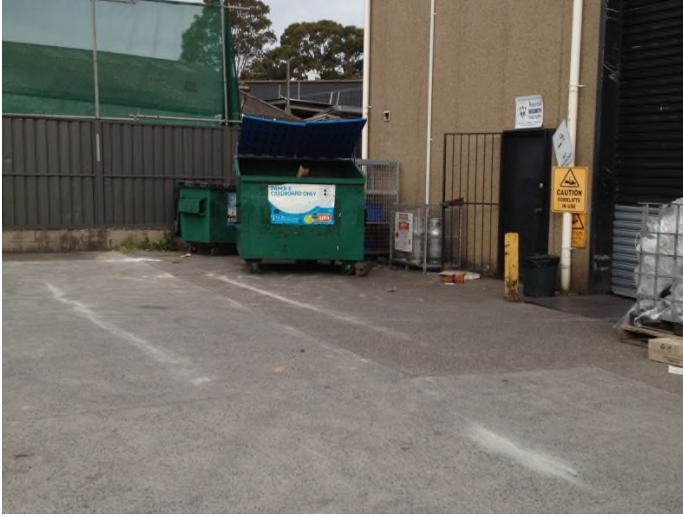
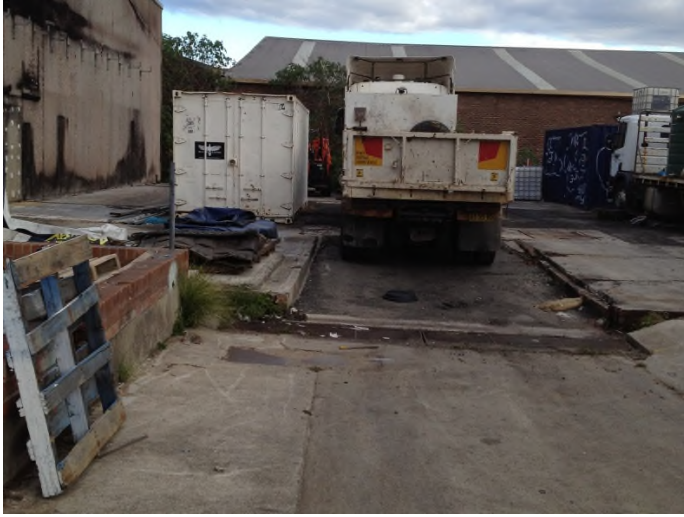
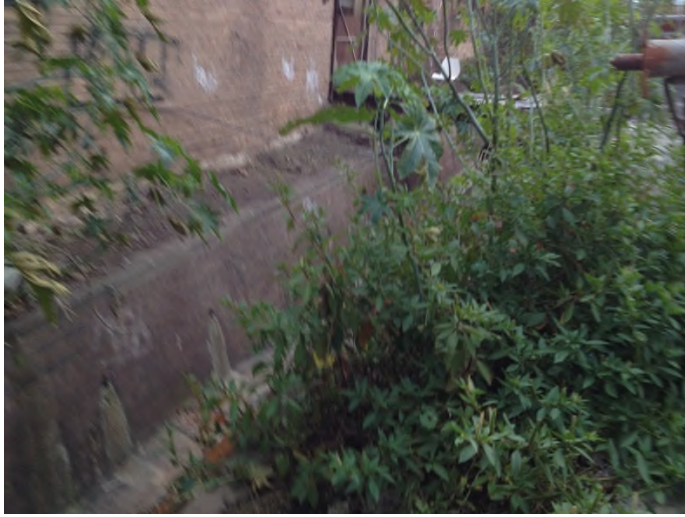
Figure 2 – Site Photographs

| <p><b>Photograph 5</b><br/>View of the area in the vicinity of borehole BH103 towards the east.</p> | <p><b>Photograph 6</b><br/>View of the existing building and the pavement area adjacent to the eastern boundary</p> | <p><b>Photograph 7</b><br/>View of the parking area in the middle of the site towards the south-west.</p> | <p><b>Photograph 8</b><br/>View of the existing storm-water channel within the site.</p> |
