# **ACID SULPHATE SOILS ASSESSMENT**

**Malco Site  
Rich Street,  
Marrickville NSW**

**E & D Danias Pty Ltd**

**14<sup>th</sup> October 2013**

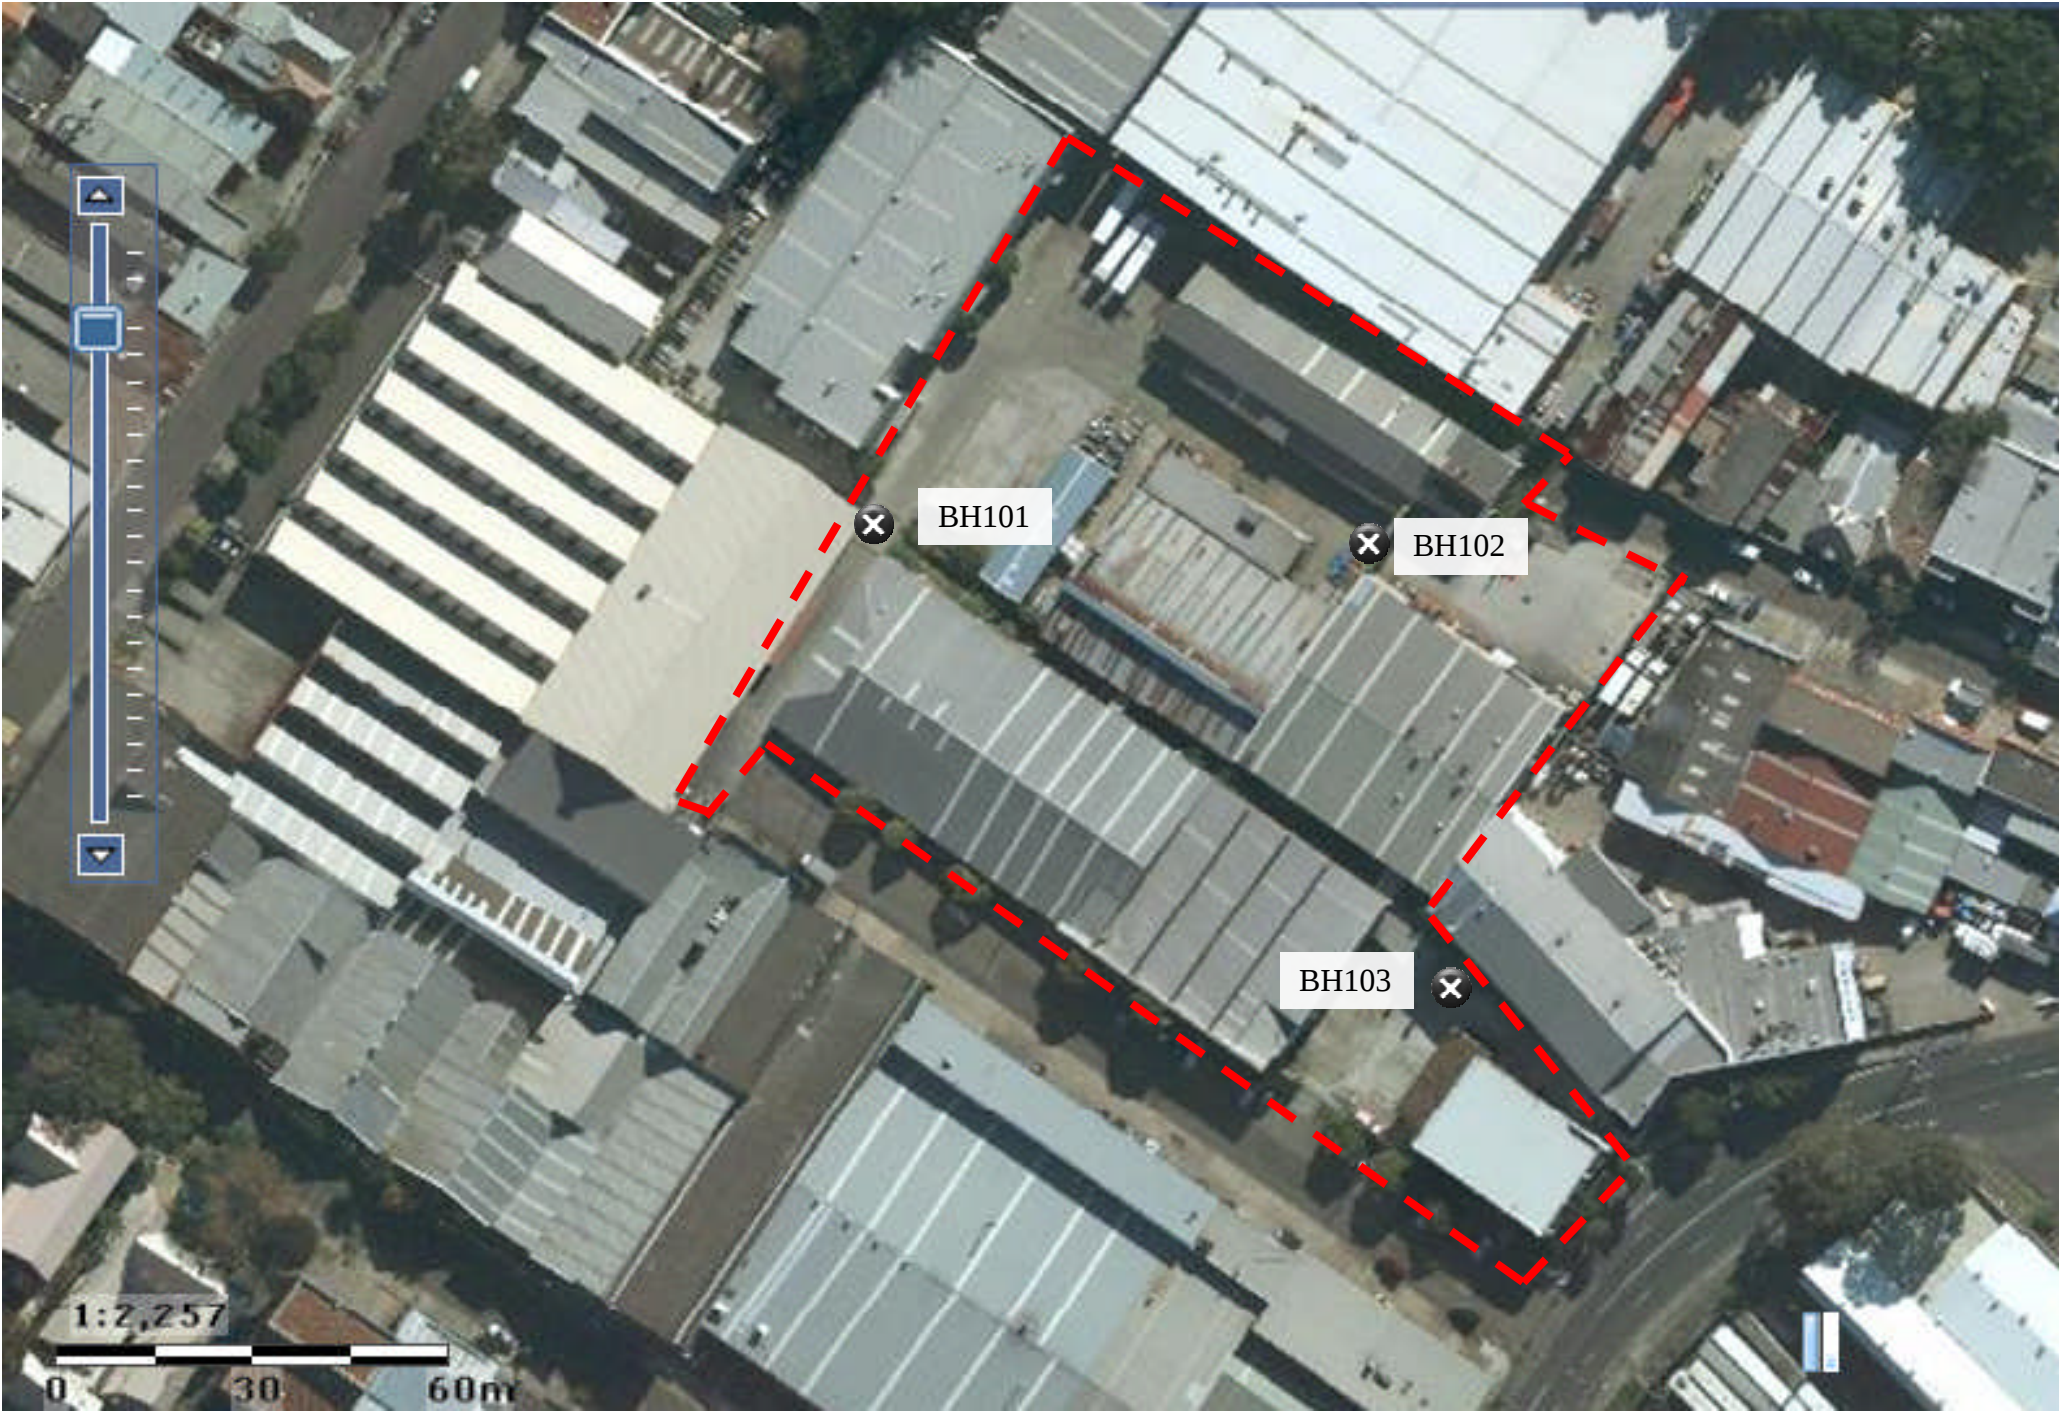
SITE PLAN

A soil sampling and analysis program was used to consolidate the nature and degree of Acid Sulphate Soils present in the surface and subsurface geology. Samples were collected from three (3) boreholes (BH101 to BH103) drilled within the site. The boreholes were drilled to a maximum depth of 10.7m below ground level (BGL), that being in bedrock, with samples collected at varying depths depending on the soil profile (the borehole locations are presented in Figure 2 – Site Plan in Appendix A).
