**PRELIMINARY ASSESSMENT FOR SITE CONTAMINATION  
POTENTIAL**

Proposed Subdivision – Middlebrook Road, Scone NSW

Prepared by RCA Australia

RCA ref 9523-701/1

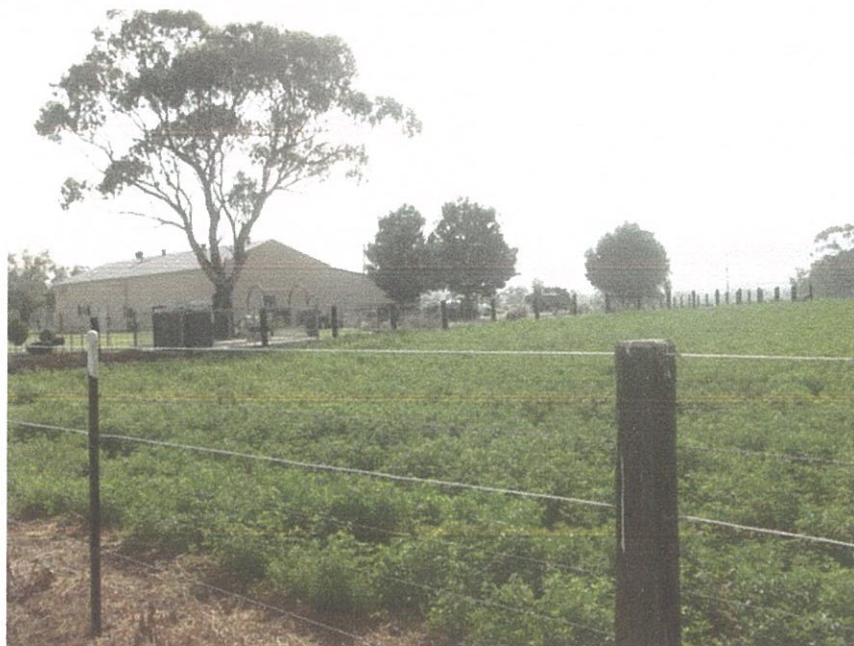
**PHOTOGRAPH 1** *Property located at Middlebrook Road, Scone (Lot 52 in DP 750941) and the subject of this assessment. View is to the north east and the residence is shown to the left of this image. Healthy green lucerne is also shown, with no signs of contamination.*

There was no evidence of potentially contaminating land uses at the property other than for grazing and the growing of lucerne in a paddock near the eastern boundary of the property (**Photograph 1**). Small amounts of cow manure were observed within the property.

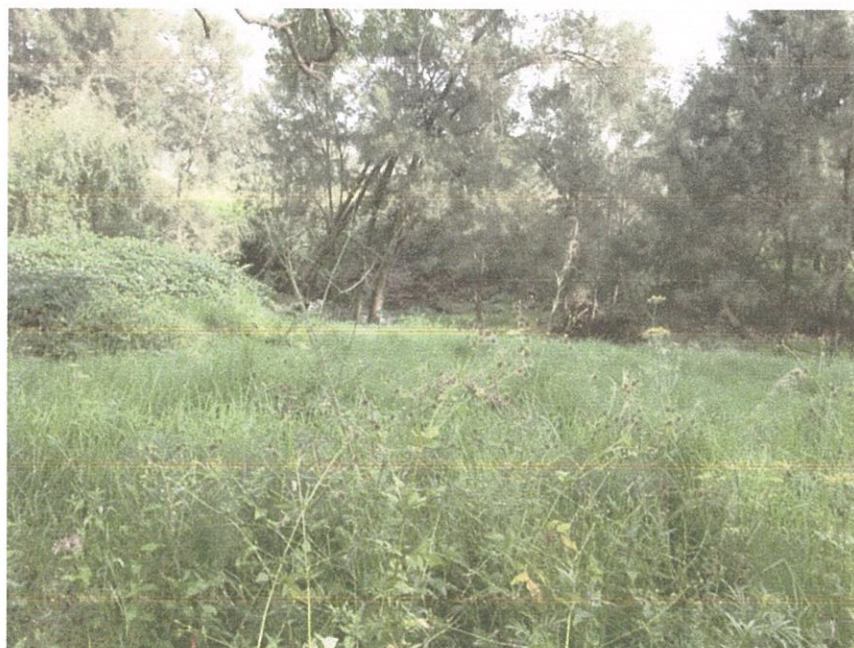
**PHOTOGRAPH 2** *Property view to the western boundary, view to the west, A creek is shown in centre of image. No contamination was observed in the creek, and all the foliage was healthy.*

The property located at Middlebrook Road, Scone NSW slopes gently towards the west and contains healthy foliage (refer to **Appendix B, Photographs 1, 2, 3, 5 and 6**). A creek is located at the western boundary of the property (**Photograph 2**). There were no indications of visual or odour contamination in this creek. There is also a residence located near the eastern boundary of this property (**Photograph 1**); and there were no activities which may be creating contamination issues observed at this property at the time of inspection.

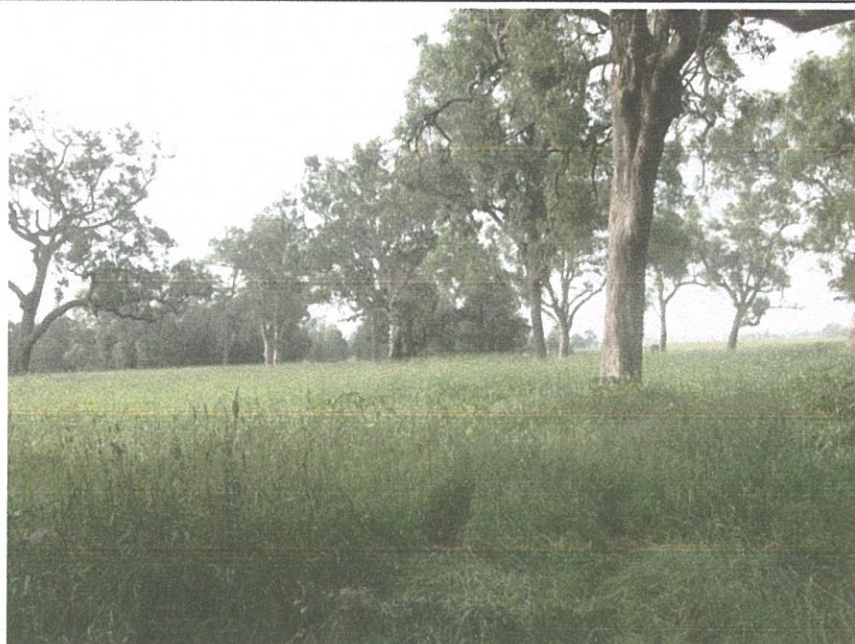
**PHOTOGRAPH 3** *Paddock area to the west of the property, view to the east. Healthy foliage and no signs of contamination.*

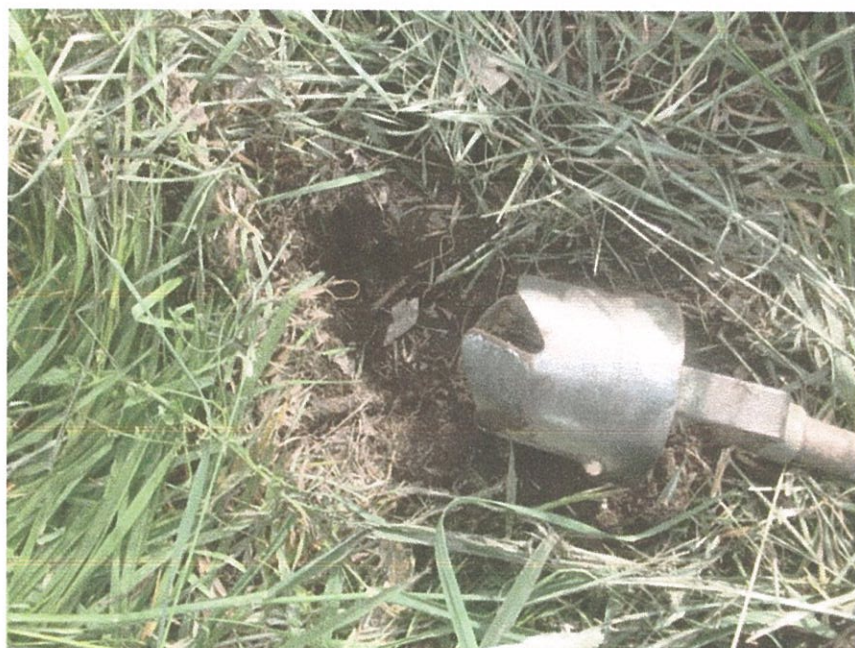
**PHOTOGRAPH 4** *Subsurface soils within western end of property. Natural and brown soil (silt and clay) and there were no visual or odour signs of contamination.*

RCA visually inspected the soil within a limited number of superficial (surface to 50mm depth) locations within the property. The soil within the property was brown, natural soil (silt and clay) with no visual or odour signs of contamination (example shown in **Photograph 4**).

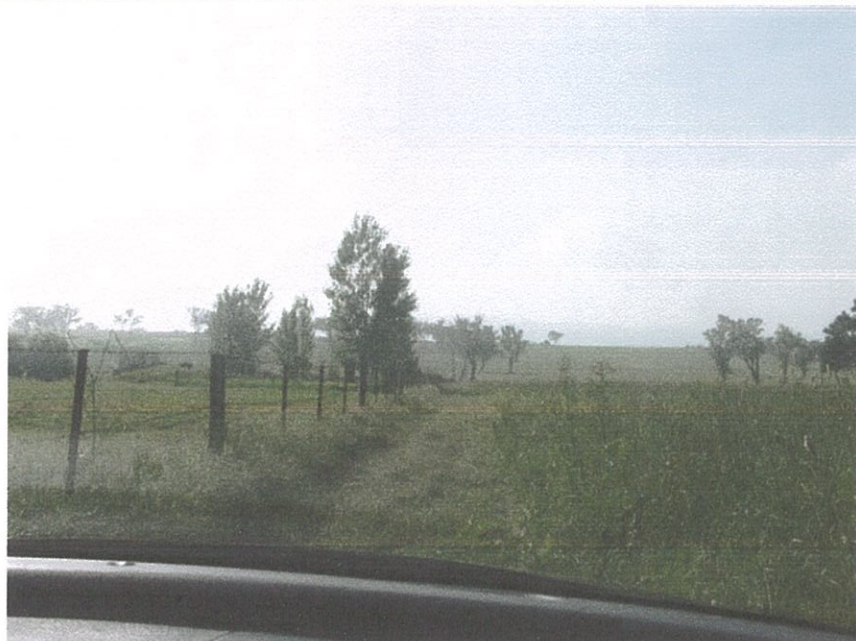
**PHOTOGRAPH 5** *Near to the northern boundary of the property, view to the east. No visual or odour signs of contamination; and the foliage is healthy within the property (right of fence line); and outside the property (left of fence line).*

The vegetation immediately outside the property, e.g. trees, is healthy (example shown in **Photograph 5**). There was no visual or olfactory evidence of contamination or contaminating activities observed in close proximity to the site from the neighbouring properties.

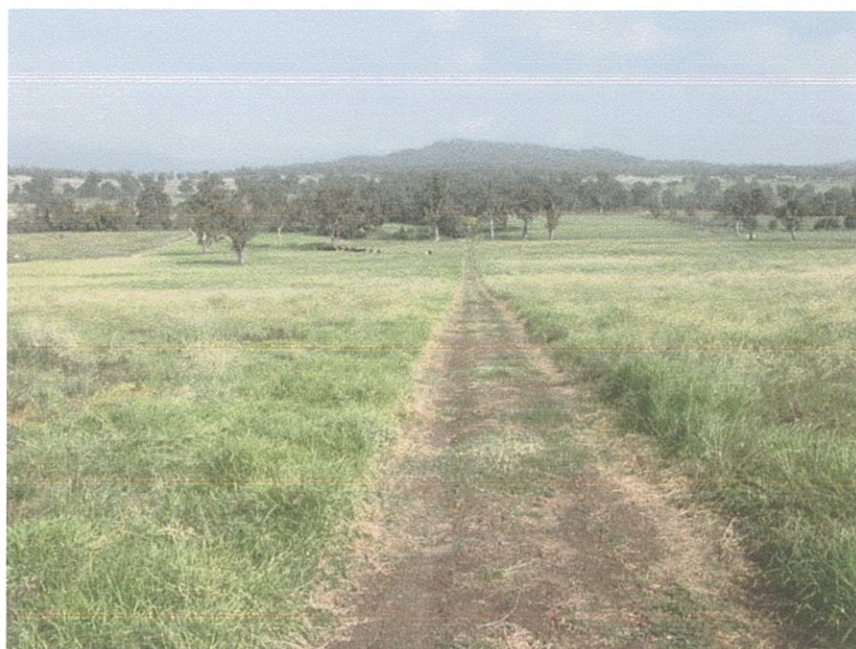
**PHOTOGRAPH 6** *Central area of the property, view to the west. Evidence of recent weed spraying Soil samples (3) were taken in the brown patched area to the left of the track. **Note: despite the indications of weed spraying in isolated areas, the foliage was healthy and there were no visual or odour indications of contamination.***

In addition, RCA was prepared for the collection of soil samples for the analysis of potential contamination. The collection of soil samples was considered necessary in an isolated and central section of the site, given the recent spraying of weeds in that area (refer to **Appendix B, Photographs 6, 7 and 8**).

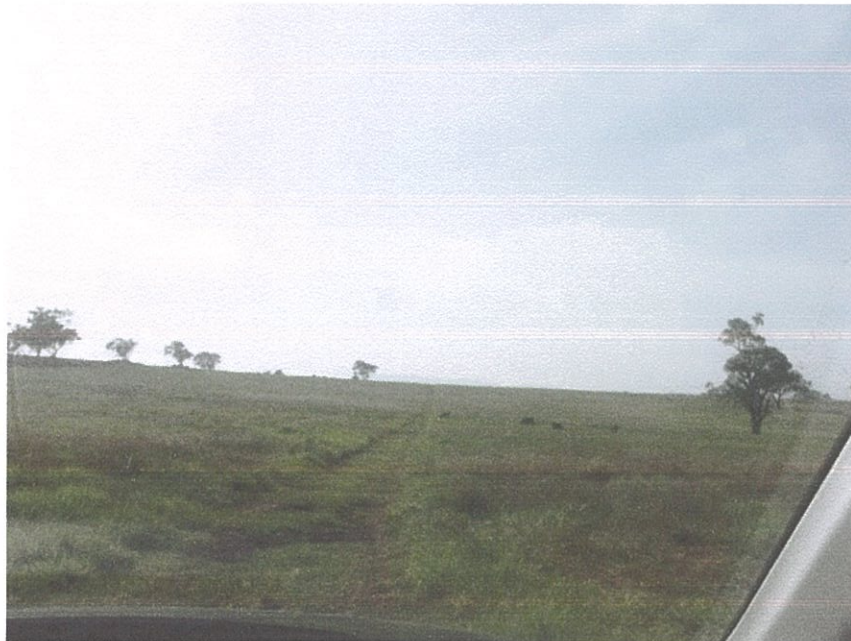
**PHOTOGRAPH 7** *Central area of the property, view to the east (i.e. “reverse” view of **Photograph 6**). Soil samples (3) were taken in brown patched area to the right of the track.*

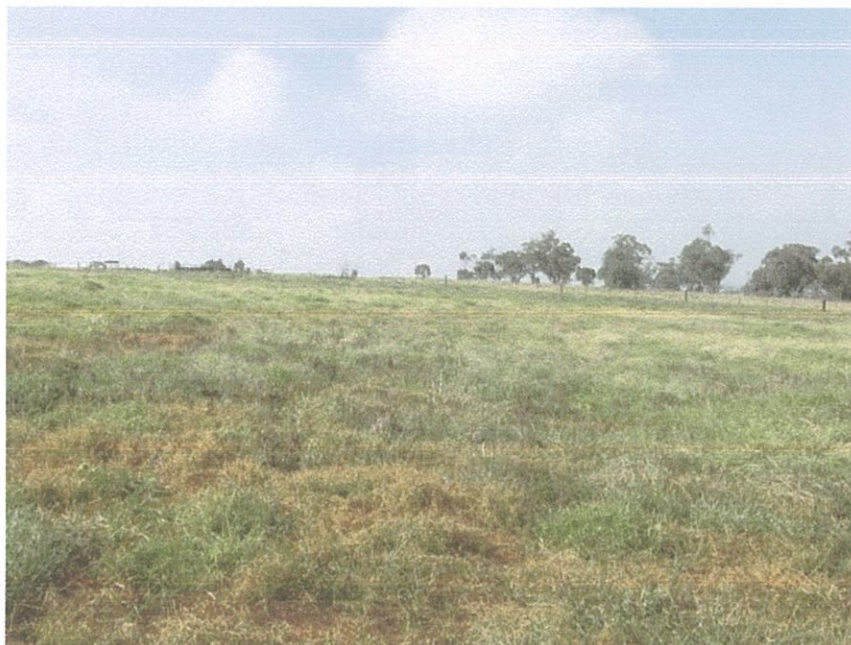
**PHOTOGRAPH 8** *Central area of the property, and this photograph was taken from the access track, looking south. The soil samples (3) were taken from the locations of brown patches, and approximately 10m apart.*

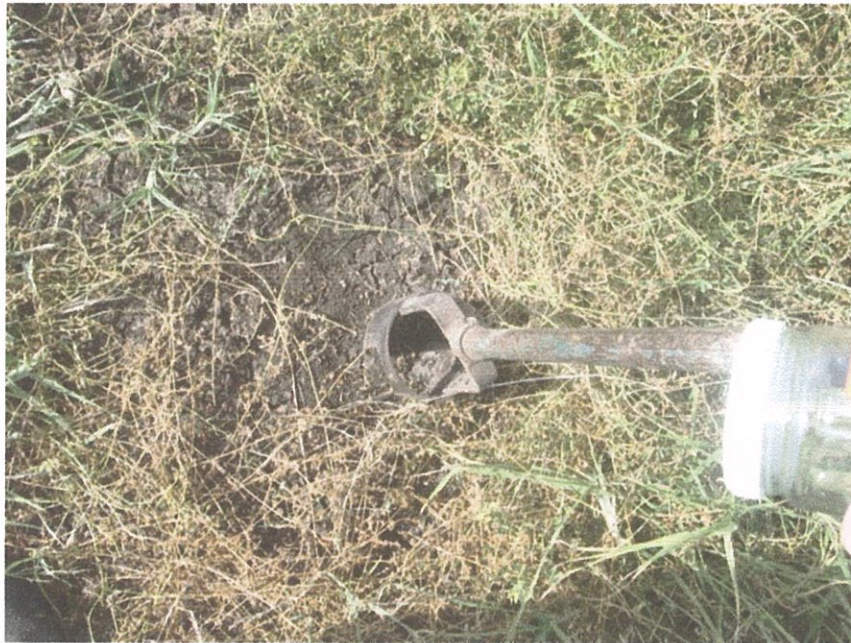
**PHOTOGRAPH 9** *Example of soil sample (**sample no. 9523-1**) taken in the central area of the property vicinity and as shown in **Photograph 8** , to check the presence of Organochloro and Organophosphate Pesticides in the soil following limited weed spraying in that area. **All soil samples (3) reported laboratory results less than the detection limits, and also below the strictest Health Investigation Level (HIL "A", residential) for Organochloro and Organophosphate Pesticides.***

Soil samples below the surface were recovered using a hand auger within this area. The general locations of these soil samples are shown **Appendix B, Photograph 9**. The samples were retained for the analyses as described above. An example of one of the samples taken is shown in **Photograph 9**.
