Stage 1 & Stage 2 Contamination Assessment:

Lot 126 DP263356, Anembo Street, Moss Vale, NSW

Mark Passfield
SEEC Reference 12000191- CA STAGE 2-01

Date: 29th April 2014

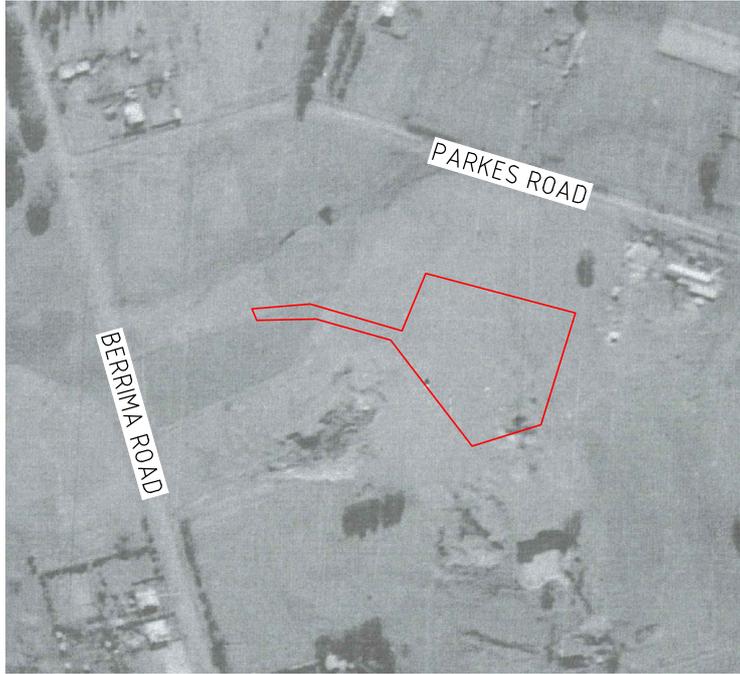
DRAWING TITLE		
HISTORICAL AERIAL PHOTOS		
1949 AND 1969		
PROJECT NO.	SHEET NO.	REV
12000191	FIGURE 3	A

- 1949 - The quarry is clearly shown on Lots 7, 8 and 29 and Section 3 DP975386 and B/158739 but the use of it as a landfill is not. There could have been access to the quarry from Watson Road. There is no disturbance of the subject site.

- 1969 - The quarry is clearly shown on Lots 7, 8 and 29 and Section 3 DP975386 and B/158739 but the use of it as a landfill is not. There is access to the quarry from Watson Road. There is no disturbance of the subject site.

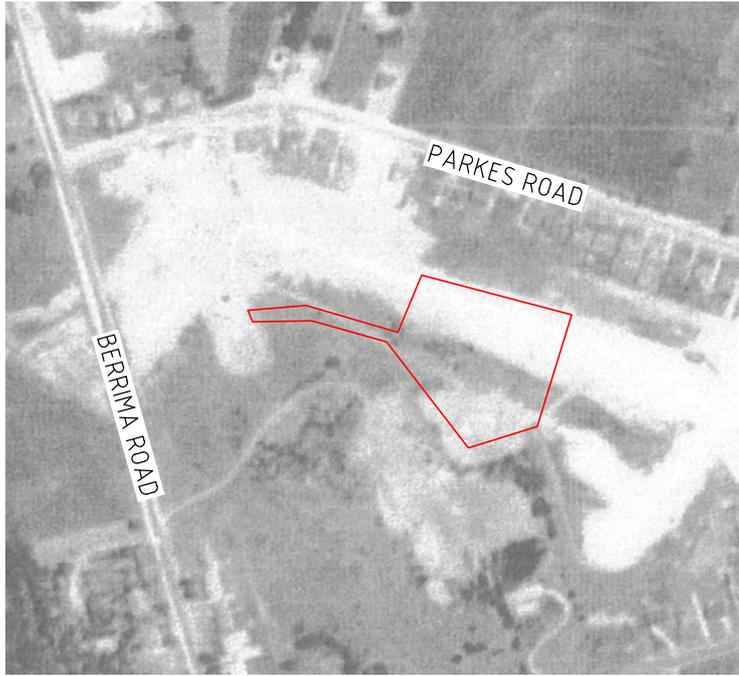
DRAWING TITLE		
HISTORICAL AERIAL PHOTOS 1979 AND 1989		
PROJECT NO.	SHEET NO.	REV
12000191	FIGURE 4	A

- 1979 - The quarry/landfill appears to have been filled and capped. There is some disturbance in the north of the subject site. It appears associated with the construction of Anembo Street. There are informal tracks from the Anembo Street earthworks site to the former quarry on the subject site.

- 1989 - Anembo Street is being developed and the disturbance on the subject site appears to have been rehabilitated. There is a minor track from Anembo Street onto the subject site.

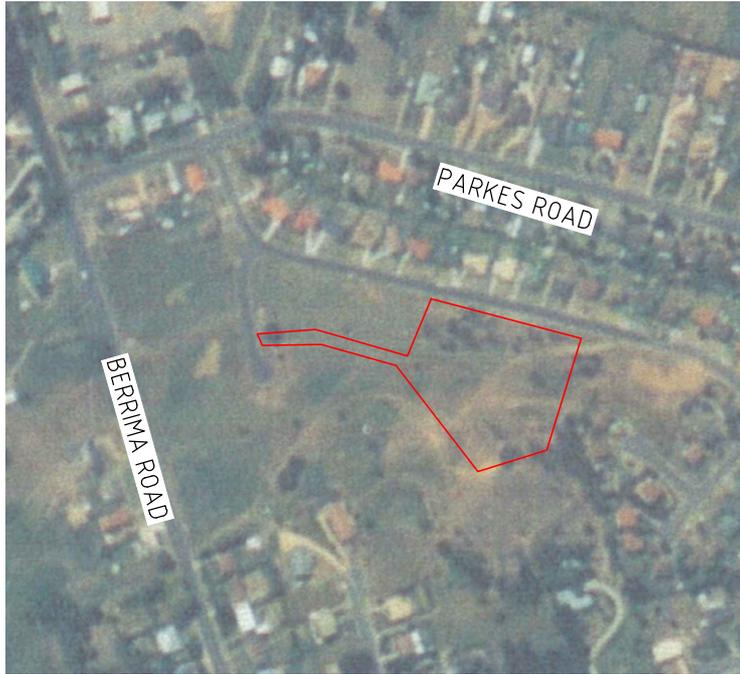
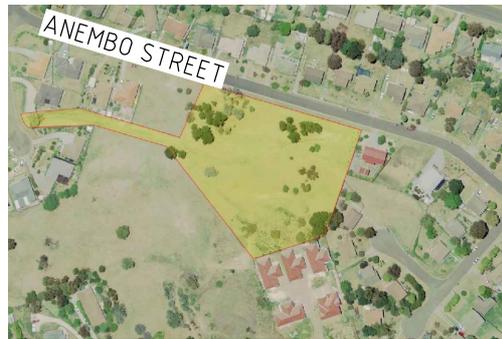
DRAWING TITLE		
HISTORICAL AERIAL PHOTOS 1997 AND 2006		
PROJECT NO.	SHEET NO.	REV
12000191	FIGURE 5	A

- 1997 - There are two minor tracks onto the subject site from Anembo Street and Berrima Street. They converge at about the quarry site.
- 2006 - The subject site is undeveloped and well vegetated. There are no clear tracks onto it from surrounding roads.

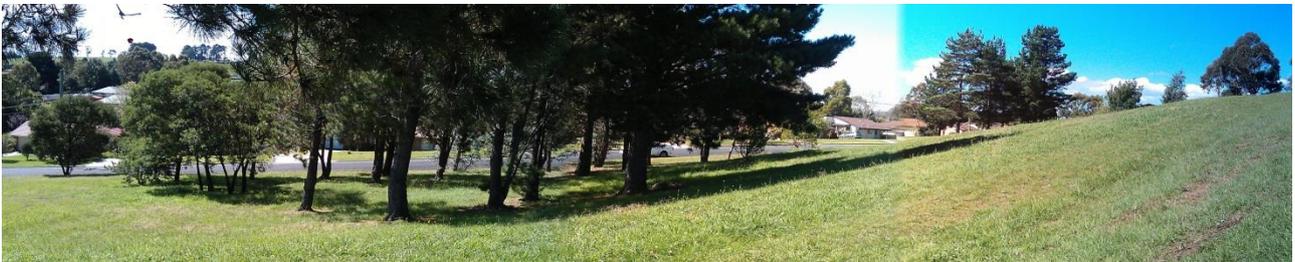
At the time of our site inspection (19th March 2013) the subject site was undeveloped and well vegetated (Figures 6 and 7). There is an area in the south east corner of the site that has obviously been quarried (Figures 7 and 8). This area is approximately 2,500 m² in size. The land surface near it is slightly disturbed.

Figure 6 - View north across Anembo Street

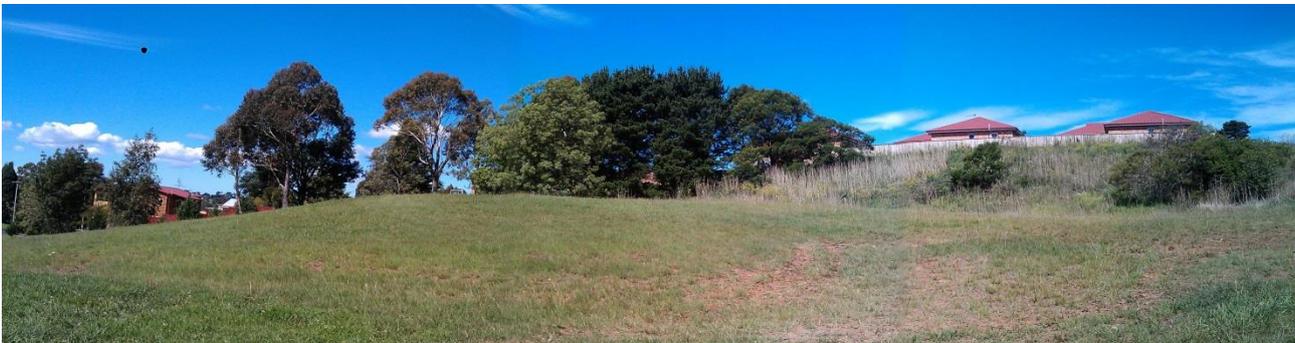
Figure 7 - View East. Quarry site is on top right of photograph.

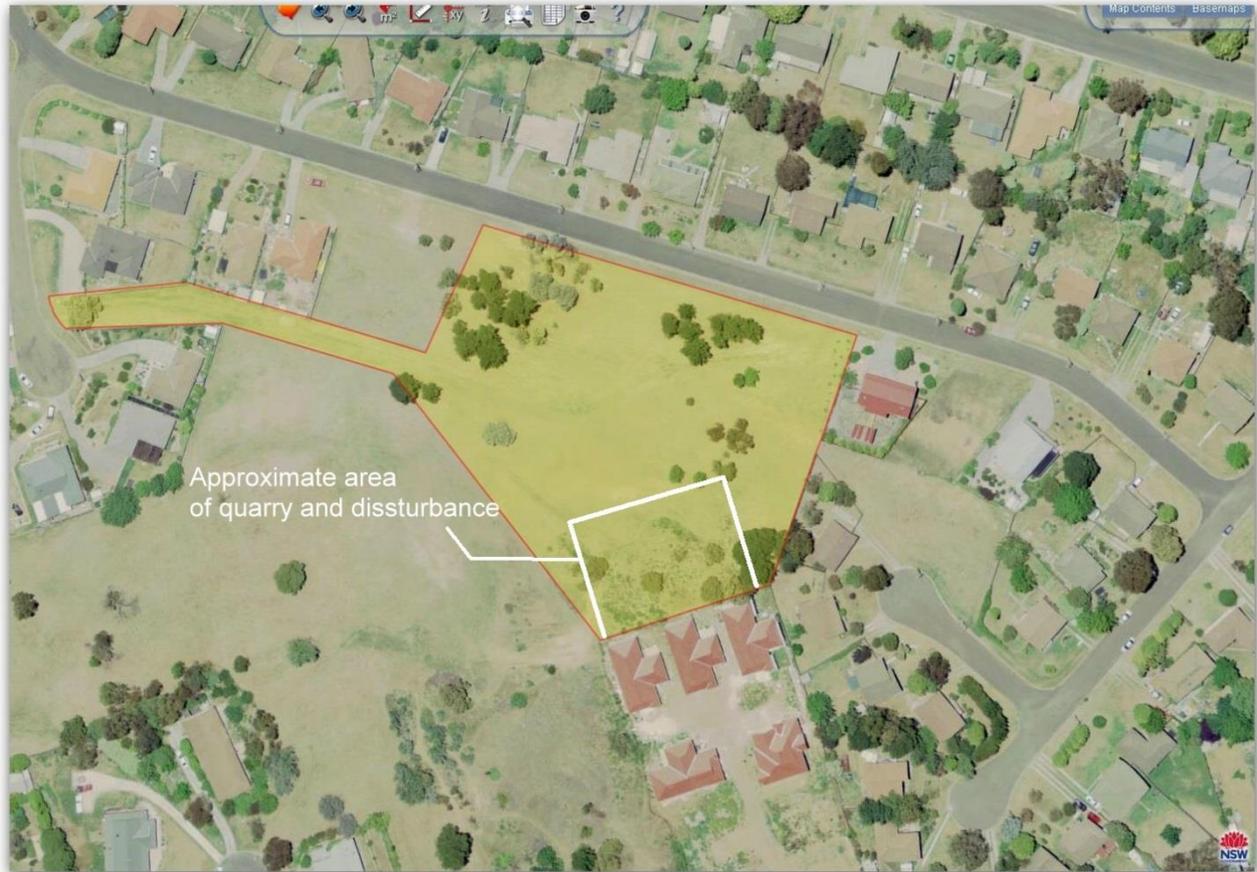
The remnants of old access tracks can be seen in the landform, both appear to have provided access to the quarry area. To the immediate southeast of the quarry is another (offsite) area that also appears to have been used as a quarry; the land here is significantly disturbed.

Figure 8 - Approximate area of old quarry and site disturbance.
