Stage 2 Preliminary Contamination Assessment 104 Shoalhaven St, Kiama, NSW

Report E2W-0247 (DR001-V1)

Project: Stage 2 Preliminary Contamination Assessment

104 Shoalhaven Street, Kiama, NSW, 2533

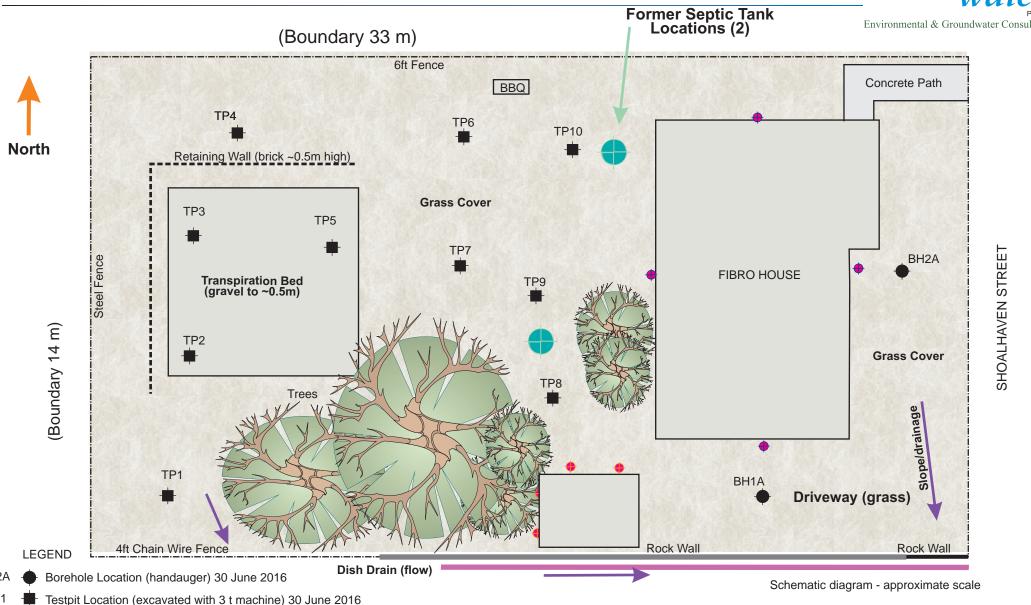
Site Plan & Soil Investigation Locations (30 June 2016)

The 14 soil sampling locations (TP1-10, BH1A-BH2A, ShedC-1, House C-1, and 1 QA sample) investigated by E2W are considered adequate for the Stage 2 preliminary contamination assessment. The sampling locations (14) were based on the site area (462 m2) and based on NSW EPA guidelines (Sampling Design Guidelines, 1995. Note: A minimum of 5 sampling points is recommended for a 500 m2 parcel of land to detect an 11.8 m diameter hotspot with 95% accuracy). The sampling density (14 samples/462 m2) is considered to be sufficient, given the variability of soil at the site.

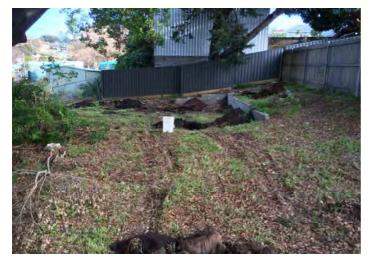
- Two aged buildings (house and shed) are in poor condition and clad with fibro sheeting. A transpiration bed (80m2) and demolished two septic tanks are situated in the rear yard.

Plate 1 (30 June 2016) View of rear yard at 104 Shoalhaven Street, Kiama. The retaining wall marks the area of the former transpiration bed. Several testpits (TP-2 & 3 and 5) are visible at the centre of the frame and location of transpiration bed. **Plate 2** showing the aged fibro and brick constructed house and front yard. **Plate 3** viewing east over the side driveway and location of BH-1 (next to yellow bin). **Plate 4** showing the rock wall and stormwater drain on the southern boundary. **Plate 5** showing the fibro garden shed located on the rear yard and south boundary.

- Excavation and offsite disposal of transpiration bed and materials comprising coke-ash, coal, slag from onsite soils to address actual/potential contamination risks associated with micro-biological hazards and gasworks related waste.

- Excavation, removal and appropriate disposal of septic tank structures.
- Excavation, removal of derelict pipework (PVC at transpiration bed, old galvanised water pipes).

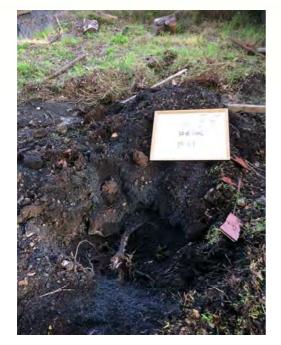
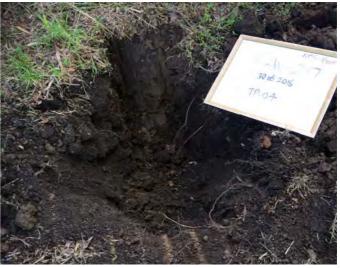
The site is unlikely to contain any gasworks infrastructure. However, some evidence of gasworks by-products such as coke ash and siliceous slag were evident in the rear yard, transpiration beds and soil profile observed in the 10 test-pit excavations.

Plates 6,7,&8 (30 June 2016) View of selected test pits (TP-1,4,5) and soil sample types located in the year yard (clay loam overlying coke ash and blue metal gravel to approximately 0.5m depth, underlain by weathered siltstone or silty clay). TP-04 located on the elevated northwest boundary of the site comprises clay loam and silty clay (no coke ash or gravel as its outside of the transpiration bed of approximately 80 m2).

- Excavation, removal and disposal of degraded soil fill (PAH/TPH/metals impact, demolition waste- concrete/bricks/metal). Covering, capping of the site (front/year yards) with clean top soil (~0.1m thick) to minimise potential exposure of contamination (gas works related waste).

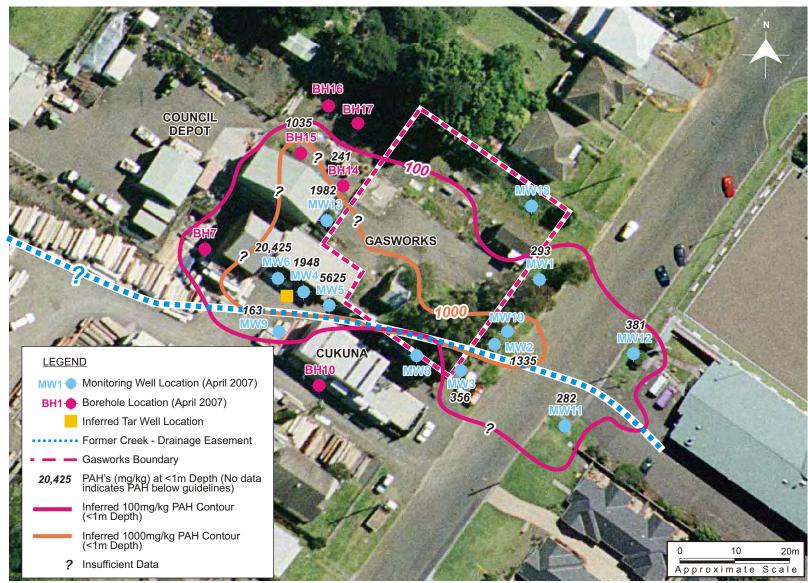
Figure 2 Reference: E2W 084 02.cdr

SITE LAYOUT & INFERRED PAH CONCENTRATIONS IN SHALLOW SOILS (<1m DEPTH)

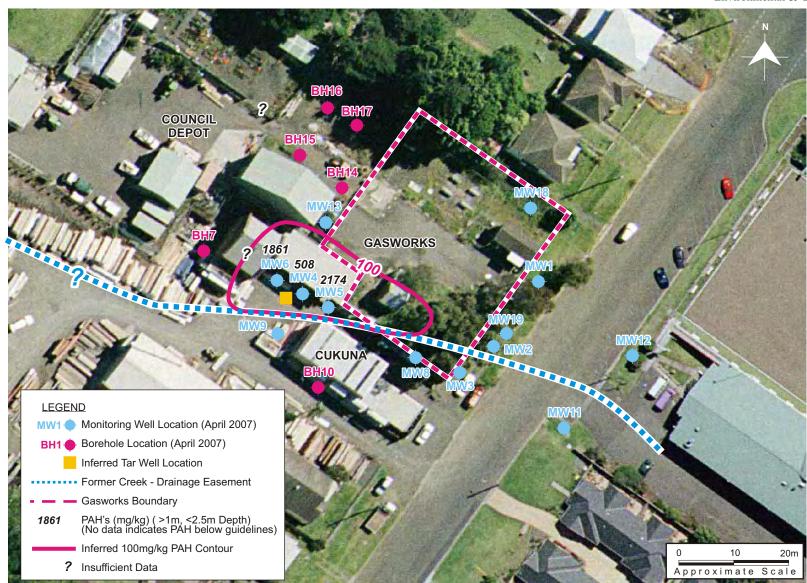
SITE LAYOUT & INFERRED PAH CONCENTRATIONS IN DEEP SOILS (>1m & <2.5m DEPTH)

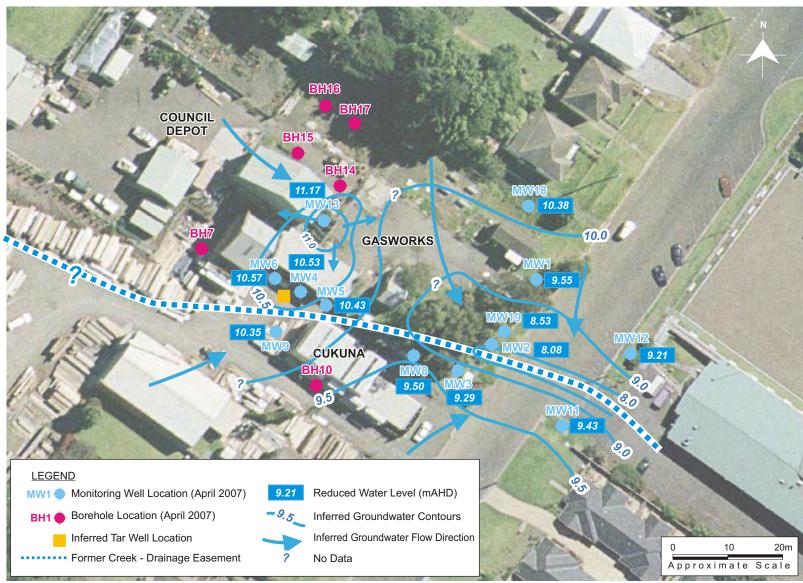
SITE LAYOUT & INFERRED GROUNDWATER FLOW REGIME (18 April 2007)
