**PHASE 1 CONTAMINATION ASSESSMENT  
152-206 ROCKY POINT ROAD  
KOGARAH NSW**

Report Date: 28 August 2013  
Project Ref: ENAURHOD04565AA

**RE: Phase 1 Contamination Assessment, 152-206 Rocky Point Road, Kogarah NSW**

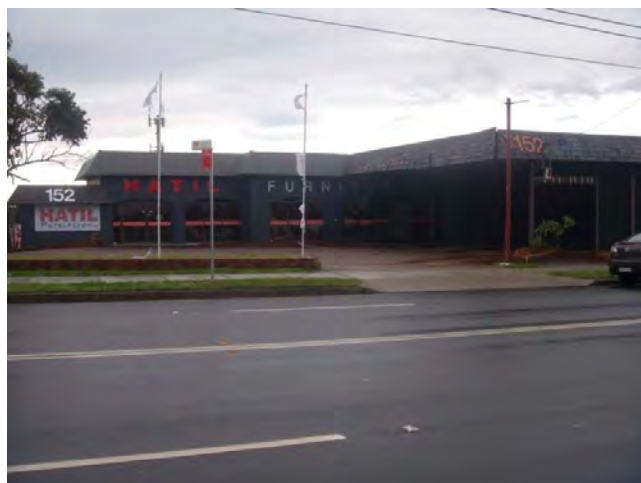
This lot comprises the northwestern quadrant of the site and is the location of a furniture showroom of brick construction (Site Photograph 1), adjoining a metal and timber warehouse used for furniture storage.

Site Photograph 1: facing southeast, overlooking furniture showroom in Lot 1 DP 405531

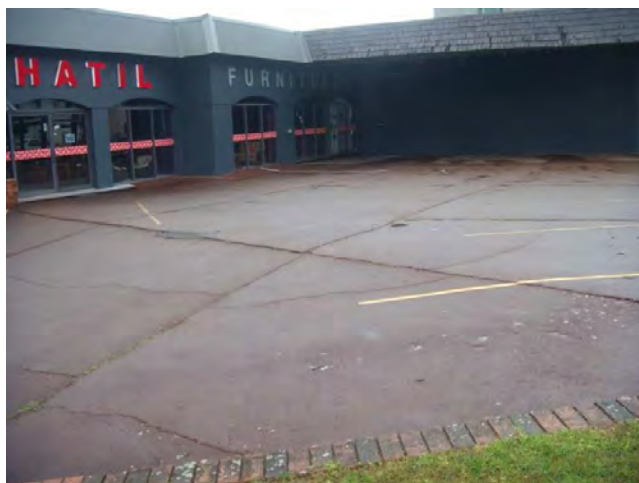
A bitumen sealed car park comprises the northwestern portion of the site (Site Photograph 2), with vehicle access via Rocky Point Road and Production Avenue. Raised garden beds (grass) are present adjacent to the northern and western site boundaries.

Site Photograph 2: facing southeast, overlooking the bitumen sealed car park within Lot 1 DP 405531

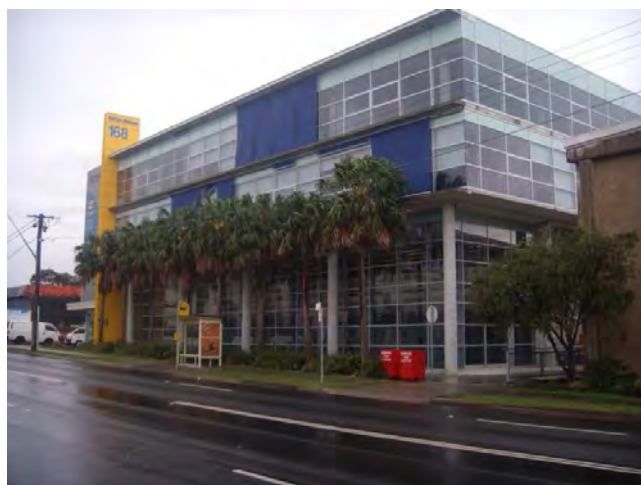
The western half of the lot comprises a recently constructed three-storey office building of reinforced concrete and glass construction (Site Photograph 3).

Site Photograph 3: facing northeast, overlooking the new office building within Lot 1 DP 1144981

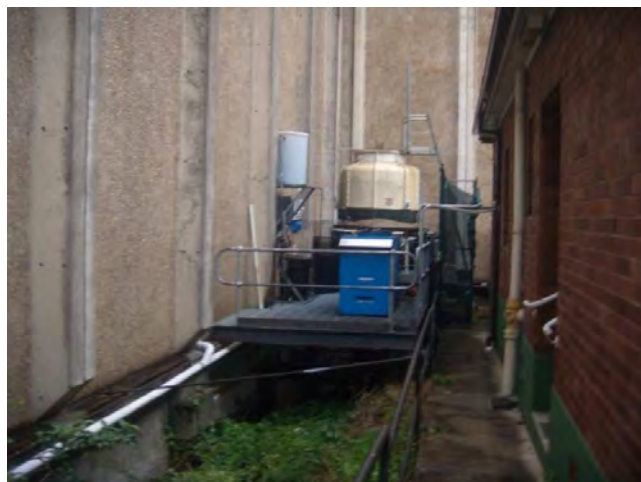
A cooling tower is located on a suspended platform between the warehouse and the office (Site Photograph 5).

Site Photograph 5: cooling tower located between the warehouse and office in Lot 1 DP 599502

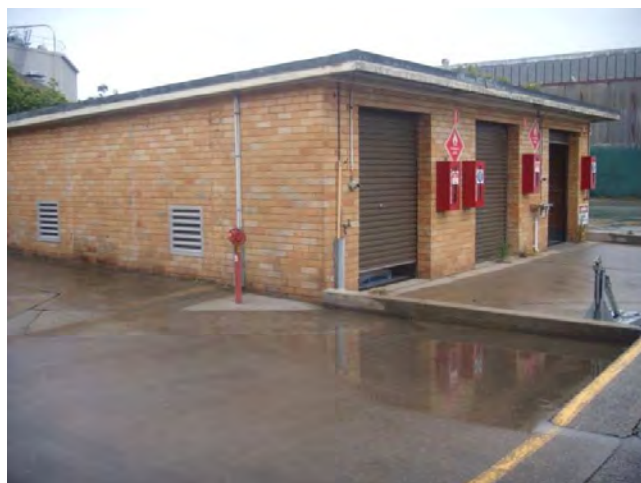
A single-storey brick building is located in the centre of Lot 2 (Site Photograph 7). This building is used as a flammable liquid store (FLS) for ethanol used in the manufacture of confectionary. The building is accessed via roller doors along its eastern façade. A concrete bund extends from the eastern face of the building to contain chemical spills, however no visible surface staining indicating past spillage was observed.

Site Photograph 7: facing northwest, overlooking the flammable liquid store in Lot 2 DP 838198

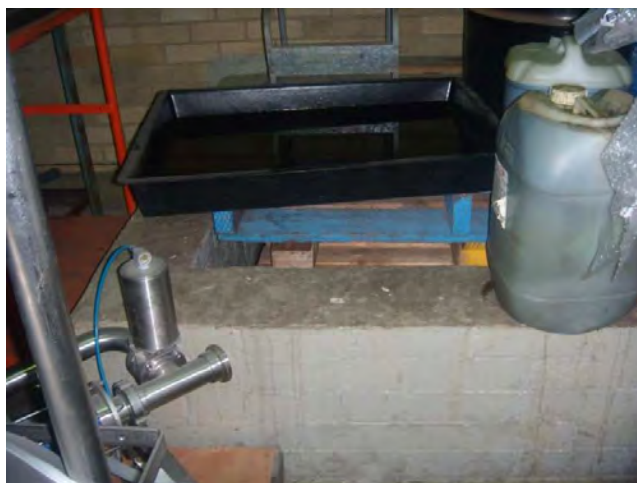
The eastern end of the building comprises the engineering section of the factory where machinery used in making confectionary is dismantled and overhauled. An elevated concrete pit used for the containment of waste oil in 44-gallon drums is present within the engineering section (eastern end) of the building (Site Photograph 8). The waste oil typically comprises heavy fraction gear box oil which is disposed off-site by a licensed waste contractor. Surface staining was not observed either within the pit or on the surrounding concrete floor.

Site Photograph 8: waste oil pit within the eastern portion of the building within Lot 22 DP 620329

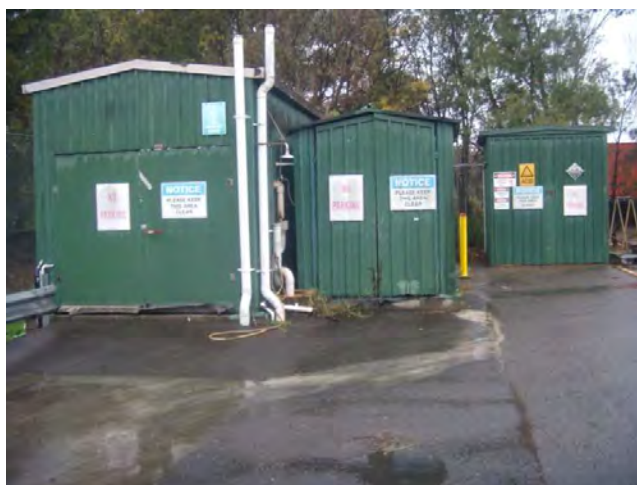
A wastewater treatment plant is located within the northeastern corner of Lot 22 (Site Photograph 10). The treatment plant uses caustic soda to neutralise sugar and glucose within the wastewater stream generated from the cooking process.

Site Photograph 10: facing east, overlooking the wastewater treatment plant in the northeastern corner of Lot 22 DP 620329

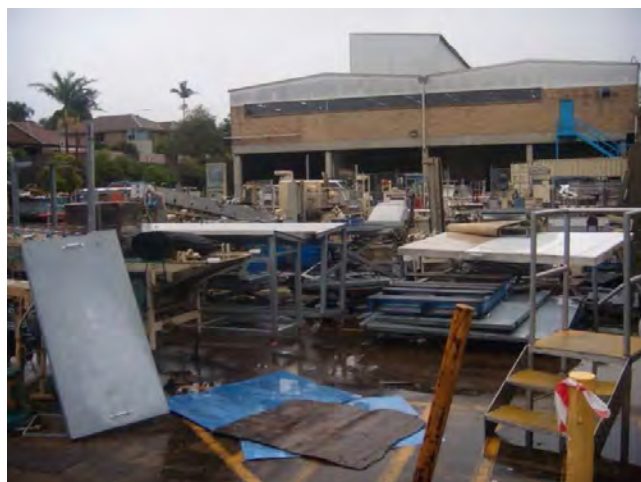
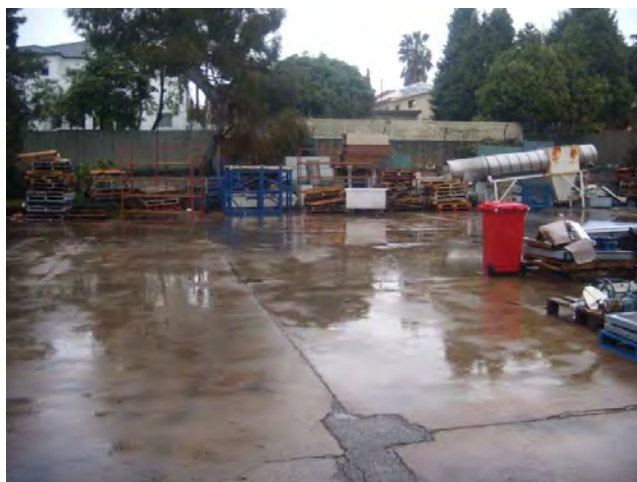
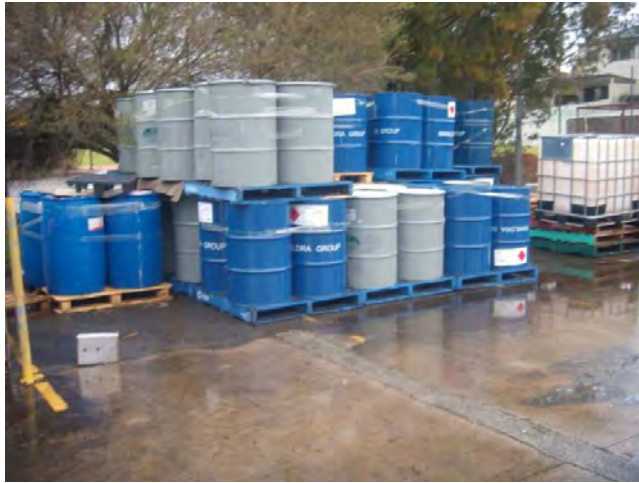
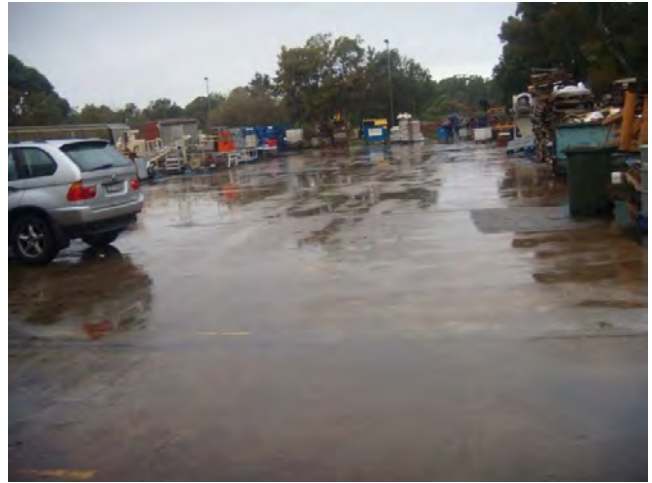
The eastern portion of Lot 22 is a concrete sealed car park used for the storage of miscellaneous items including former factory equipment and drums containing ethanol (Site Photographs 11 to 14).

Site Photograph 11: facing west, overlooking the storage area in the eastern part of Lot 22 DP 620329

Site Photograph 12: facing east, overlooking the storage area in the eastern part of Lot 22 DP 620329

Site Photograph 13: facing southeast, overlooking the ethanol drum storage in the eastern portion of Lot 22 DP 620329

Site Photograph 14: facing east, overlooking the storage area in the eastern part of Lot 22 DP 620329

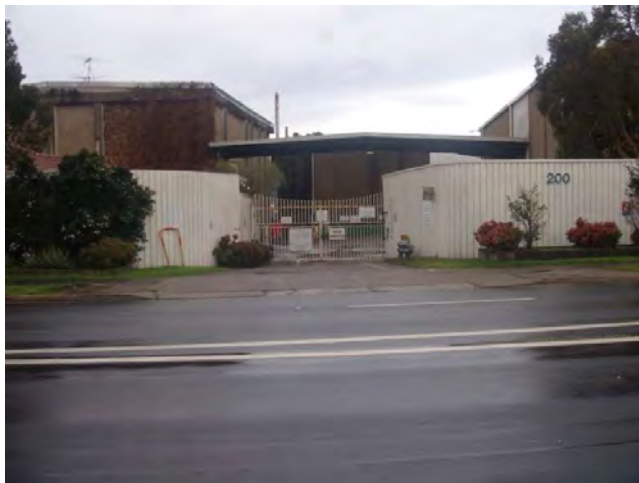
Vehicle access to Lot 22 is via a driveway off Rocky Point Road that runs adjacent to the northern boundary of the lot (Site Photograph 15).

Site Photograph 15: facing east, overlooking the vehicle entrance to Lot 22 DP 620329

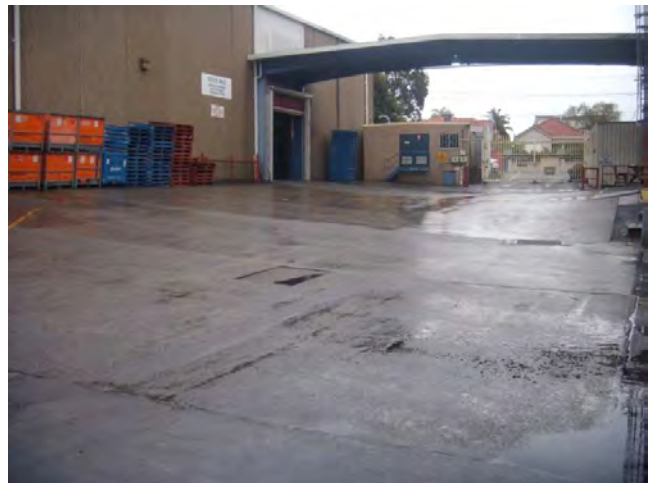
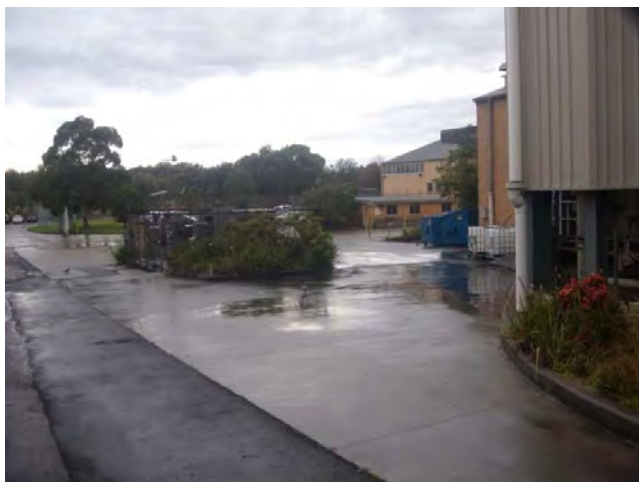
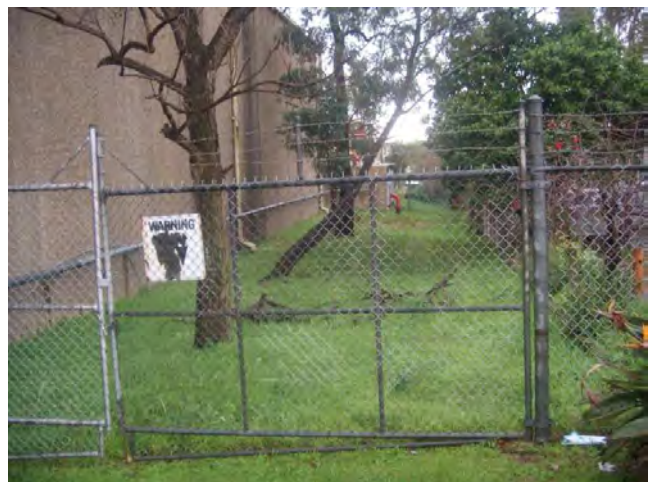
Vehicle accessways and areas of the site not occupied by buildings typically comprise concrete and bitumen pavements which were observed to be in good condition with no visible staining, however the land between the building and the southern boundary of Lot 22 is grass covered (Site Photographs 16 to 18).

Site Photograph 16: facing west, overlooking the vehicle entrance to Lot 22 DP 620329

Site Photograph 17: facing east/southeast, overlooking the eastern portion of Lot 2 DP 838198

Site Photograph 18: facing east, overlooking the grassed area adjacent to the southern boundary of Lot 22 DP 620329

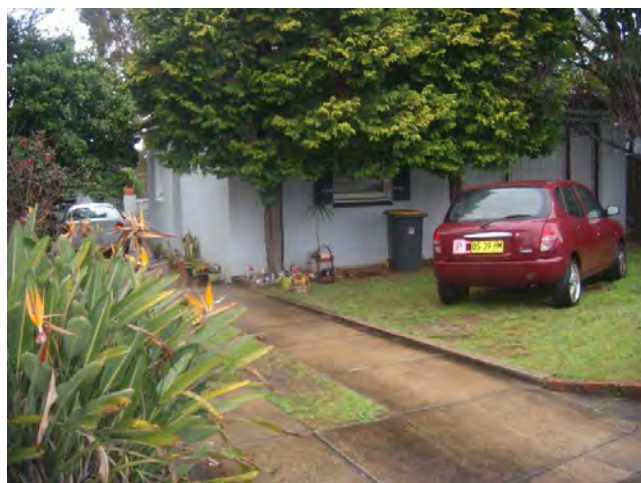
This portion of the site is occupied by a single-storey brick residence (Site Photograph 19) with a concrete sealed driveway leading to a garage in the northeastern corner of the lot.

Site Photograph 19: facing southeast, overlooking the residential dwelling in Lot 1 DP 666138

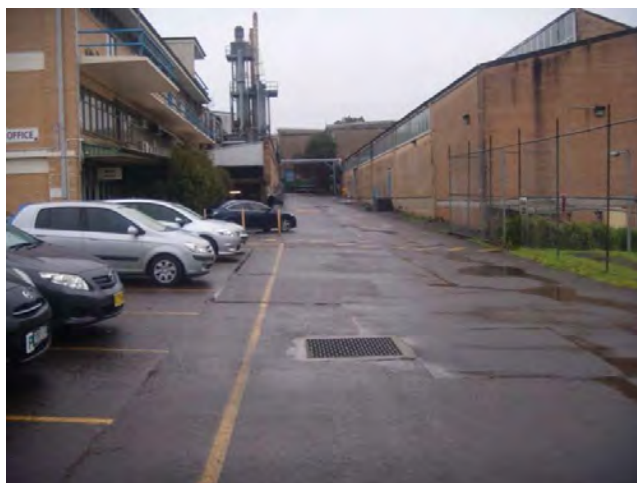
Site Photograph 20: facing west, overlooking the former location of the petrol USTs in Lot 22 DP 620329

In consideration of the process presented in Table 6.1, Coffey recommends that a targeted soil and groundwater assessment be carried out to assess the presence and extent of actual subsurface contamination, if any, as a result of the past and present occupation of the site.

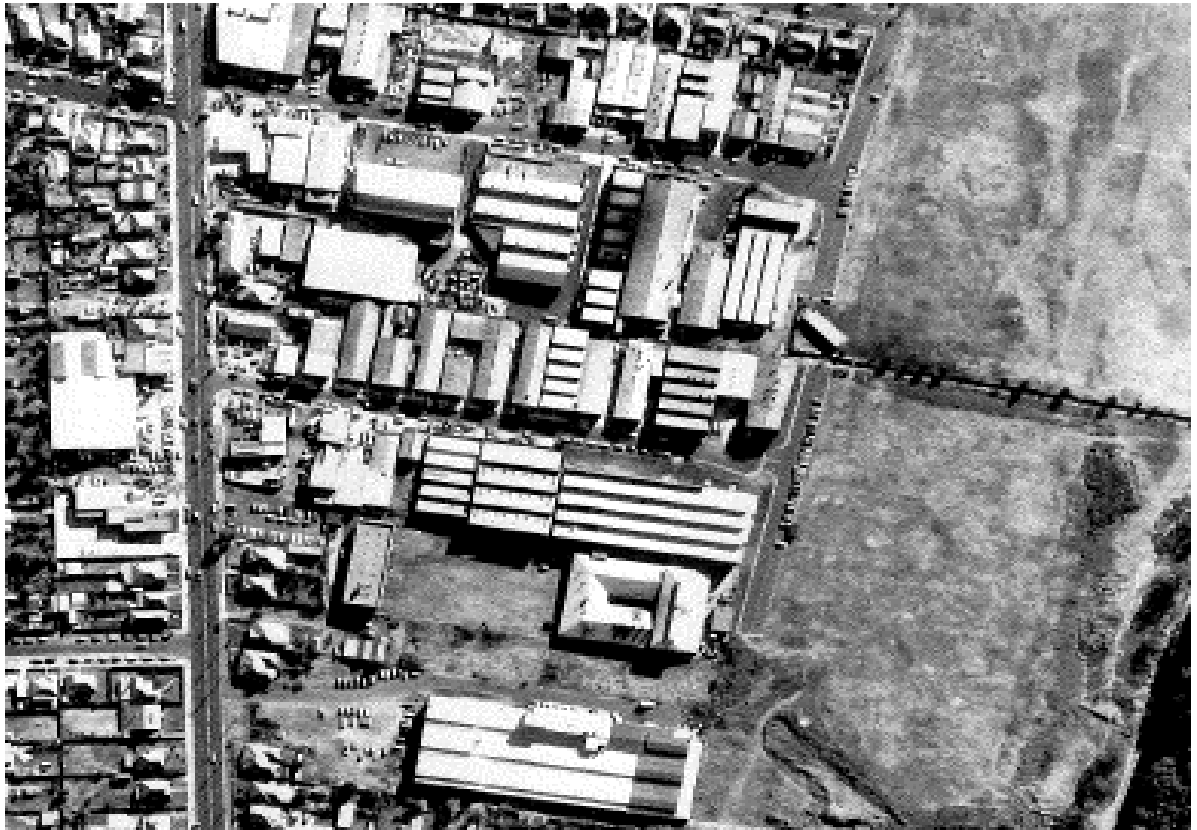
| Year | Observations |
|---|---|
| 1970 | <p>Further commercial development of the northern half of the site has occurred.</p> <p>The service station appears to remain within the northwestern quadrant of the site. The footprint of the sales building remains largely the same, however the canopy appears to have been extended towards the west to cover the fuel bowers.</p> <p>The market gardens have been replaced by a large commercial/industrial building set back</p> |

1970 photograph (north up page)

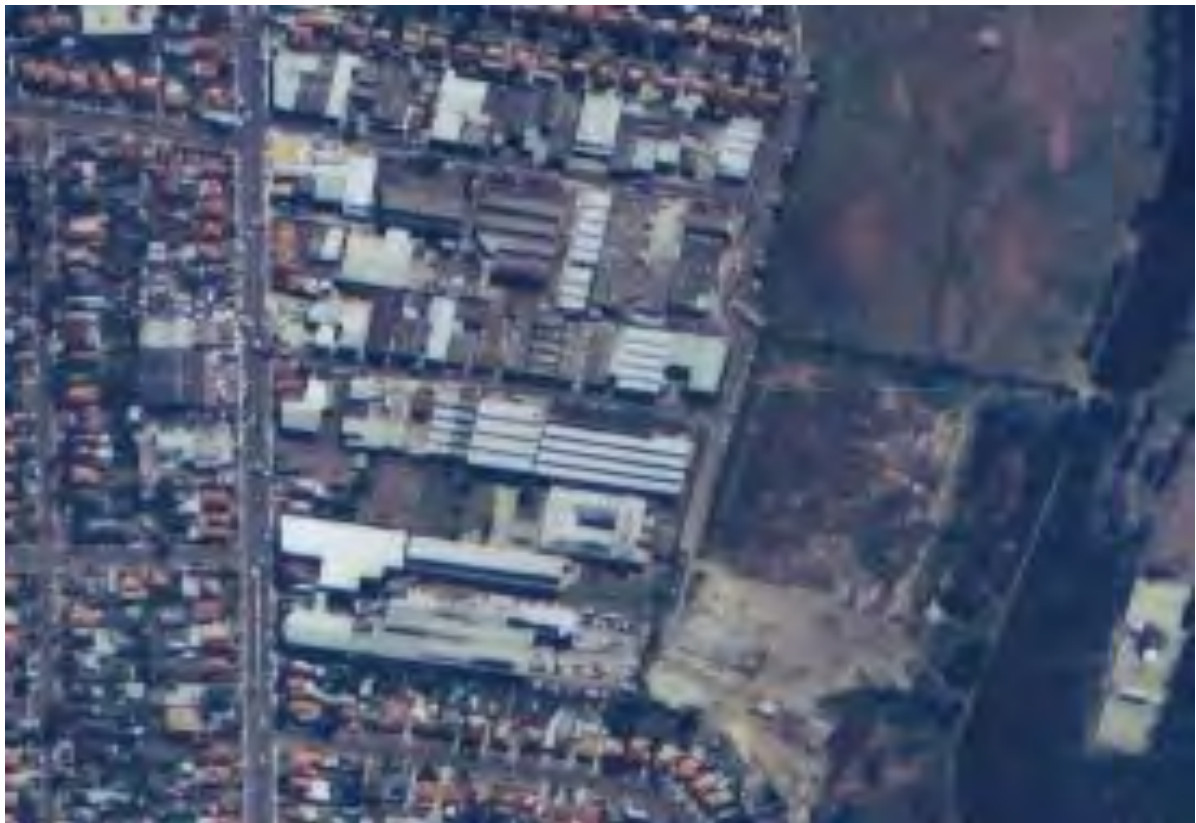
| Year | Observations |
|---|---|
| 1991 | The commercial/industrial building located in the northeastern portion of the site has been removed and replaced by a car park.<br><br>No substantial change to the surrounding area is visible with the exception of earthworks in the vacant land to the east of the southern half of the site. |

1991 photograph (north up page)
