### **STAGE 1 PRELIMINARY ENVIRONMENTAL SITE ASSESSMENT INCORPORATING SOIL SAMPLING – PROJECT AREA C**

**19 BTU ROAD  
LOT 1 DP 227233  
NOWRA HILL, NSW, 2540**

**PREPARED FOR: SHOALHAVEN CITY COUNCIL**

**PROJECT NUMBER: ENRS0394**

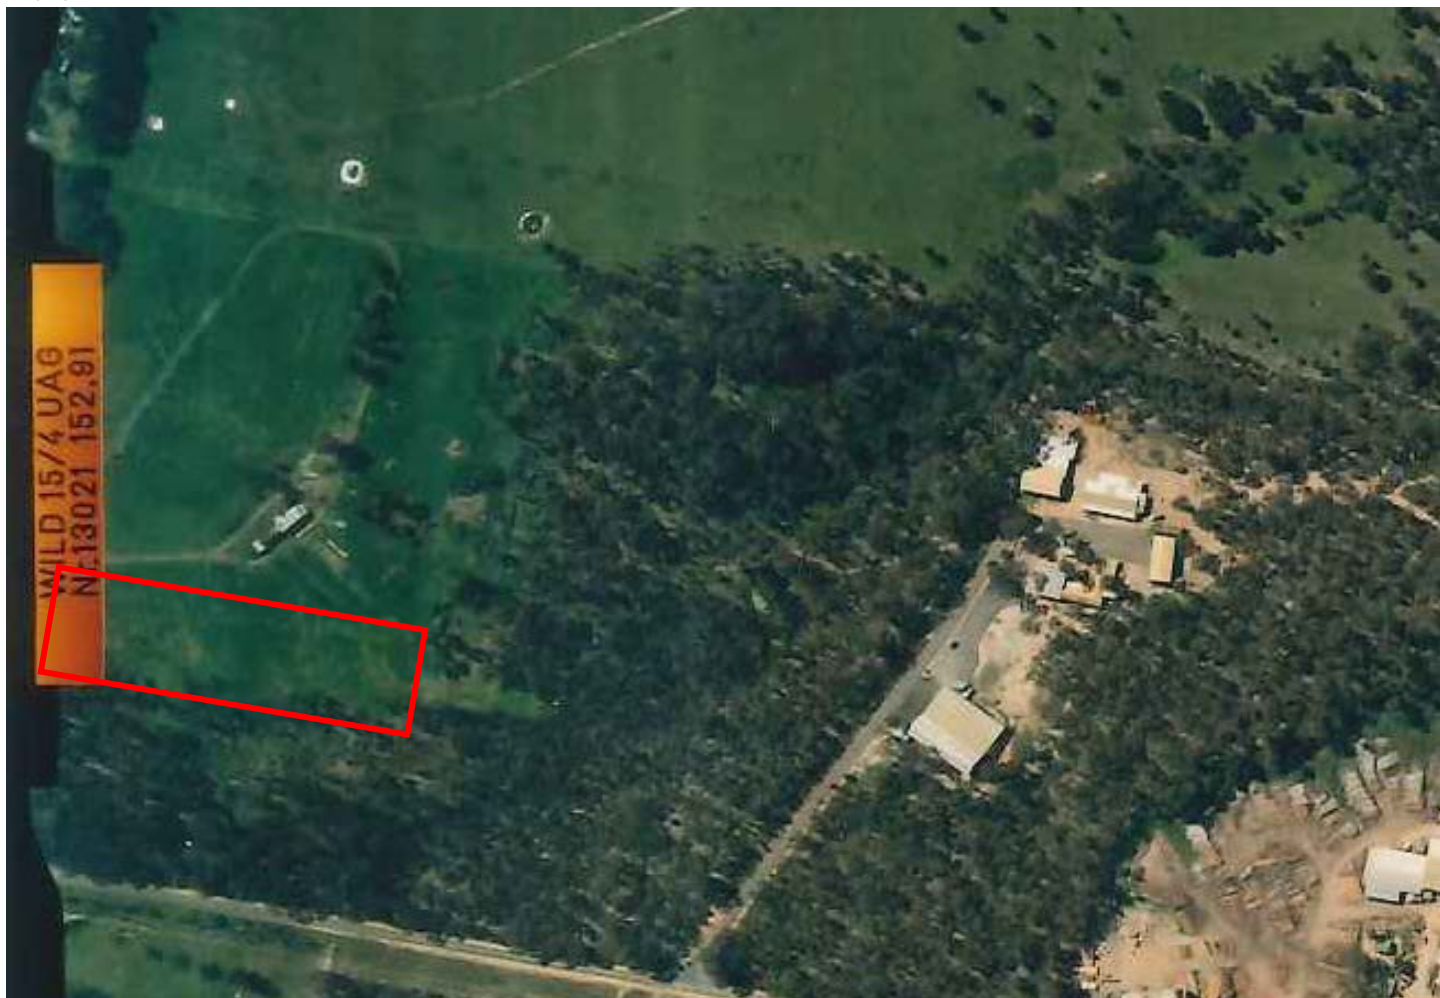
22/2/1997

| Date & Details | Observations |
|---|---|
| <b>22/2/1997</b> | <ul style="list-style-type: none"> <li>➤ Layout and conditions as per 1986 and 1994 imagery.</li> </ul> |

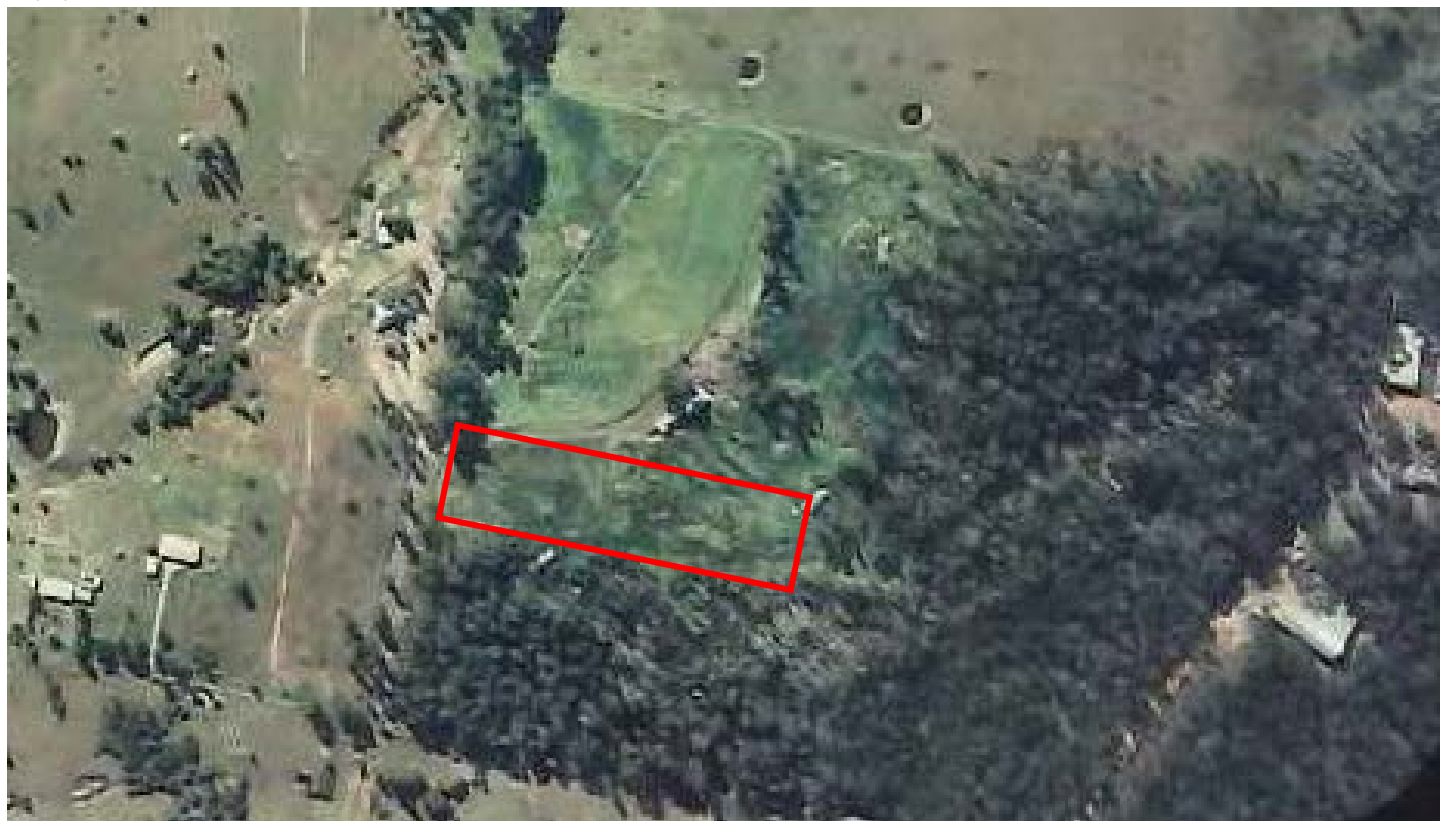
23/6/1994

| Date & Details | Observations |
|---|---|
| <b>23/6/1994</b> | <ul style="list-style-type: none"> <li>➤ Layout and conditions as per 1986 imagery.</li> </ul> |

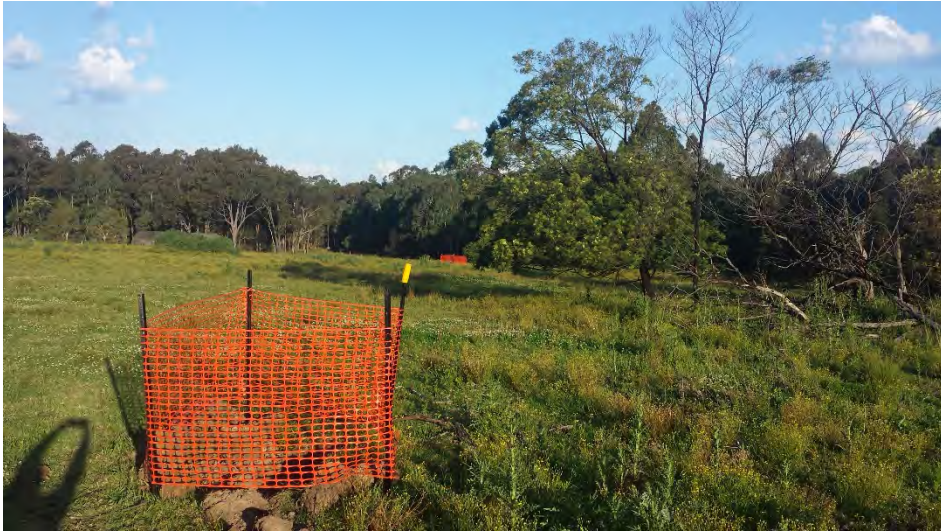
**Photo 1: TP15 and TP16**

Test pit investigations reported shallow topsoil originating from decomposed night soil described as brown clayey silt. This layer of top soil was generally 0.1-0.5 metres deep underlain by native yellow-grey clay overlying weathered grey shales to the maximum investigation depth of **2.0 m**. A summary of the test pit profiles is provided in **Table 14**. No foreign matter or groundwater was observed in test pit investigations. Test pit observations indicate there is some potential for variation in ground conditions with a deeper profile of the former biosolids in the eastern portion of the site.

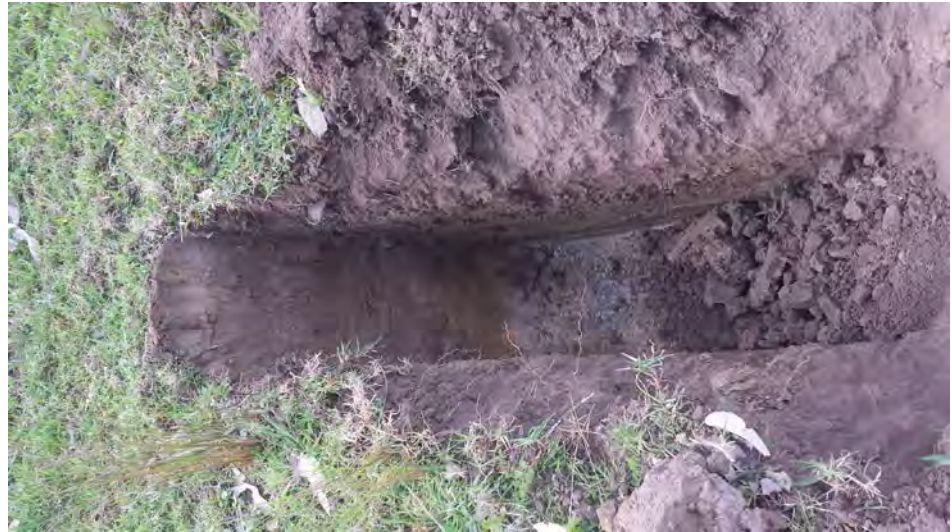
**Photo 4: TP14**

- Supplementary testing delineated a hotspot area of elevated mercury and zinc above the agricultural guidelines for biosolids within a 5 metre radius of TP14. The area is outside the development footprint and does not limit the site proposal

- Where practical excavate any residual biosolids from the building footprint to remove any risk of soil pathogens or unidentified hotspot contamination. Chemical testing and comparison against the NEPM C and D landuse guidelines reports the material is suitable to remain on site and may be moved to a less sensitive area on site;
