Report on  
Detailed Site Investigation (Contamination)

Proposed Residential Development  
871 – 877 Pacific Highway, Chatswood

Prepared for  
Megland Group Pty Ltd

Project 84722  
April 2015

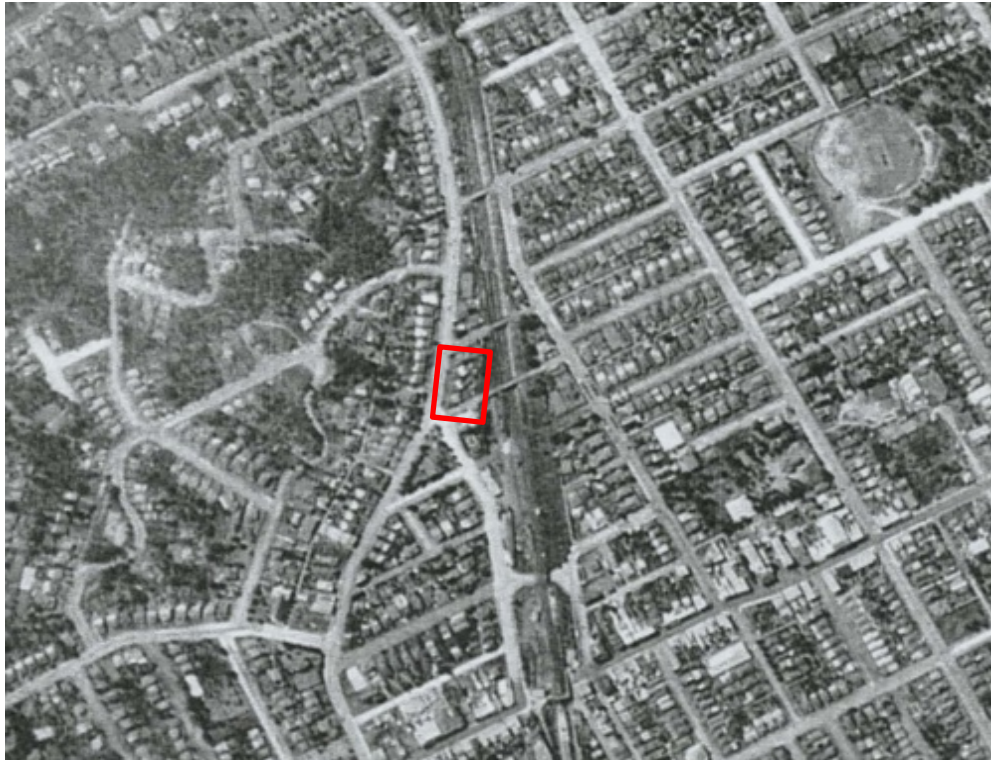
Photo 1 - 1930 image

A review of available aerial photographs from 1930, 1956, 1961, 1970, 1986, 1991, 2002 and 2014 was undertaken to evaluate the changes in land-use patterns on the site during this period. The 1930 photograph shows that the site is occupied by two or three residential dwellings. The 1956 and 1961 photographs show similar conditions to that of 1930.

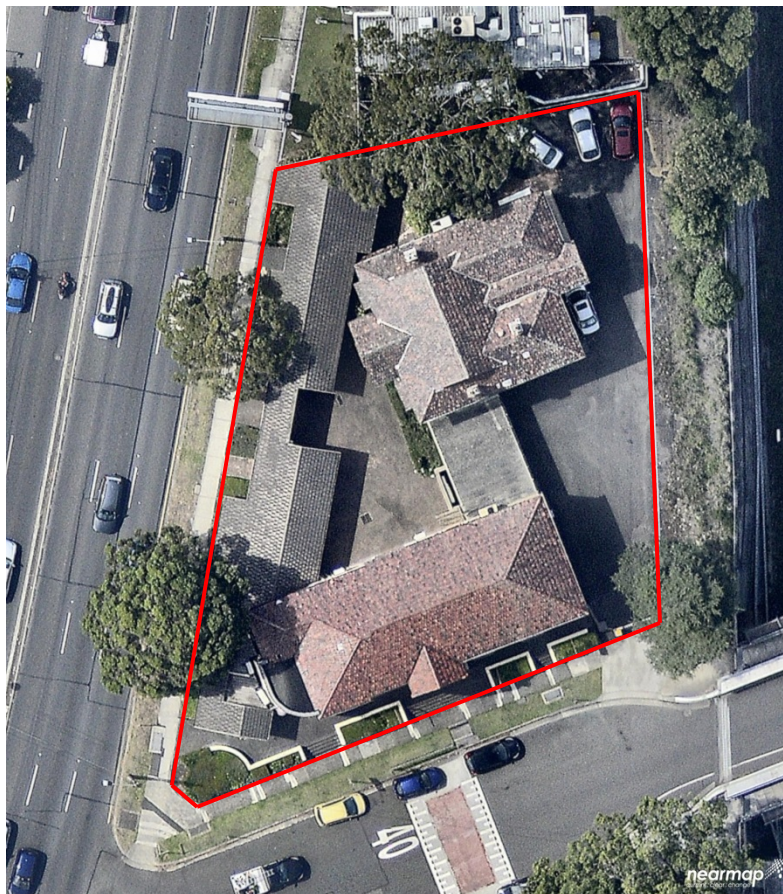
Figure 1: Location of 871 – 877 Pacific Highway, Chatswood

The potential sources of contamination are outlined in the CSM above. The site has limited access for testing equipment and therefore testing will be undertaken in the areas currently accessible. Inspection of the site during demolition/construction activities will enable the currently inaccessible areas to be assessed at a later stage. A site location plan is shown in Figure 1.

The area of the site is understood to be 1400 m<sup>2</sup>. The minimum recommended number of sampling locations for a site of this area is seven in accordance with *Contaminated Sites: Sampling Design Guidelines* (NSW EPA, 1995). Further information on the proposed sampling locations and suite of potential contaminants to be analysed is included in Sections 5 to 7 of this SAQP.
