PRELIMINARY SITE INVESTIGATION

Sep-22
J178275

NETWORKED URBAN SOLUTIONS PTY LTD

92-96 Victoria Avenue ,
Chatswood NSW 2067

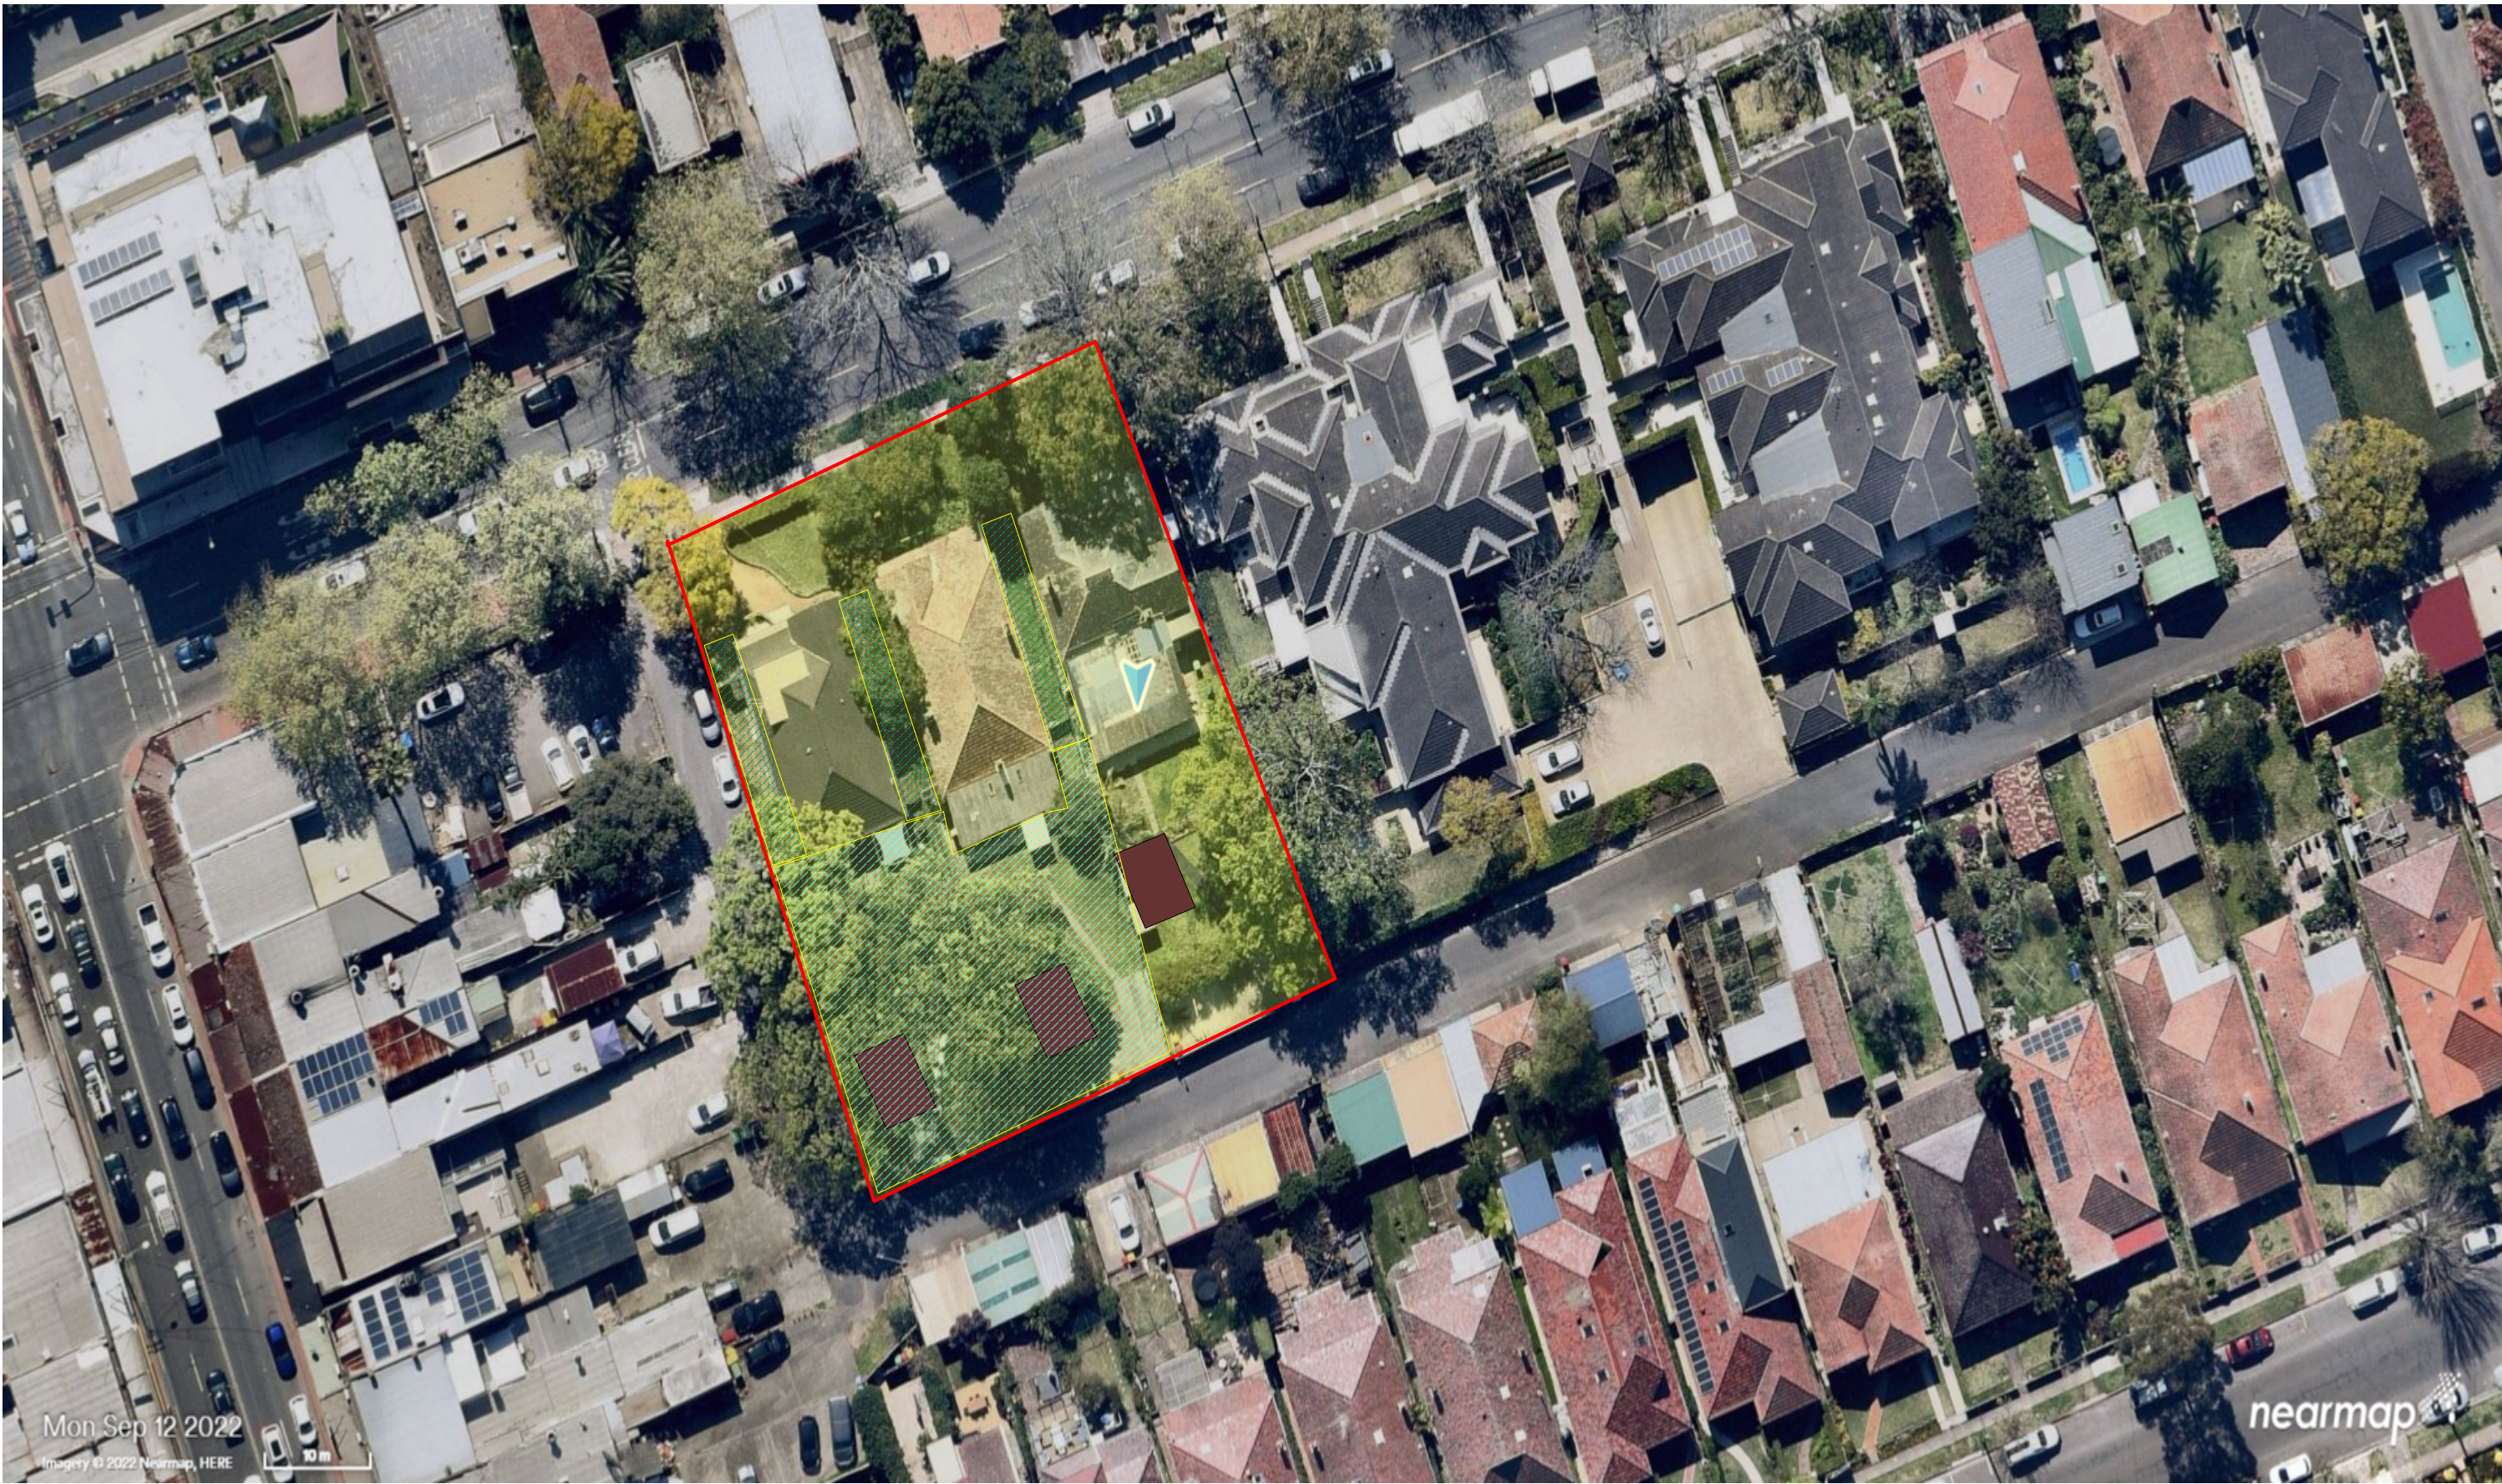
A site inspection was undertaken by a suitably experienced Greencap environmental consultant on 5th September 2022 to assess the current site condition and site land uses, relevant to the assessment of land contamination. A site layout plan depicting the identified site features is included in Figure 2. Photographs from the site inspection are provided in Appendix A. Greencap understands that the site is used as residential property with current tenants.

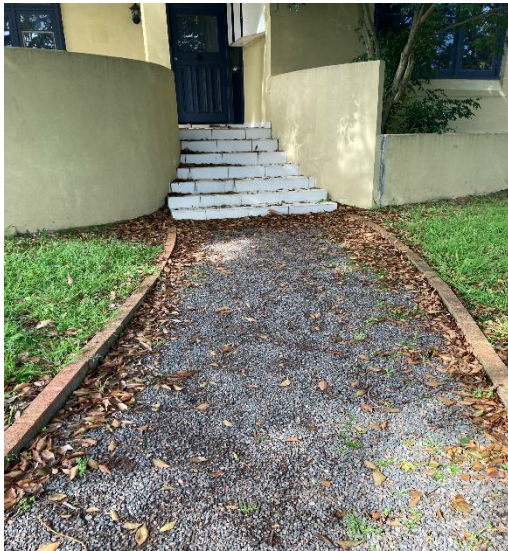
Photo 1

Lot /Address	Observations
Lot 7 /92 Victoria Avenue	The surface was sealed and covered with gravels at the pathway to the house (Photo 1) and on either sides of overgrown grass on the ground (Photo 2). On the east of the property was the stormwater drainage and water main (Photo 3 and 4). Gravel sidepaths on the east and west of the property boundary (Photo 5). The site was generally flat with a gentle slope towards north. General fly-tipping including plastic debris and organic waste bin were observed at the east of the building (Photo 6). Garden bed was observed on the south of the property with grass cover on the rest of the ground surface (Photo 7). Stormwater drainage observed on the south adjacent to the residential building (Photo 11). The west of the property was locked (Photo 8). Concrete paved surface at the sound end of the property with metal fence as boundary was observed, with the property observed to have chimney (Photo 9 and 10)

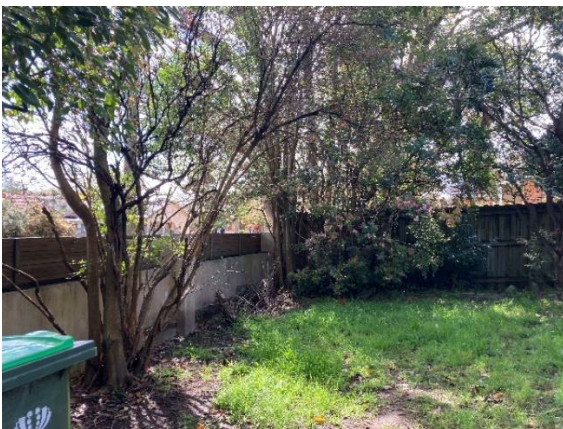
Photo 13

Lot 6 /94 Victoria Avenue	The surface was unsealed and covered with overgrown grass (Photo 12 and 13). East of the property was observed to have overgrown grass, with plastic tubs and empty paint cans (Photo 14). The west of the property along the boundary had partially sealed path (Photo 15). Water line on the entrance to the west was observed (Photo 16). The rear of the property was inaccessible.
Lot 5 /9 Victoria Avenue	The entrance to the property was sealed (Photo 17) with part of the east side observed to have overgrown grass (Photo 18). Along the boundary of the building to the east were trolleys, ladder etc (Photo 19) and west of the property were metal tubes and metal ladder (Photo 20). The rear of the property was inaccessible (Photo 21 And 22)

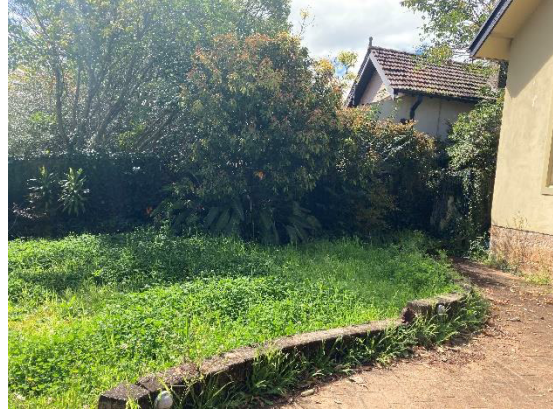
Photo 18

There was no visual evidence of phytotoxic impact (i.e. plant stress or dieback) observed at the site during the site inspection. Vegetation on all the three properties also appeared healthy (see Photo 18)

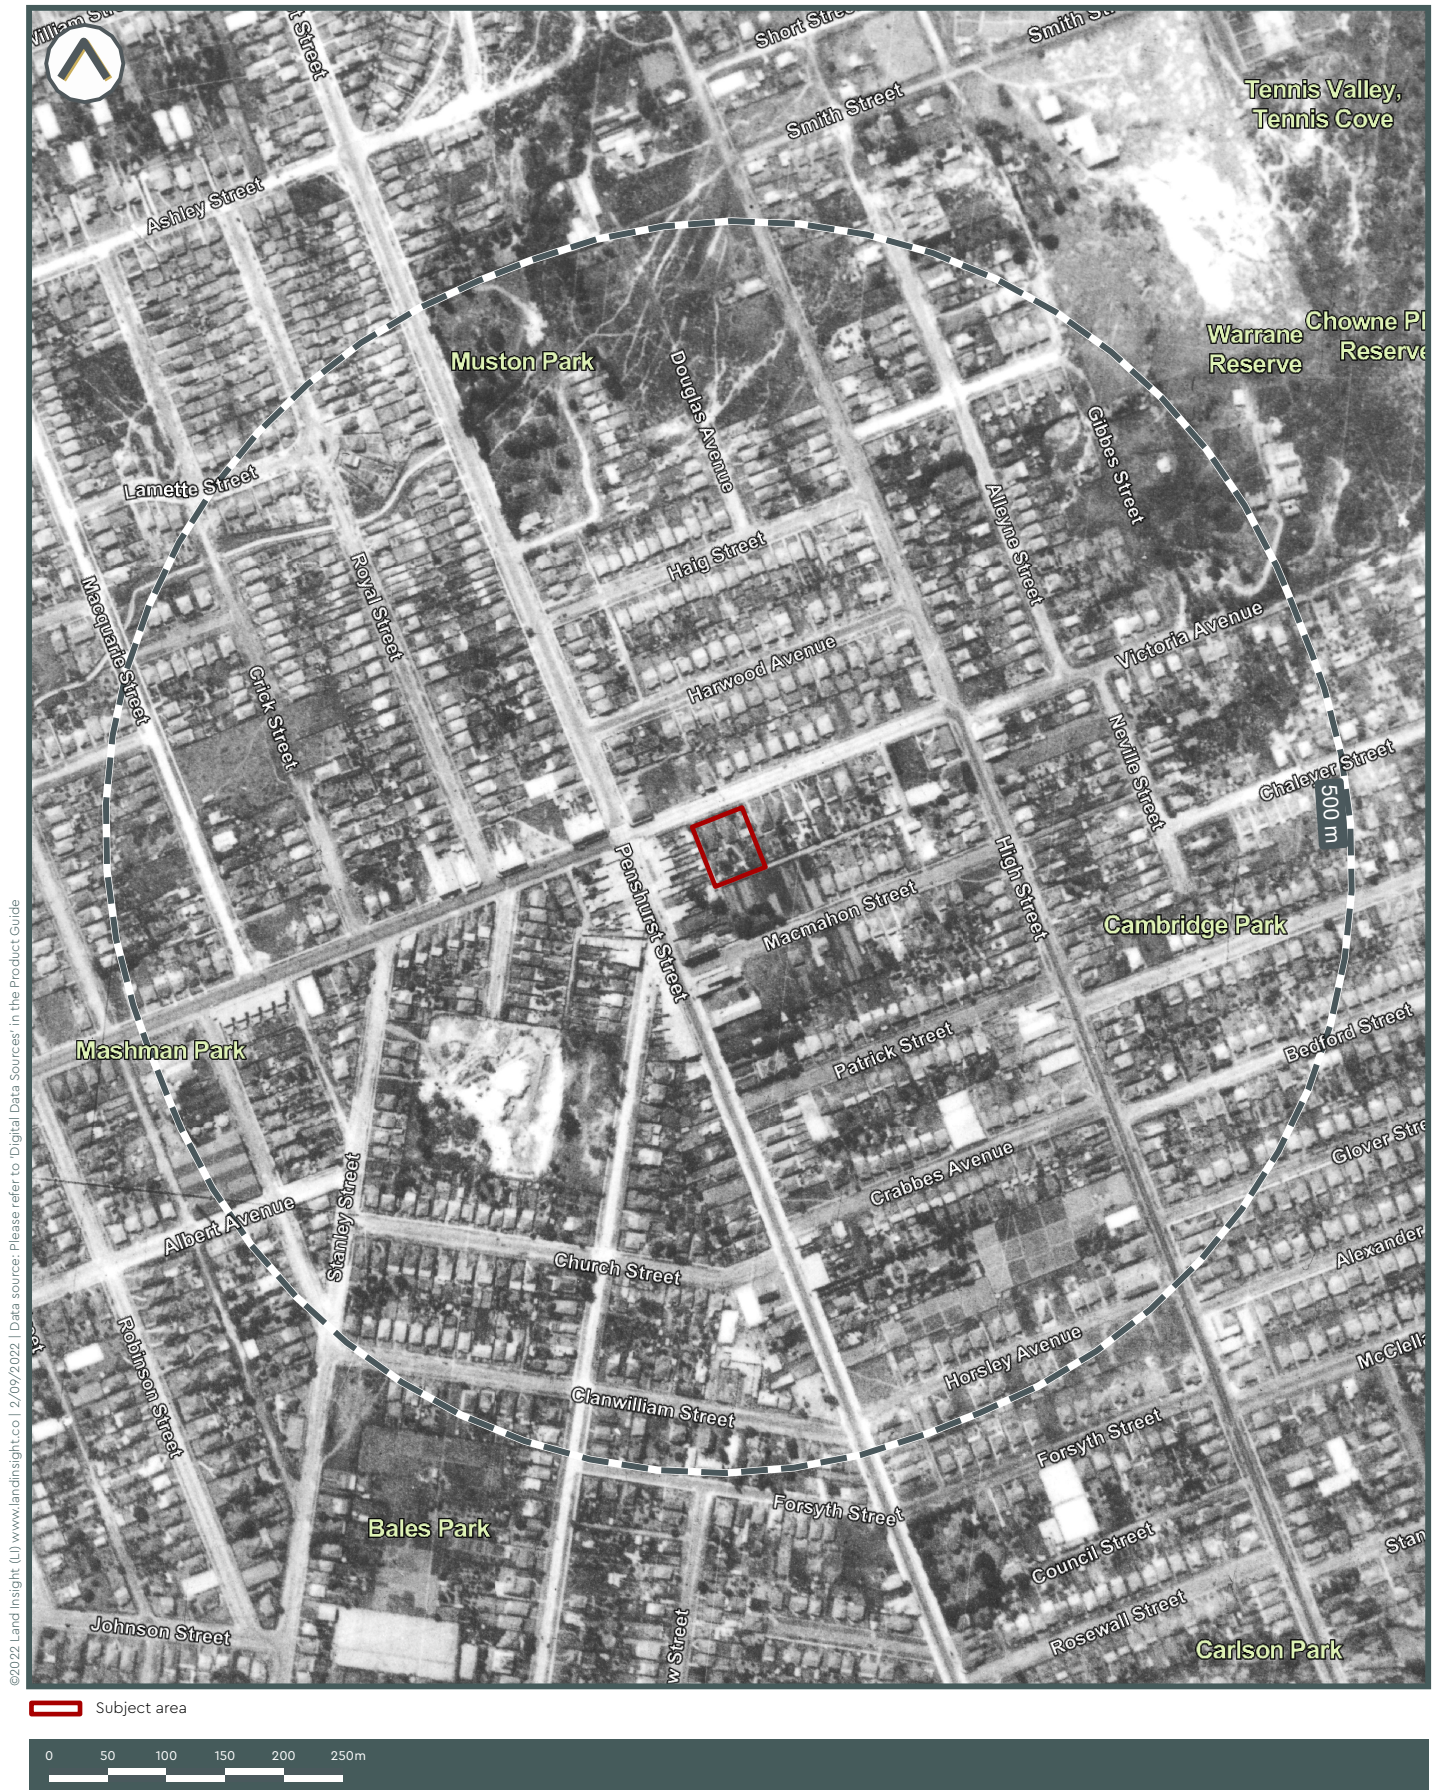
Historic Aerial Photograph - 1930

Year	Observations
1930	Onsite: Three buildings observed on site Offsite: Surrounding area largely has residential buildings and few scattered vacant lands with Muston park on the north , Cambridge park on the east and mashman park on the west.
1943	Onsite: No significant changes observed onsite Offsite: More buildings were observed on the previous vacant land with one building built on the largely vacant land between stanley street and church street.
1951	Onsite: The site remains unchanged since 1943 Offsite: Building structures observed in the surrounding area
1961	Onsite: No significant changes observed onsite except for few trees on the property Offsite: Construction activities on the the land between church street and stanley street observed . A cylindrical structure observed on the east near Gibbes street.
1965	Onsite: No significant changes observed since 1961 Offsite: No significant changes observed since 1961
