Proposed Seniors Living  
Development  
Preliminary Contamination  
Assessment

Lot 2 DP 1145348  
107 Haussman Drive  
Thornton

NEW17P-0074-AB  
29 June 2017

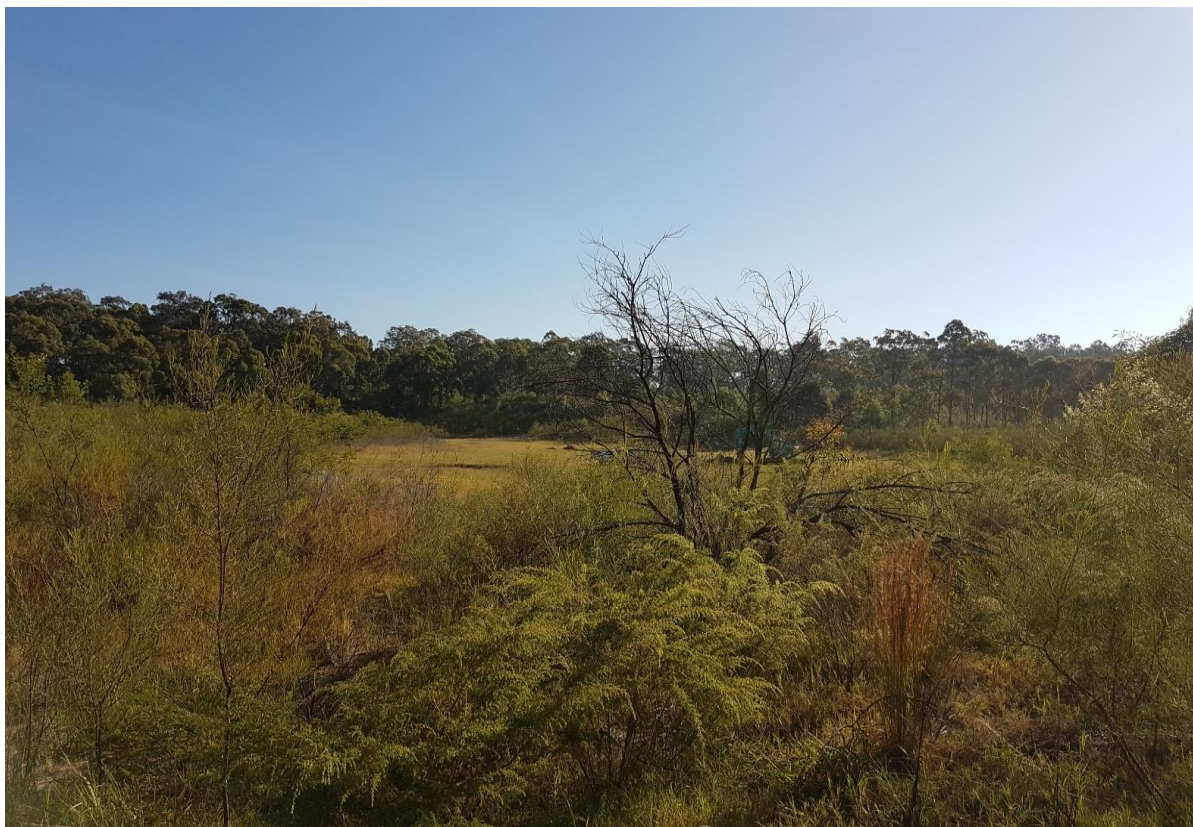
Photograph 1 - Overall site with vacant lower area in central portion visible

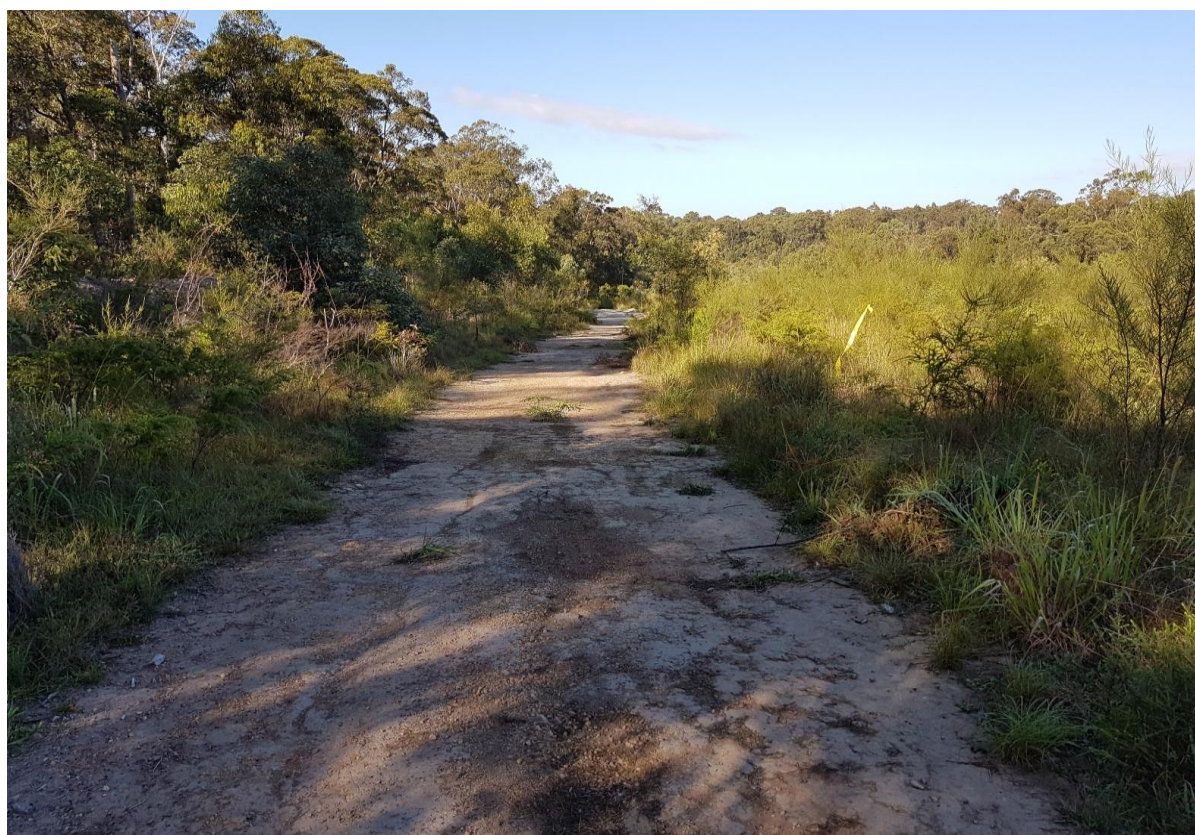
Photograph 2 - Typical photograph of site showing bushland and access track

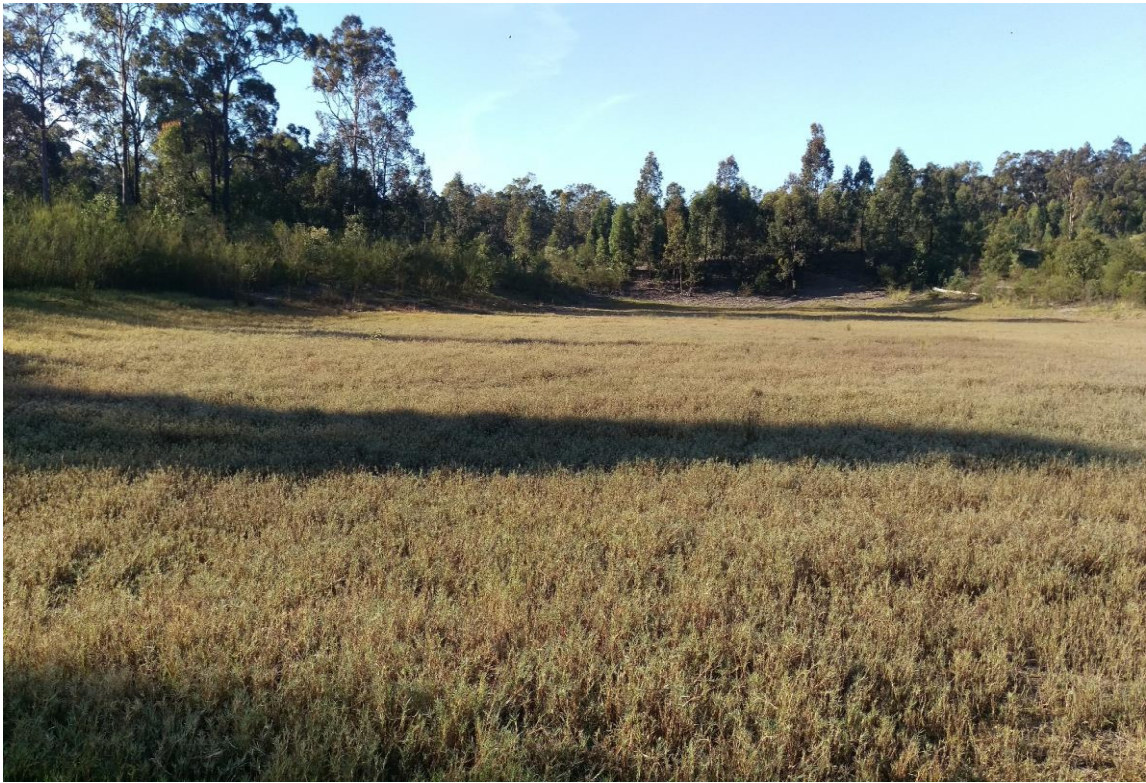
During the site walkover, the majority of the site was observed to be bushland (re-vegetated quarry lands). A vacant, lower lying area was present in the centre of the site, which appeared to be a partially filled quarry void. An access track was present around the perimeter of the former quarry area.

Photograph 3 - Vacant lower-lying area in central portion of site

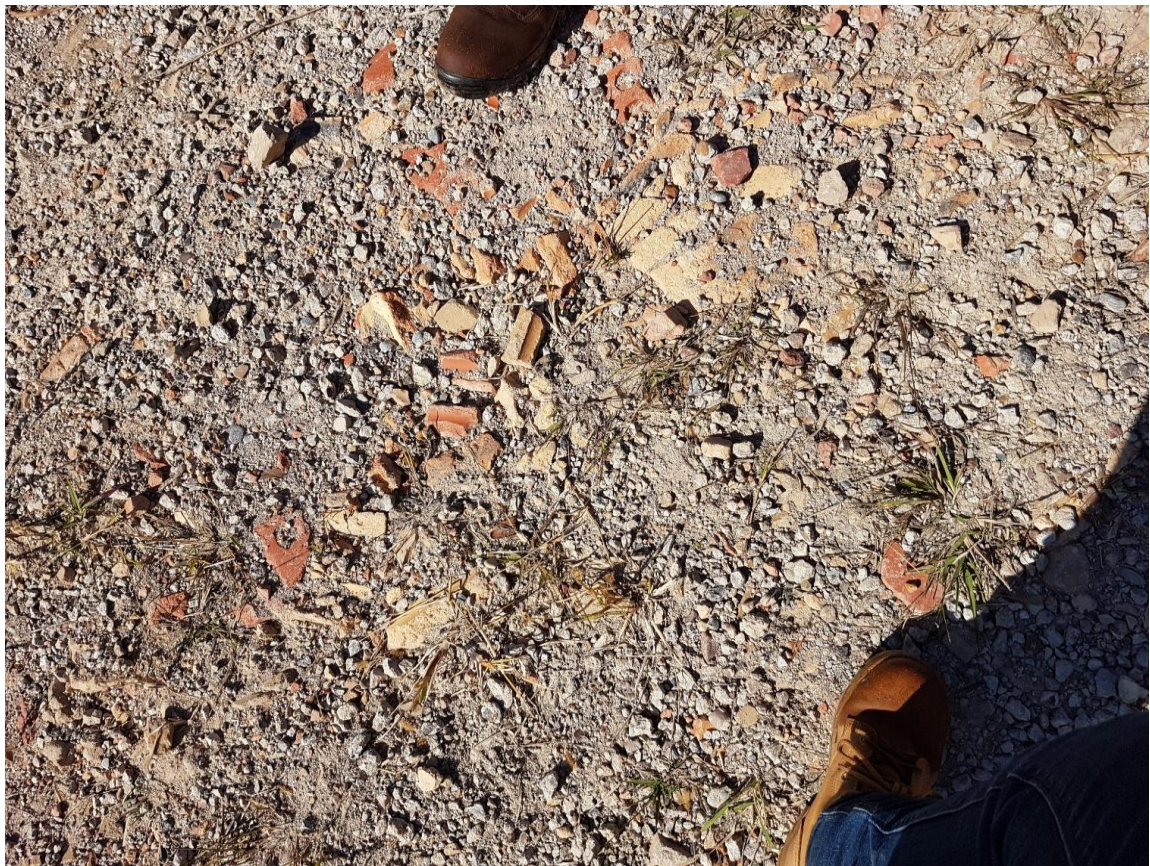
- An access track is present from the site's western boundary to the central part of the site. This access track was observed to have been paved with crushed bricks (see Photograph 4). No potential Asbestos Containing Materials (ACM) were observed in this material;

Photograph 4 - Fill material including bricks in access road on western entry to site

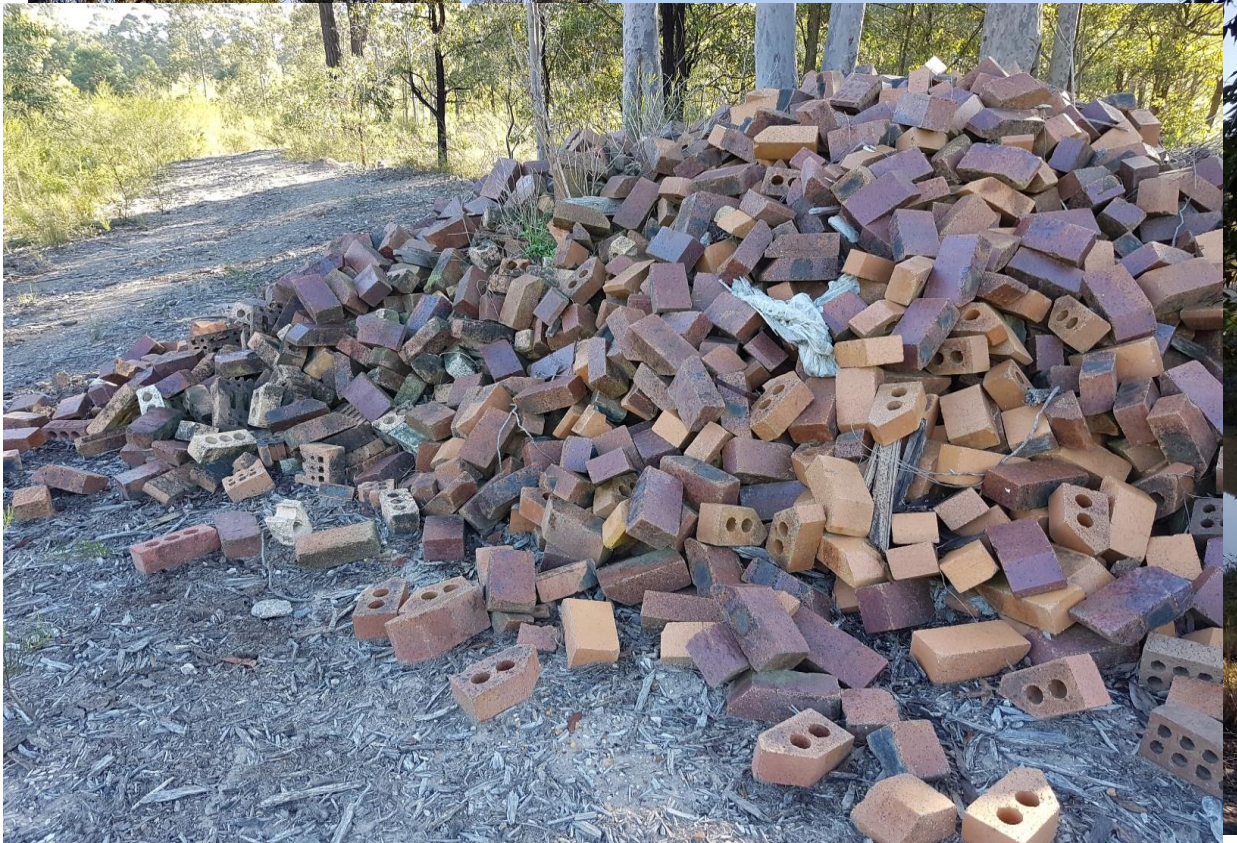
A stockpile of bricks was observed to the east of the central lower area, and fill containing bricks was observed on the access track providing egress to the site. Fill containing brick fragments was also observed in a test pit (TP11) on the northern side of the site. The bricks appear to have been imported to the site for forming access tracks. No obvious potential Asbestos Containing Materials (ACM) were observed in the stockpile of bricks, the access roads, or the fill in the test pits.

Photograph 5 - Stockpile of bricks observed on site

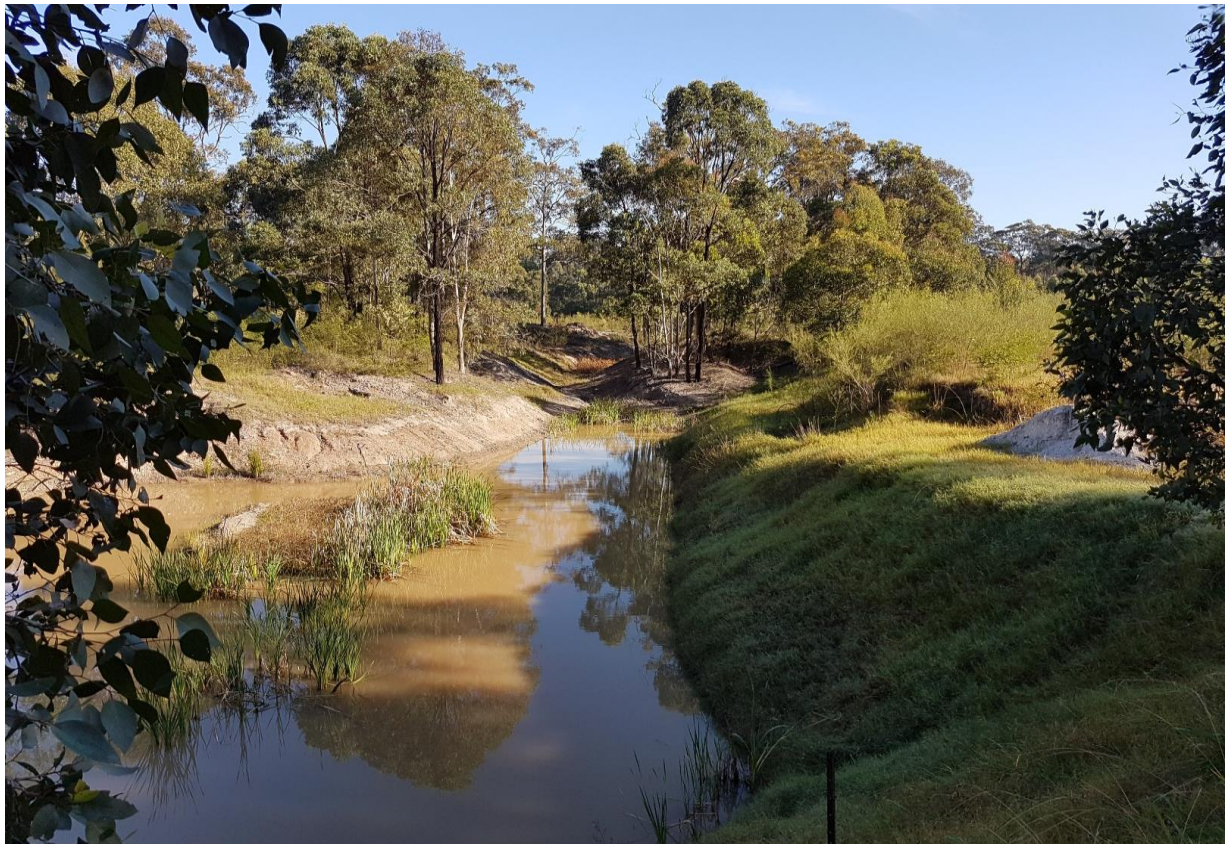
- A drainage channel was observed on the eastern side of the lower central area (see Photograph 6);
- Two surface water ponds were observed in the eastern portion of the site (see Photographs 7 and 8). One of these contained water at the time of walkover, and the other was dry. The drainage channel from the centre of the site drains to these ponds. Overflow from the ponds would drain off-site to the east.

Photograph 6 - Surface water pond on eastern side of site, with drainage channel visible in background

No samples were collected in AEC 3. The potential for contamination in this AEC is low. Taking into account that excess water from AEC 3 flows off-site, assessment of potential contamination is recommended.

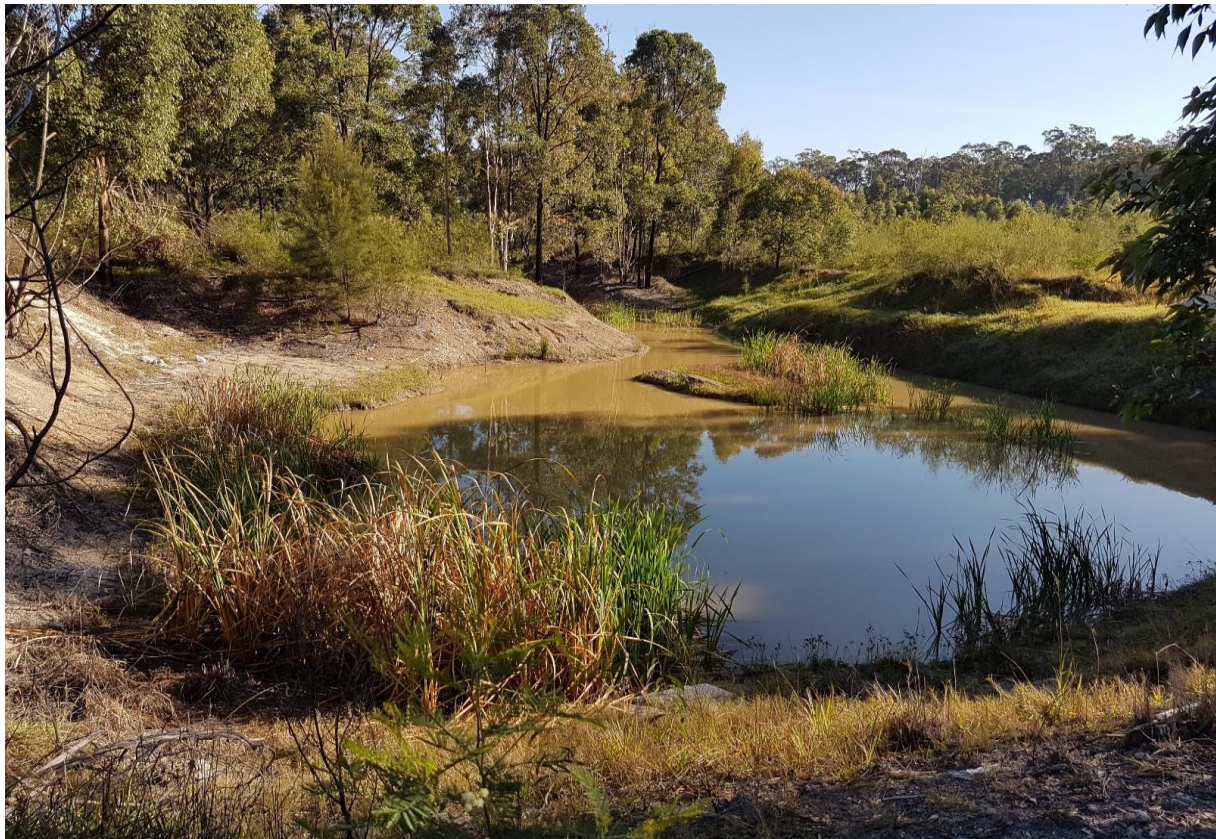
Photograph 7 - Surface water pond on eastern side of site

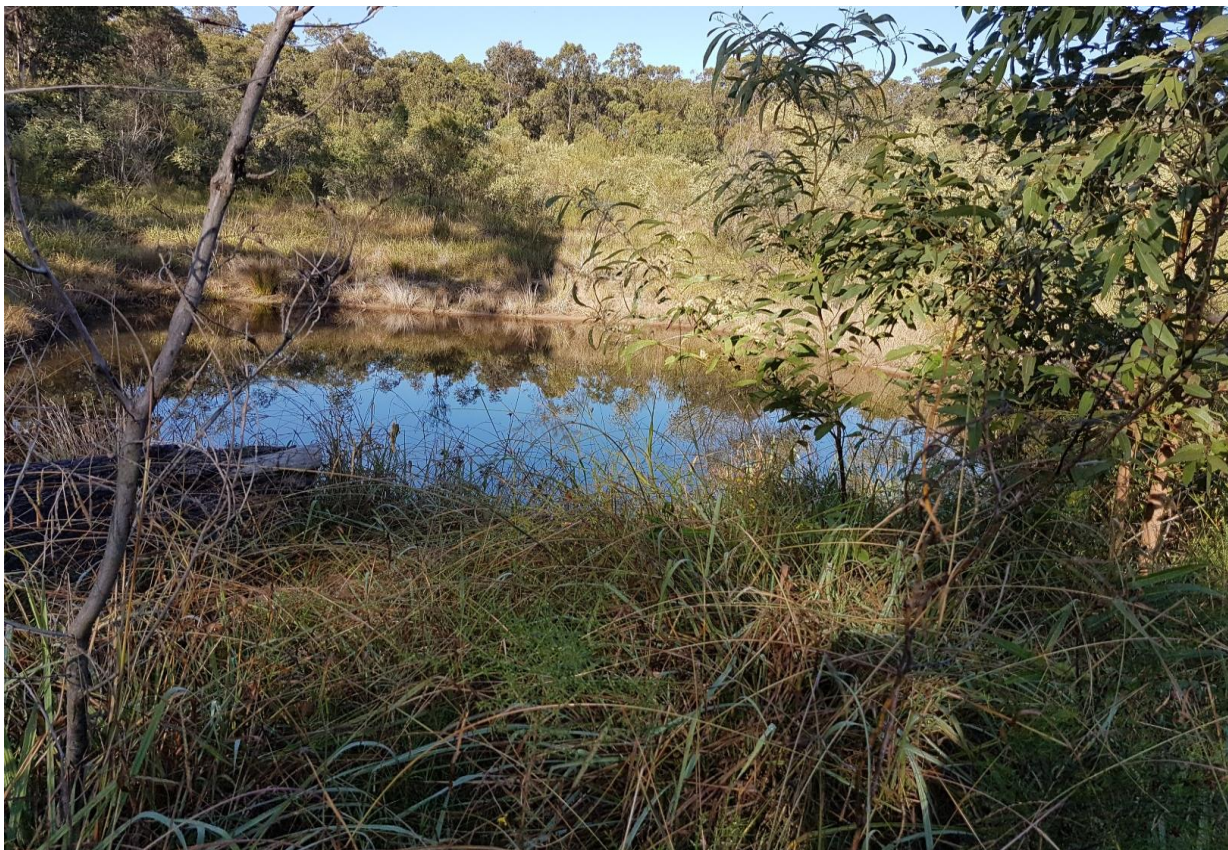
Photograph 8 - Surface water pond on eastern side of site
