PRELIMINARY GEOTECHNICAL ASSESSMENT

PROPOSED PLANNING PROPOSAL

361 NORTH ROCKS ROAD, NORTH ROCKS, NSW

Date: 23 March 2021 Ref: 31775Rrpt rev4

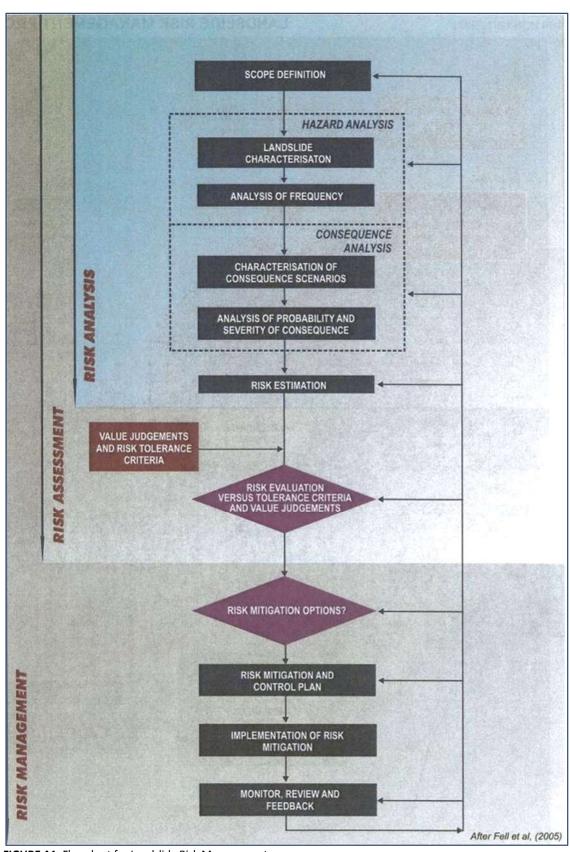
FIGURE A1: Flowchart for Landslide Risk Management.

This figure is an extract from GUIDELINE FOR LANDSLIDE SUSCEPTIBILITY, HAZARD AND RISK ZONING FOR LAND USE PLANNING, as presented in Australian Geomechanics Vol 42, No 1, March 2007, which discusses the matter more fully.
