RGS32154.1- AC

**RE: Proposed Heartwood Community Residential Development
Lot 456 DP755557, Bellingen
Preliminary Desktop Study – Site Contamination Assessment (SCA)**

1 INTRODUCTION

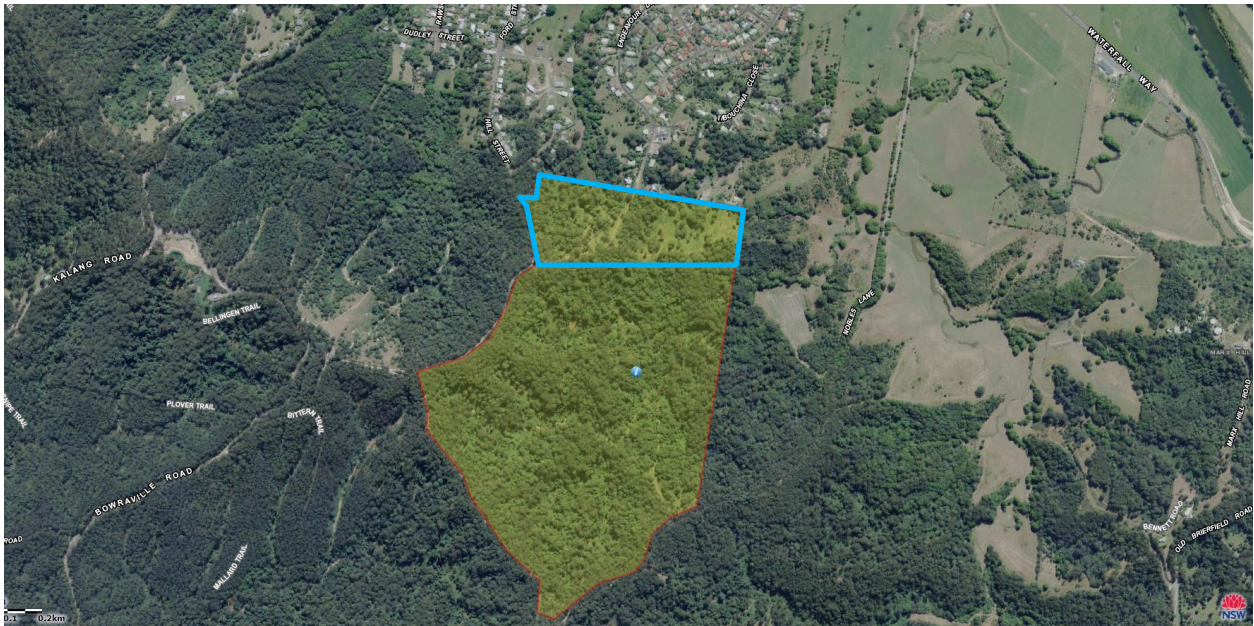
Satellite photograph obtained from the NSW Government 'Six Maps' (dated 2009) that illustrates the site location and setting. The site boundaries are shown by a yellow shaded red box. The approximate extent of the proposed residential development is shown by a blue box.

The site is situated within a region characterised by moderately to steeply sloping terrain. The northern portion of the site where development is proposed is dominated by an east-west trending ridgeline in the south of the development footprint (i.e. blue box above). A north plunging ridgeline spur bisects the development and grades down towards Endeavour Drive.

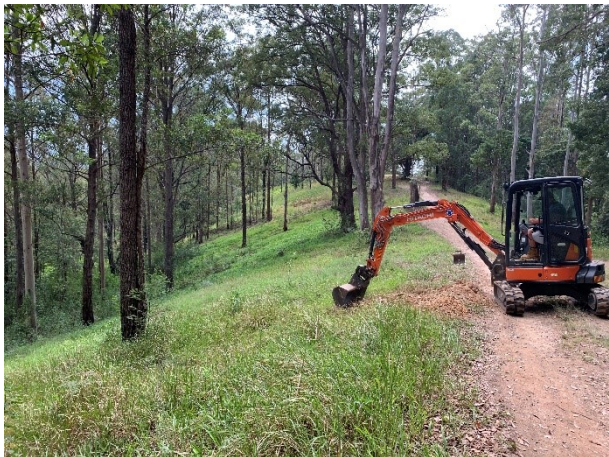
Looking south on grade dirt track from near the existing end of Endeavor Drive.

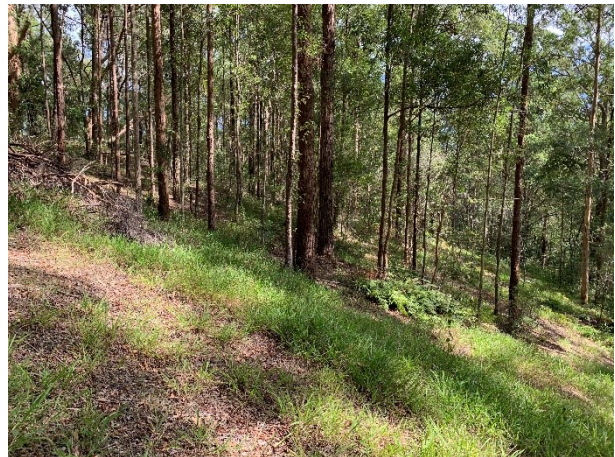
Looking west across the northern face of the east-west trending ridgeline towards sparse vegetation

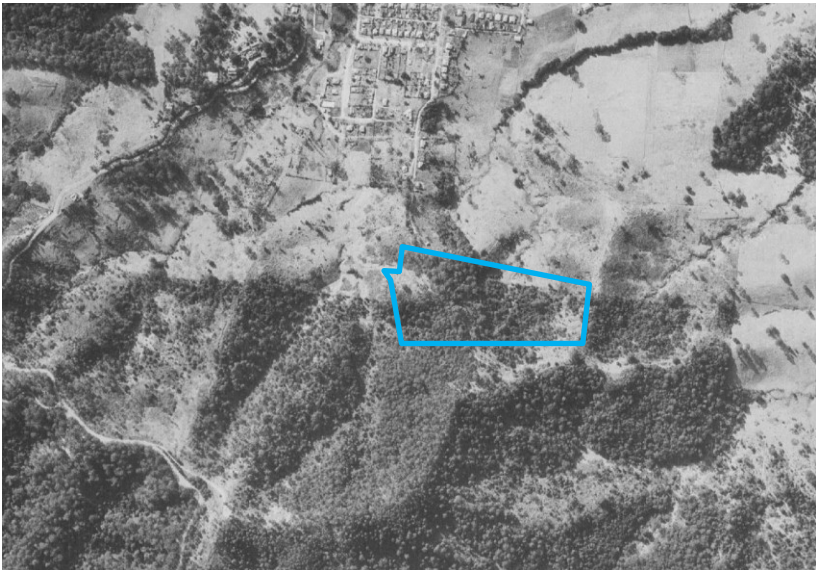
Photograph (Source)	Photograph Extract	Observations of Site Conditions	Observations of Surrounding Areas
1964

Site is undeveloped. Dense vegetation with some cleared areas	Prior to the construction of Endeavour Drive, surrounding area is vacant.

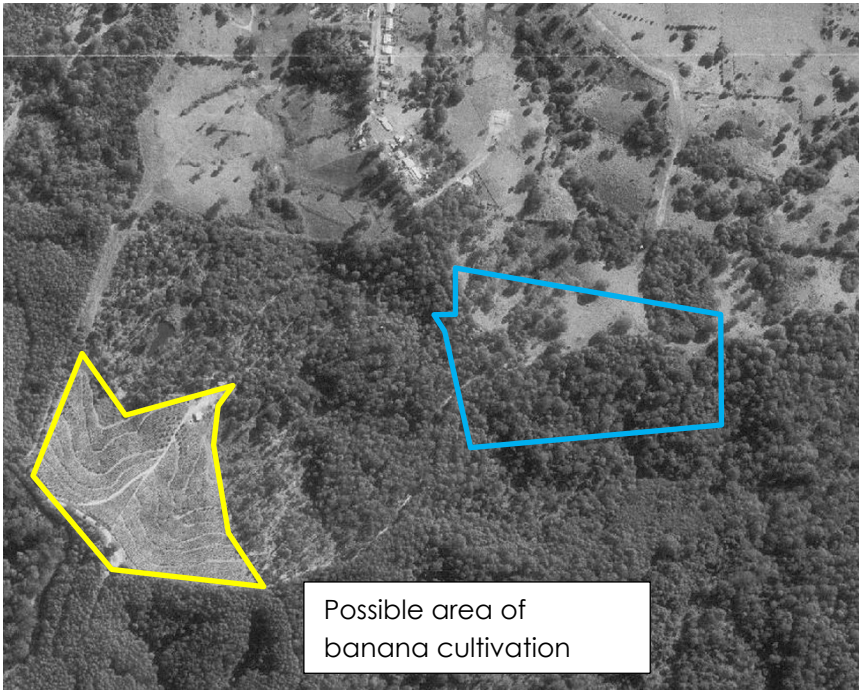
1984

<p>Possible area of banana cultivation</p>	Some changes to vegetation.	<p>Early construction of Endeavour Drive. Farming land cleared to the west, likely banana cultivation. Several buildings on northern portion of cleared land Possible packing sheds?).</p>
------	---	-----------------------------	--

Based on the land title search a portion of the original lot has been used for banana cultivation, this was prior to the development of Lot 456 DP 755557. Cross referencing with the historical photographs this portion is to the west of the western boundary of Lot 456 DP 755557. It appears there was an access road from the farming area that cuts through Lot 456 DP 755557, however, there is no evidence to suggest the site was ever occupied by packing sheds or used for any other farming operations.

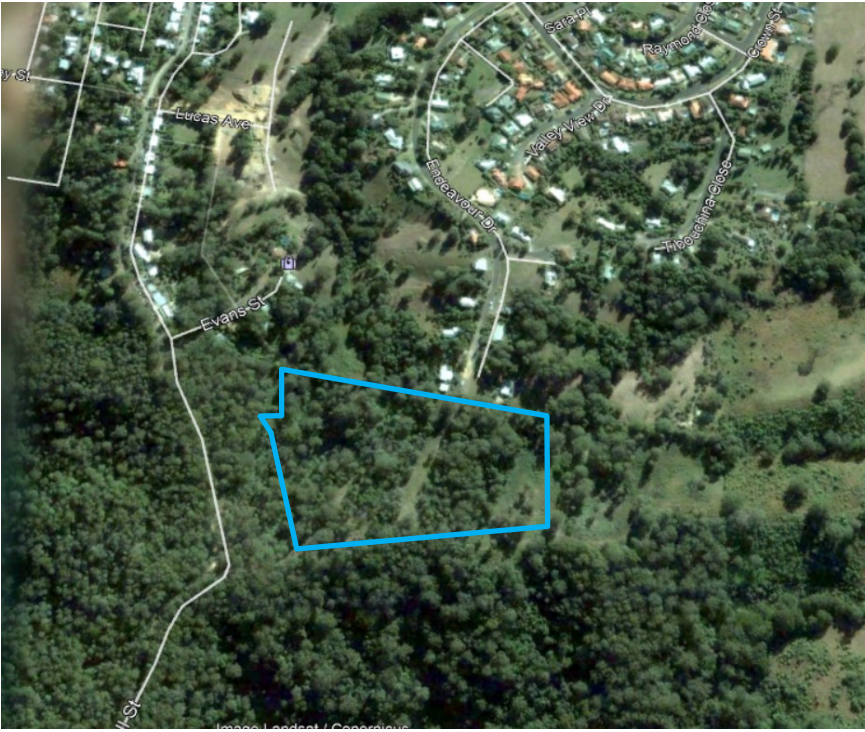
<p>2004 (Google Earth)</p>

<p>Similar to previous, some minor clearing.</p>	<p>Further development of Endeavour Drive subdivision. Farming area to west of site overgrown.</p>
------------------------------------	--	--	--
