Stage 1 Preliminary Site Investigation

48 CAMPBELL STREET, GERRINGONG, NSW 2534

Prepared for Allen Price & Scarratts Pty Ltd

Ref: 10791.EV.P.234-R01R1

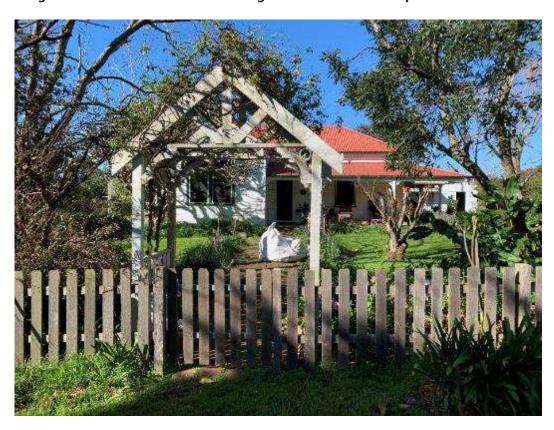
Image 6.2.1 View of residential dwelling located in the central portion of the site looking south

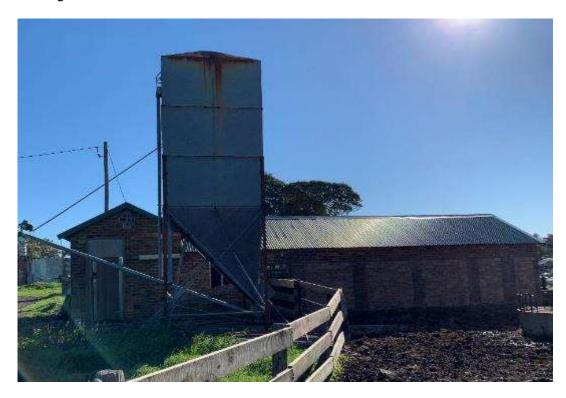
Image 6.2.2 View of historical dairy farm building and feed silo located in the central portion of the site looking north

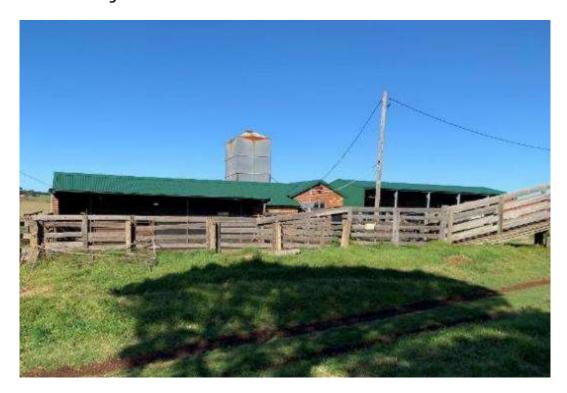
Image 6.2.3 Second view of historical dairy farm building and feed silo located in the central portion of the site looking south

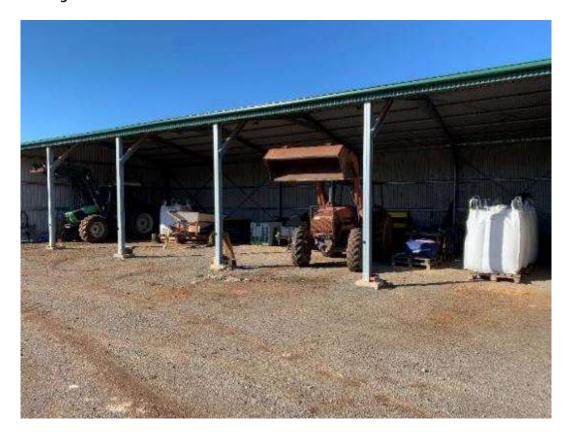
Image 6.2.4 View of machinery shed and stored plant materials located in the central portion of the site looking southeast

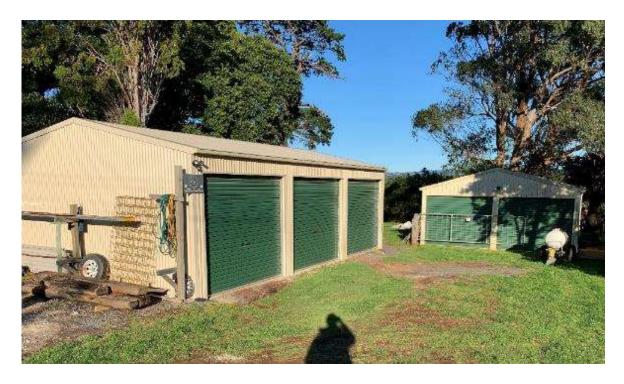
Image 6.2.5 View of two single storey metal clad sheds located in the central portion of the site looking west

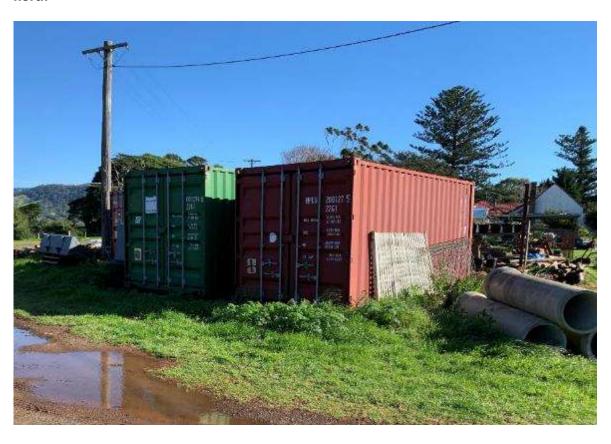
- Nine metal storage containers were observed within the central portion of the site, to the south and south east of the central east dwelling;
- One plastic rainwater tank was observed within the central portion of the site, to the south east of the central east dwelling;

Image 6.2.6 View of metal storage containers observed within the central portion of the site looking north

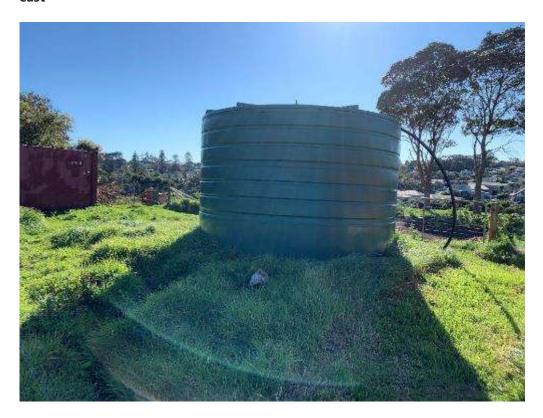
Image 6.2.7 View of plastic rainwater tank observed within the central portion of the site looking north east

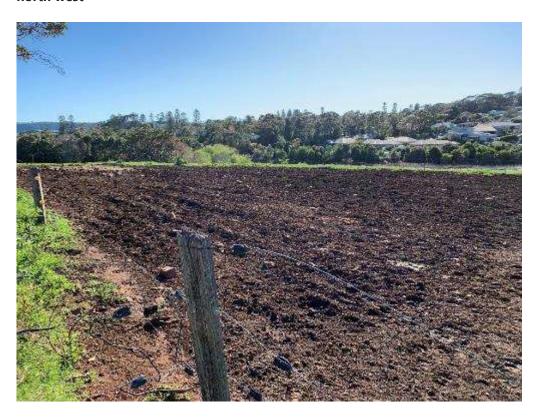
Image 6.2.8 View of livestock impacted soils observed within the eastern portion of the site looking north west

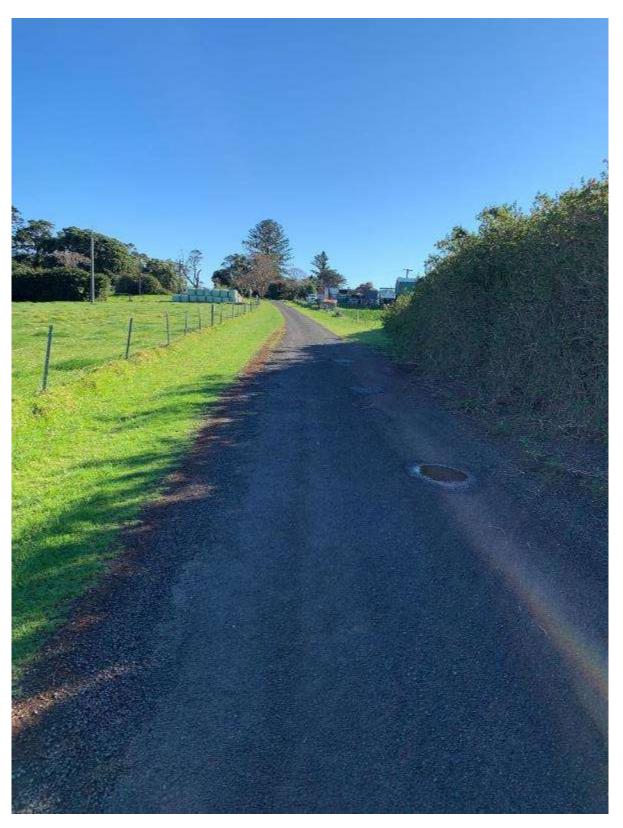
Image 6.2.9 View of asphalt roadway observed within the central portion of the site looking north

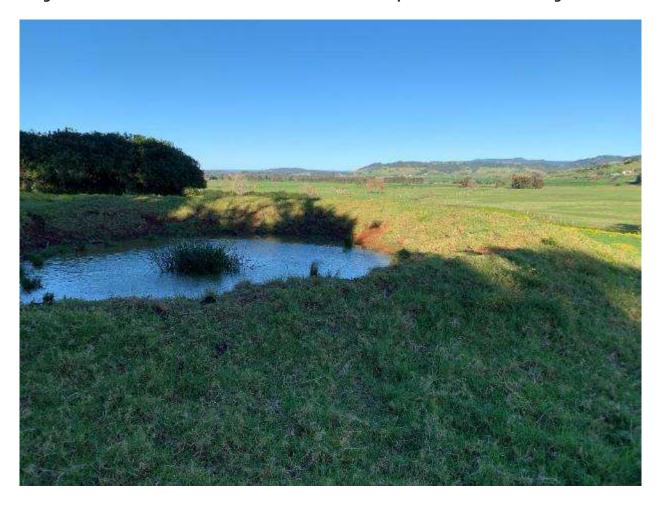
There was one dam observed on site, located in the north western portion of the site. The dam appeared to be fed by rainwater. There was no algae, sheen, odour or staining observed within the dam water located on the site.

Image 04.1 View of dam observed within the north-western portion of the site looking south west

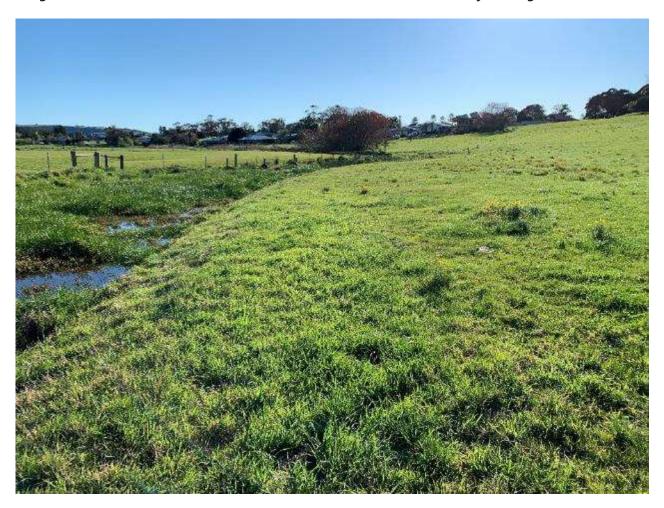
There were intermittent creek lines observed to run in a general north-south direction, located outside the east and west boundaries of the site.

Image 04.2 View of creek line located outside of the western site boundary looking north

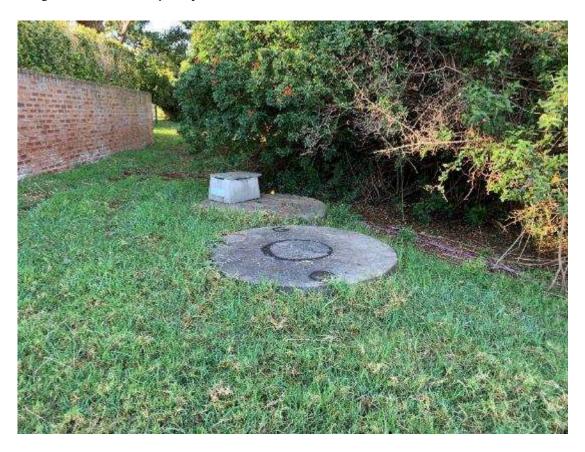
Two septic systems and associated infrastructure were observed adjacent to the western side of the residential dwelling located in the central north portion of the site. A spray area from the observed septic system was not determined

Image 6.8.1 View of septic systems observed on the site

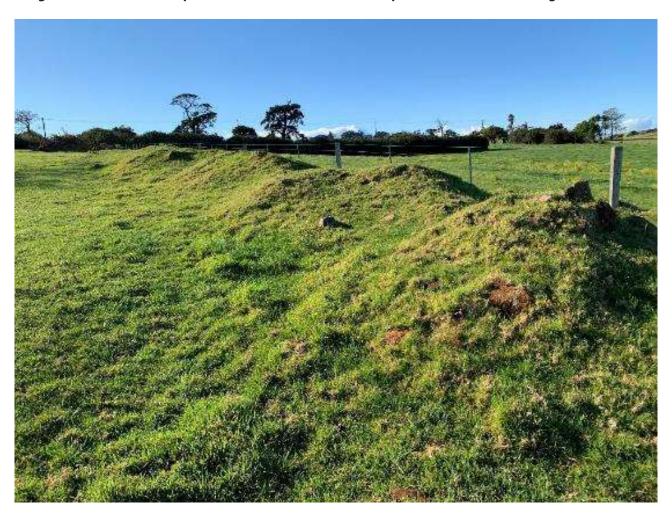
Image 6.89.1 View of stockpile 1 located within the western portion of the site looking south east

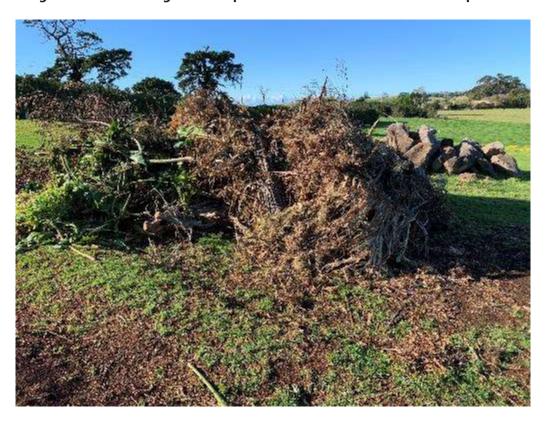
Image 6.89.2 View of organic stockpile 2 was located within the western portion of the site looking east

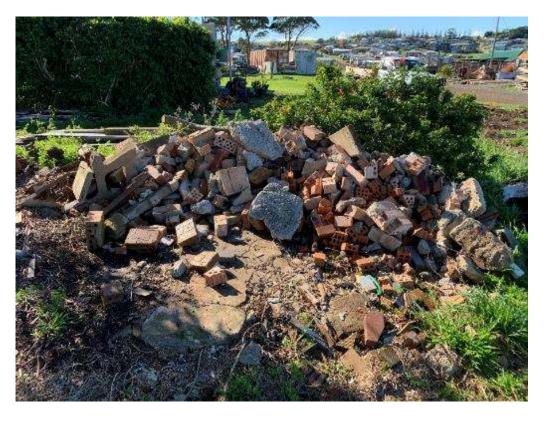
Image 6.89.3 View of building waste (brick/concrete) stockpile 5 located within the central east portion of the site looking east

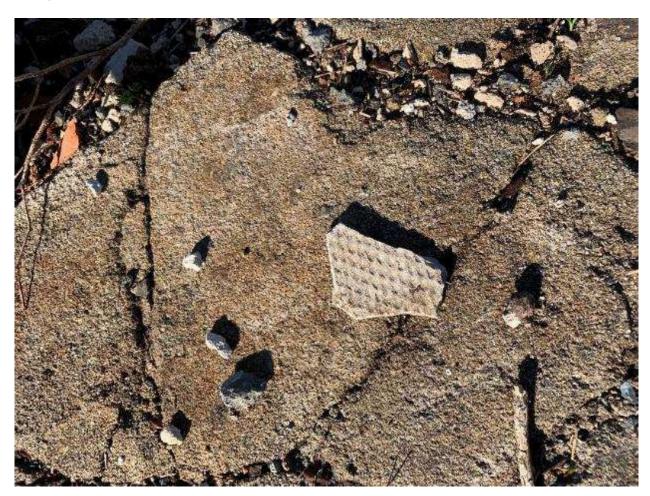
There was visual evidence observed during the walkover, of potential asbestos containing materials within the building waste (brick/concrete) stockpile 5, located within the central portion of the site.

Image 6.10.1 View of fibrous cement fragment observed within building waste (brick/concrete) stockpile 5

A hazardous building materials survey was not within the scope of this project.

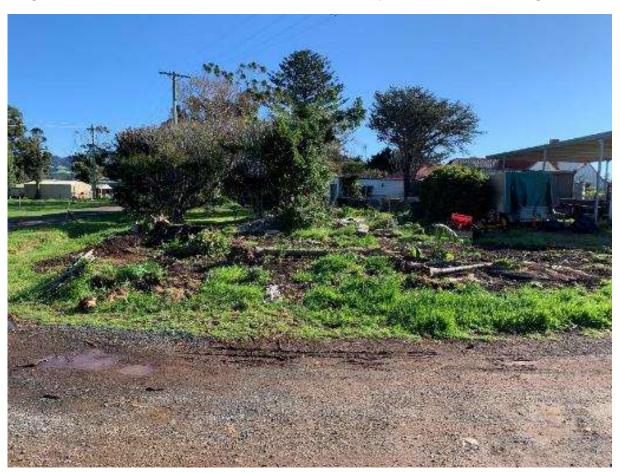
Image 6.811.1 View of Fill area 3 located within the central portion of the site looking north

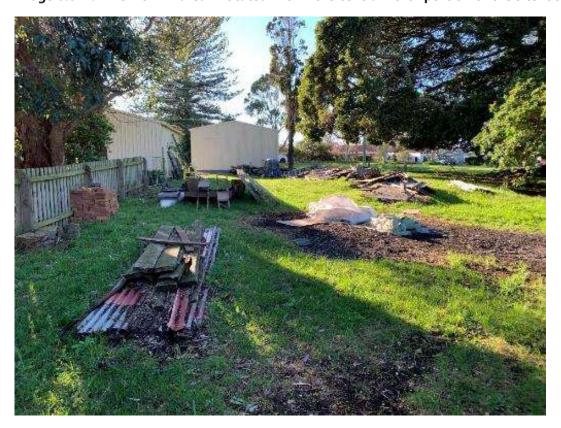
Image 6.811.2 View of Fill area 1 located within the central north portion of the site looking east

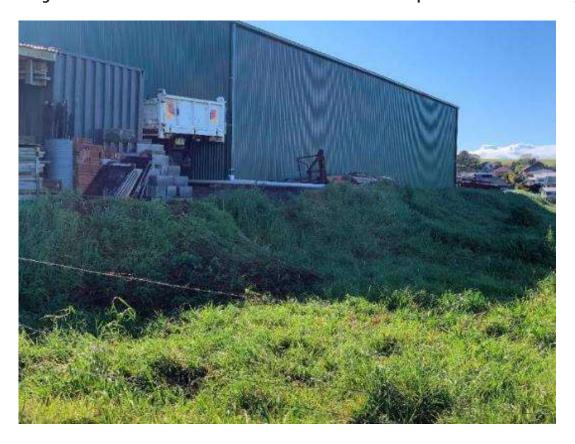
Image 6.211.3 View of fill area 6 located within the central east portion of the site looking west

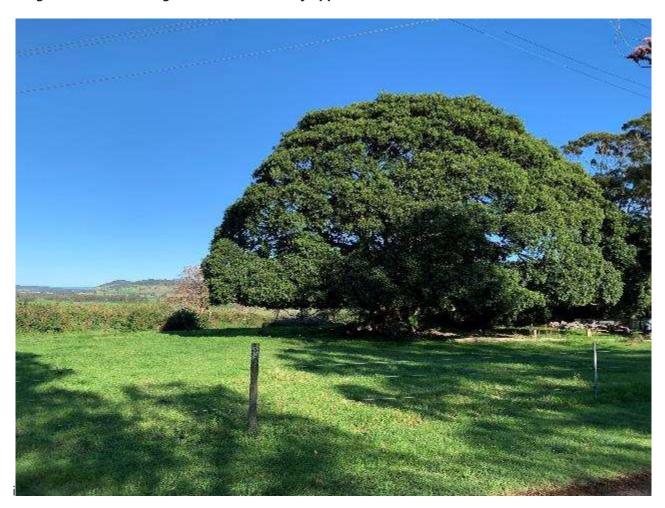
There was no visual evidence observed to suggest widespread or significant phytotoxic impact in the form of plant stress and/or dieback in vegetation present on the site. Similar observations were made of vegetation on land immediately beyond the site boundaries.

Image 6.12.1 View of vegetation with a healthy appearance onsite

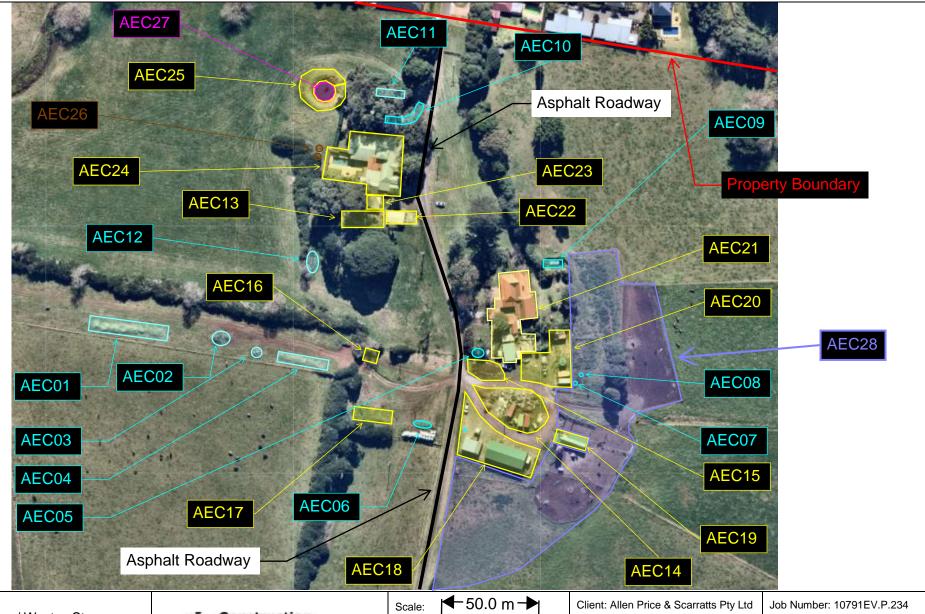
Drawing No: Figure 2	Sheet: Site Layout
Drawn By: NW	Location: 48 Campbell Street, Gerringong, NSW, 2534
Date: 03 September 2021	Project: Stage 1 Preliminary Site Investigation
Scale: 0m 50m 100m	Client: Allen Price & Scarratts Pty Ltd

The general layout of the site is present in Figure 2. The layout plan also includes locations on site of:
