**Preliminary Contaminated Site Investigation  
For proposed Rezoning at  
Lot 4 DP635505,  
150 Lismore Rd,  
BANGALOW, NSW 2479**

Report Number: 642 Version 1

**Date: 21<sup>st</sup> May 2021**

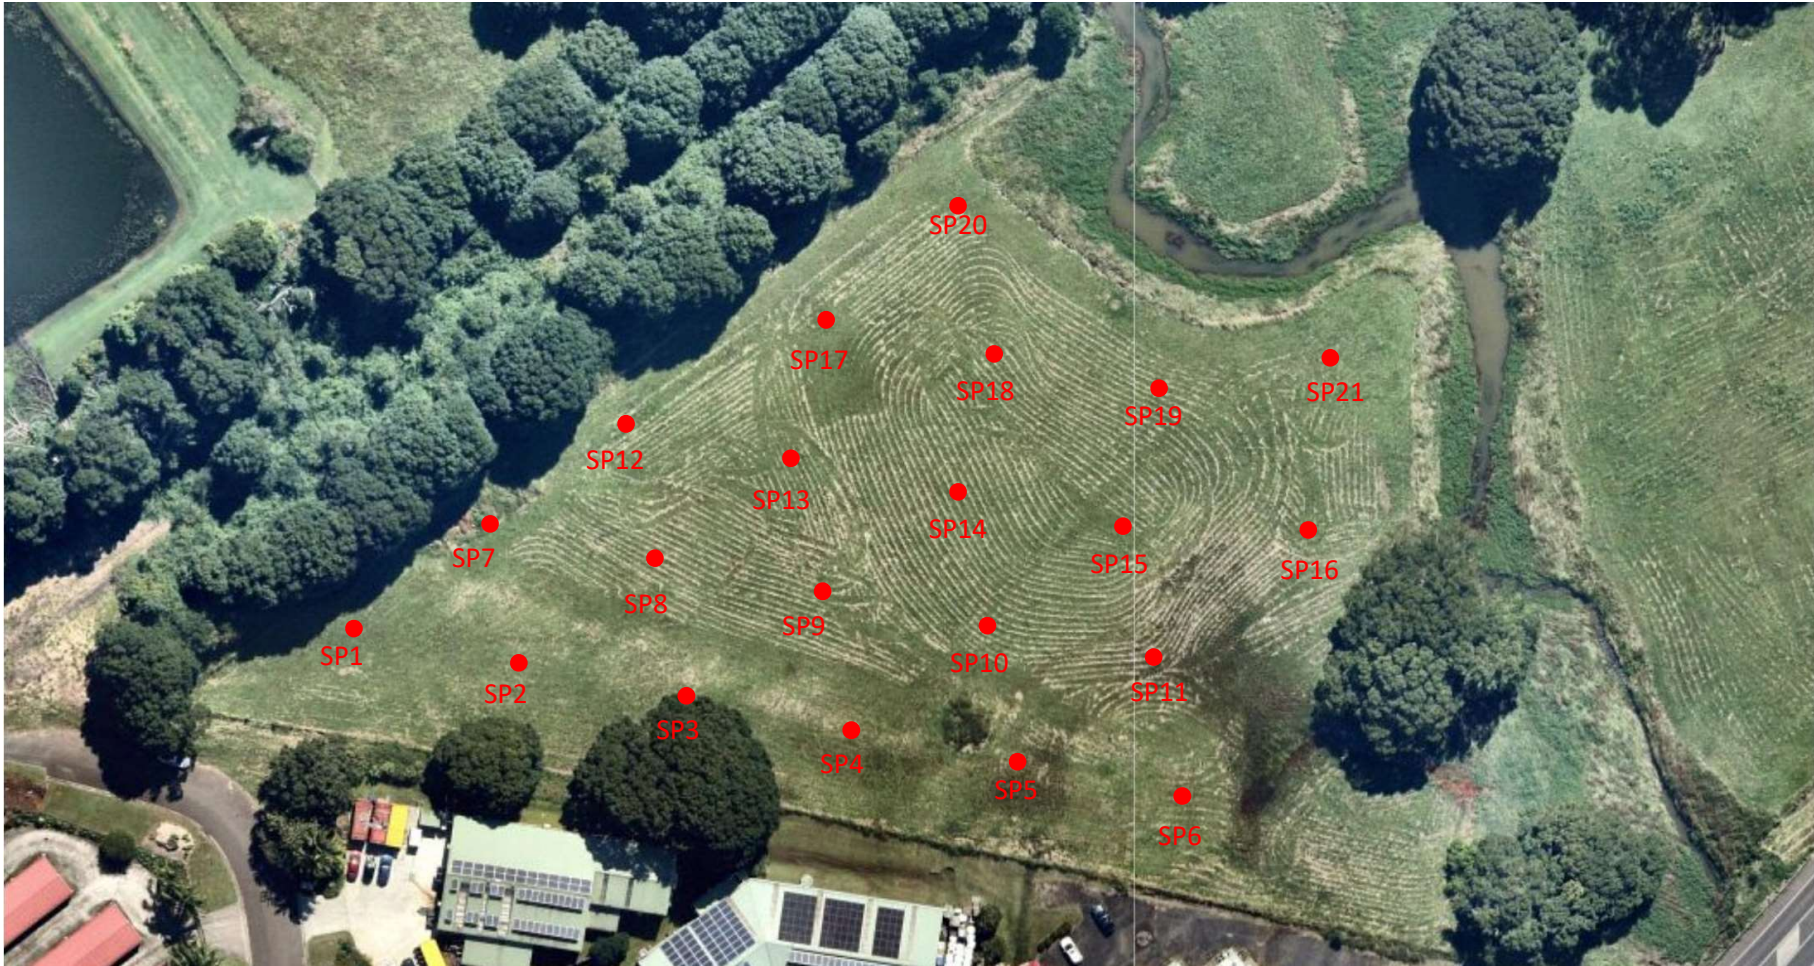
Surface samples (0–150mm depth) were collected using a stainless-steel spade, with soil being placed in snap lock plastic sample bags. The sampling procedure utilised in this investigation was in accordance with AS 4482.1 – 2005.

Figure 4. Sampling Plan.

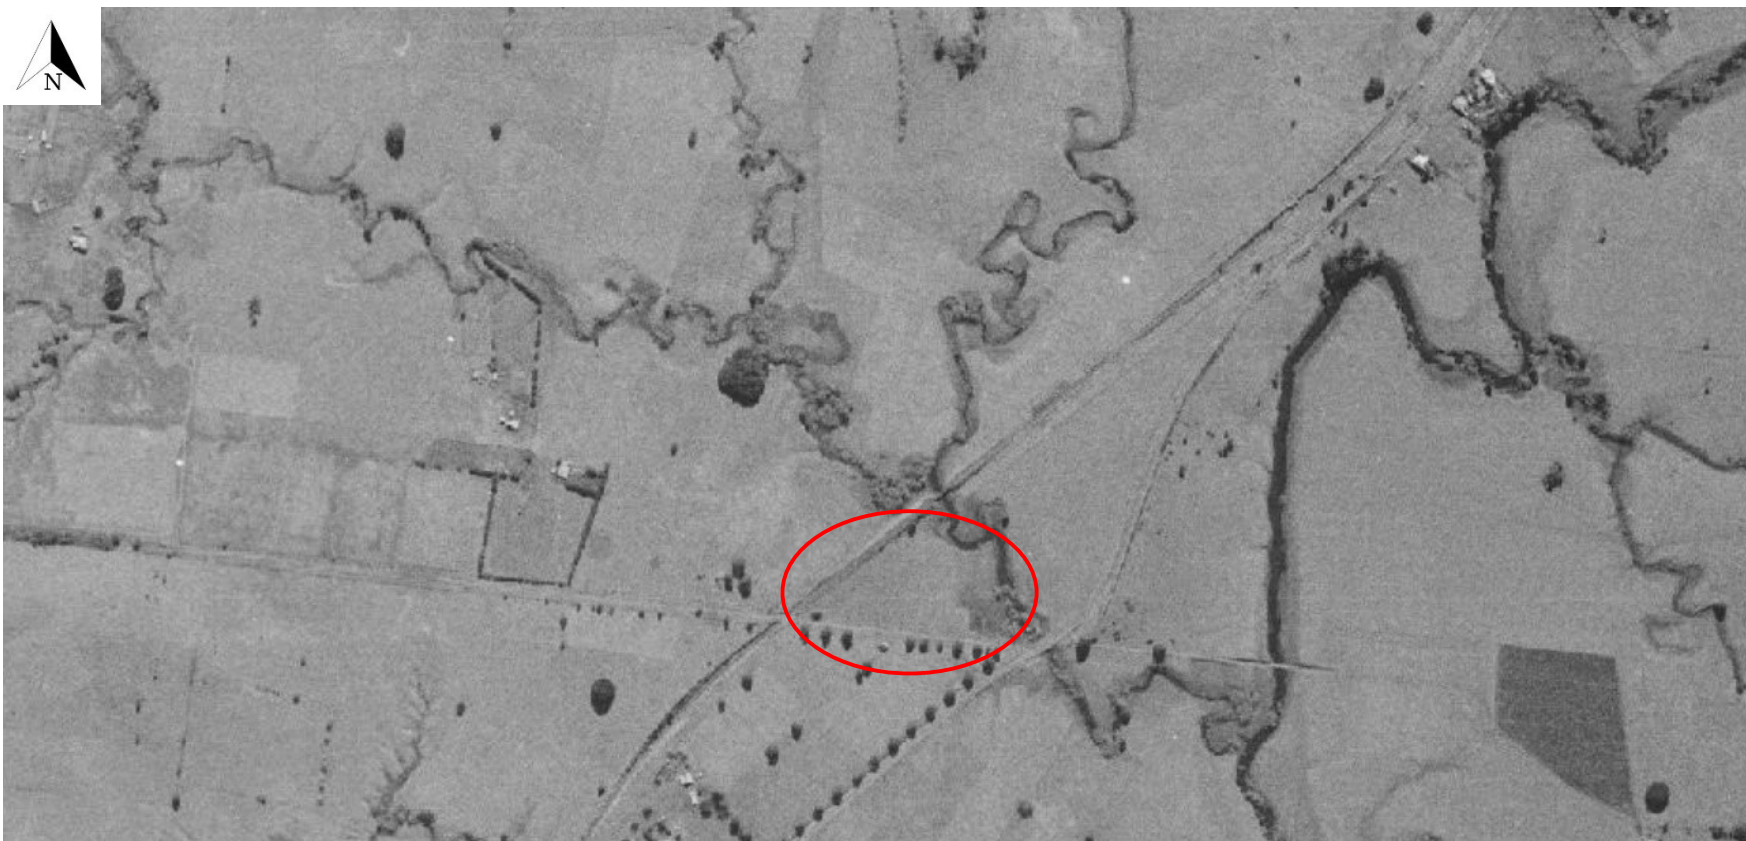
In the 1958 image, no structures are visible on the property. Similarly, no evidence of intensive Agriculture such as cropping is evident. Surrounding lands appear similar indicating broadscale grazing is likely on the site and surrounds. This site is relatively devoid of treed vegetation. No intensive Agricultural pursuits are evident. The site is presumed to have been once part of a larger holding. A review of available parish maps from 1917 and 1969 indicate the possibility of a larger allotment that extended to the north and east and west (i.e. nearly to outskirts of Bangalow and both beyond the railway to the west and Lismore Rd to the east). It is noted Dudgeons Lane formed the southern boundary of the site in 1958.

**Figure A1.** 1958 Historical Aerial of Investigation Area and surrounding area of site. Approximate location of Investigation Area is circled.

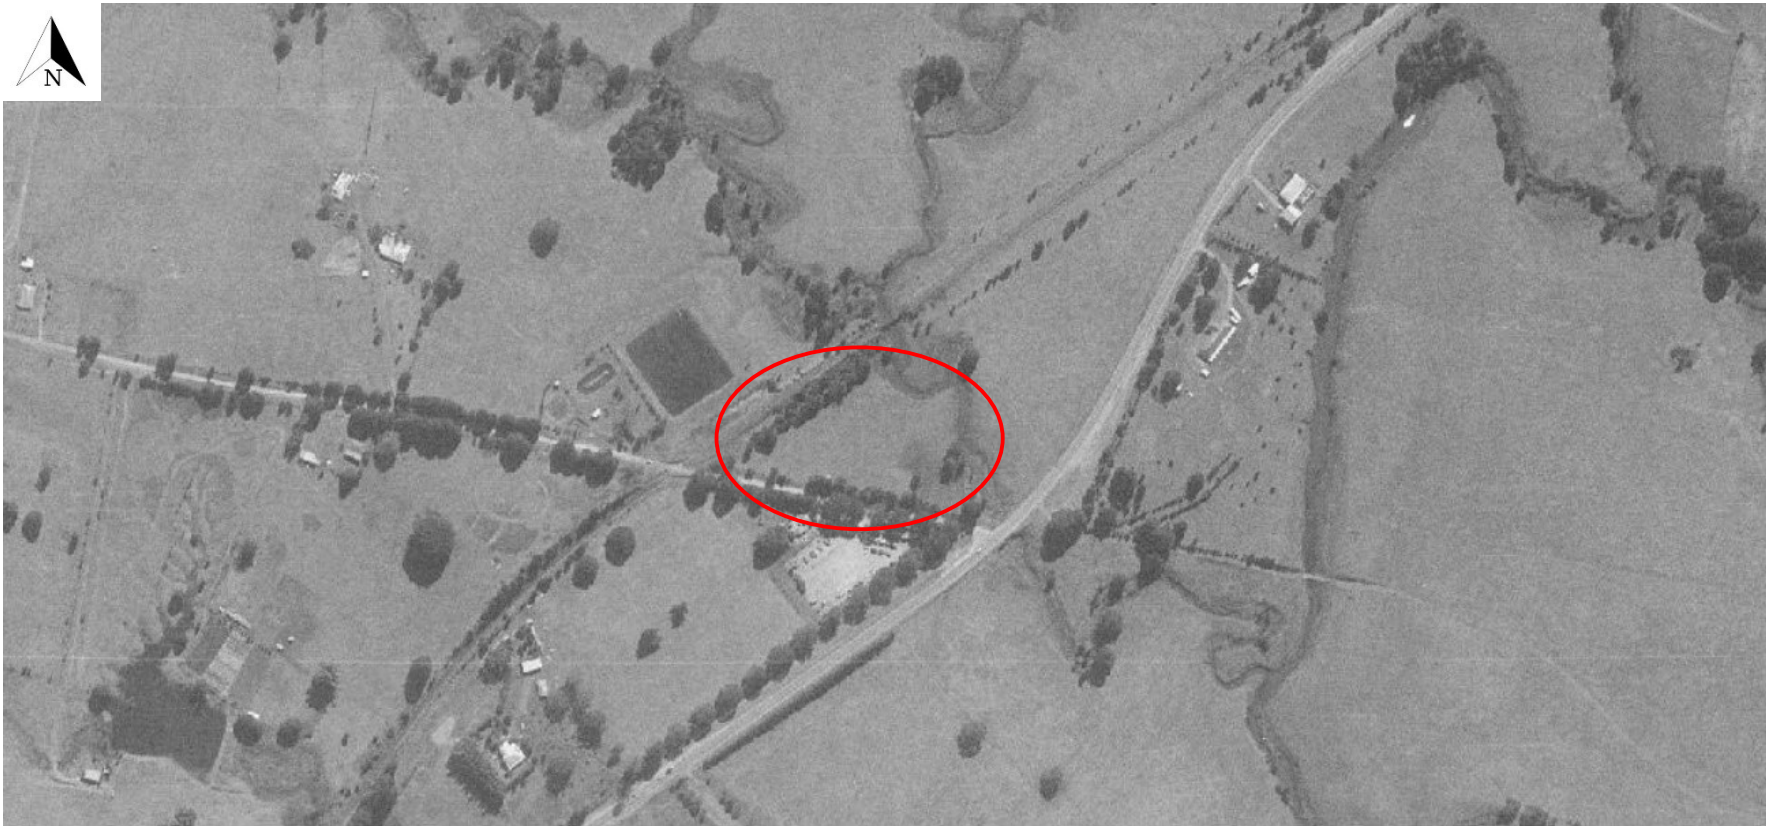
Industrial landuses to the south of the site are apparent in the 1987 image with these increasing in subsequent aerial imagery. Grazing is still apparent on the site. No dwellings or any other structures are visible. Tree growth is still considered low.

**Figure A3.** 1987 Historical Aerial of Investigation Area and surrounding area of site. Approximate location of Investigation Area is circled.

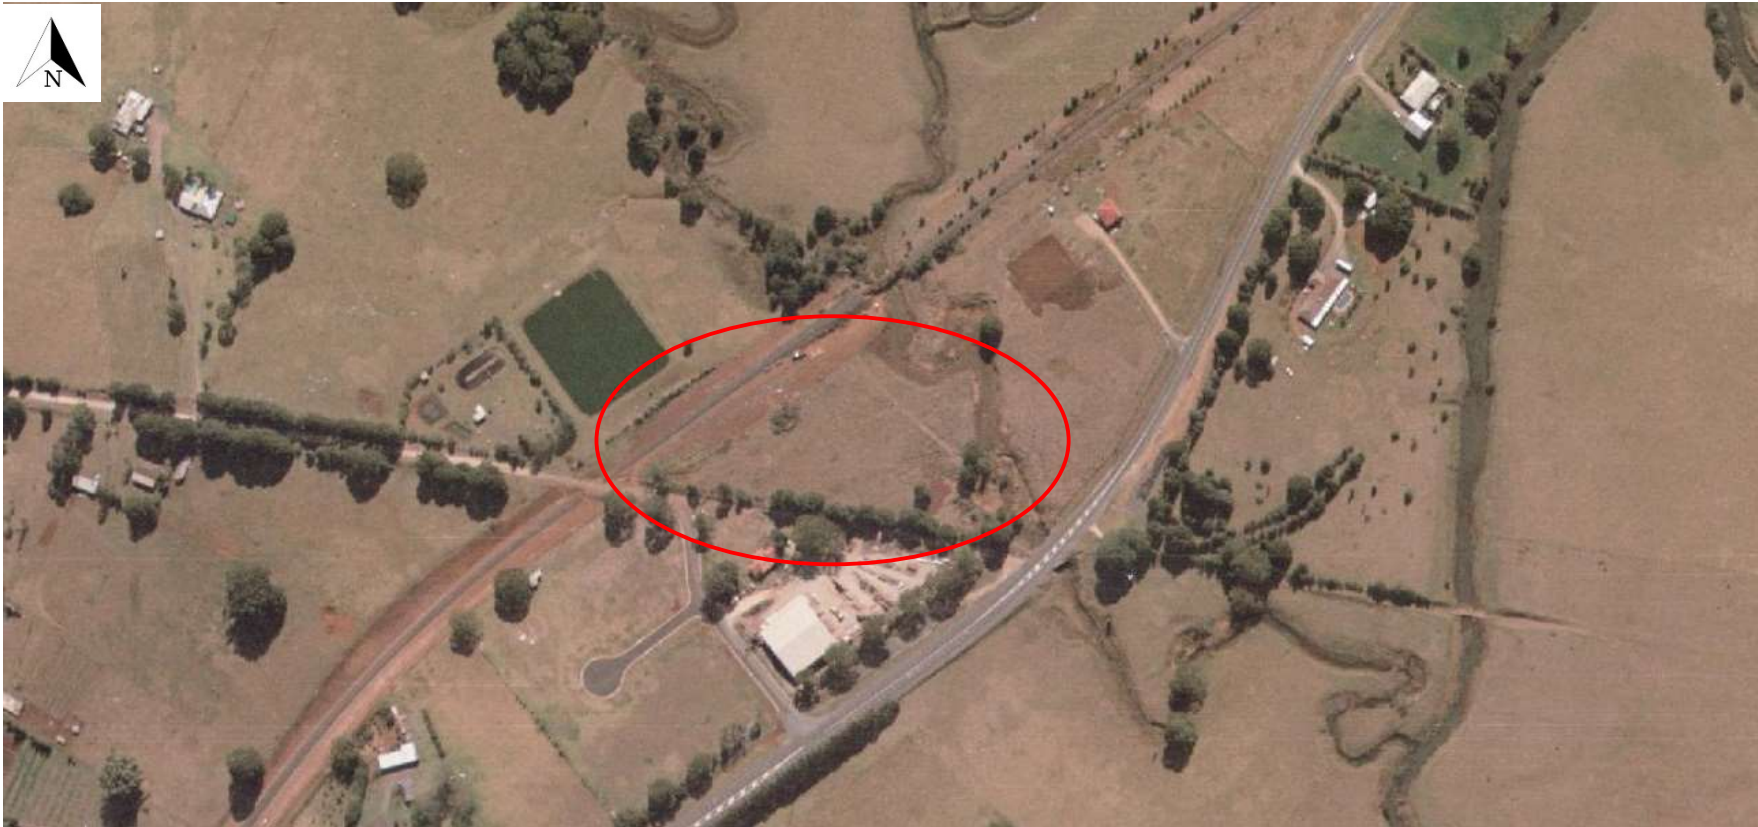
The current dwelling can be seen on imagery from 1991. This dwelling is located in the northern section of the site and well outside the bounds of the current Investigation Area.

**Figure A4.** 1991 Historical Aerial of Investigation Area and surrounding area of site. Approximate location of Investigation Area is circled.

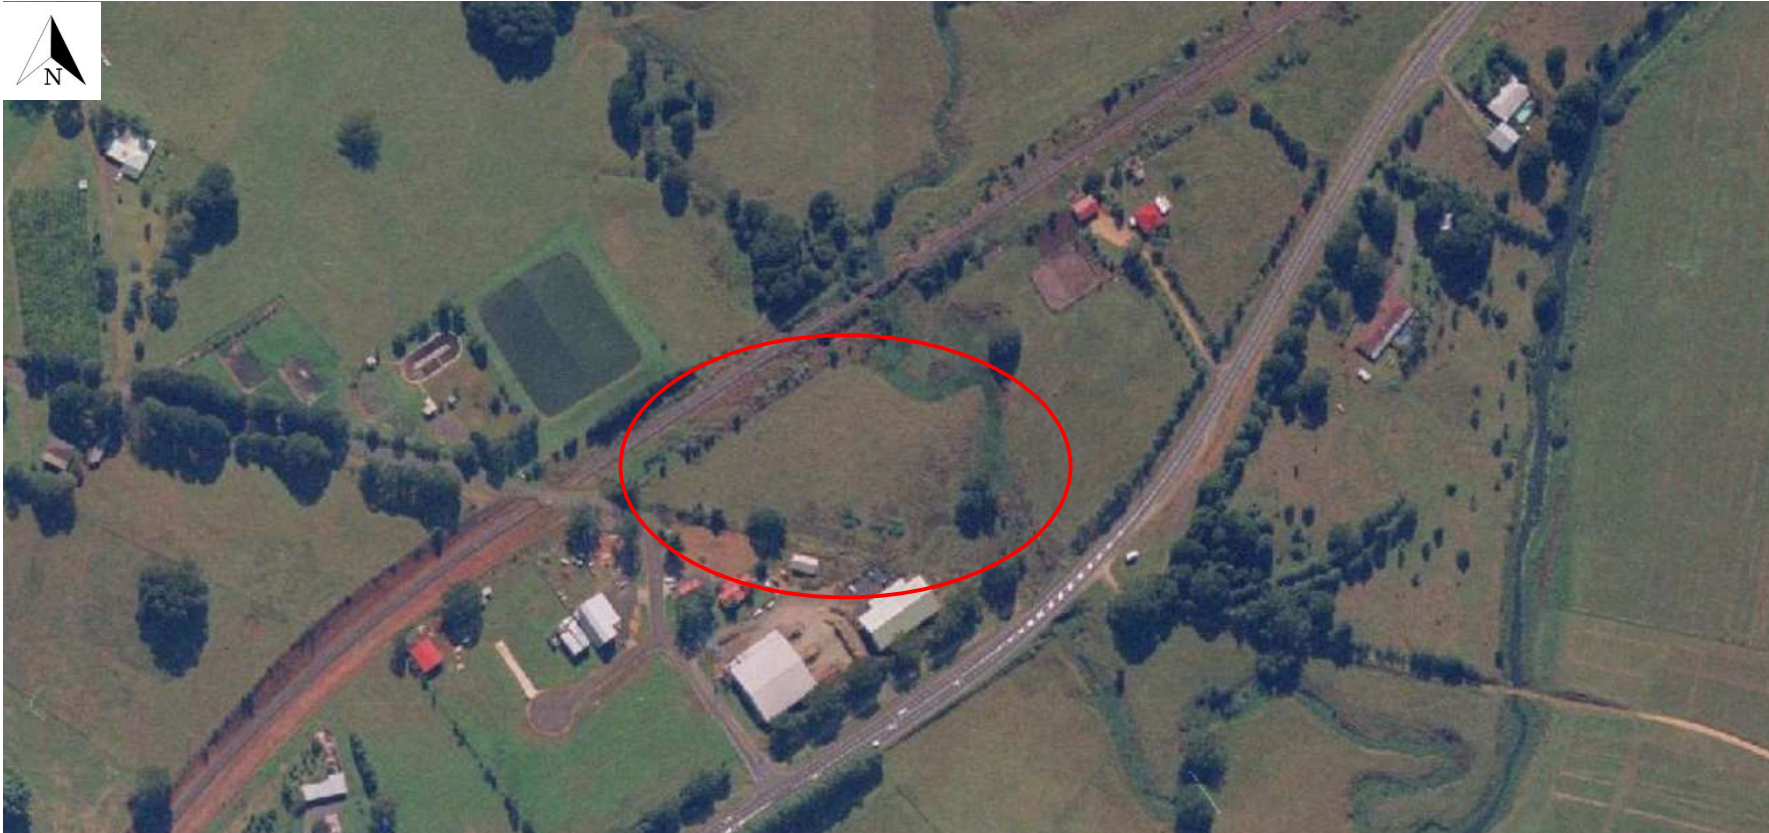
Imagery from 1997 (to date) continues to show a site that is relatively devoid of trees, a single dwelling and no intensive Agricultural practices such as cropping.

This same imagery (i.e. 1997 to date) show the Industrial estate expansion. Dudgeons Lane is rerouted in the 1997 image. Increases in residential dwellings in the locality is apparent, especially with the expansion of Bangalow.

**Figure A5.** 1997 Historical Aerial of Investigation Area and surrounding area of site. Approximate location of Investigation Area is circled.

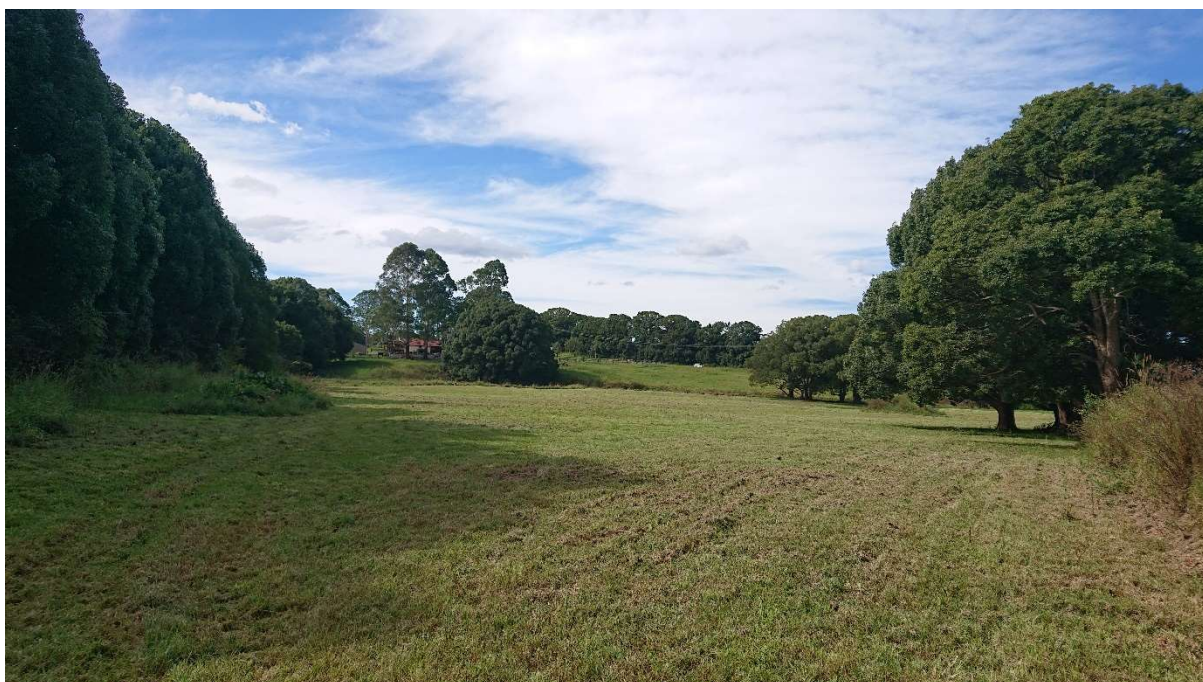
**Plate A1.** General view Investigation Area (Photograph taken at entrance from Dudgeons Lane)

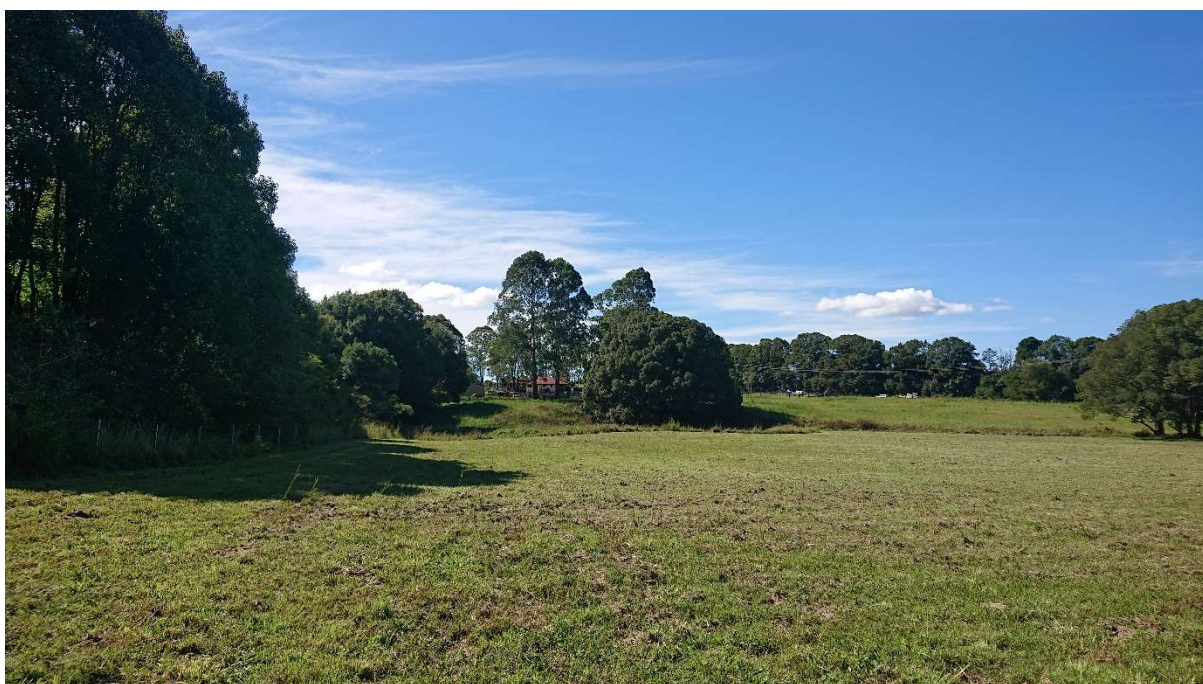
**Plate A2.** General north-easterly view of Investigation Area (Photography taken near SP7).

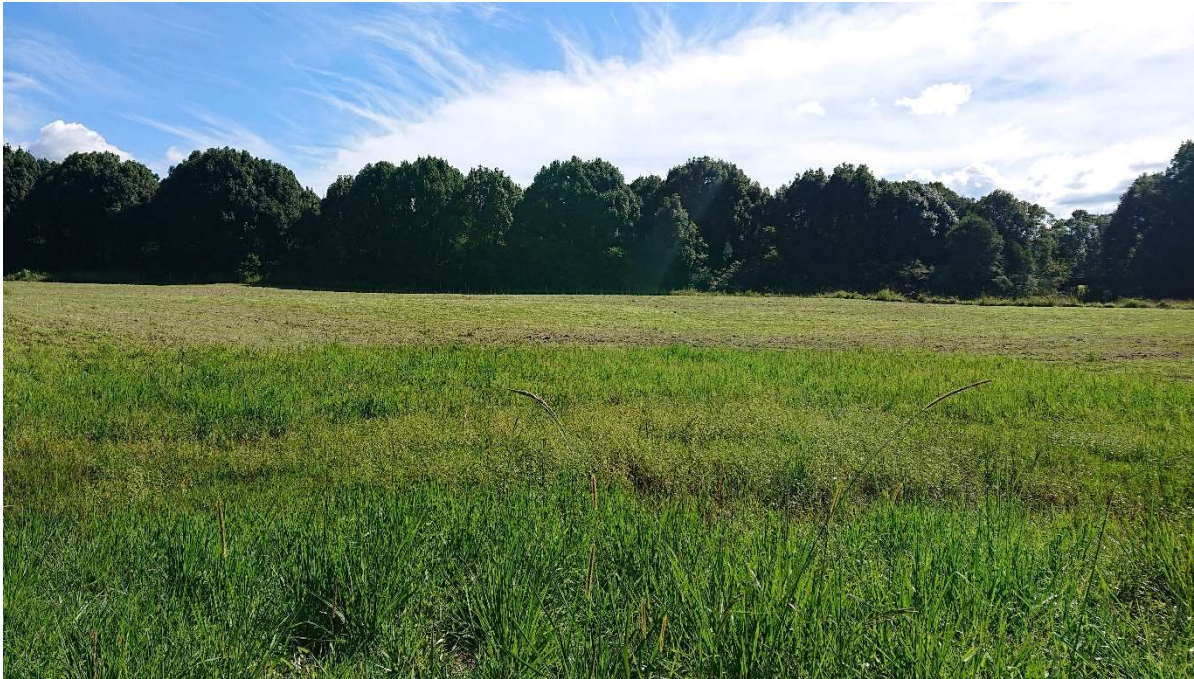
**Plate A3.** General westerly view of Investigation Area (Photograph taken near SP6)

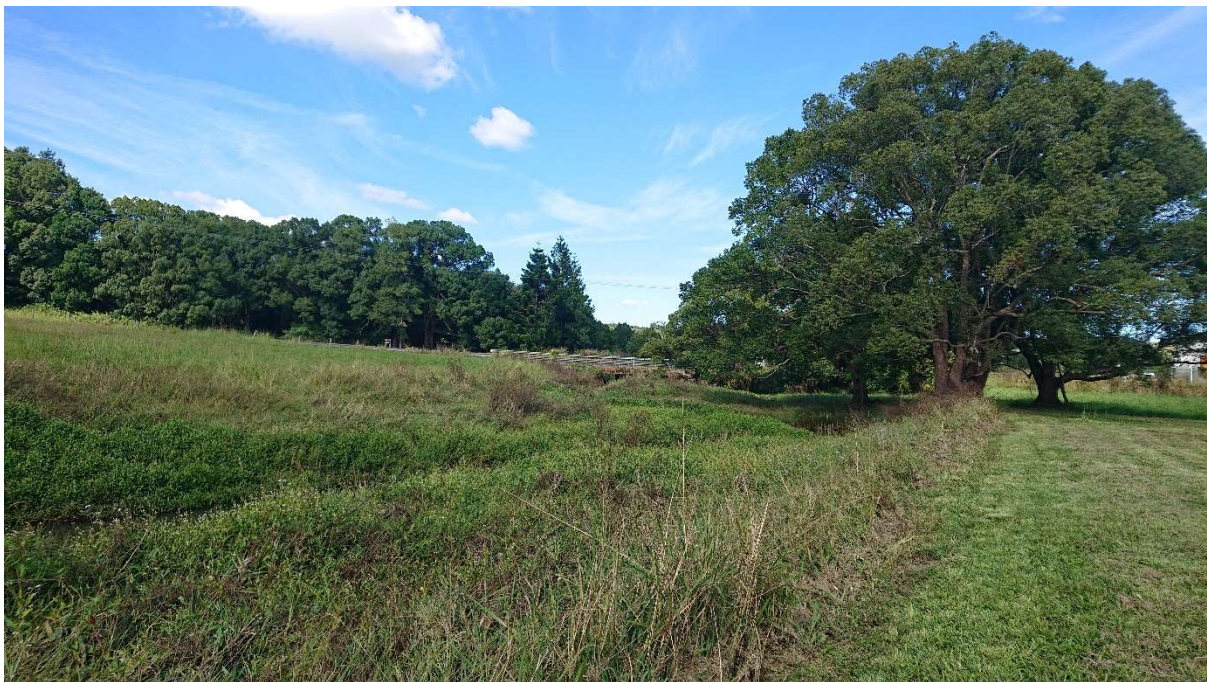
**Plate A4.** General view of Maori Creek (Photograph taken near SP21 with southerly view).
