DETAILED SITE INVESTIGATION (DSI)

Liberty Service Station – Inverell, NSW

24-26 Glen Innes Road, Inverell, NSW

ENV Solutions

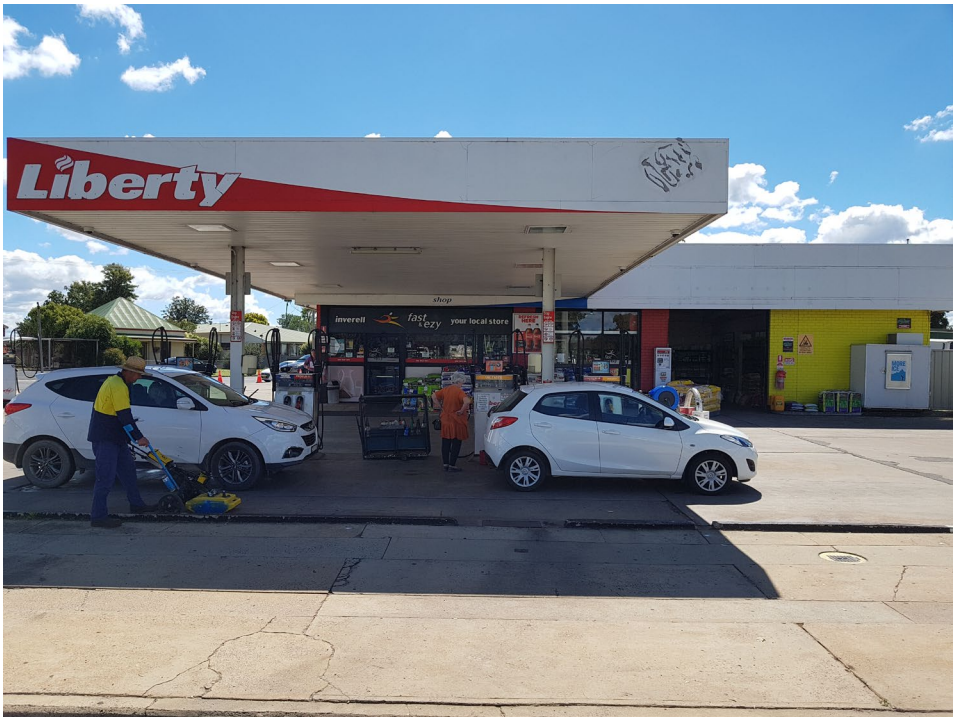
| Photo No. | Date | |
|---|---|---|
| 1 | 29/03/2021 | |

| Photo No. | Date | |
|---|---|---|
| Description Looking north from Glen Innes Road toward the sales building and canopy. Underground service location is occurring in the foreground, using Ground Penetrating Radar (GPR). | | |

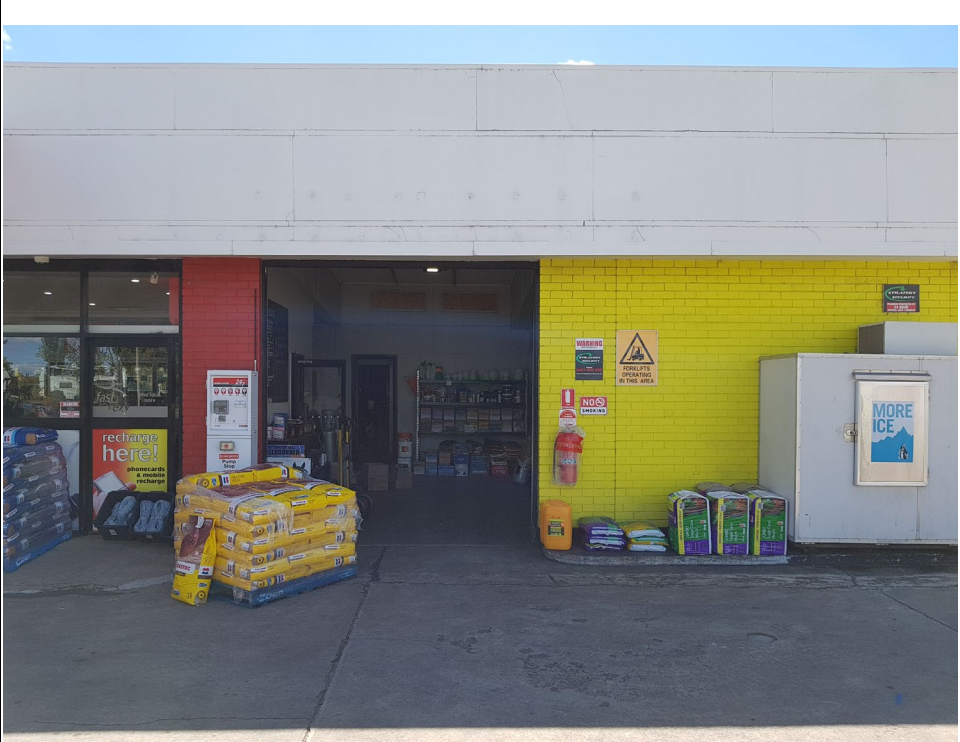
| Photo No. | Date | |
|--|---|---|
| 3 | 29/03/2021 | |

| Photo No. | Date | |
|--|---|---|
| Description Looking north towards the main sales building (eastern portion), where animal produce (fodder) is sold. The area in the foreground is where anecdotal information provided by the site operator suggests an old, abandoned UST may be present. | | |

It should be noted that there is anecdotal information to suggest the presence of an abandoned UST in the eastern site portion, thought to be present in front of (south of) the current produce sales area (east portion of main building) (Garry Campbell, pers. comm., 2021). The possible presence of an abandoned UST in this location should be considered in any future development proposal. Soil results to date suggest that if a tank is present in this area, there are unlikely to be gross soil impacts associated with its presence.

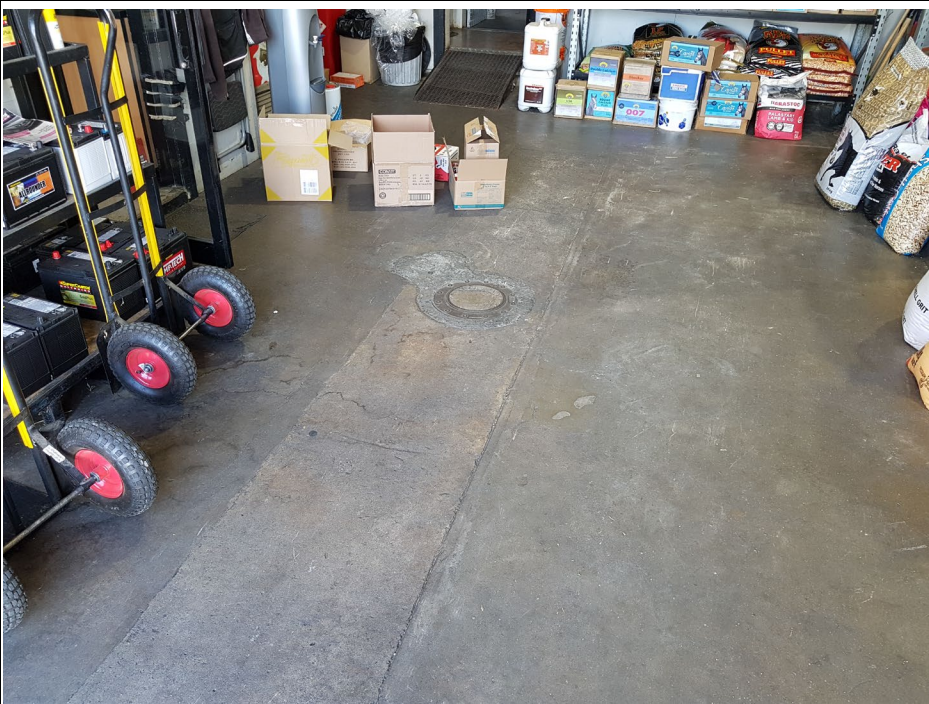
| Photo No. | Date | |
|--|---|--|
| 4 | 29/03/2021 | |

| Photo No. | Date | |
|--|---|--|
| Description Looking into the fodder storage area. Anecdotal information provided by the operator indicates the circle in the centre is associated with an old hydraulic hoist used as part of the former mechanical workshop operations. | | |

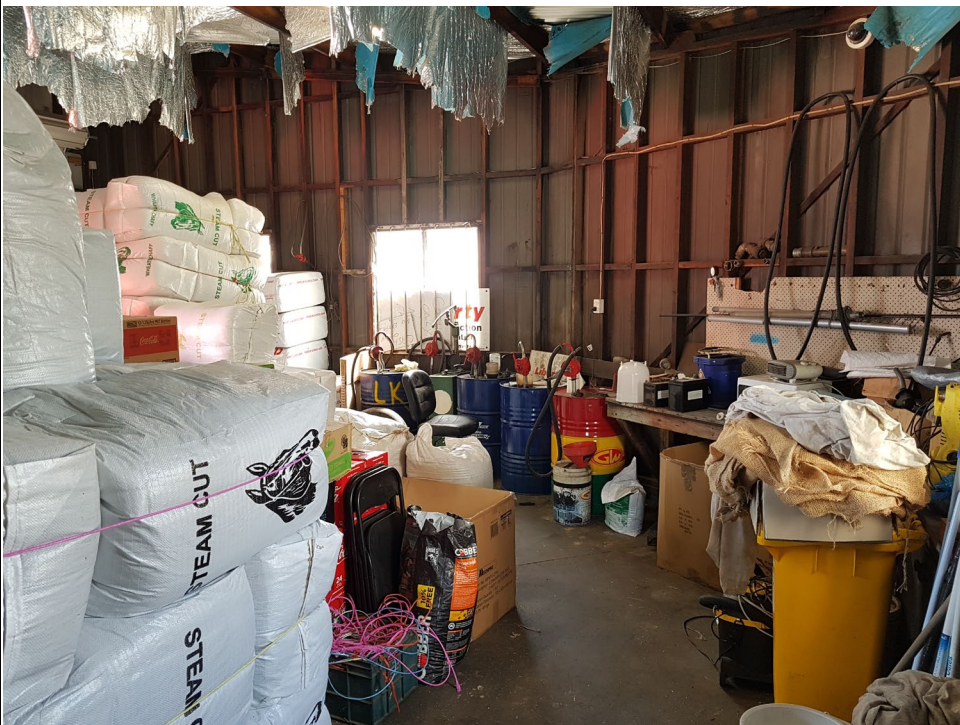
| Photo No. | Date | |
|--|---|---|
| 5 | 29/03/2021 | |

| Photo No. | Date | |
|--|---|---|
| Description Looking into the attached shed at the northern end of the main building. This area was formerly used as a mechanical workshop, and several 200 L drums used to store waste oil were still present in one area. | | |

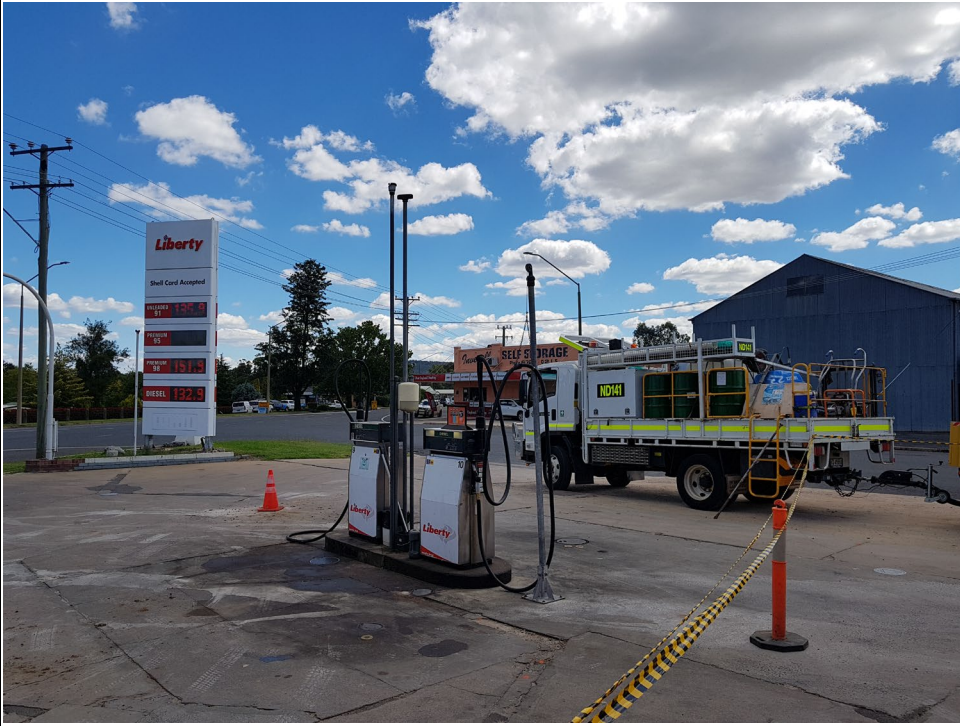
| Photo No. | Date | |
|--|---|---|
| 9 | 30/03/2021 | |

| Photo No. | Date | |
|--|---|---|
| Description Looking south-west towards the 2 x diesel bowsters. Staining from filling activities is visible on the concrete. | | |

Minor hydrocarbon concentrations (less than assessment criteria) were also reported in shallow soils within BH9 and deeper soils within BH8. These boreholes are located adjacent to the diesel dispensing bowsers and USTs. The chemical composition of the hydrocarbon concentrations in this area are indicative of diesel fuel and are likely a result of leaks and spills from the bowsers during refuelling and potentially, leakage from the bowsers, lines and diesel UST(s).

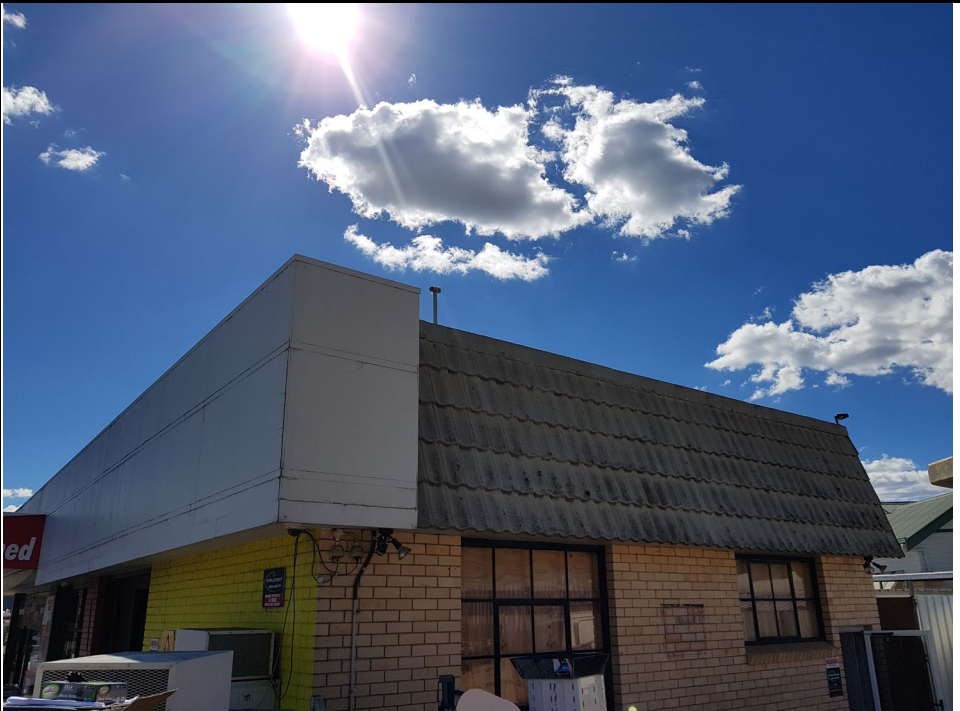
| Photo No. | Date | |
|---|---|--|
| 10 | 29/03/2021 | |

| Photo No. | Date | |
|---|---|--|
| Description Looking north-west at the roof of the main building's eastern portion. An old vent pipe was located on top of the roof, and may be associated with a former UST in this area (refer also to Photo 3). | | |
