Preliminary & Detailed Site Investigation Report

9 Palaran Avenue, North Kellyville NSW 2155
Lot 3 in DP 249675

Project Ref. **P33391.1_R01**

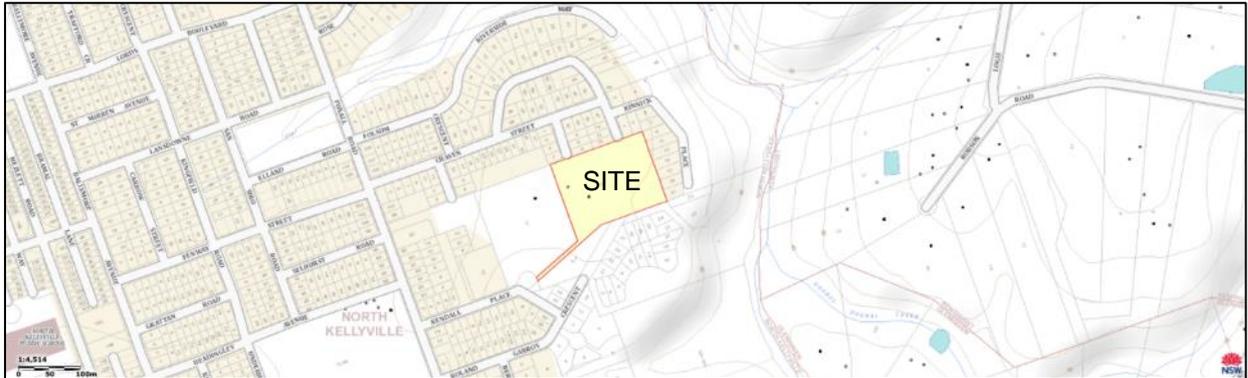
The Site is legally identified to comprise Lot 3 in DP249675, also identified as 9 Palaran Avenue, North Kellyville NSW 2155 (as shown within the insert below) –

Image source: SIXMap accessed 2021, edited by Geotest.

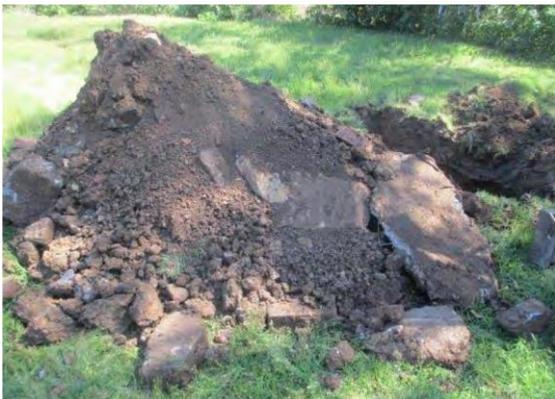
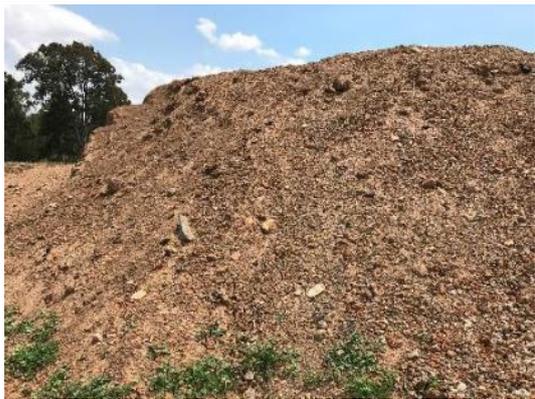
This example (above left) showing a high % concrete rubble which renders these soils aesthetically un-suitable – requiring treatment prior to consideration for re-use.

For the purposes of assessing aesthetic suitability in relation to the visual presence of anthropogenic foreign debris (non-hazardous) in soils, Geotest considered soil material visually estimated to contain $\geq 1\%$ foreign matter to be elevated and warrant management for aesthetic limits.

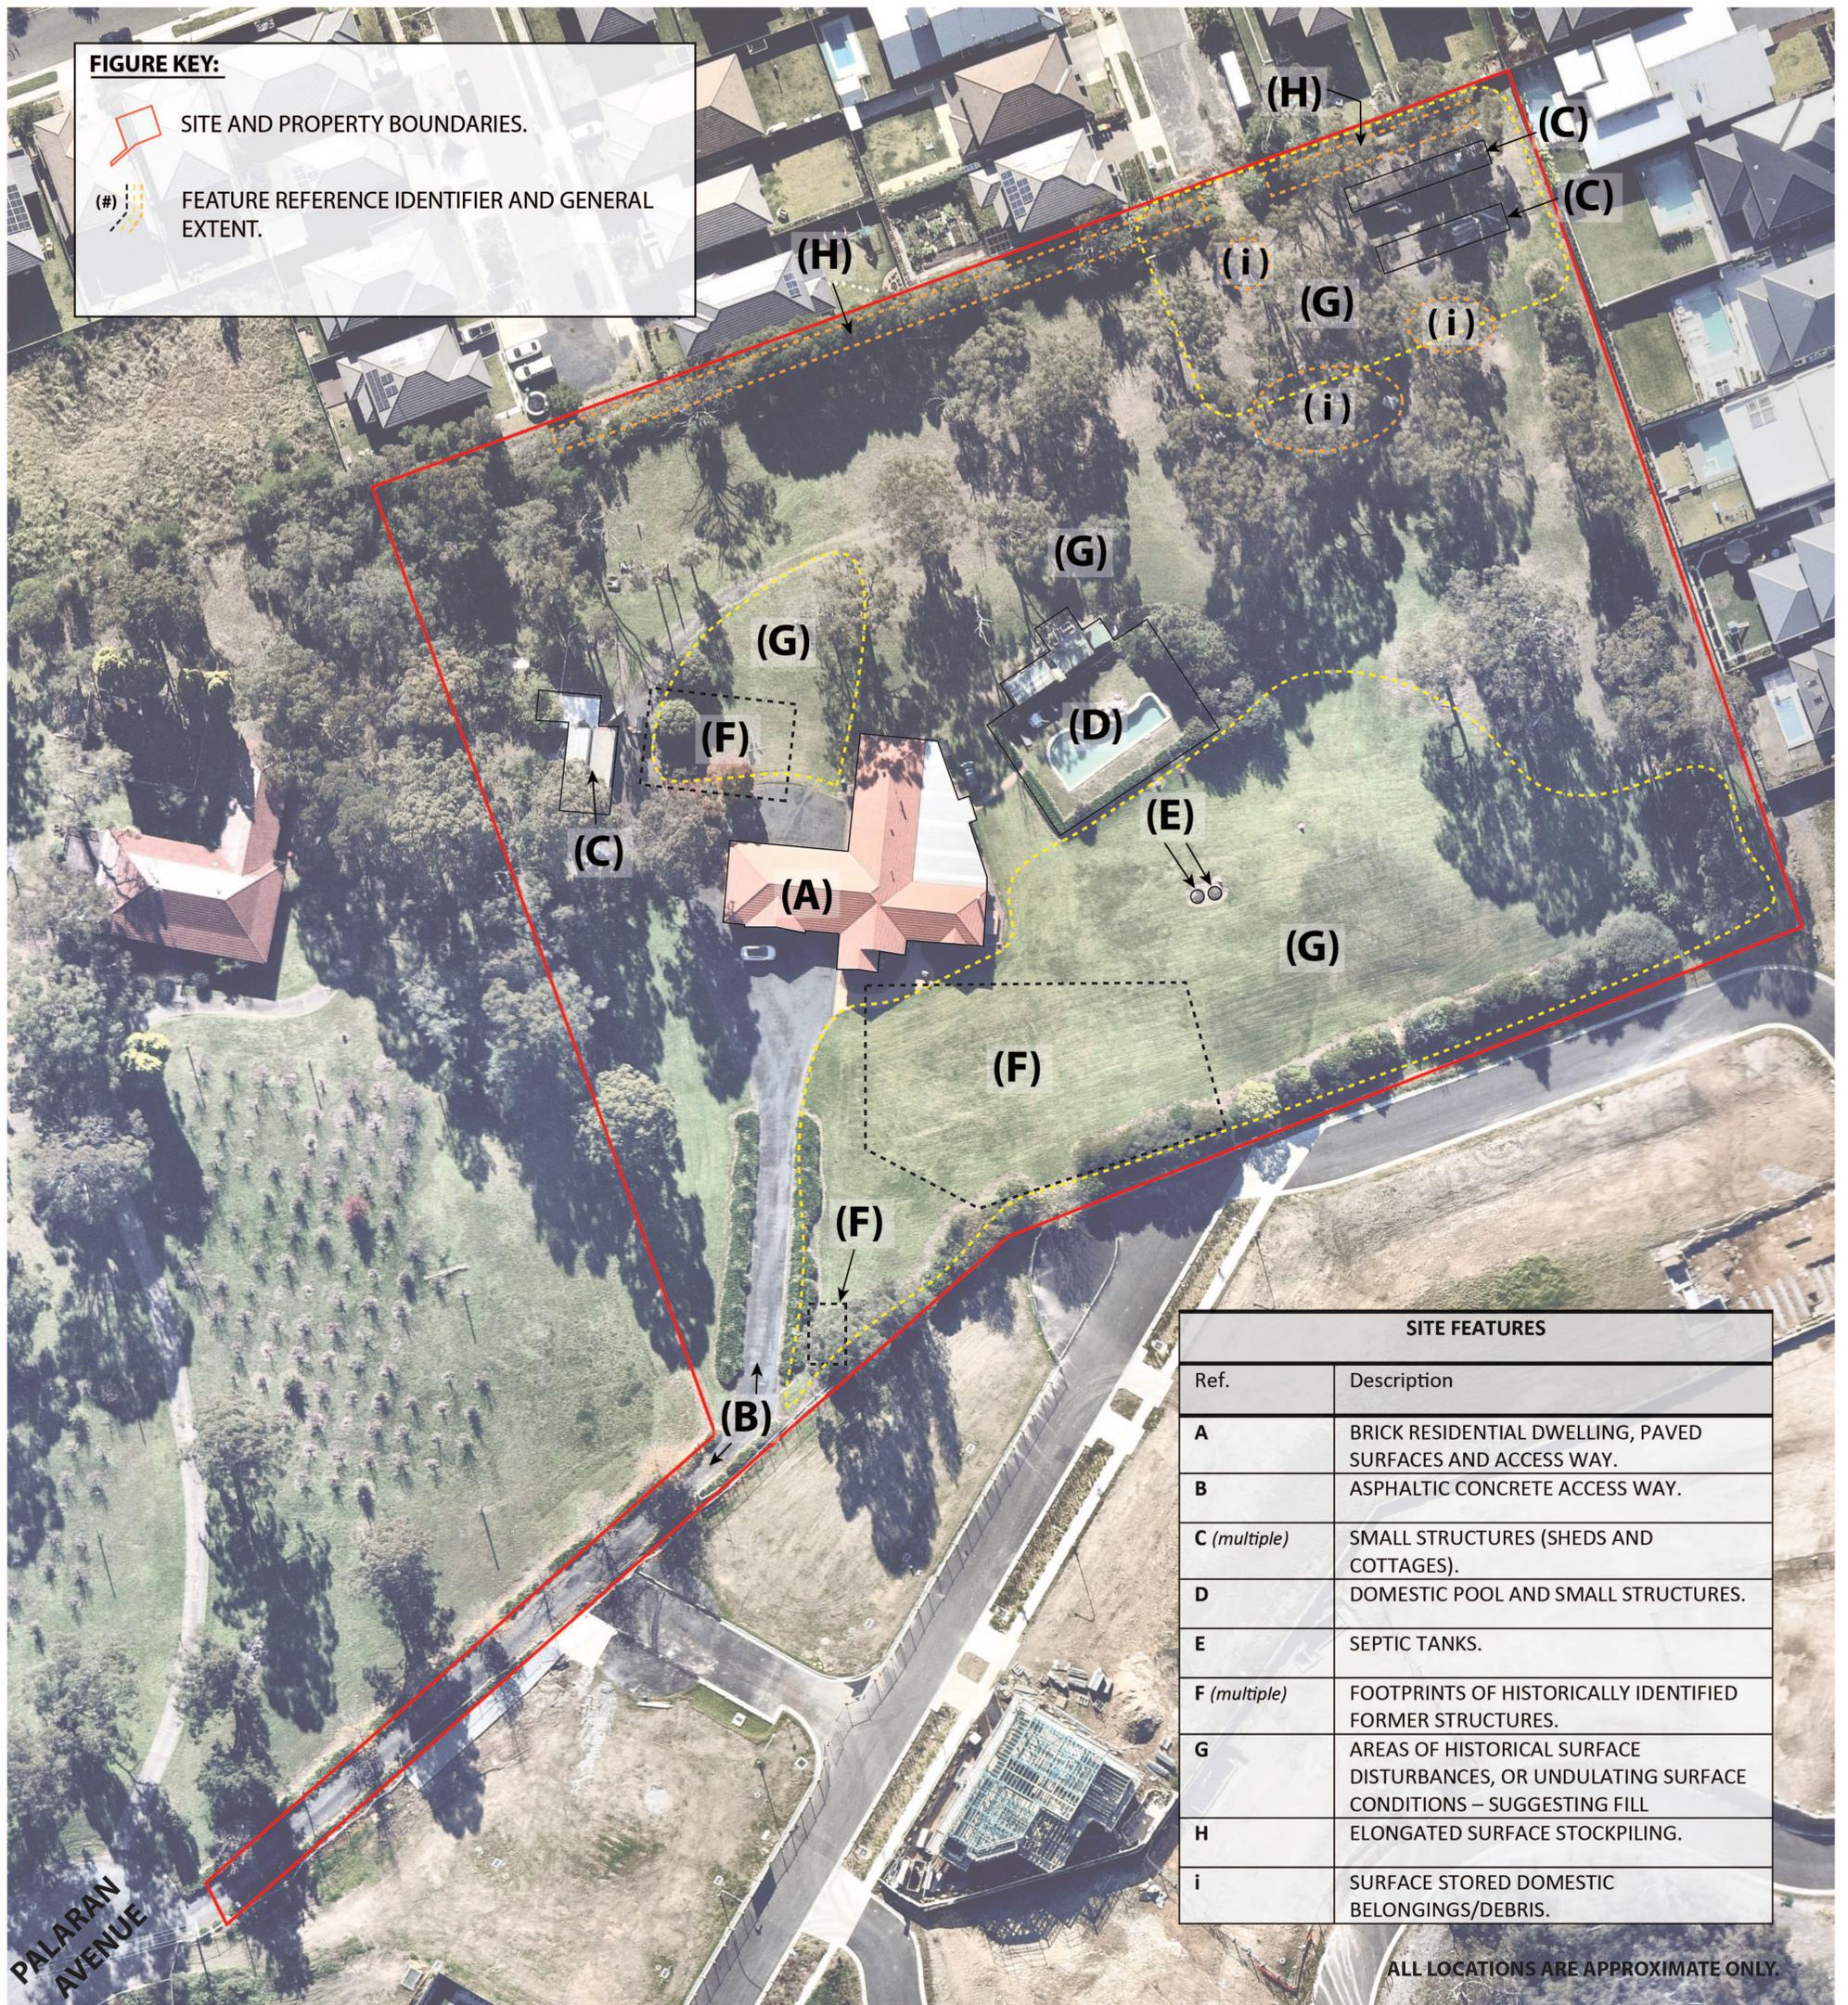
Figure: **Figure 2**

Title: **Site Layout and Areas of Environmental Concern**

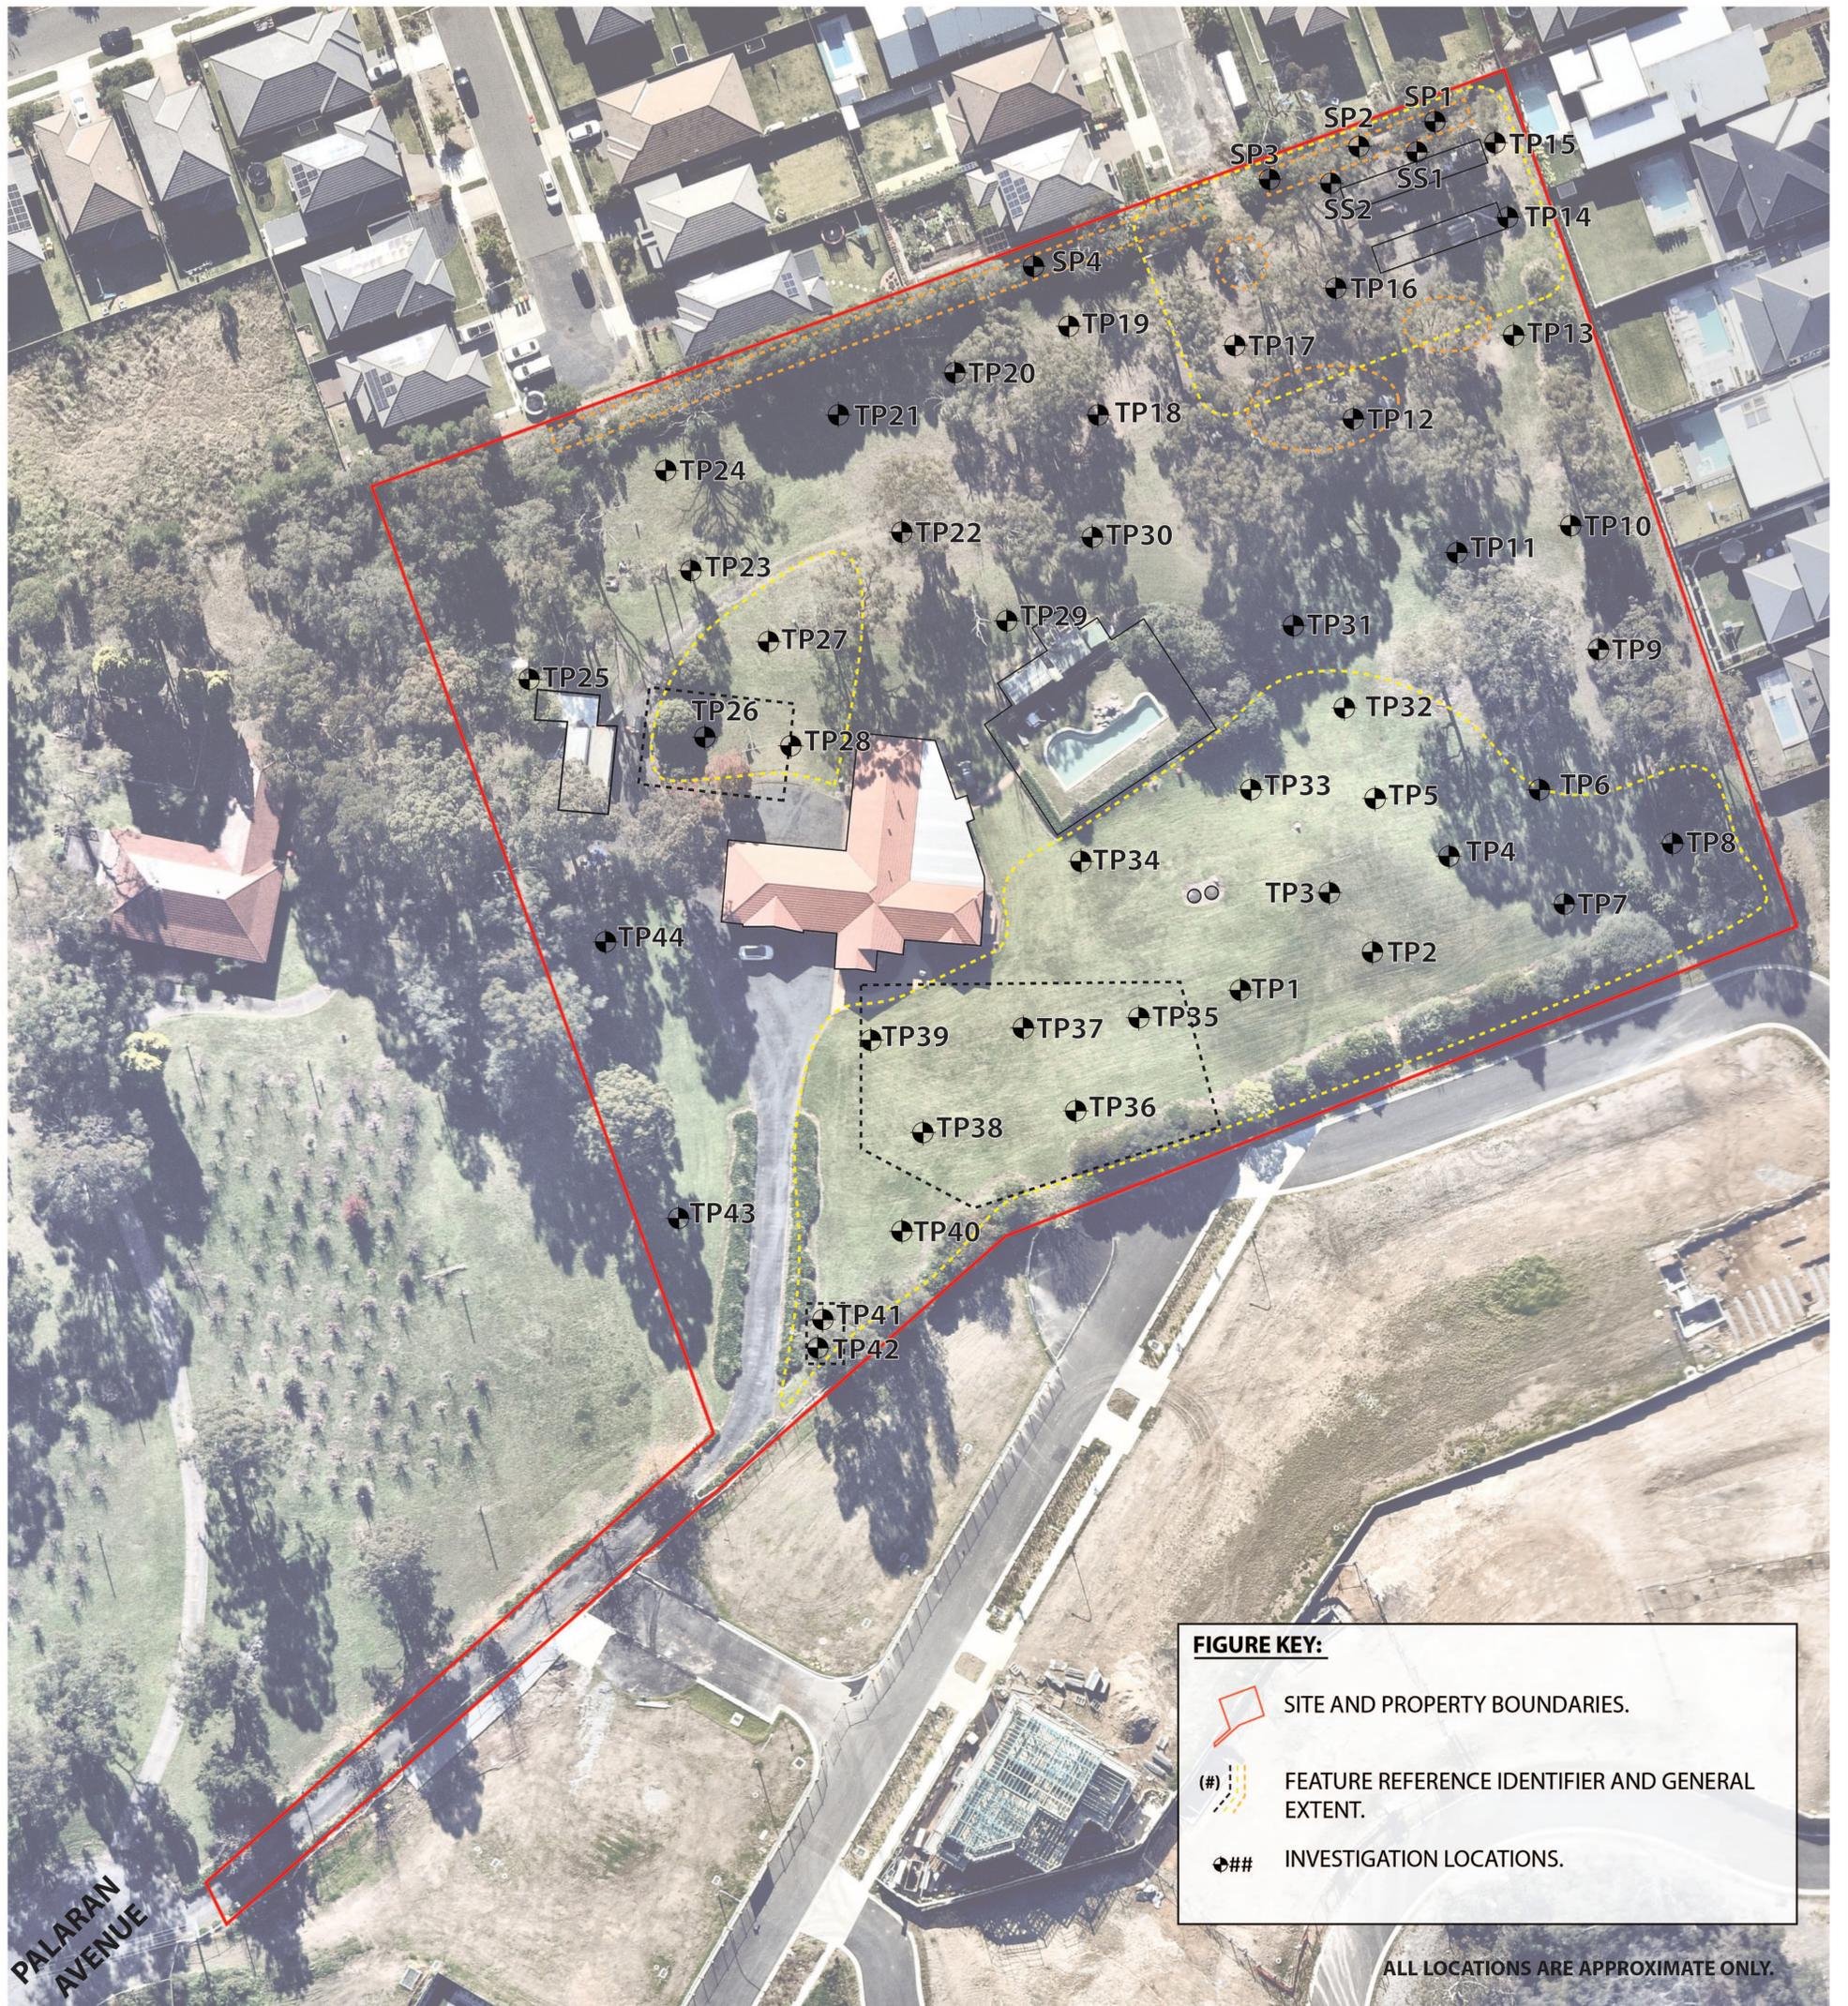
Title: Plan of Site Investigation Locations

Further detail has been provided within Section 11.2 below relating to the presence, depth and condition of fill/disturbed soils at the various inspection locations, and further the type of inclusion observed in and on soils. Field test-pit summary logs are presented in Appendix B, detailing individual test pit conditions and other observations. Individual test pit locations are shown on Figure 3, presented as an attachment to this report.

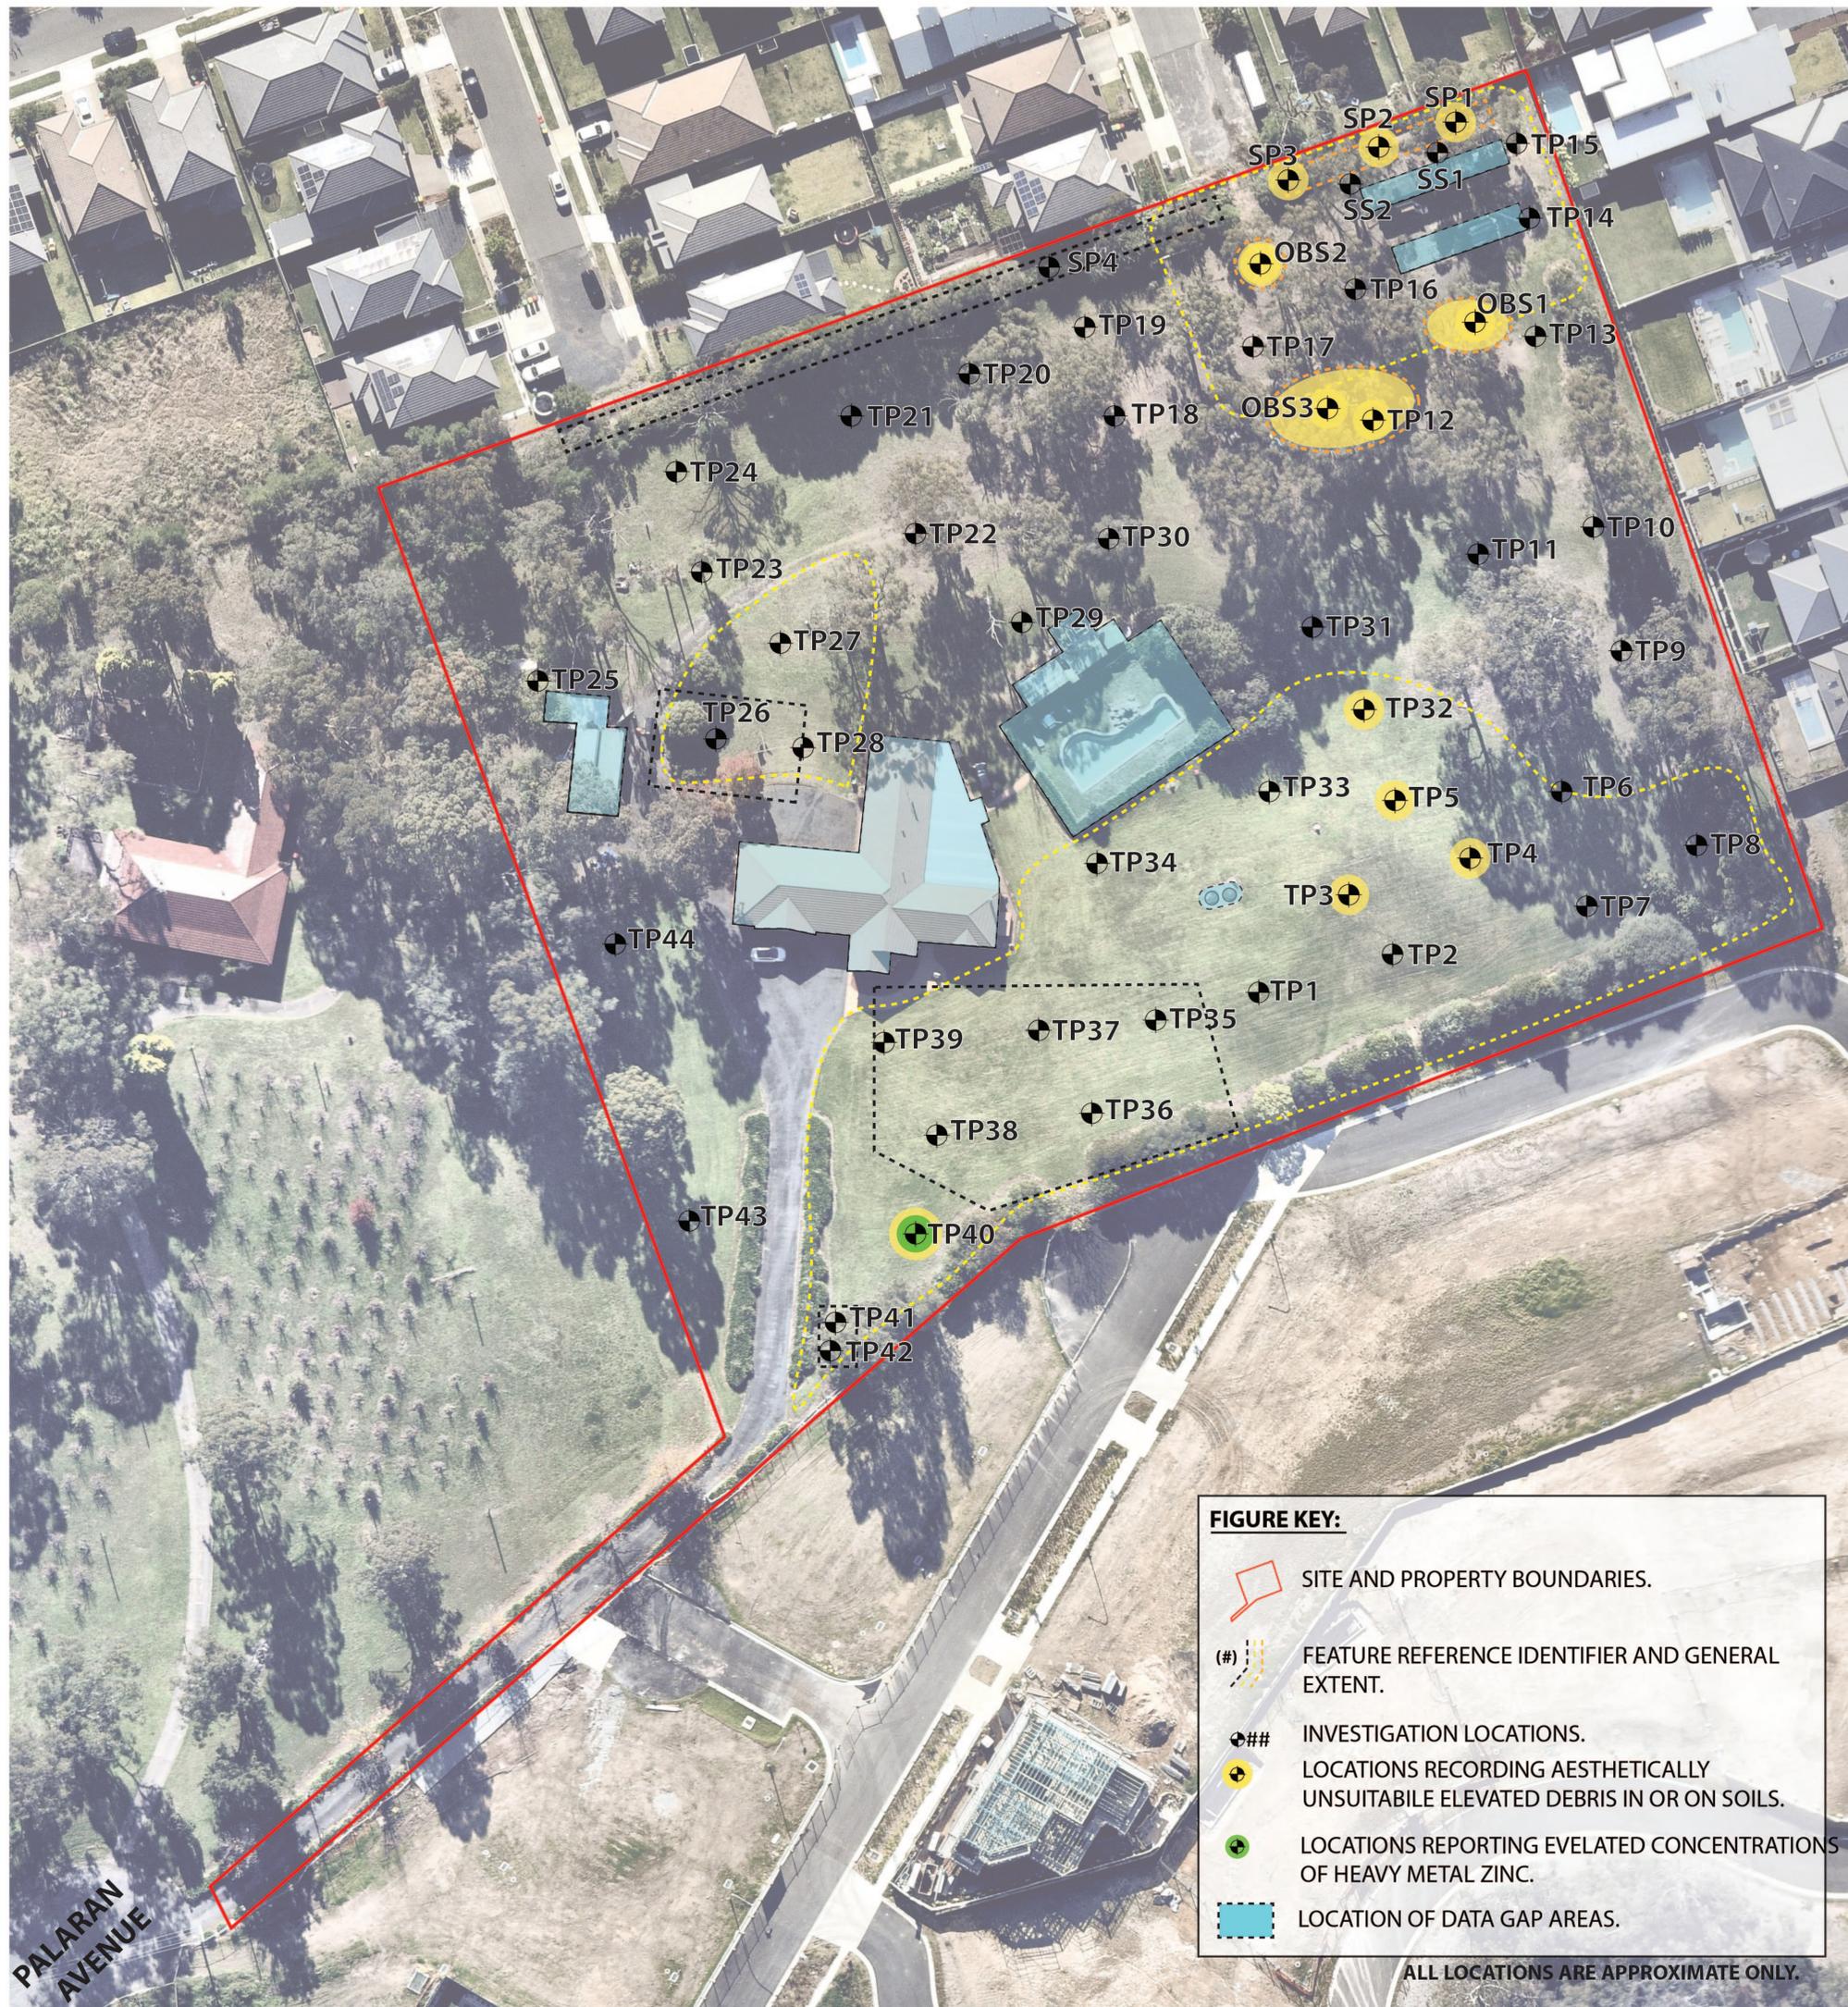
Title: **Site Exceedances & Data Gap Areas**

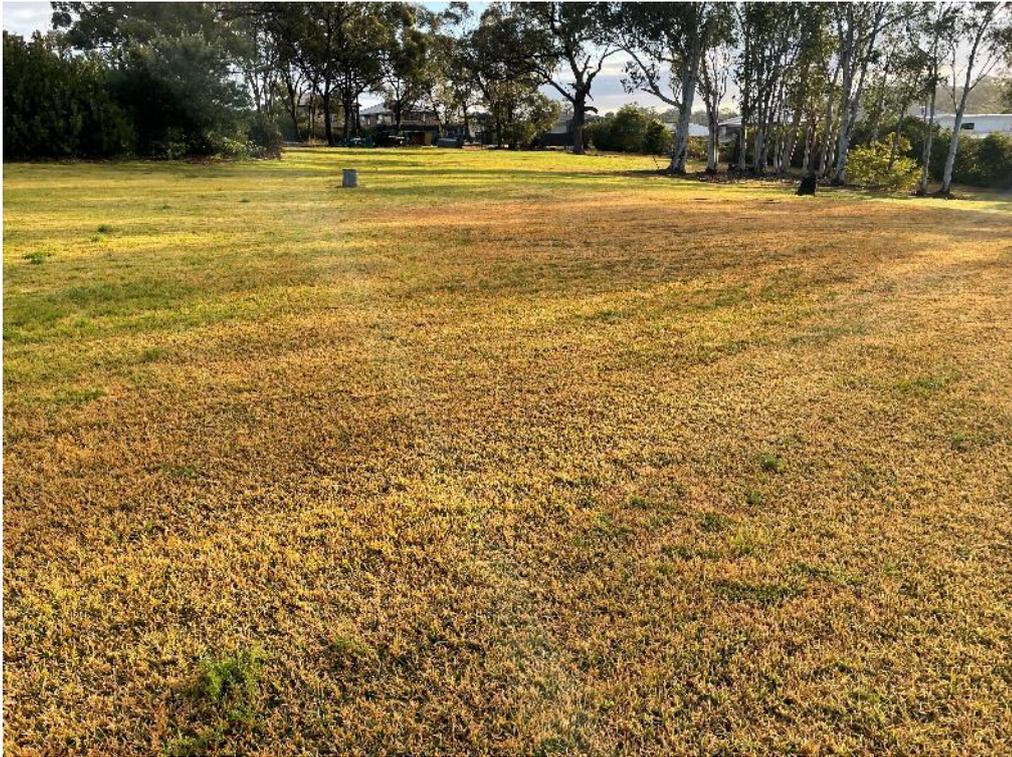
Above image showing typical example of Site condition, showing the eastern portion of the site. Image collected from centre of the site the Site facing NE.

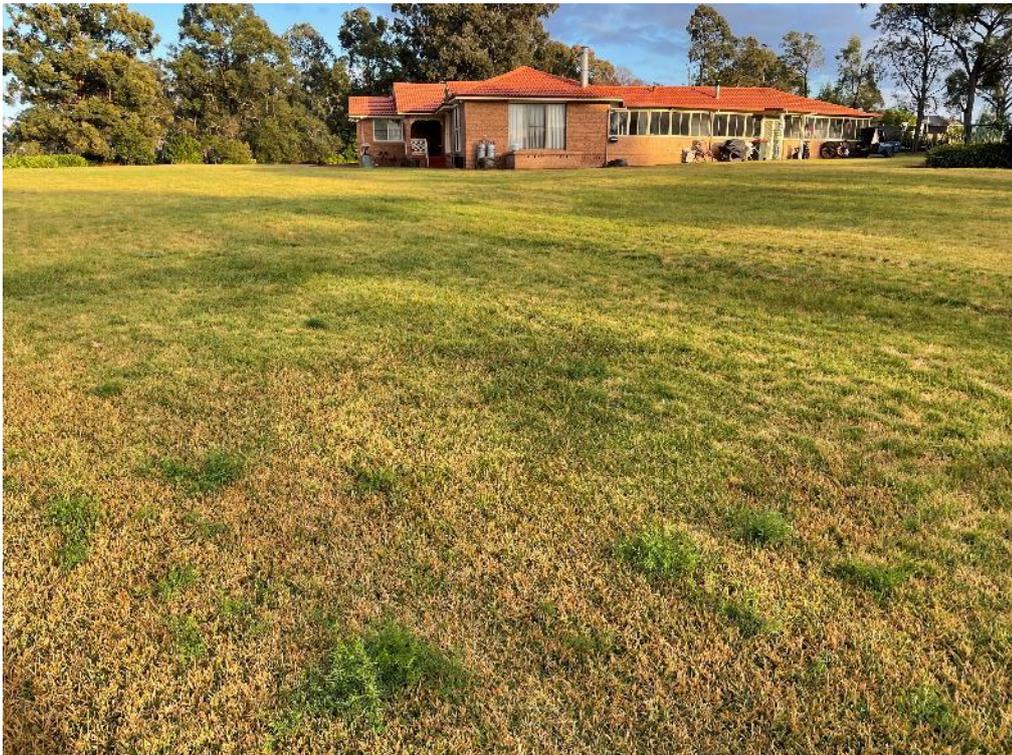
Above image showing example of Site conditions present within the western portion of the Site including the residential dwelling. Image taken from centre of site facing NW.

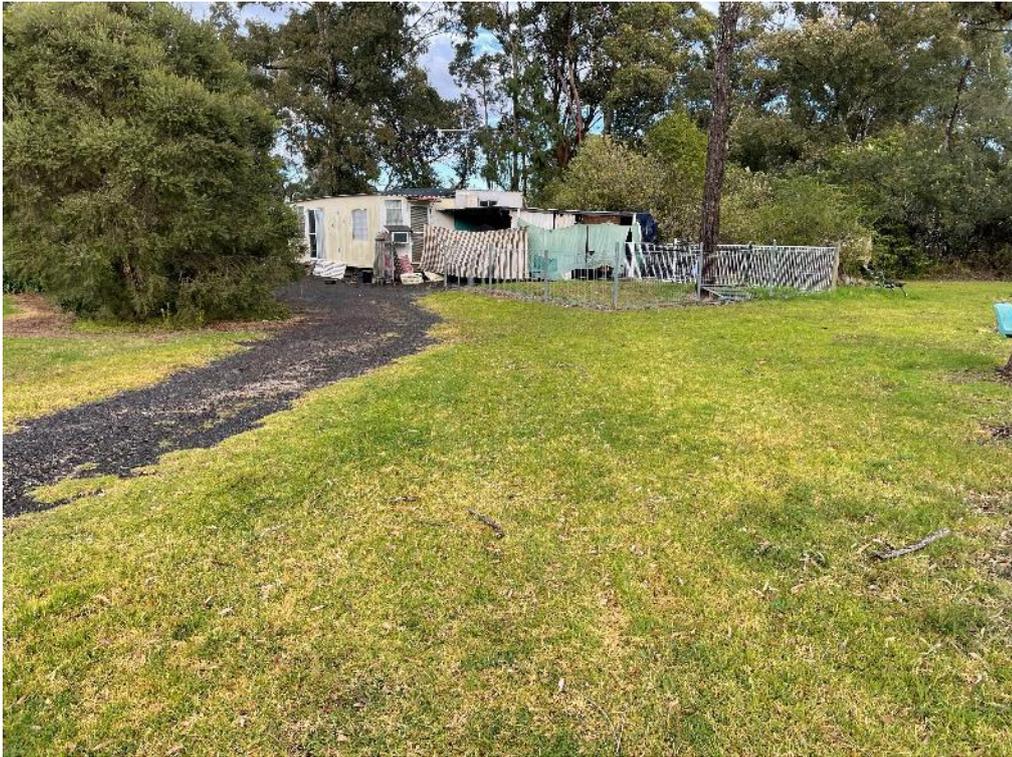
Above image showing example of granny flat located on the western boundary of the site. Image taken from northern portion of site facing SW.

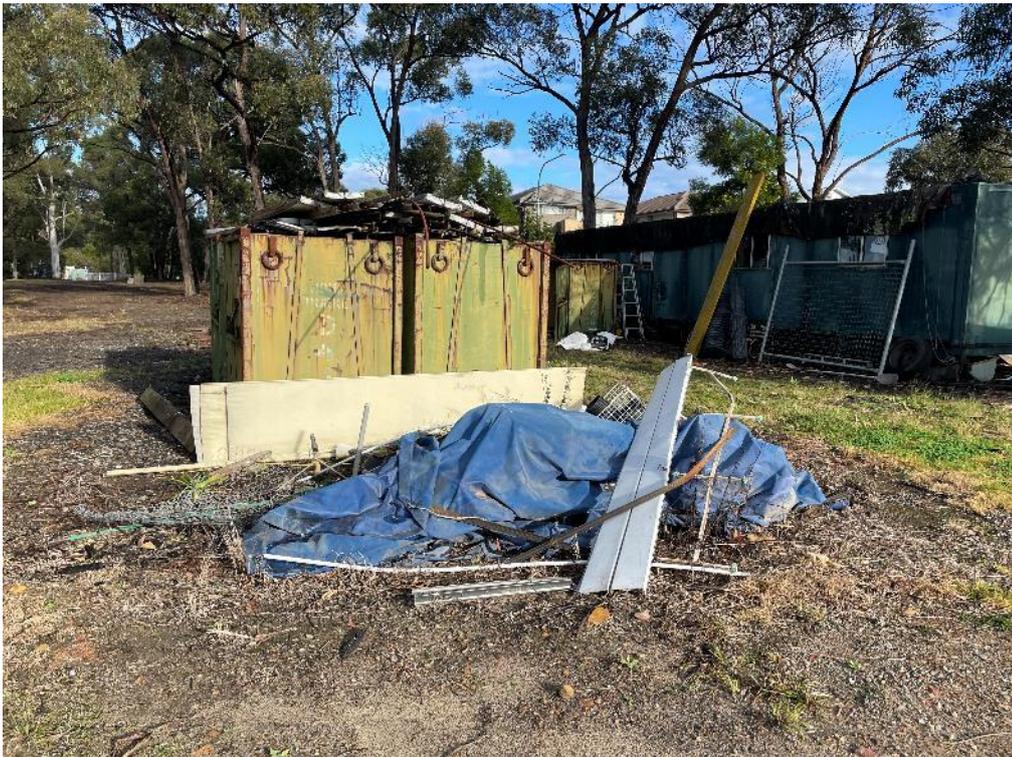
Image showing example of structures located in the north-eastern corner of the site. Image taken from north-eastern corner facing W.

- Minor storage of belongings and debris was observed within the north-eastern corner of the Site, near to the two metal sheds. The belongings consisted of various construction materials such as metal, brick, timber and plastic. The debris were not considered to represent significant waste streams.

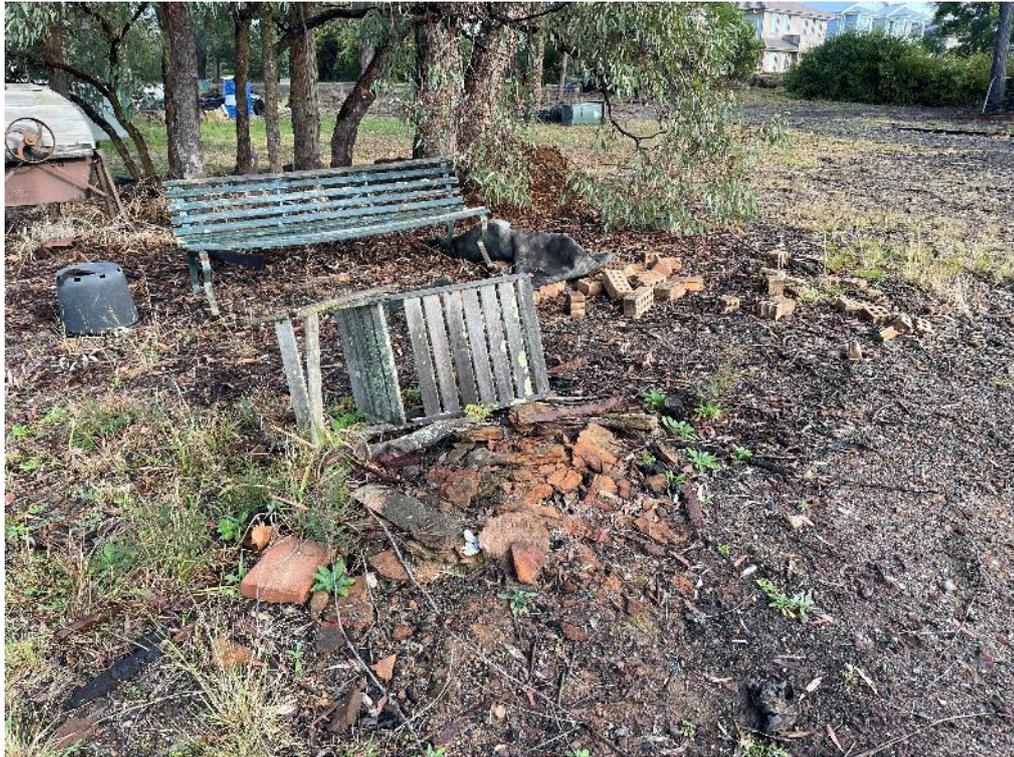
Image showing example of surface stored wastes and debris observed at multiple locations in the north-eastern portion of the site.

The OBS locations refer to minor storage of wastes and debris, including car parts, timber, steel, and plastic observed at select locations and are expected to be managed as part of the proposed demolition and Site clean-up works.

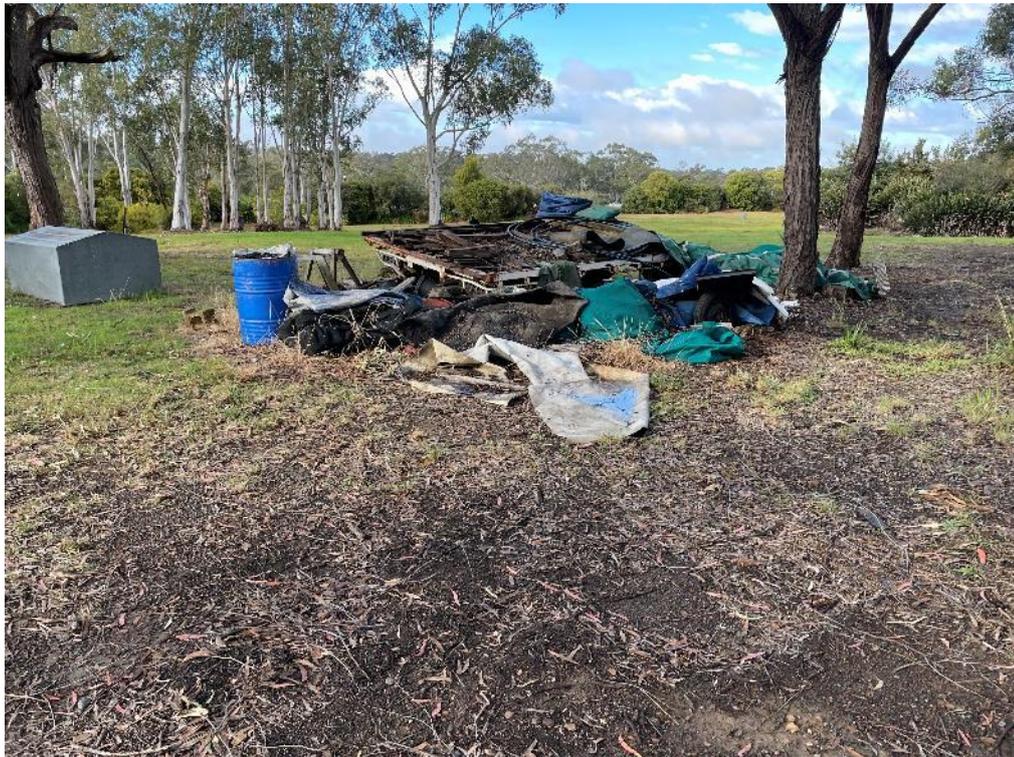
Additional image showing example of stored wastes and debris located in the north-eastern portion of the site.

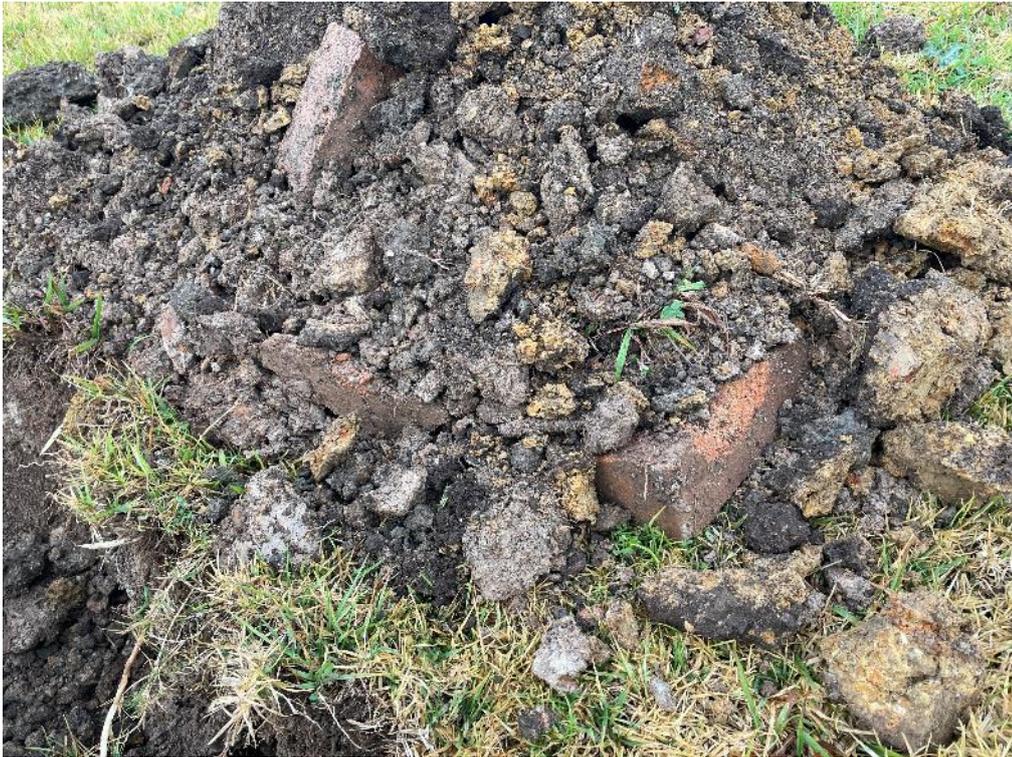
Image showing example of fill materials containing elevated concentrations of foreign materials (brick).

The Site was observed to be generally free of material considered aesthetically un-suitable. This is with exception to 9 test pit location where elevated concentrations of foreign materials (brick, concrete, glass and/or tile) were observed within the fill or stockpile soils profile and 3 locations where elevated debris was stored at the surfaces, impacting on Site aesthetical suitability.

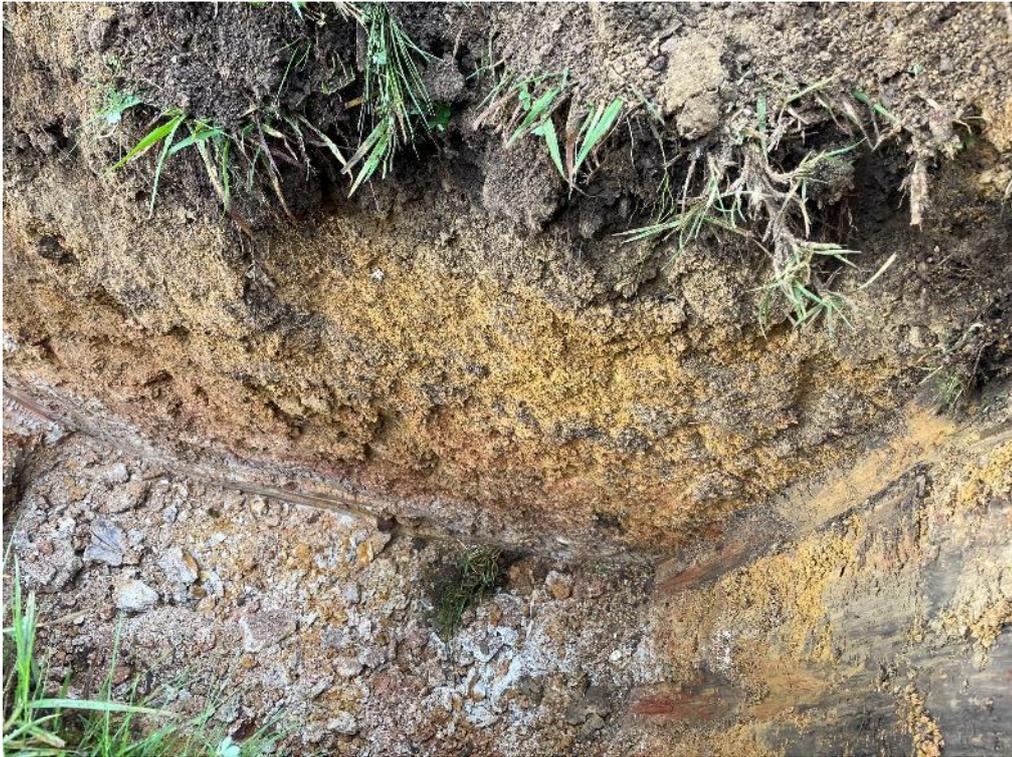
Above image showing example of residual soil profile encountered at the Site.
