# Jamberoo Road, Kiama

## Archaeological Due Diligence Assessment Report

Report prepared for White Constructions Pty Ltd  
May 2012

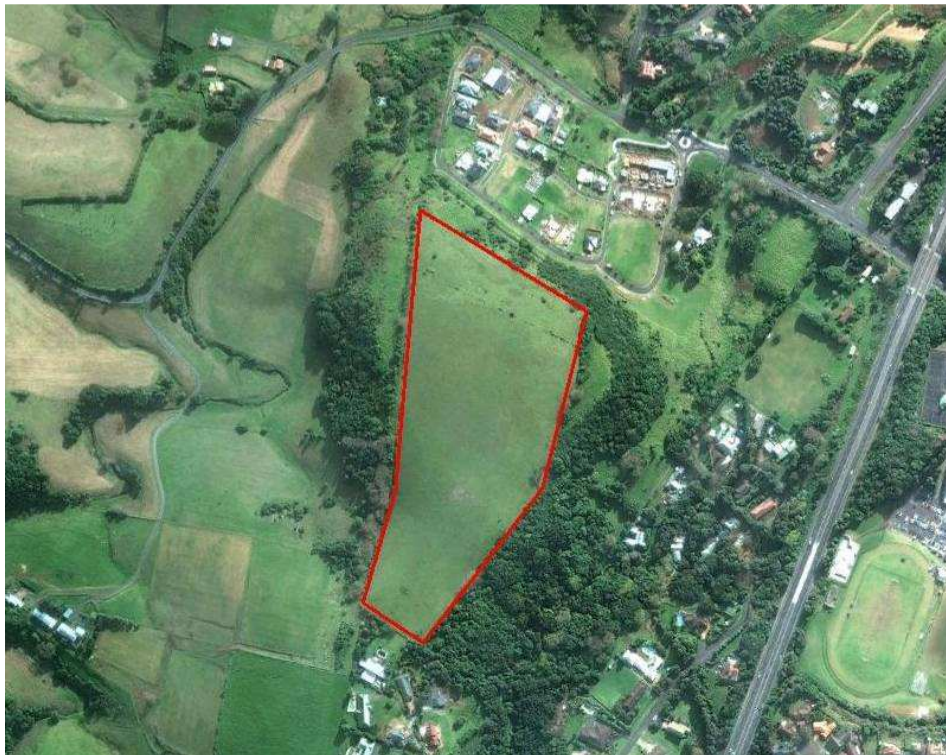
**Figure 1.2** 2012 Aerial of Study Area. The study area boundary is outlined in red. (Source: Google Earth with GML amendments 2012).

The study area comprises undeveloped agricultural land located in the western outskirts of the suburb of Kiama, NSW (Figure 1.1), approximately 500m west of the Princes Highway. The study area is bounded to the north by a residential development and lies approximately 200m south of Jamberoo Road. The study area is also bounded to the east and west by bushland, and to the southwest by agricultural land and a residential zone (Figure 1.2). The site includes six land allotments: Lots 1, 2, 3 and 4, Section 67 DP 758563, and Lots 1 and 2 DP797732.

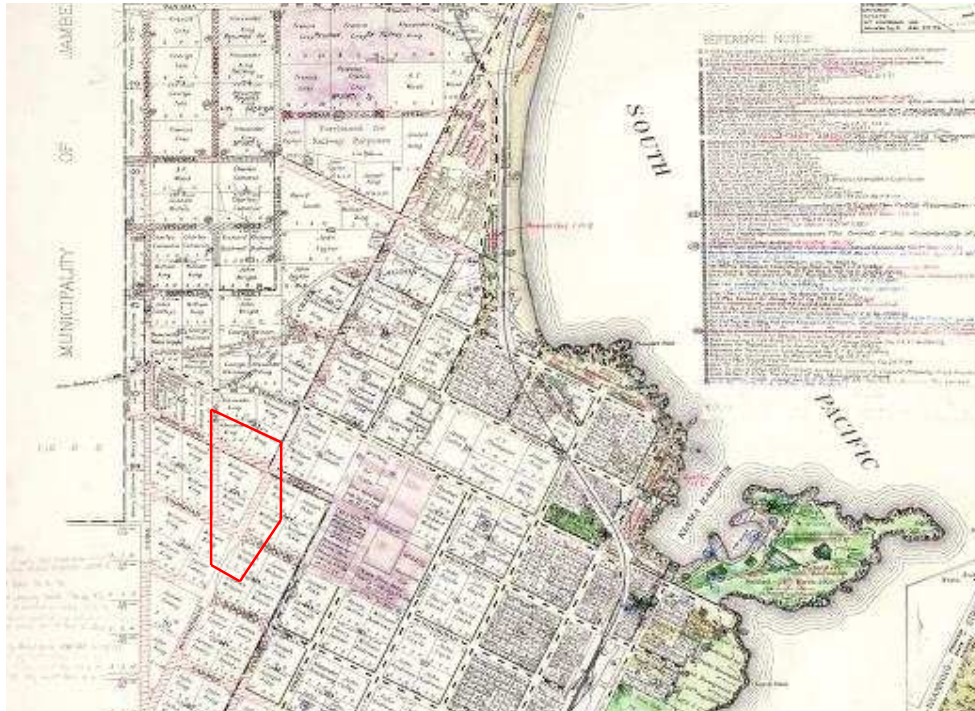
**Figure 3.1** Parish Map—July 1932. The approximate boundary of the study area is outlined in red. (Source: Department of Lands)

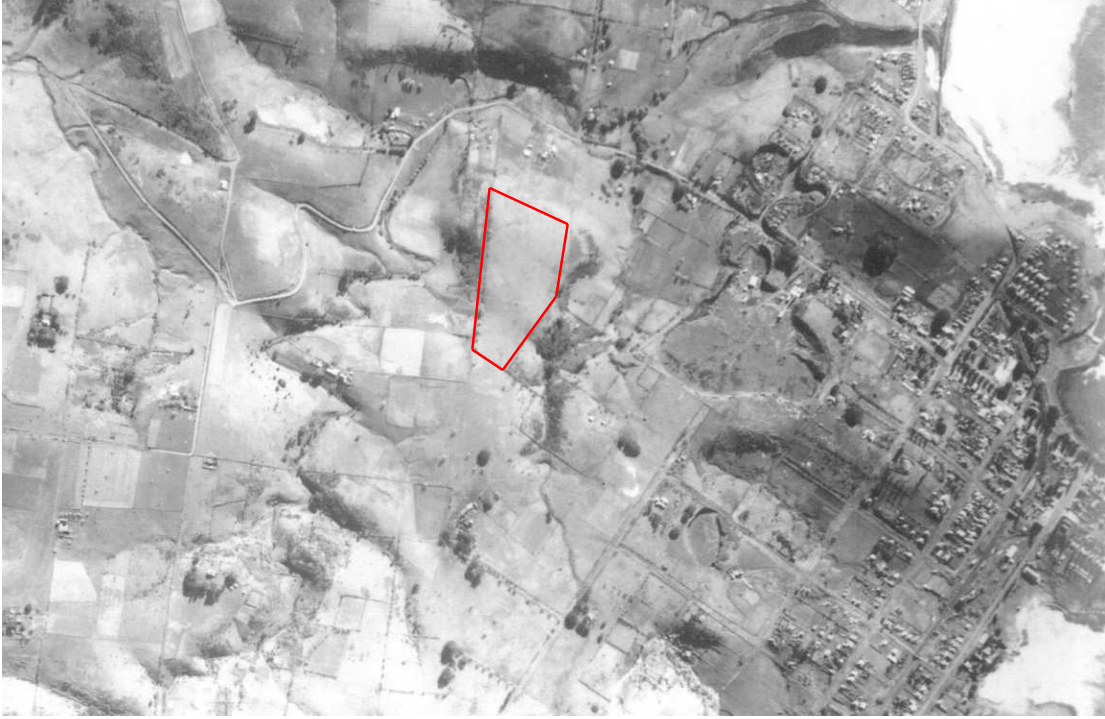
The 1949 aerial (Figure 3.3) show the study area to be a green field. There is no evidence of any ploughing or cropping. There was also no evidence for any buildings. There was a notable line, possibly a fence, running east–west through the site, in the approximate location of the Section 69 northern boundary. There was also a faint line along the approximate location of the Section 67 northern boundary. The copse of trees located along the western and eastern boundaries of the study area was less dense than its current condition.

**Figure 3.3** 1949 Aerial Photograph. The approximate boundary of the study area is outlined in red. (Source: Department of Lands)

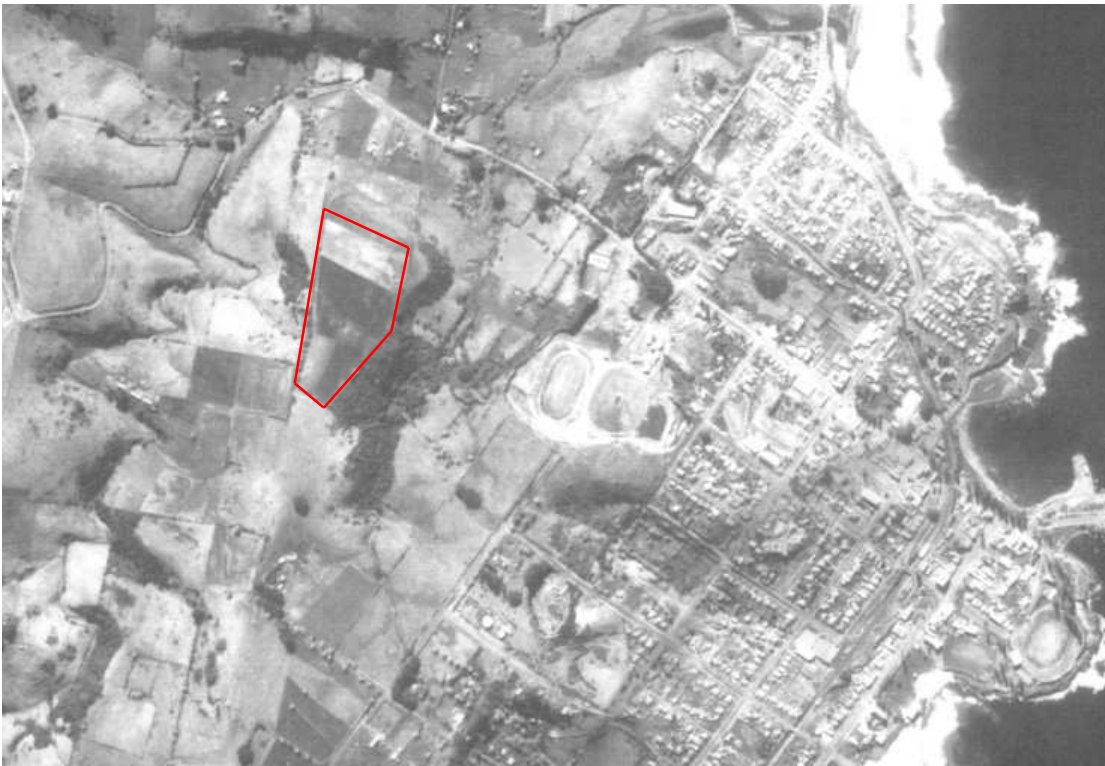
**Figure 3.4** 1979 Aerial Photograph. The approximate boundary of the study area is outlined in red. (Source: Department of Lands)

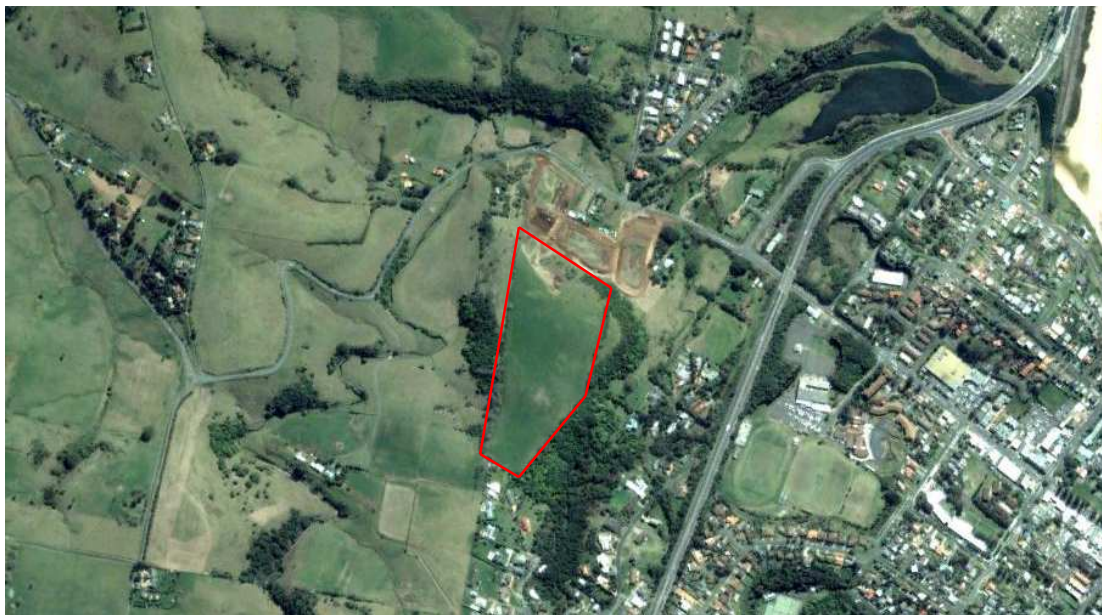
The 2005 aerial (Figure 3.5) shows that there was some preliminary grading works for road constructions, undertaken within the north-west corner of the site. These works appeared to have been related to the residential development north of the site. There was a notable line running east–west through the middle of Section 67.

**Figure 3.5** 2005 Aerial Photograph. (Source: Google Earth 2012)

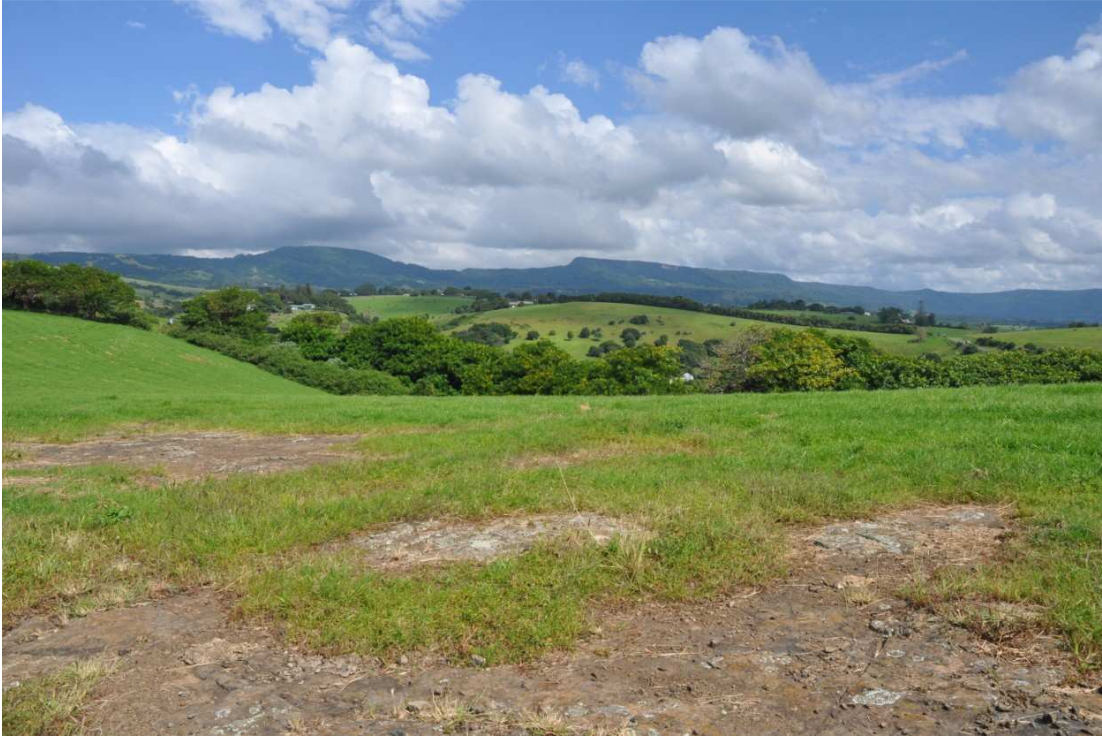
A number of bedrock exposures were noted along the crest of the hill, and mid-slopes across the study area. A particularly large area of exposed bedrock was located towards the south of the site along the crest of the hill (this rock exposure can be seen in recent aerial photographs of the site). This indicated that soil depth across the majority of the site was fairly shallow (Figure 4.1).

**Figure 4.1** Exposed bedrock to south of study area in foreground, view to southwest from study area, area of dense vegetation is Spring Creek, and southerly escarpment in background. (Source: GML 2012)

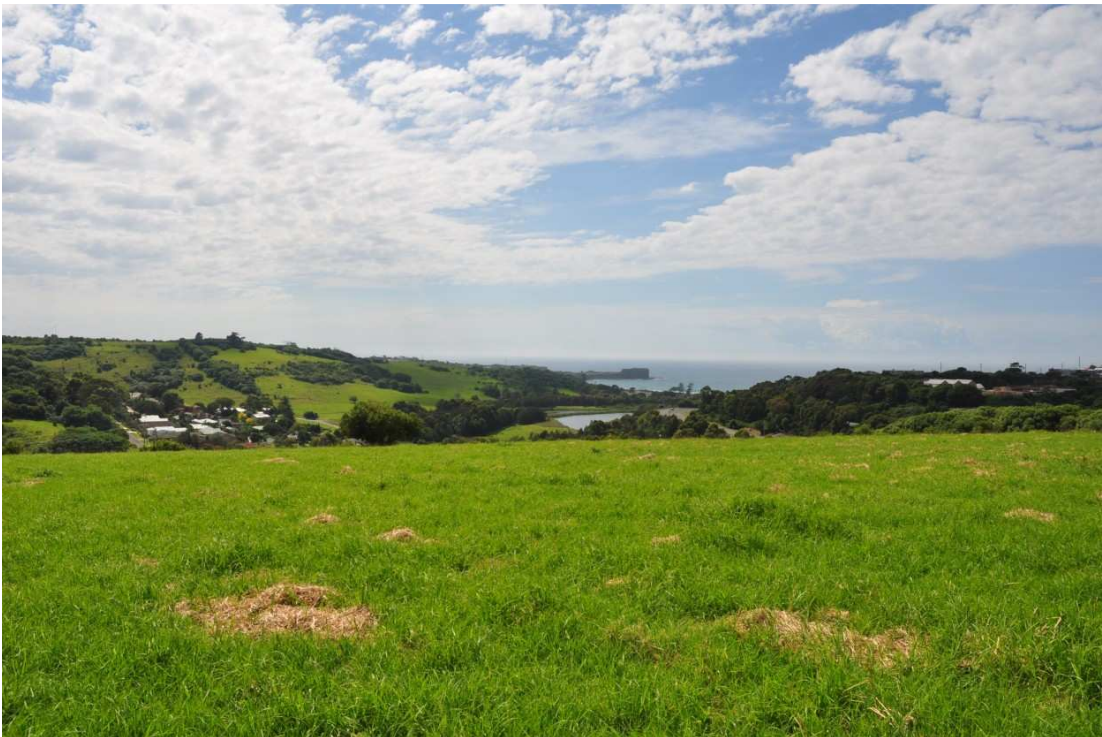
**Figure 4.2** View from north of site. Example of similar low rolling hill landform to the west, Willow Gully Creek to east (heavily vegetated area), view to the coastline and headland in the background. (Source: GML 2012)

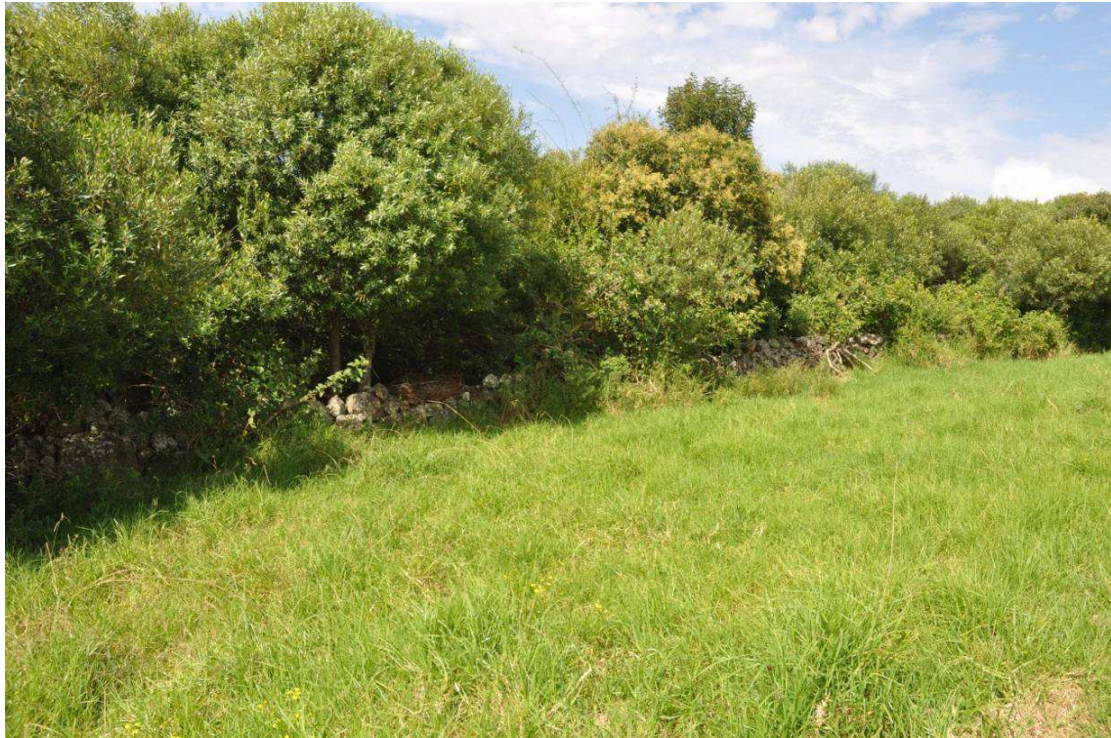
Dry stone walls were observed along the western, southern and eastern boundaries of the study area. The walls were constructed from local stone and varied in their states of deterioration. The walls are a maximum of 1m in height (Figure 4.3 and Figure 4.4).

**Figure 4.3** An example of the dry stone walls that lined the boundaries of the study area. (Source: GML 2012)

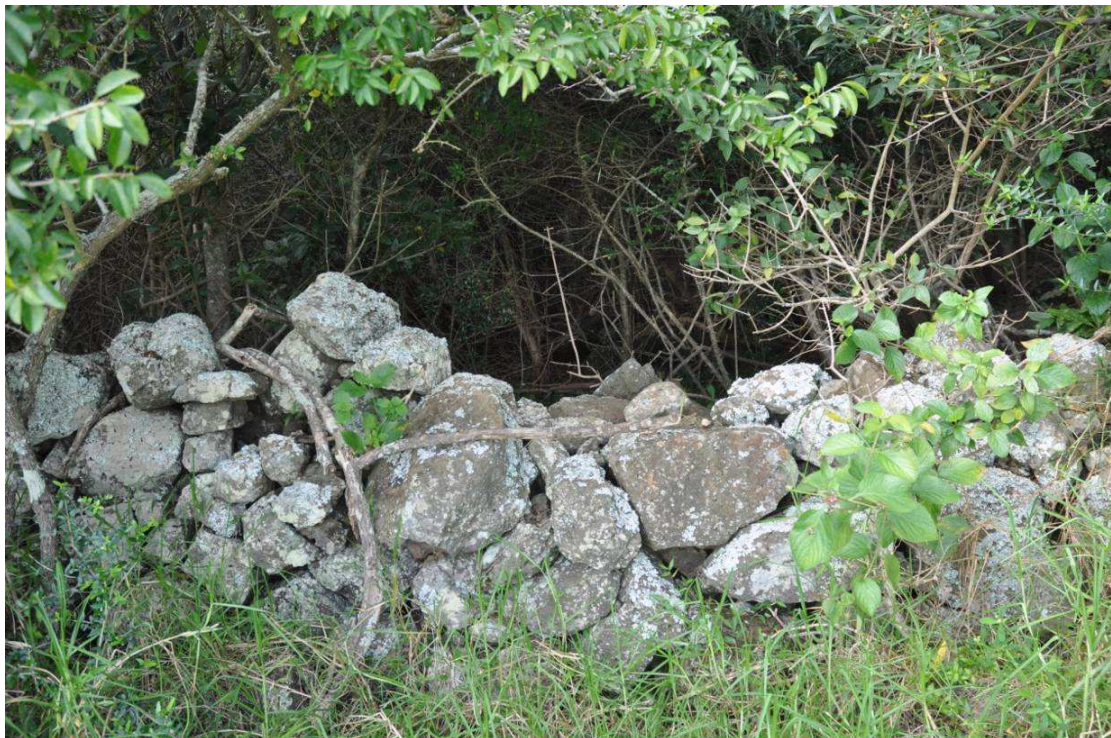
**Figure 4.4** Close up of a dry stone wall that lined the boundaries of the study area. (Source: GML 2012)
