## Planning Proposal

**Maclean Highway Service Centre  
Lot 2 DP634170  
Schwonberg Street, Townsend**

**PLANNERS NORTH, July 2020**

# **Planning Proposal Supporting Documents Bundle**

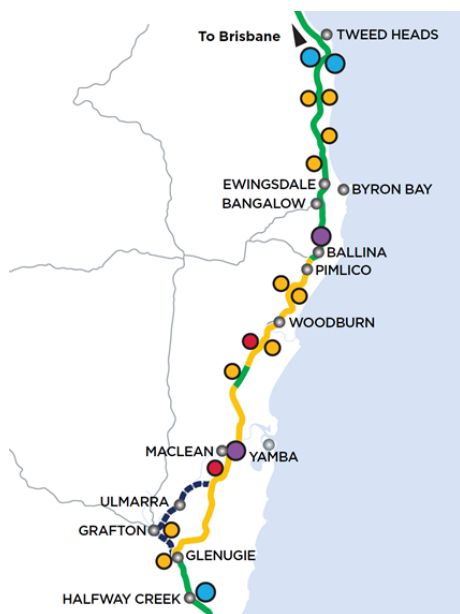
**Plan 1.1** illustrates the subject site in its local context. The below graphic shows the proposed service centre and rest area network from Tweed Heads through to Halfway Creek.

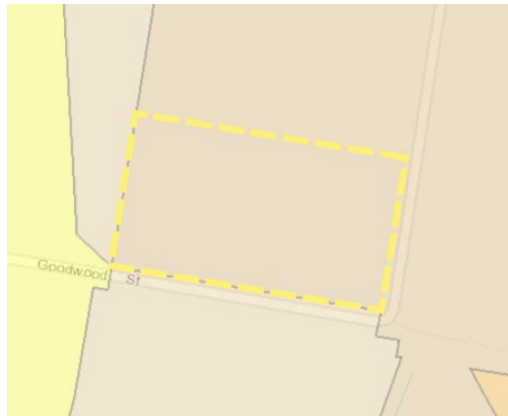
#### Land Zoning Map

Legend  RU2

Minimum Lot Size	40ha
Acid Sulfate Soil Classification	Class 3
Height of Buildings	No height limit specified
Flood Planning	Flood planning area

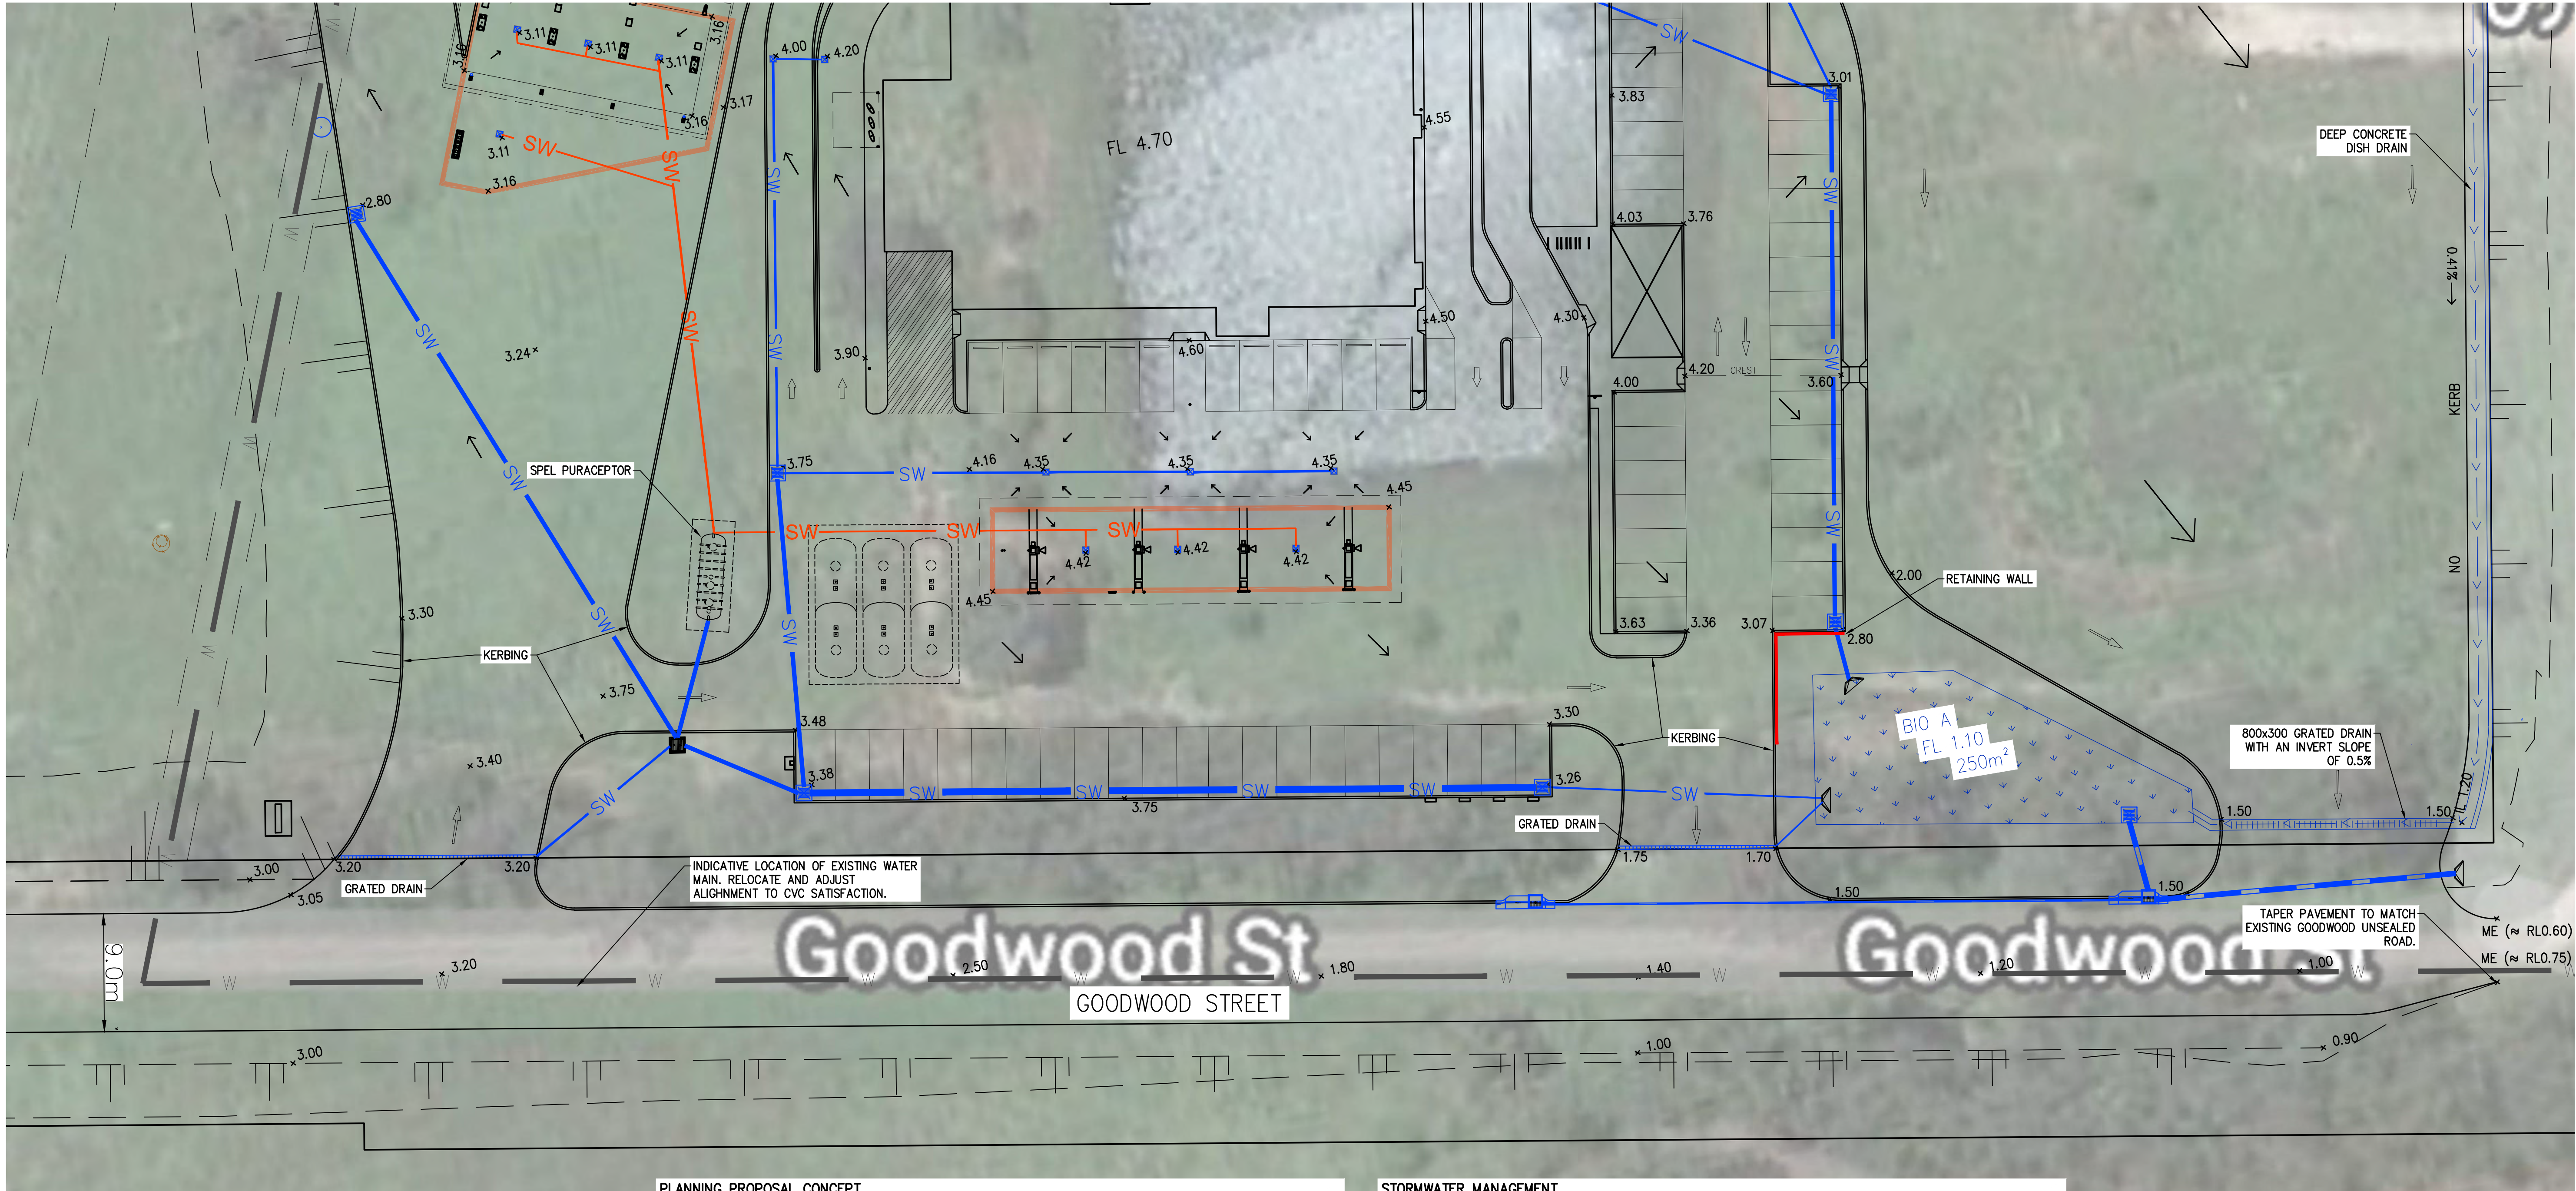
Project No.	20033
Drawing No.	PP02
Amendment No.	A

**PLANNING PROPOSAL CONCEPT**

The civil works shown on these drawings are conceptual only. They have been prepared to demonstrate the size a retail fuel service centre and how it could be arranged to manage its stormwater and flood impacts. The widths and heights of road works, and the extent of filling and batters is entirely conceptual and subject to further design and consultation with CVC through the development and construction approval processes.

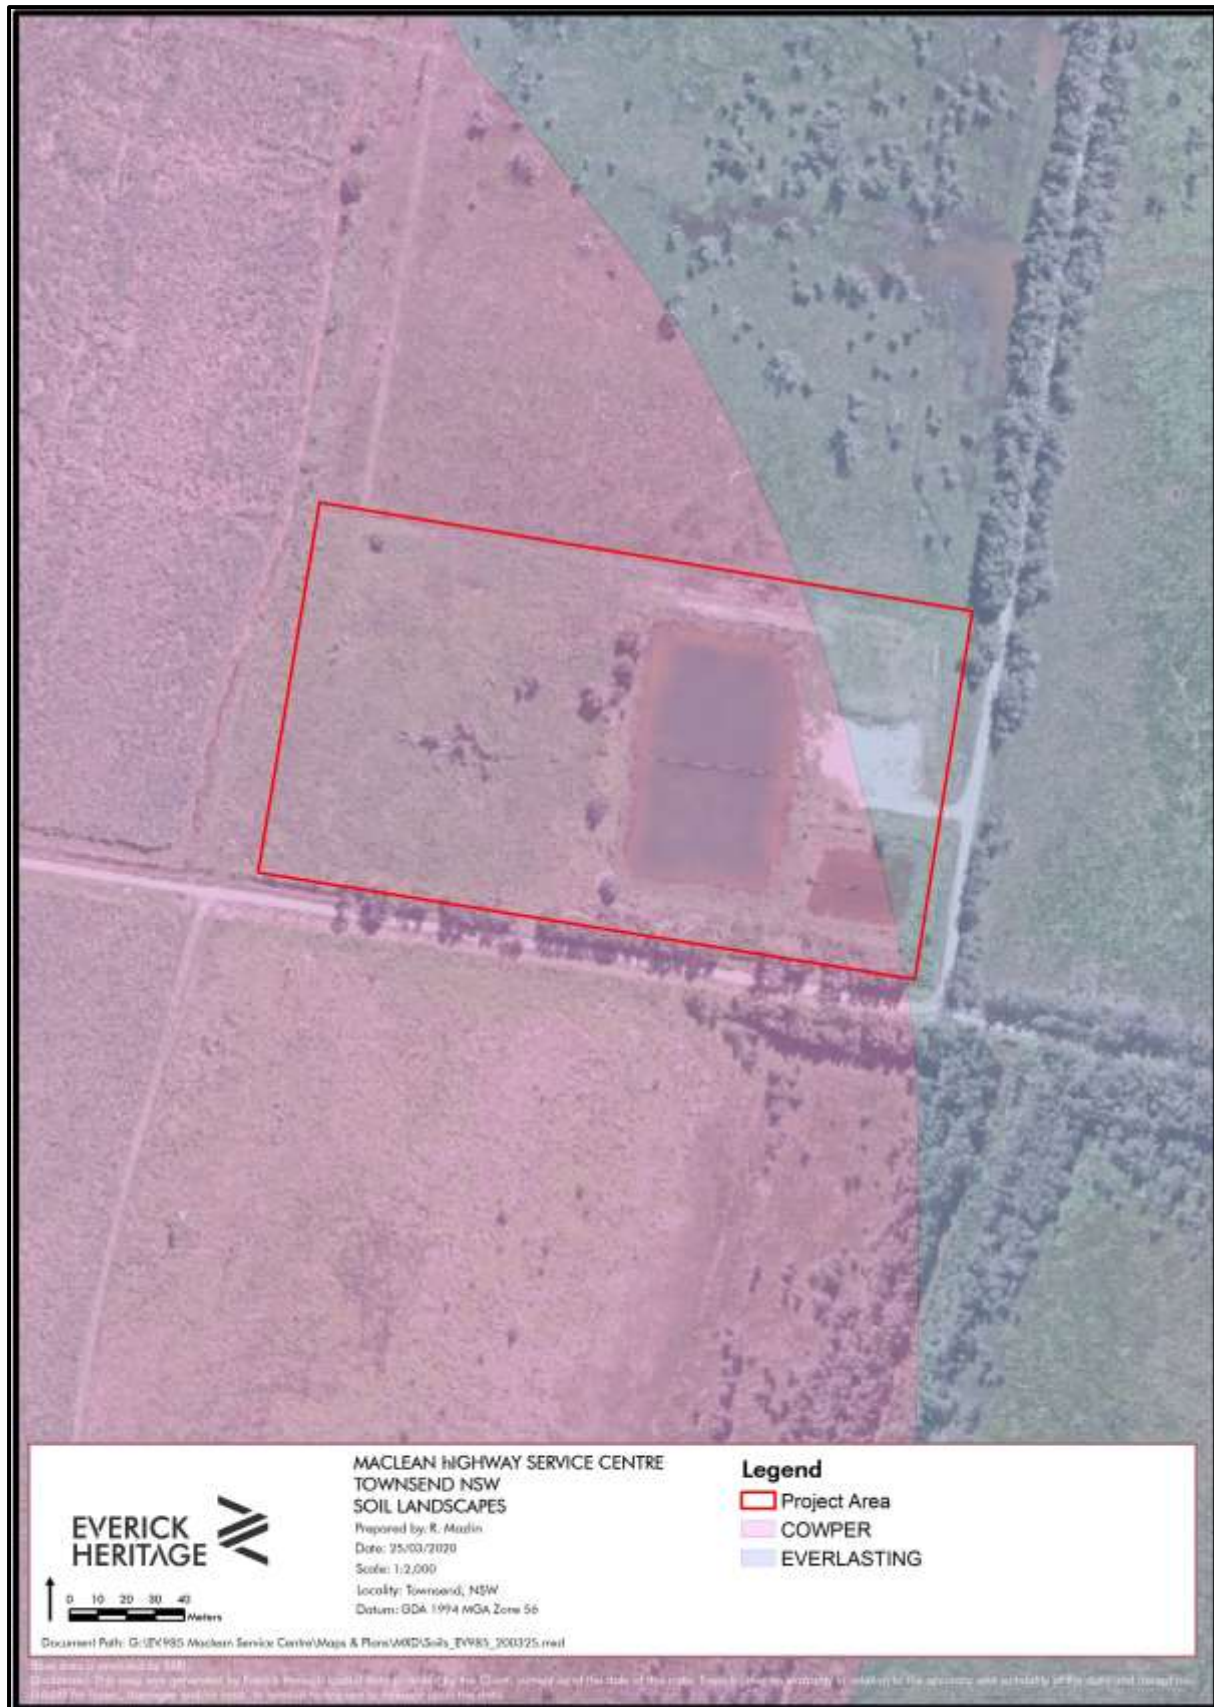
Figure 4: Project Area soil landscape mapping.

The Project Area is mapped as being part of the 'Cowper' but immediately adjacent to the 'Everlasting' soil landscape (Morand 2001 see Table 1 Figure 4);

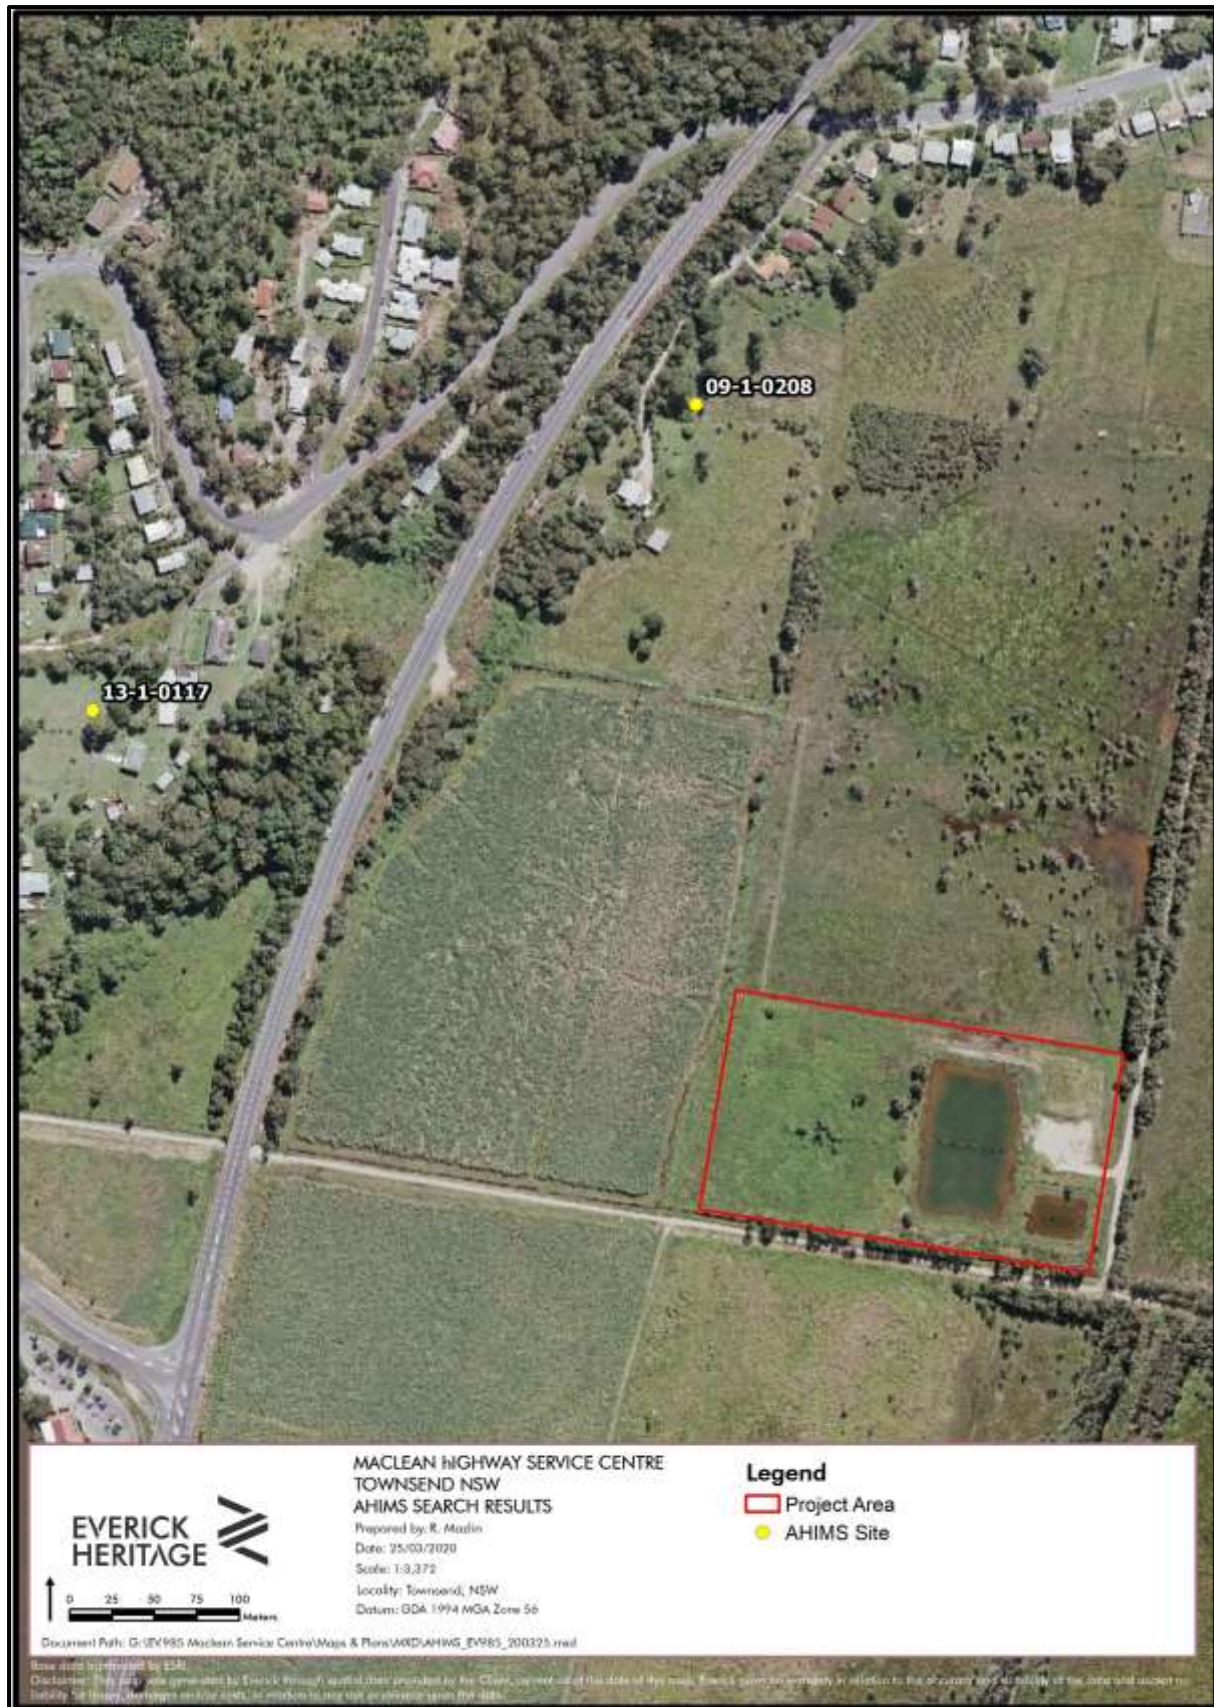
Figure 5: AHIMS search results (#490266).

An 'Extensive' search was undertaken of the AHIMS database (Reference: 490266) on 11 March 2020 (Table 2 and Appendix B). The search area was defined as Lot 2 DP634170 with a buffer of 1 km. One (1) Aboriginal site was returned by the AHIMS search, being the Hillcrest Reserve recorded by Katrina Stankowski, which is understood to be an Aboriginal historic site in Maclean which now comprises the current Aboriginal housing area to the west of the Pacific Highway (see Australian Museum Consulting 2015). The site coordinates were recorded in the AGD datum and when converted to the GDA datum this site coordinate is considered accurate. The other entry returned is a PAD. This PAD 15 'site' is located near to the north of the Project Area on a ridge crest that runs eastward from Hillcrest Reserve and is not considered to extend into the Project Area (see **Figure 5**). The site record for PAD 15 indicate that it is not a site.

Site ID	Site Name	Easting	Northing	Site Type
13-1-0117	Hillcrest Reserve	519880	6740071	Habitation Structure; Potential Archaeological Deposit
09-1-0208	PAD 15	520235	6740251	Potential Archaeological Deposit

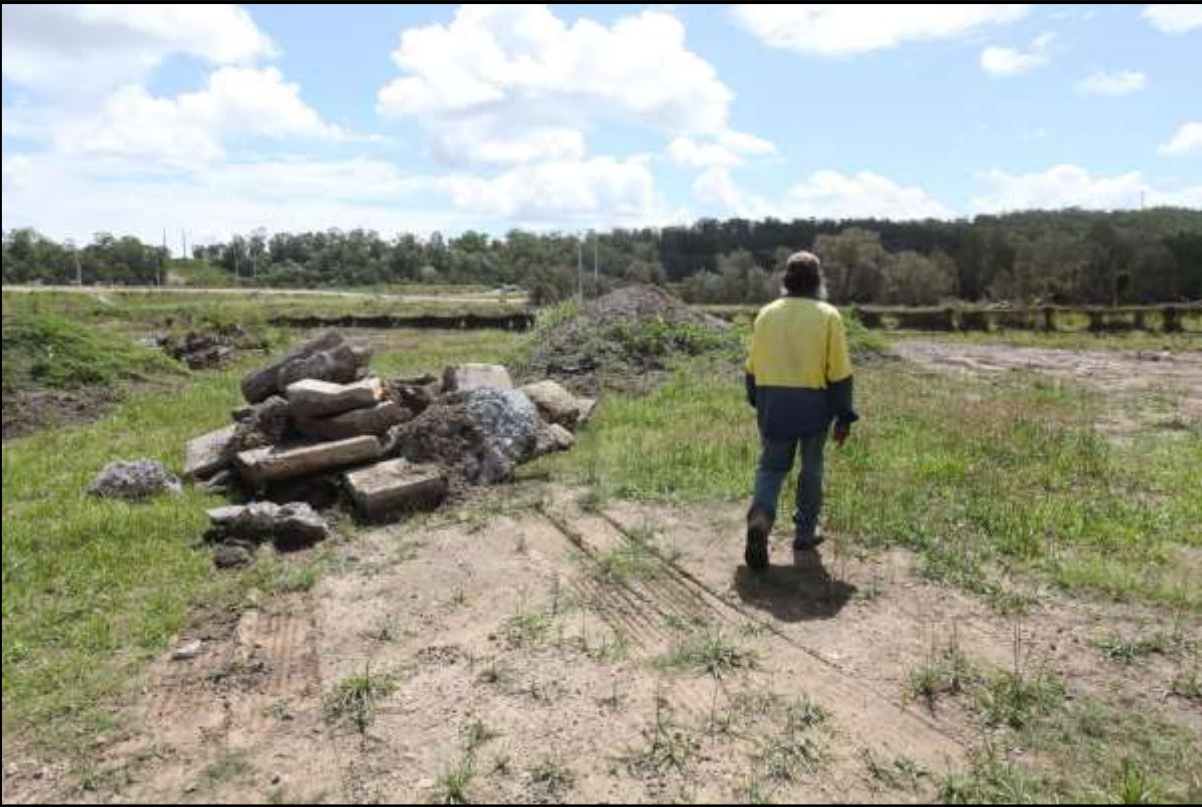
Figure 9: Typical ground surface visibility and around soil stockpiles.

A site inspection of the Project Area was undertaken on Tuesday 18 February 2020 with Mr Firlin Laurie from Yaegl Traditional Owners Aboriginal Corporation ('TOAC') and Tim Hill (Everick Heritage Principal Northern NSW). The site inspection aimed to identify the potential for the Project Area to contain Aboriginal archaeological sites (Table 4) and to document the nature and extent of previous soil disturbance and locate intact soils with the potential to contain archaeological sites (Figure 9 - Figure 11).

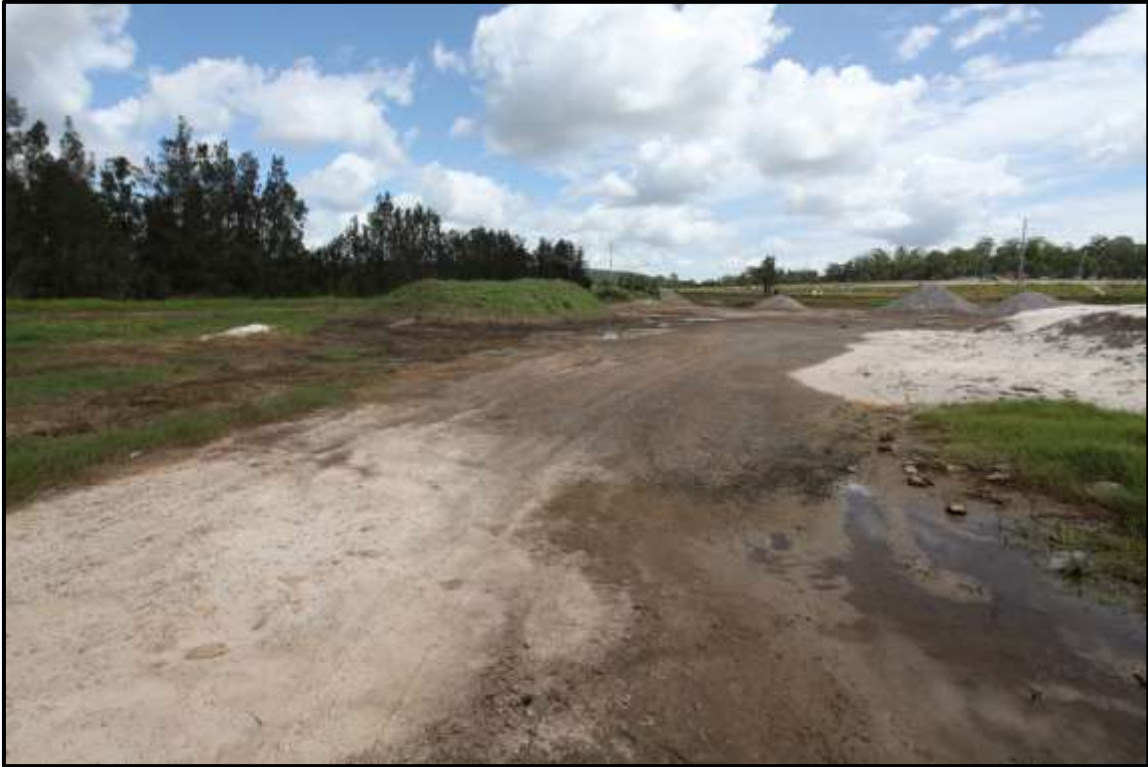
Figure 10: Simple formed access and soil stockpiles.

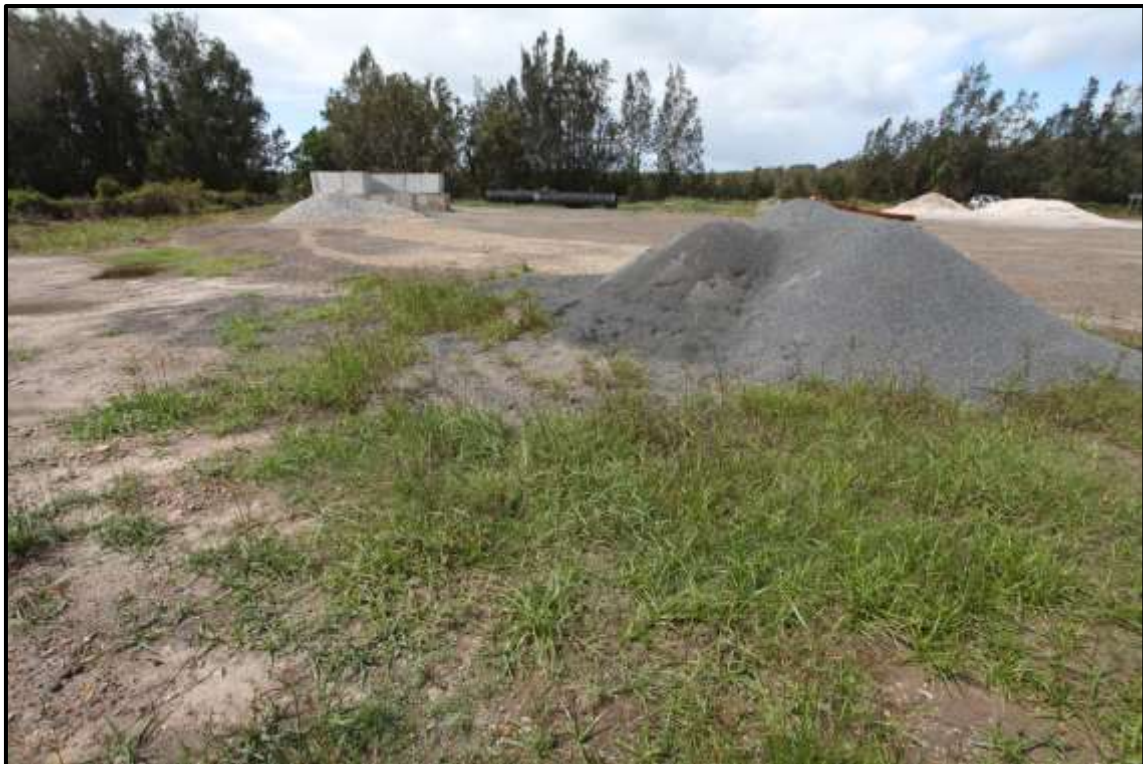
Figure 11: Council stockpile area with grass cover.

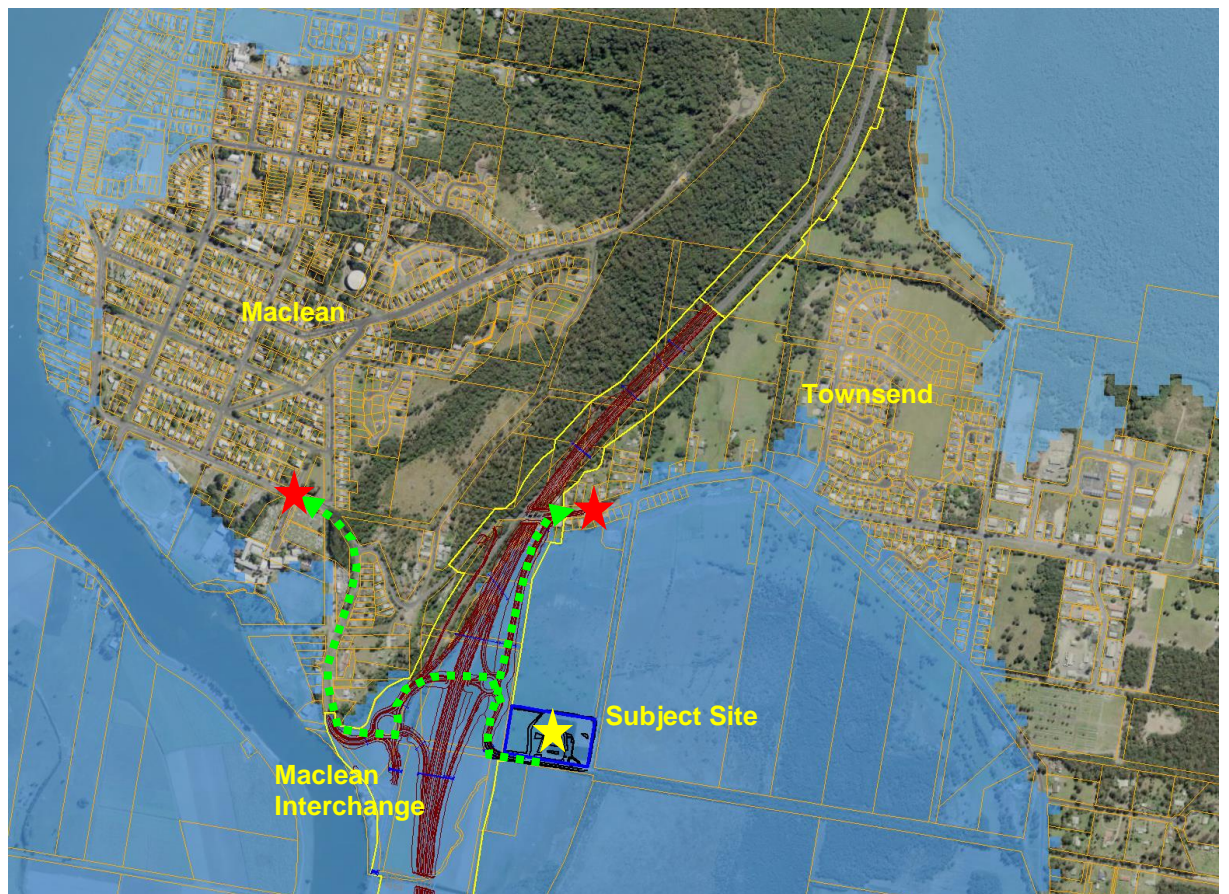
Volume 4 Traffic & Parking Assessment

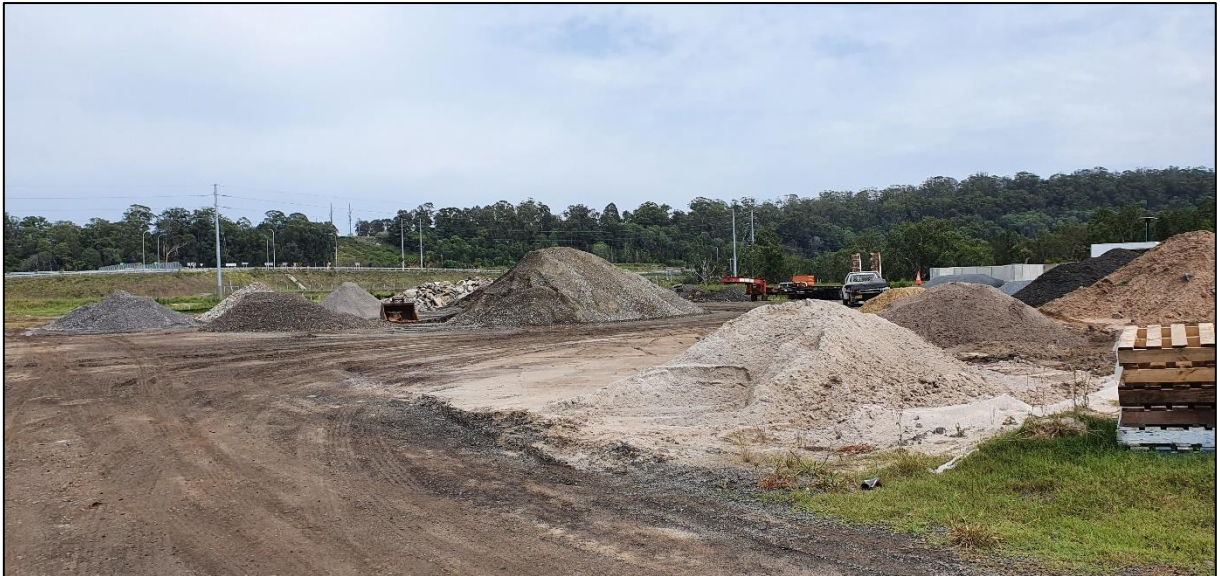
**Figure 1: From the eastern part of the site looking north-west.**

The site (Figure 1) is located at 2 Schwonberg Street, Townsend, as shown on Drawing 1 in Appendix D. The site is relatively flat and low lying. The north-eastern part of the site contained some stockpiles of soil and gravel. There is a vacant low-lying paddock to the north of the site, Schwonberg Street to the east, Goodwood Street to the south and a low lying paddock and the Pacific Highway to the west.

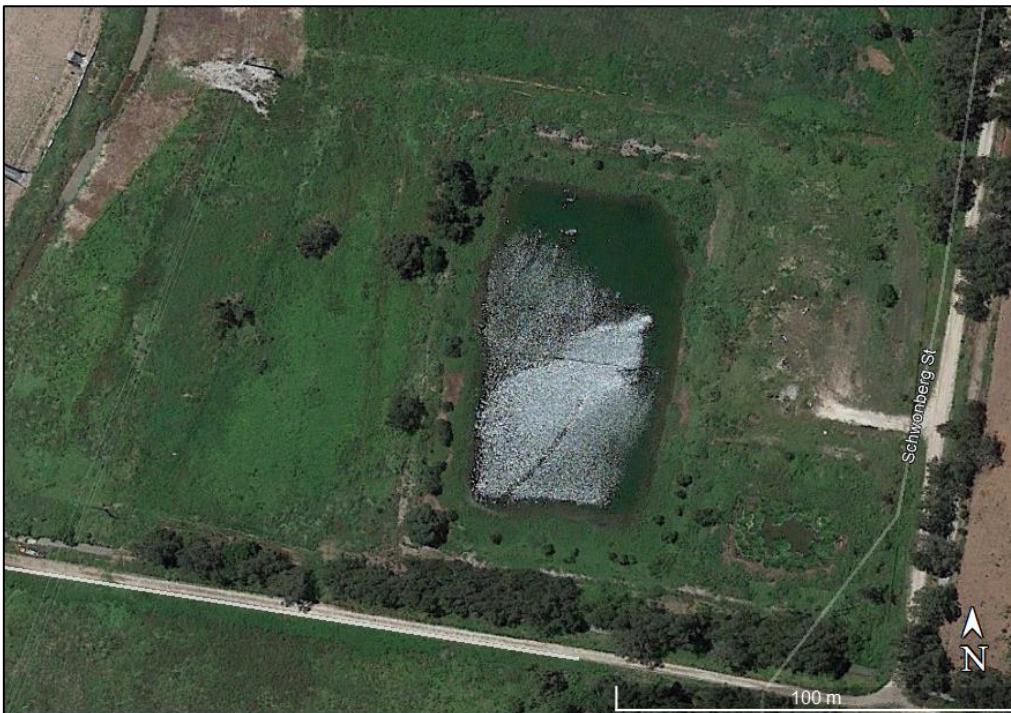
Reference to Google Earth aerial imagery (Figure 2) indicates that there were previously two ponds at the site, which was part of the Maclean-Townsend sewerage scheme. It is understood that the ponds were remediated about 2018.

**Figure 2: Google Earth aerial imagery dated 14 December 2017.**

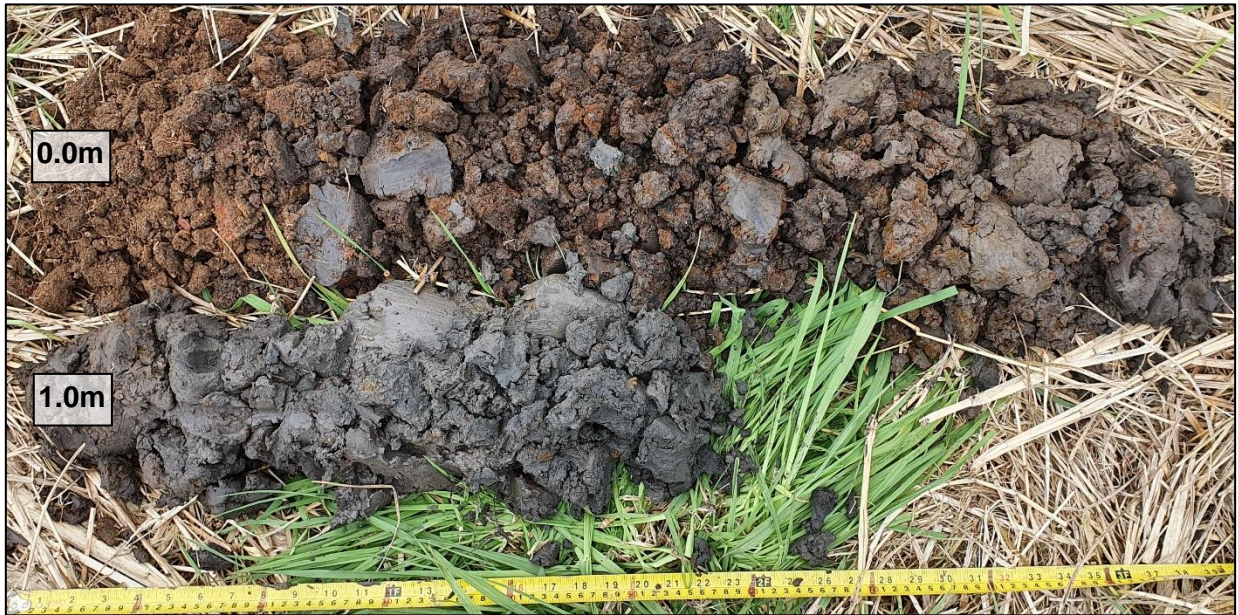
The auger cuttings obtained while drilling Bore 3 are shown in Figure 4.

**Figure 4:** Bore 1 auger cuttings.

Groundwater was observed at 0.9 m to 1.4 m depth in Bores 2 to 4 and 7. There was no groundwater observed in Bore 1 whilst augering. The remnant CPT holes collapsed at 0.8 m to 1.4 m upon withdrawal of the CPT rods. It should be noted that groundwater levels are affected by factors such as climatic conditions and soil permeability and will vary with time.
