### **Randwick Junction Draft Heritage Items**

Inventory Sheets and Heritage Study

## **Randwick Junction Inventory Sheets – Draft Heritage Items**

# Heritage Conservation Area Review

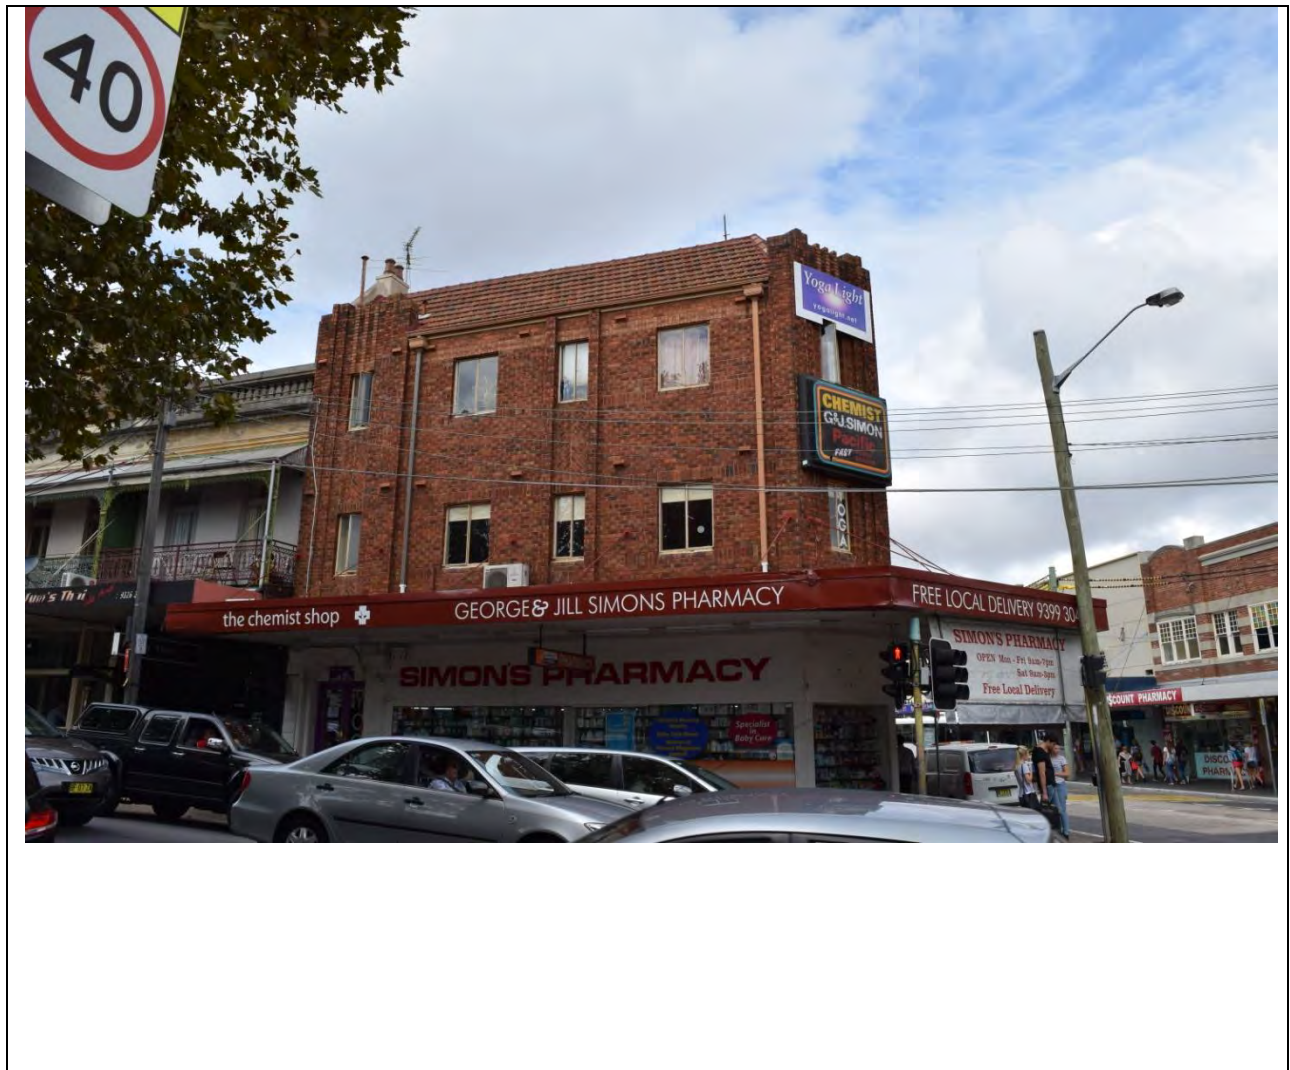
<b>Physical condition and Archaeological potential</b>	Overall the exterior of the building appears to be in good condition with few signs of material decay. The building is heavily covered in intrusive advertising, particularly on the splayed corner facade and most of the below awning facade.					
<b>Construction years</b>	<b>Start year</b>	1923	<b>Finish year</b>	1923	<b>Circa</b>	<input checked="" type="checkbox"/>
<b>Modifications and dates</b>	The original Victorian Filigree building constructed on the site was partially demolished in the early 1920's to make way for the current building.					
<b>Further comments</b>	It is recommended that the above awning facade and the pressed metal awning soffit be listed as heritage item on the Randwick Local Environmental Plan (LEP) 2012 as little interior fabric of significance remains.

Image caption	The Inter-War Art Deco building on the corner of Alison and Belmore Roads.				
Image year	2015	Image by	City Plan Heritage	Image copyright holder	Randwick City Council

<b>Recommendations</b>	<p>It is recommended that only the above awning facade and awning are to be listed on Schedule 5 of the Randwick LEP 2012. It is further recommended that the upper level signage on the splayed corner be removed as it obscures much of the significant fabric.</p> <p>A Heritage Assessment or Heritage Impact Statement should be prepared for the building prior to any major works being undertaken. Archival photographic recording, in accordance with the Heritage Office publication <a href="#">Photographic Recording Of Heritage Items Using Film or Digital Capture</a>, should be undertaken before major changes.</p>
------------------------	---

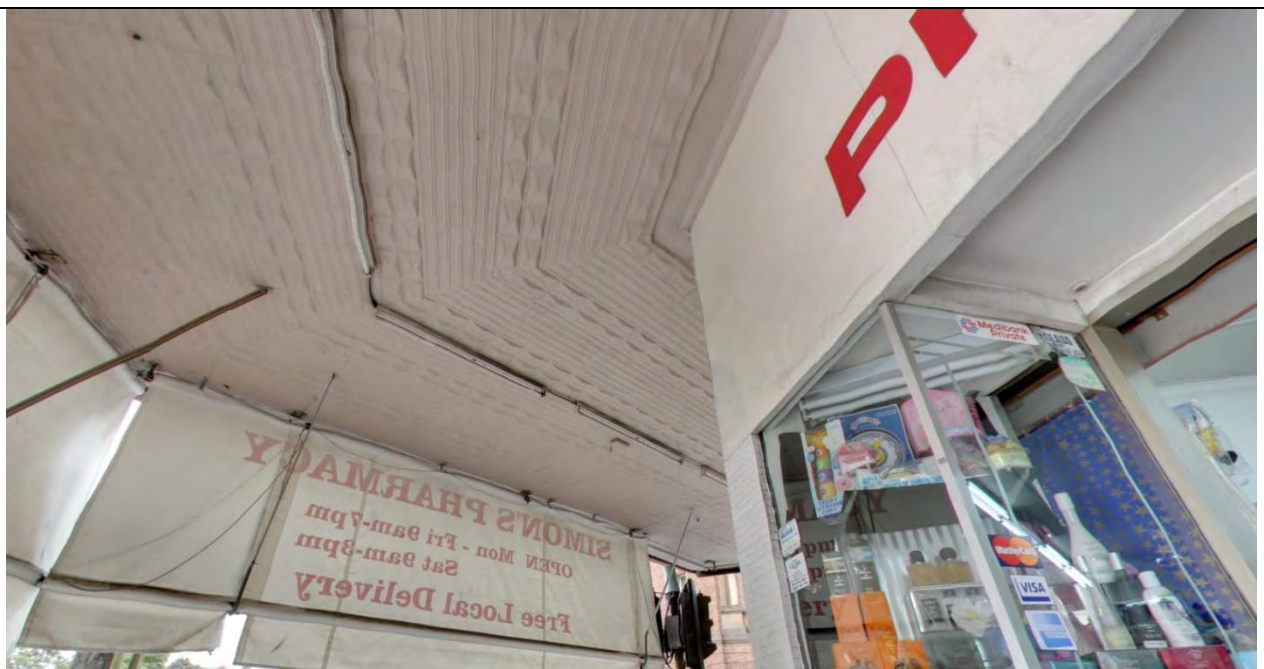
<b>Image caption</b>	The original 1920's pressed metal soffit still in good condition under the awning.				
<b>Image year</b>	2015	<b>Image by</b>	City Plan Heritage	<b>Image copyright holder</b>	Randwick City Council

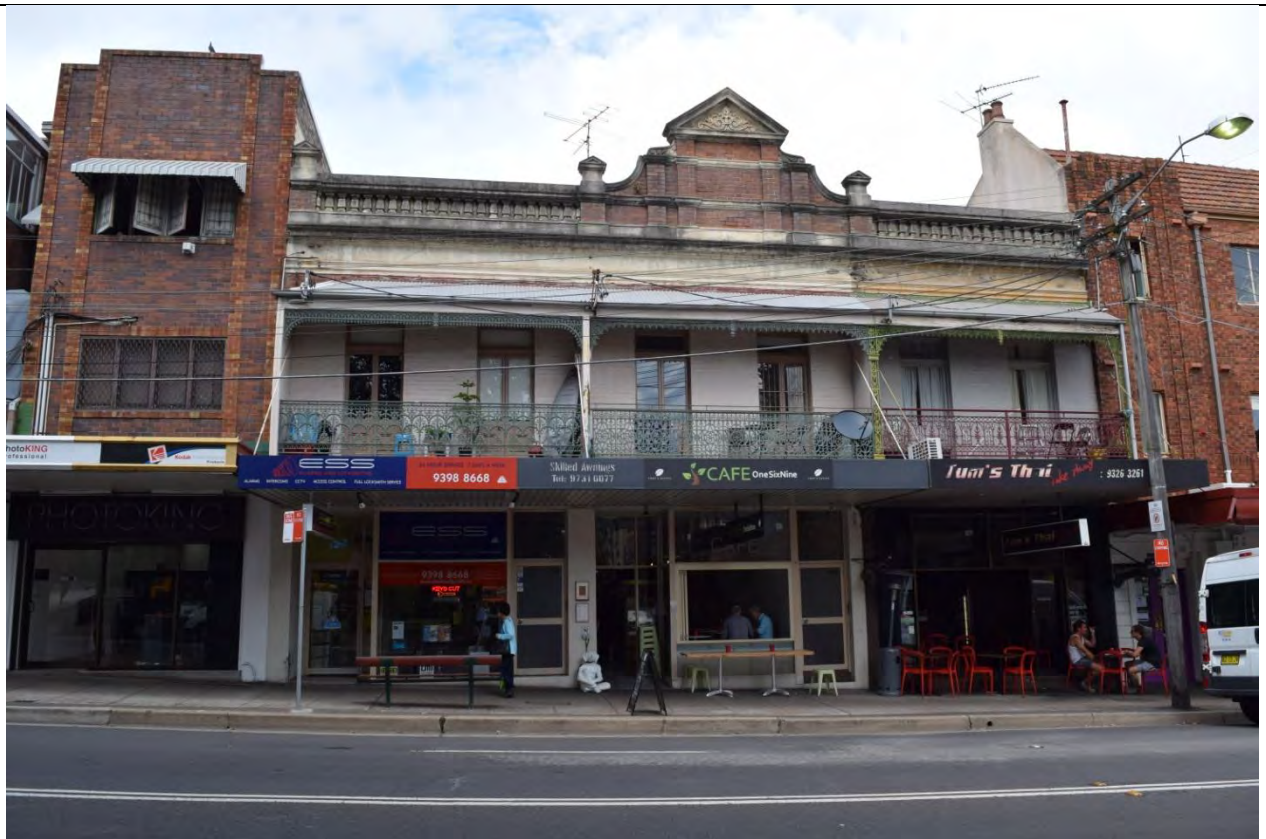
Physical condition and Archaeological potential	The first floor facade and the classically detailed decorative parapet with central pediment appear to be in good condition aside from the unsightly patina on the sandstone. Two of the wrought iron balcony posts are missing with the remaining showing some signs of deterioration.					
Construction years	Start year	1887	Finish year	1887	Circa	<input checked="" type="checkbox"/>
Modifications and dates	<p>The subject building was originally part of a larger corner building that was demolished in the 1920's. During this demolition a large corrugated iron corner balcony supported on posts was also removed. The original balcony can be seen in Image 6. The subject building has also undergone a series of alterations predominately associated with the change of use for ground floor tenancies:</p> <p><b>167 Alison Road</b></p> <ul style="list-style-type: none"> <li>• 1986 – Alterations to convert the first floor area into an office space</li> <li>• 1999 – Extension of outdoor seating for existing restaurant</li> </ul> <p><b>169 Alison Road</b></p> <ul style="list-style-type: none"> <li>• 2000 – Outdoor seating installed</li> <li>• 2008 – Refurbishment and upgrade of existing commercial and residential tenancies including the subdivision of the property into two lots</li> <li>• 2009 – Installation of a stairway between 167-169 Alison Road</li> <li>• 2010 – Fit out and change of use to a cafe</li> </ul>

<b>Image caption</b>	167-171 Alison Road taken from the opposite side of the Road.				
<b>Image year</b>	2015	<b>Image by</b>	City Plan Heritage	<b>Image copyright holder</b>	Randwick City Council

<b>Recommendations</b>	<p>Listing of the building on Schedule 5 of the Randwick LEP 2012 as a Heritage Item is recommended.</p> <p>Full interior inspection should be undertaken on this building to establish if any significant original elements dating from the 1887 construction remain. An inspection of the ornate parapet is further recommended to detect and repair any deterioration of the face brick and sandstone.</p> <p>A Heritage Assessment or Heritage Impact Statement should be prepared for the building prior to any major works being undertaken. Archival photographic recording, in accordance with the Heritage Office publication <a href="#">Photographic Recording Of Heritage Items Using Film or Digital Capture</a>, should be undertaken before major changes.</p>
------------------------	---

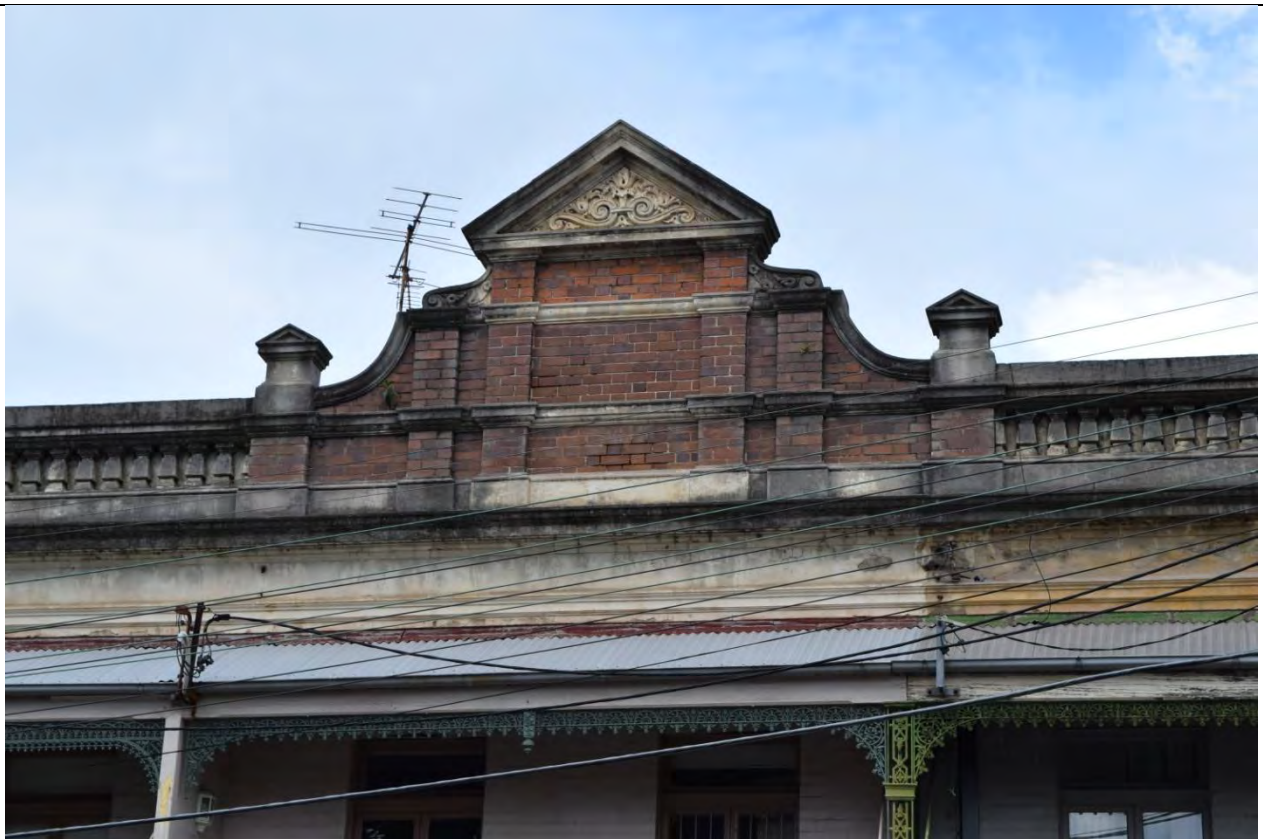
<b>Image caption</b>	A detailed view of the ornate parapet.				
<b>Image year</b>	2015	<b>Image by</b>	City Plan Heritage	<b>Image copyright holder</b>	Randwick City Council

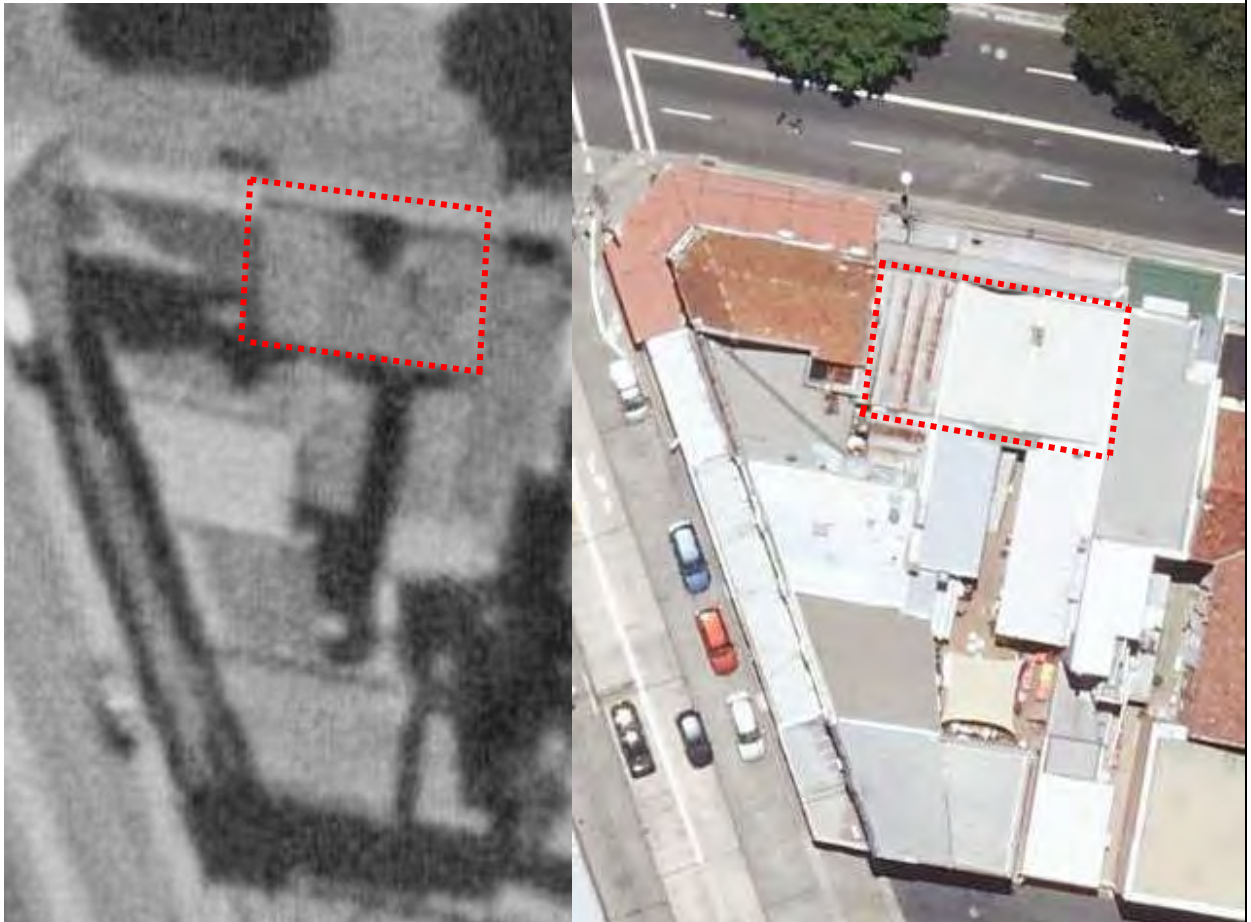
<b>Image caption</b>	A 1943 aerial of the subject site (left) and the current aerial image (right) show little change since this period.				
<b>Image year</b>	1943 & 2015	<b>Image by</b>	SixMaps	<b>Image copyright holder</b>	SixMaps 2015

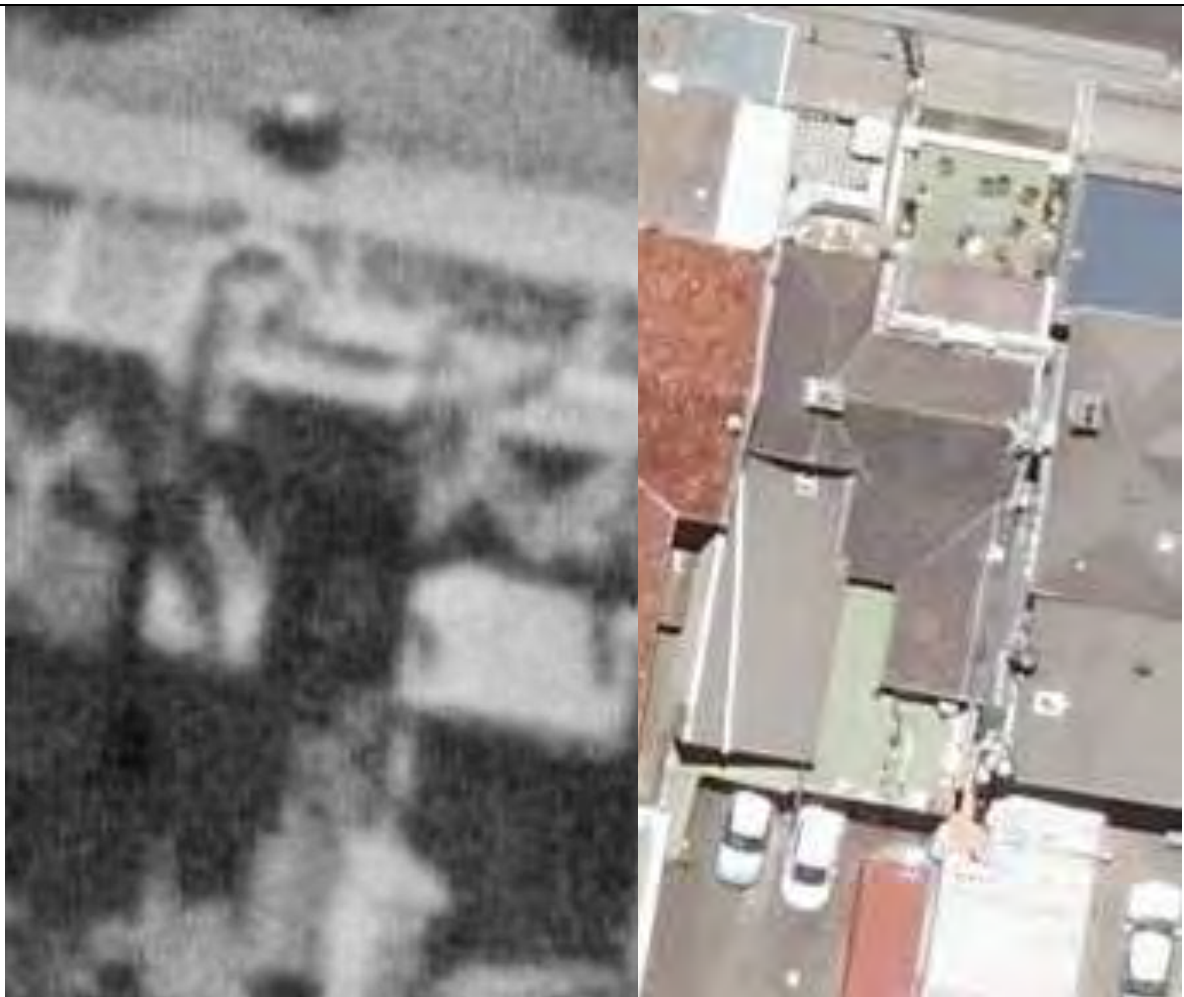
<b>Image caption</b>	The 1943 aerial of the subject site (left) shows the subject building without the front commercial addition. The current aerial image (right) show substantial alterations to front and rear of the subject building.				
<b>Image year</b>	1943 & 2015	<b>Image by</b>	SixMaps 2015	<b>Image copyright holder</b>	SixMaps

Physical condition and Archaeological potential	The remaining exterior fabric of 'Montrose' is generally in good condition. Advertising from the current tenant 'Randwick Cellars' obscures some of the significant architectural elements. A large telegraph pole outside the property boundary further obscures the subject buildings architectural features.					
Construction years	Start year	1888	Finish year	1888	Circa	<input checked="" type="checkbox"/>
Modifications and dates	Pre-1980's - The subject site underwent modifications to become a bottle shop, during this period it is likely the front retail section of the property was added.					
Further comments

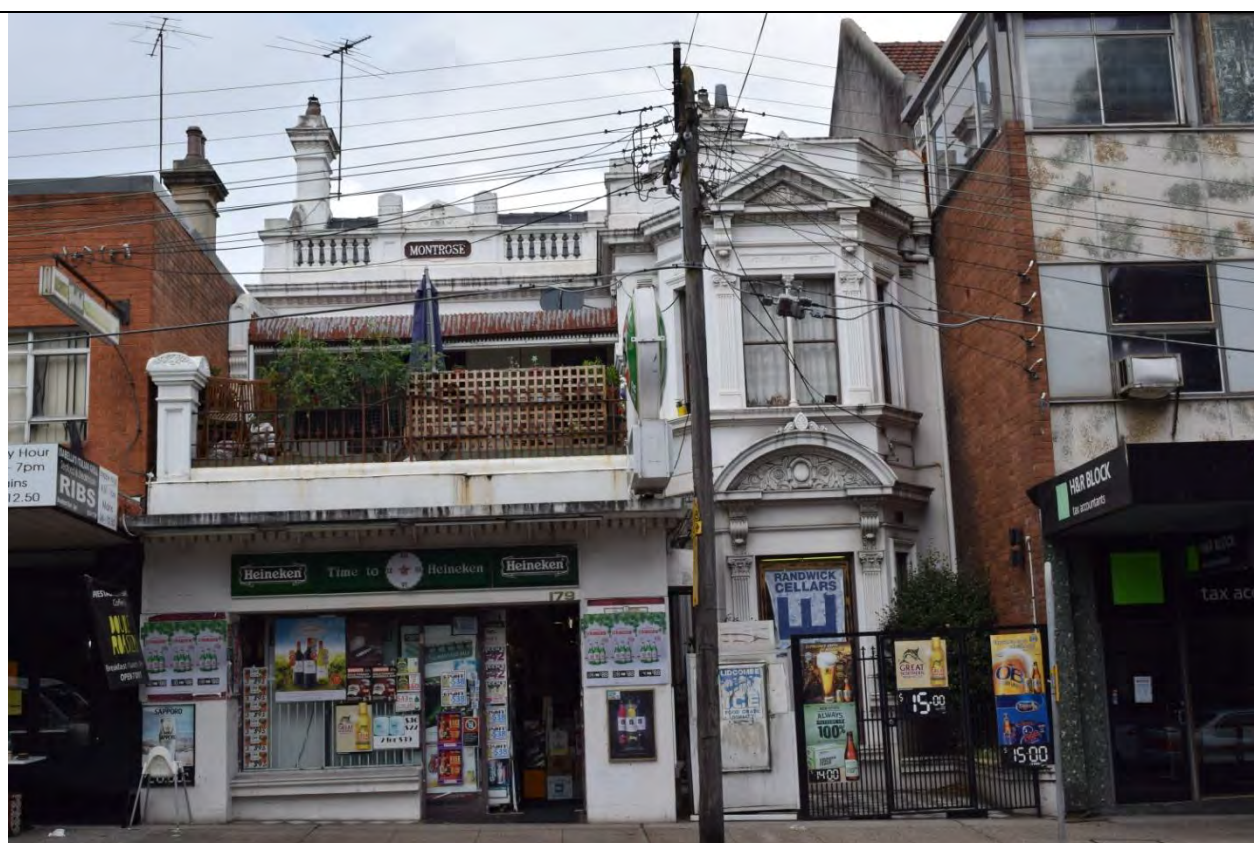
<b>Image caption</b>	The Victorian Italianate building known as 'Montrose' is viewed from Alison Road				
<b>Image year</b>	2015	<b>Image by</b>	City Plan Heritage	<b>Image copyright holder</b>	Randwick City Council

<b>Recommendations</b>	<p>It is recommended that the building be listed as a Heritage Item on Schedule 5 of the Randwick LEP 2012.</p> <p>The amount of advertising signage from the bottle shop should be reduced as it detracts from the significant Victorian Italianate presentation of the building.</p> <p>The building should be retained and conserved. A Heritage Assessment or Heritage Impact Statement should be prepared for the building prior to any major works being undertaken. Archival photographic recording, in accordance with the Heritage Office publication <a href="#">Photographic Recording Of Heritage Items Using Film or Digital Capture</a>, should be undertaken before major changes.</p>
------------------------	---

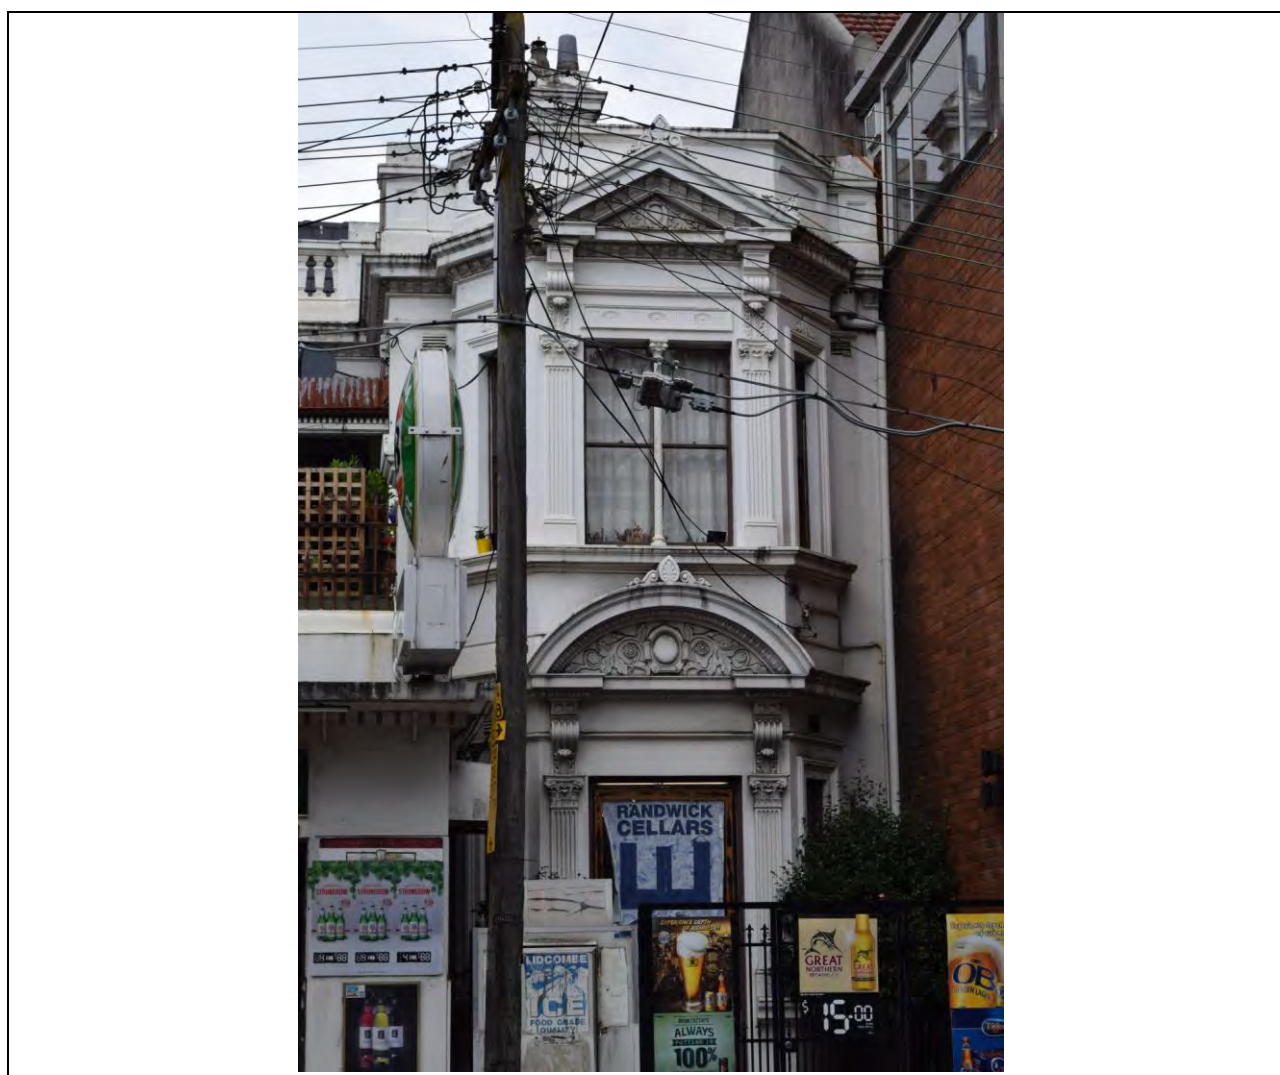
<b>Aesthetic significance</b> SHR criteria (c)	The facade of 'Montrose' is largely intact featuring Victorian Italianate architectural elements creating aesthetically distinctive building along Alison Road. Much of the original mouldings and embellishments are intact and in good condition.
<b>Social significance</b> SHR criteria (d)	The subject building has no known associations with a specific historically significant community or cultural group.
<b>Technical/Research significance</b> SHR criteria (e)	The research conducted to date does not indicate any potential for archaeological resource. The building, however, has potential to yield information on the construction system of the Victorian Italianate buildings.
<b>Rarity</b> SHR criteria (f)	The building is an architecturally distinctive Victorian Italianate style terrace featuring the key characteristics of the style that was once immensely popular in Australia as a domestic style and influenced the rapidly expanding suburbs of the 1870-1880s. Many examples of this style survive within the Randwick Junction Heritage Conservation Area and therefore this building is not considered a rare example of its type.

<b>Image caption</b>	A detailed view of the ornate faceted bay of 'Montrose'				
<b>Image year</b>	2015	<b>Image by</b>	City Plan Heritage	<b>Image copyright holder</b>	Randwick City Council

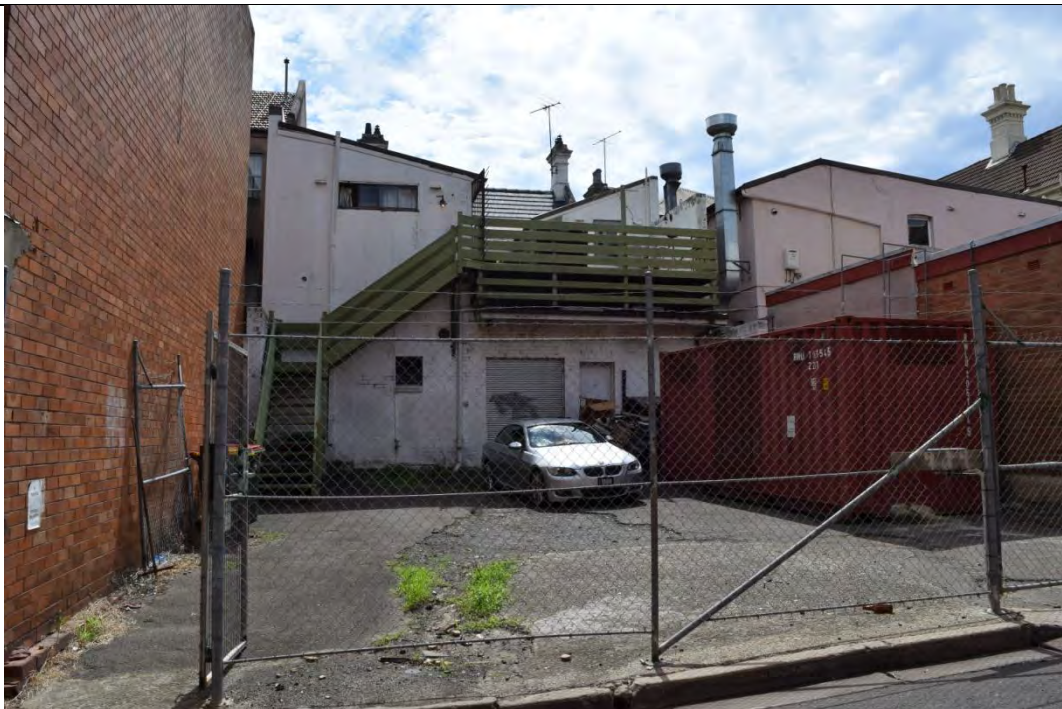
<b>Image caption</b>	Rear of the property, viewed from Bells Lane				
<b>Image year</b>	2015	<b>Image by</b>	City Plan Heritage	<b>Image copyright holder</b>	Randwick City Council

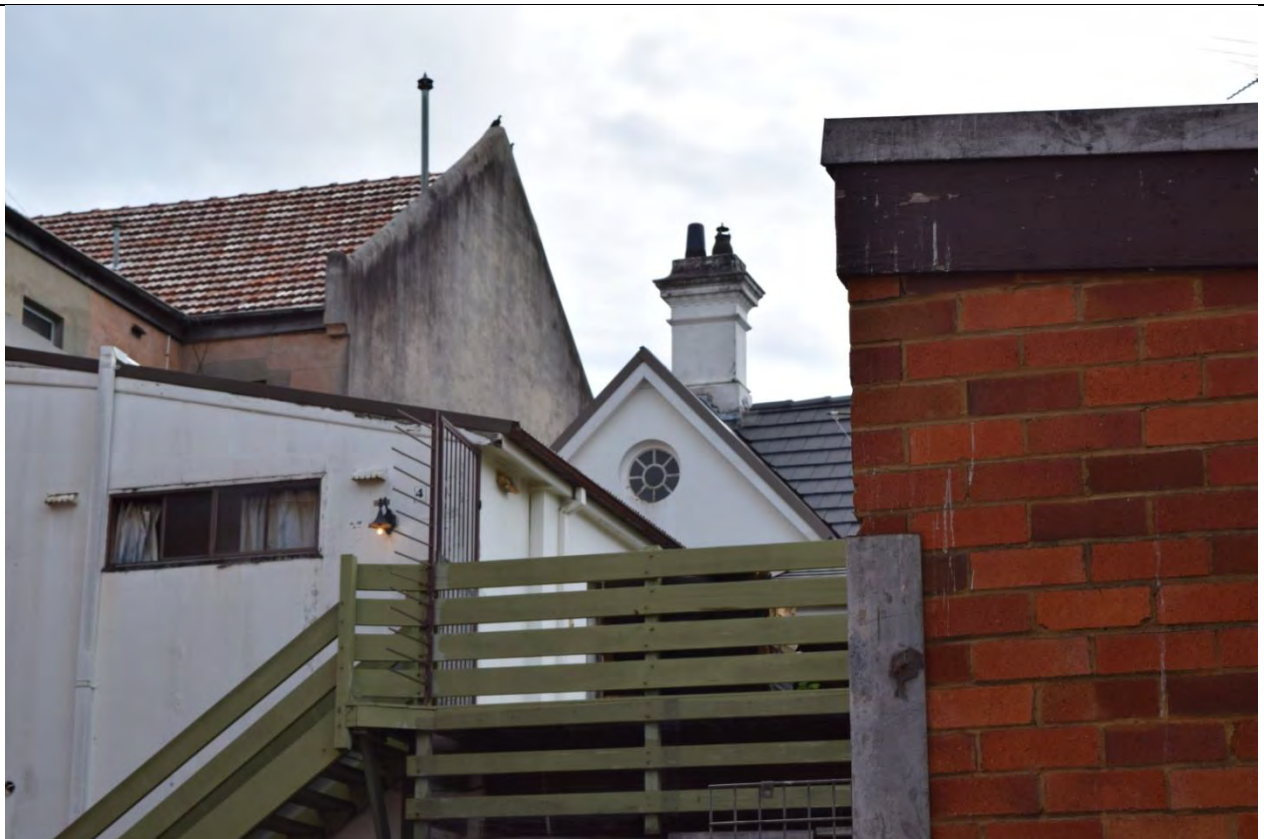
<b>Image caption</b>	Rear of property, viewed from Bells Lane				
<b>Image year</b>	2015	<b>Image by</b>	City Plan Heritage	<b>Image copyright holder</b>	Randwick City Council

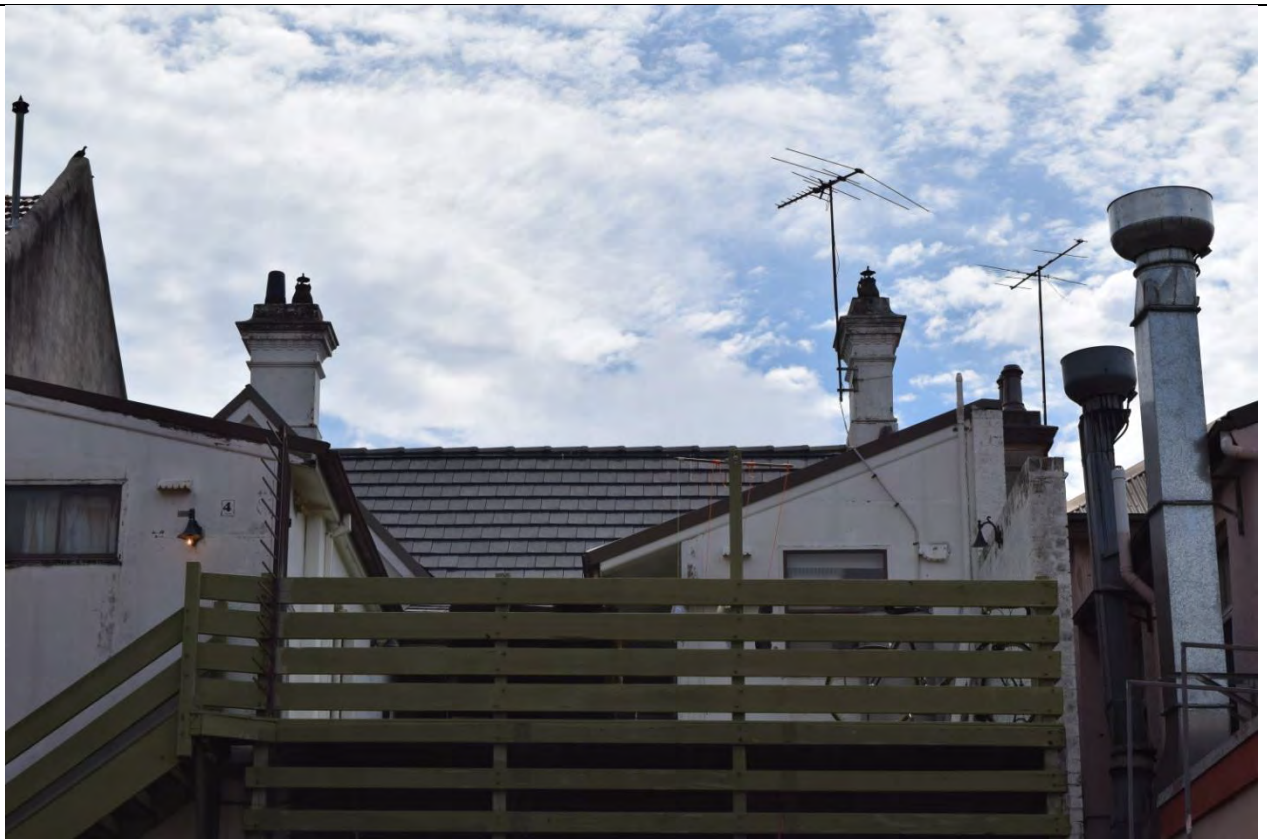
<b>Image caption</b>	Rear of property, viewed from Bells Lane				
<b>Image year</b>	2015	<b>Image by</b>	City Plan Heritage	<b>Image copyright holder</b>	Randwick City Council

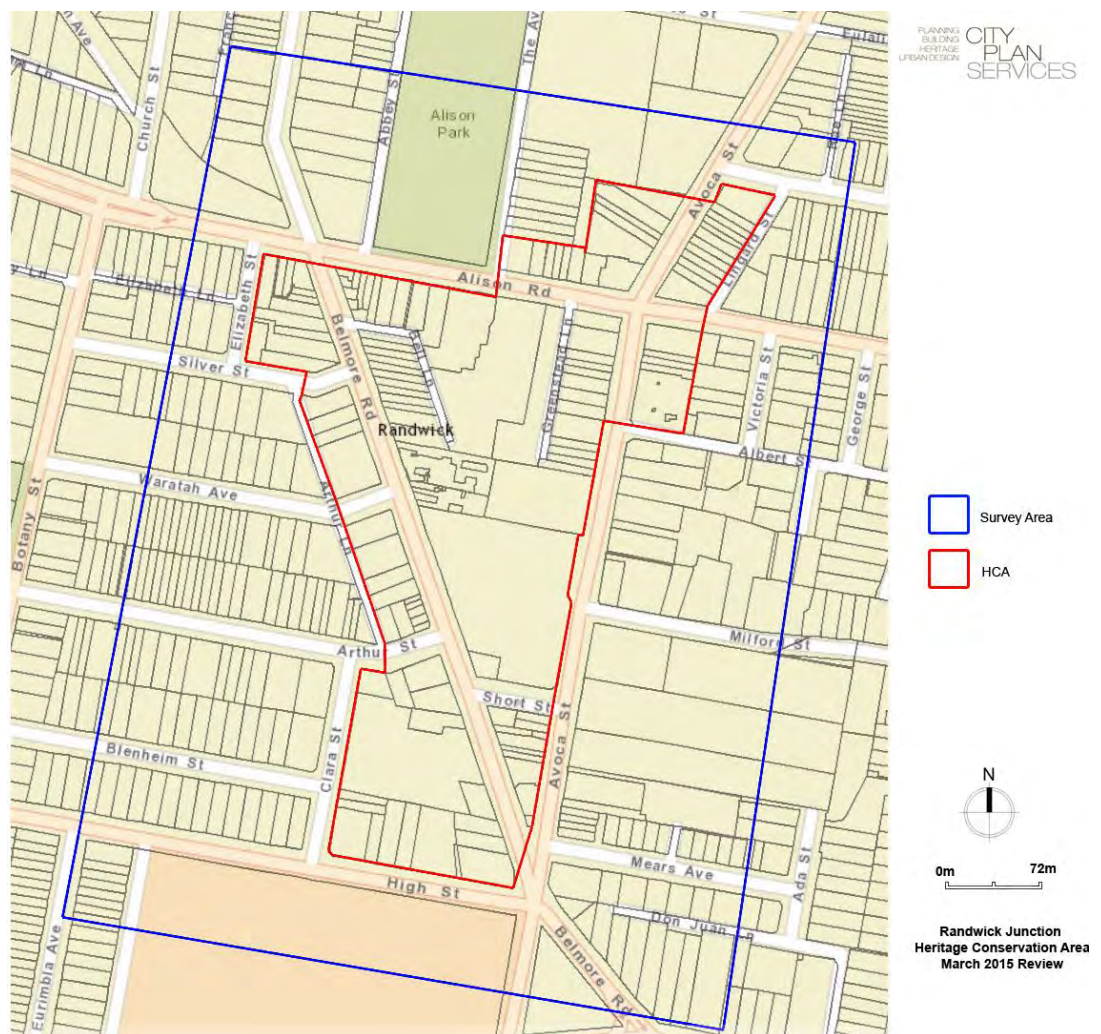
Figure 1: Extent of the Study Area around the Randwick Junction Heritage Conservation Area

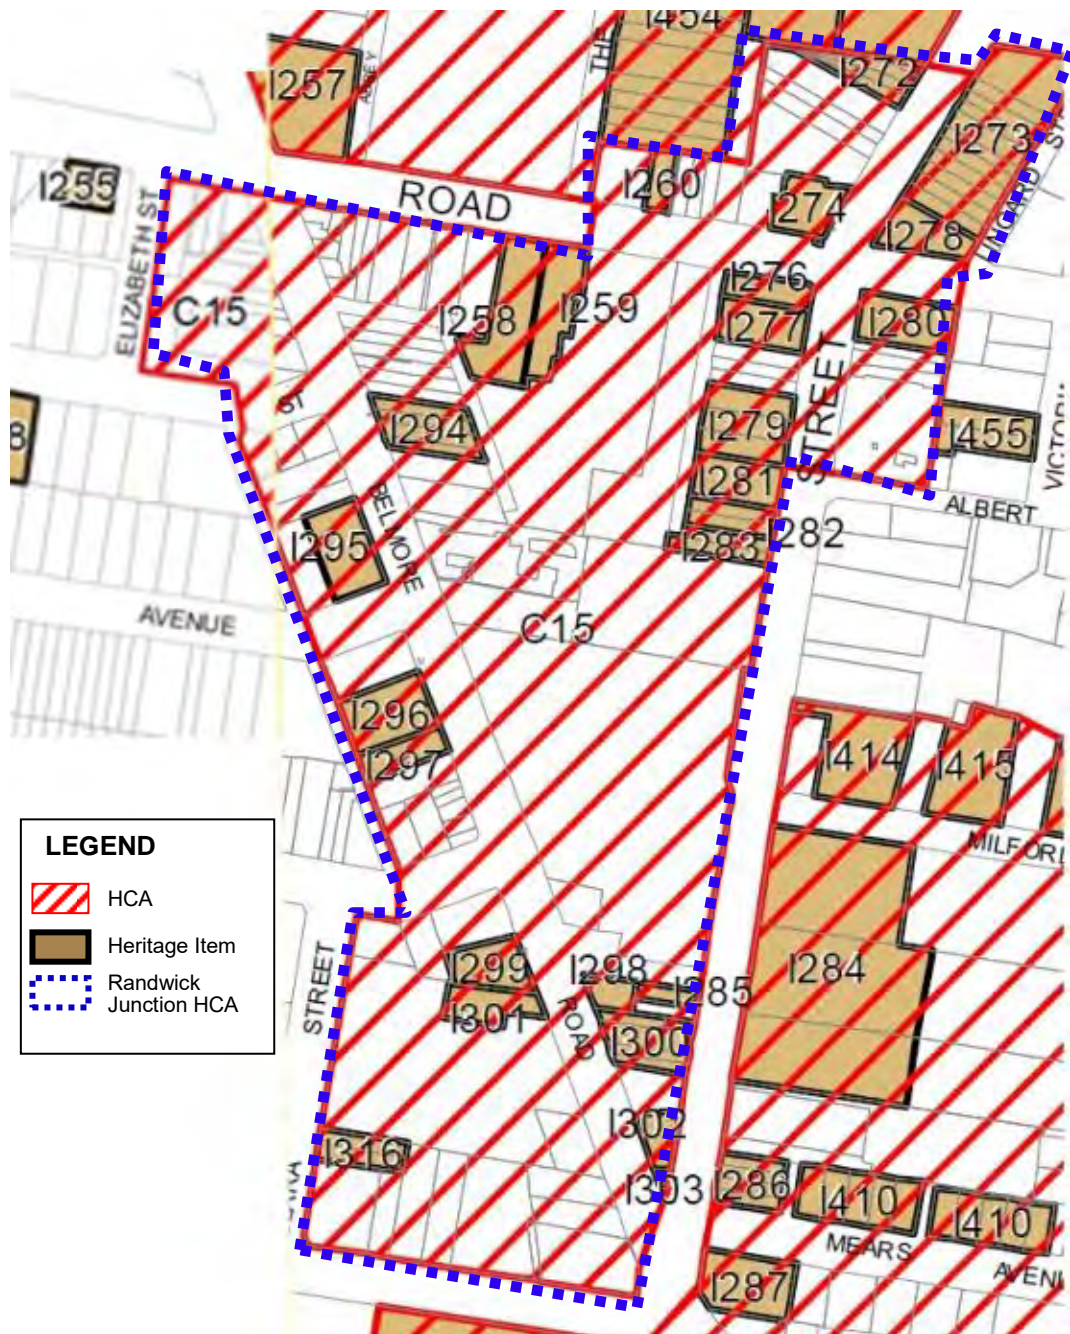
Figure 14: Excerpt from the Randwick Heritage Maps sheets 2 and 7 showing the existing Heritage Items within the boundaries of the Randwick Junction HCA (defined in dark blue dashed line for clarity). (Source: Randwick City Council LEP 2012).

- The entire allotment at 60 Belmore Road (SP7779), including the address known as 25 Waratah Avenue, should be included in the curtilage of Heritage Item No. I295

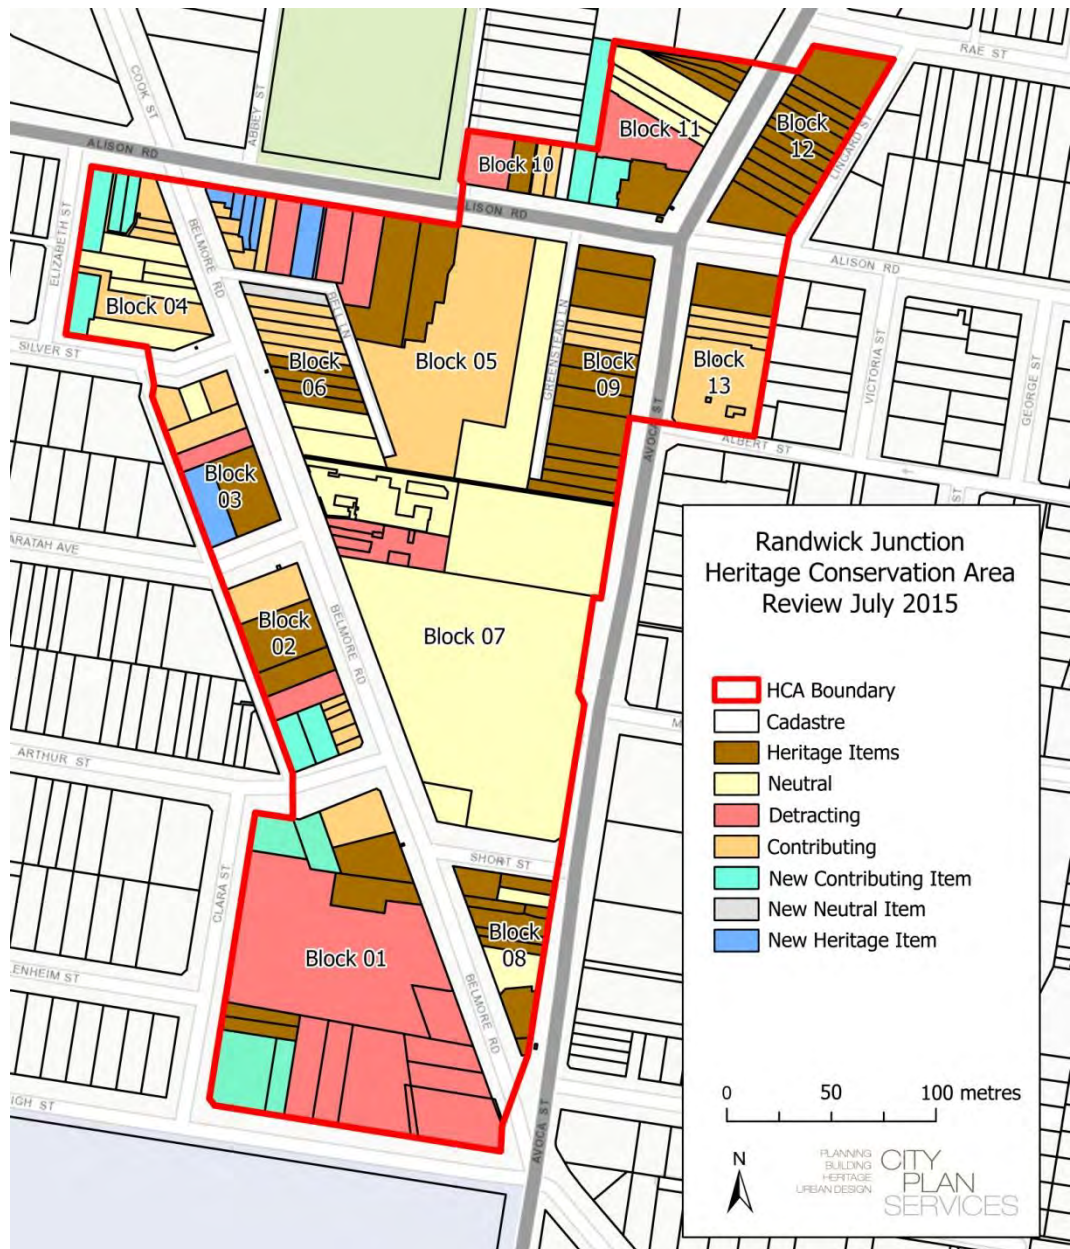
Figure 15: Survey Grading. See Appendix 6 for A3 Map (Source: City Plan Heritage, Cadastre supplied by Randwick City Council).

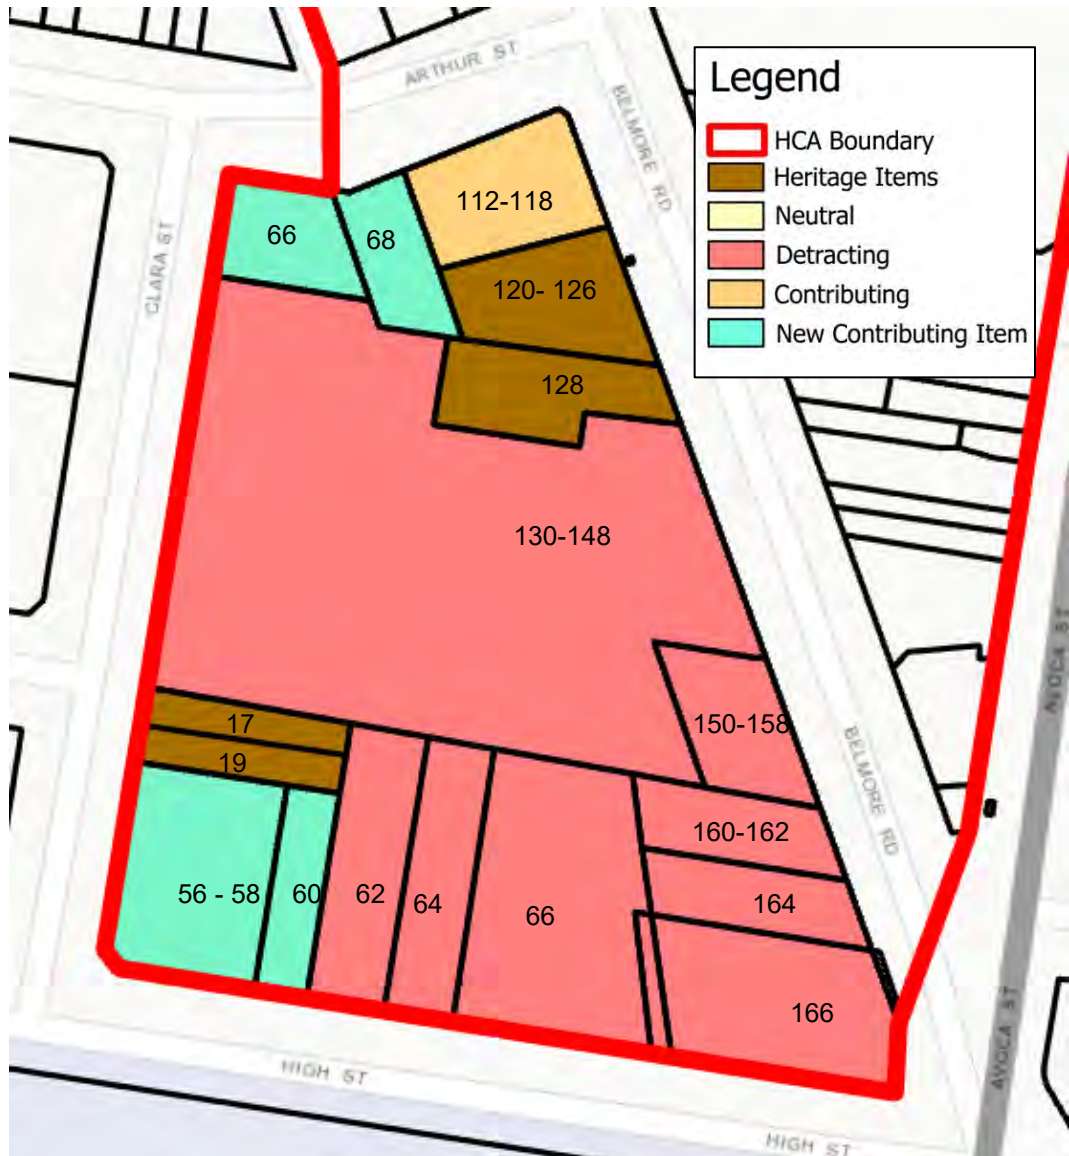
Block 01 is bounded by High, Clara and Arthur Streets, and Belmore Road. It is dominated by the Randwick Plaza and its associated facilities marking the southern end of the Randwick Junction HCA. Notwithstanding, the northern edge along Arthur Street and south western corner of the block are occupied by Heritage Items and Contributing buildings that significantly add to the heritage character of the Randwick Junction HCA through their mainly Inter-War, and Federation and Victorian residential architectural style and intact fabric. At the northern end of the block, several buildings have been sympathetically adapted for commercial uses (namely 68 Arthur Street). These modifications are representative of the changing character of the municipality and the increasing demand for retail and commercial uses within the Randwick Junction HCA.

Figure 16: Detail of Block 01 showing contributions (Source: City Plan Heritage)

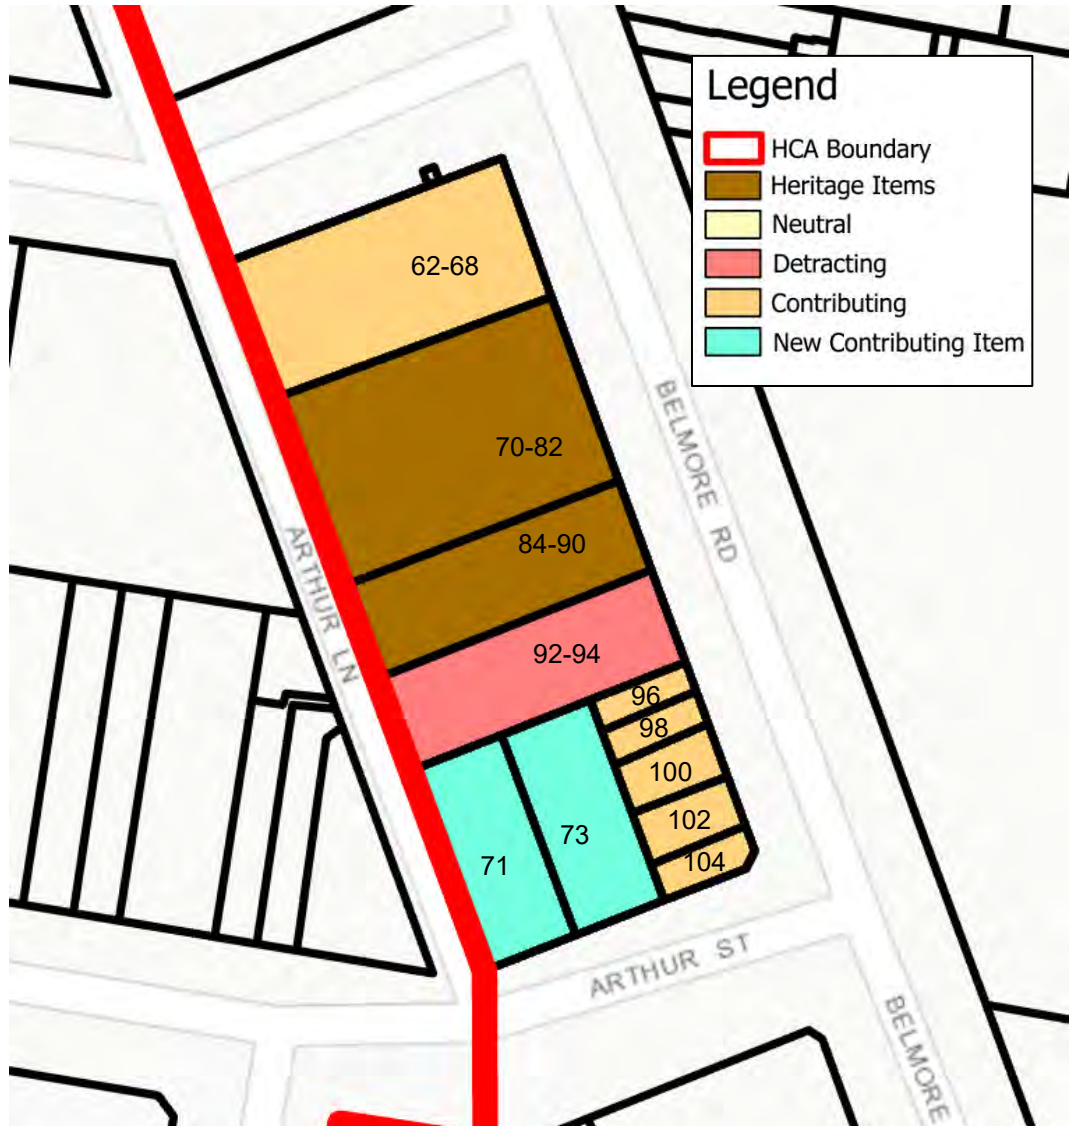
Block 02 is a small rectangular block bounded by Arthur Street to the south, Arthur Lane to the west, Waratah Avenue to the north and Belmore Road to the east. With the exception of one building (84-90 Belmore Road), the entire block consists of significant Inter-War residential flat and commercial buildings including two Heritage Items. The bulk of the properties are Contributing and essentially present three-storey building scale and highly decorated facade fenestrations that contrast with the neutral character of the Royal Randwick Shopping Centre on the opposite side of Belmore Road.

Figure 17: Detail of Block 02 showing contributions (Source: City Plan Heritage)

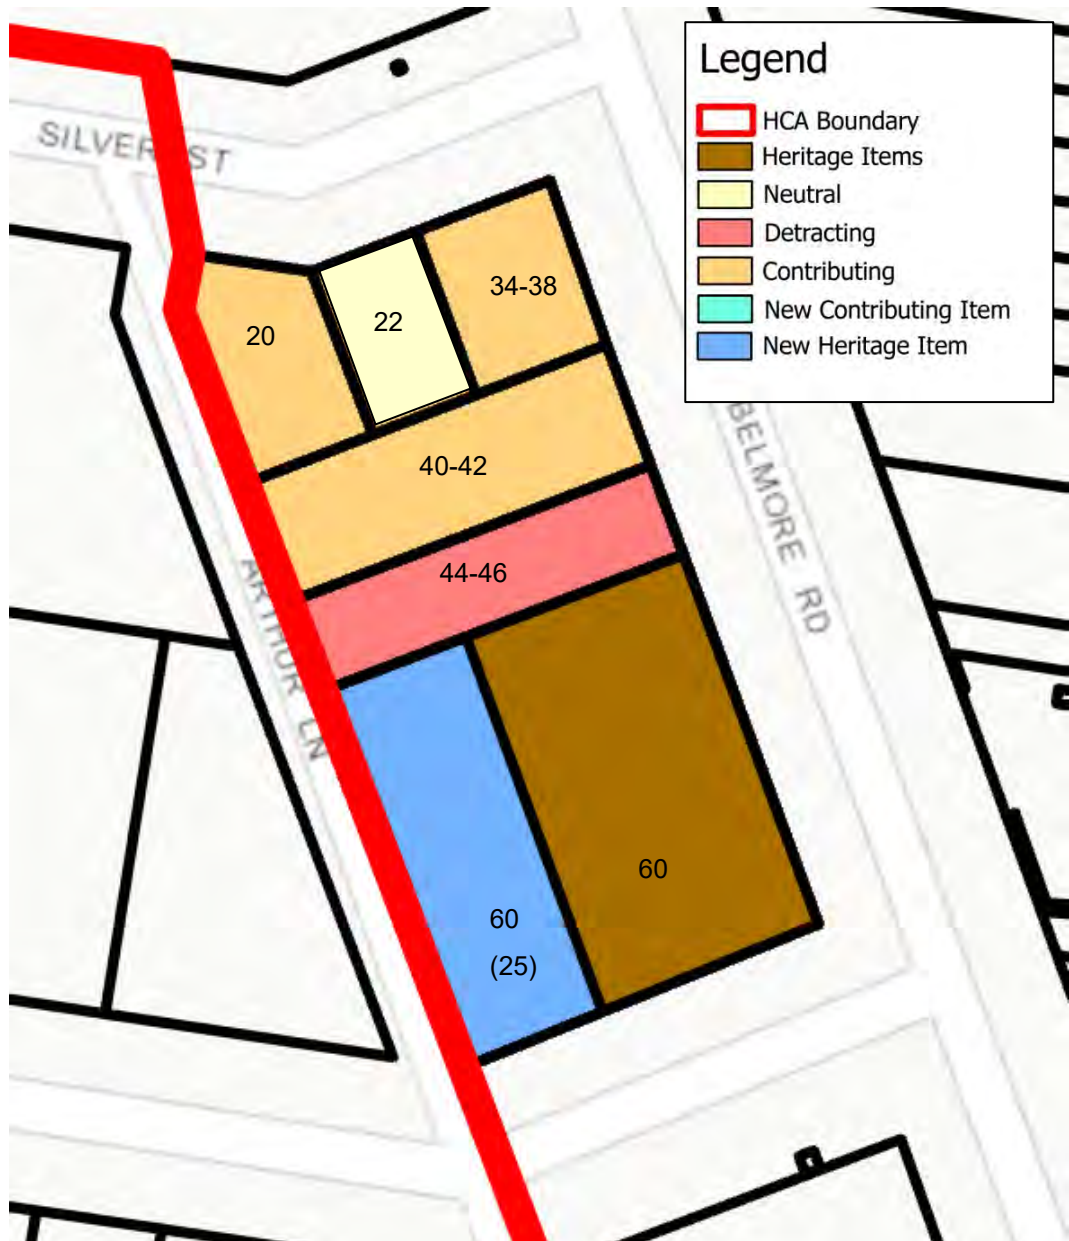
Block 03 is similar to Block 02 in terms of rectangular shape, small size and concentration of significant building stock. The Block has only one detracting element with the remainder being Contributing Items and a Heritage Item spanning along the half length of Belmore Road frontage of the Block. The Inter-War Art Deco residential and commercial building at Waratah Avenue corner acts as a transitional element from the three-storey, mainly residential flat developments, to the two-storey commercial strip of Belmore Road. The detracting building with its blank rendered parapet interrupts the decorative and aesthetically pleasing above awning facade fenestration of the Block. The vertical engaged piers on the facades of all Contributing Items and the Heritage Item clearly provide evidence of vertical pattern of individual bays seen throughout the Randwick Junction HCA.

Figure 18: Detail of Block 03 showing contributions (Source: City Plan Heritage)
