### **Randwick Junction Draft Heritage Items**

Inventory Sheets and Heritage Study

## **Randwick Junction Inventory Sheets – Draft Heritage Items**

# Heritage Conservation Area Review

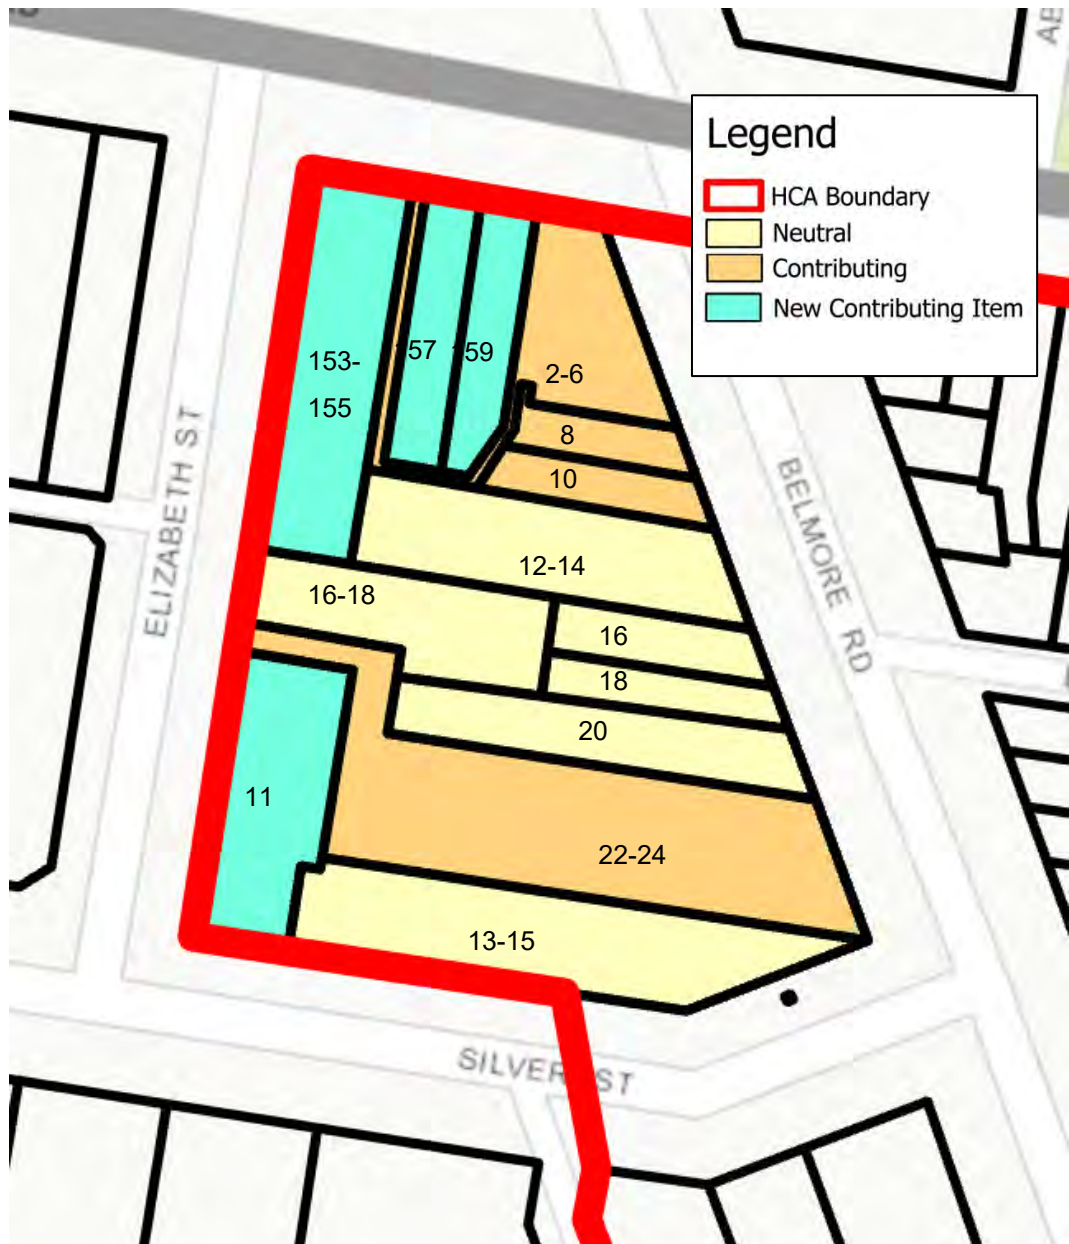
Block 04 is one of the six blocks within the Randwick Junction HCA that has no detracting element, which would adversely affect its significant characteristics. Bounded by Silver and Elizabeth Streets, and Alison and Belmore Roads this irregular Block is characterised by essentially two-storey Federation and Inter-War period residential and commercial strip featuring highly decorative segmental arched or stepped parapets, engaged piers, and ribbon windows reflecting the building's individual tenancy layout. Traditional materials and finishes of face brick with rendered or stone bands and projecting mouldings with neutral colour schemes give the dominant heritage streetscapes of the Block regardless of the unsympathetic paint finish of one building (153-155 Alison Road) and high blank parapet of another (12-14 Belmore Road). The 2008 new medical and commercial building at the corner of Silver Street and Belmore Road is considered to be a neutral infill building designed to take form of its allotment but at the same time marking the end of the block with a higher element opposite the three-storey Alkoomie Flats. Its copper like vertically panelled facades combined with vertically proportioned glazing allows somehow a comfortable presentation along the streetscapes of Belmore Road and Silver Street.

Figure 19: Detail of Block 04 showing contributions (Source: City Plan Heritage)

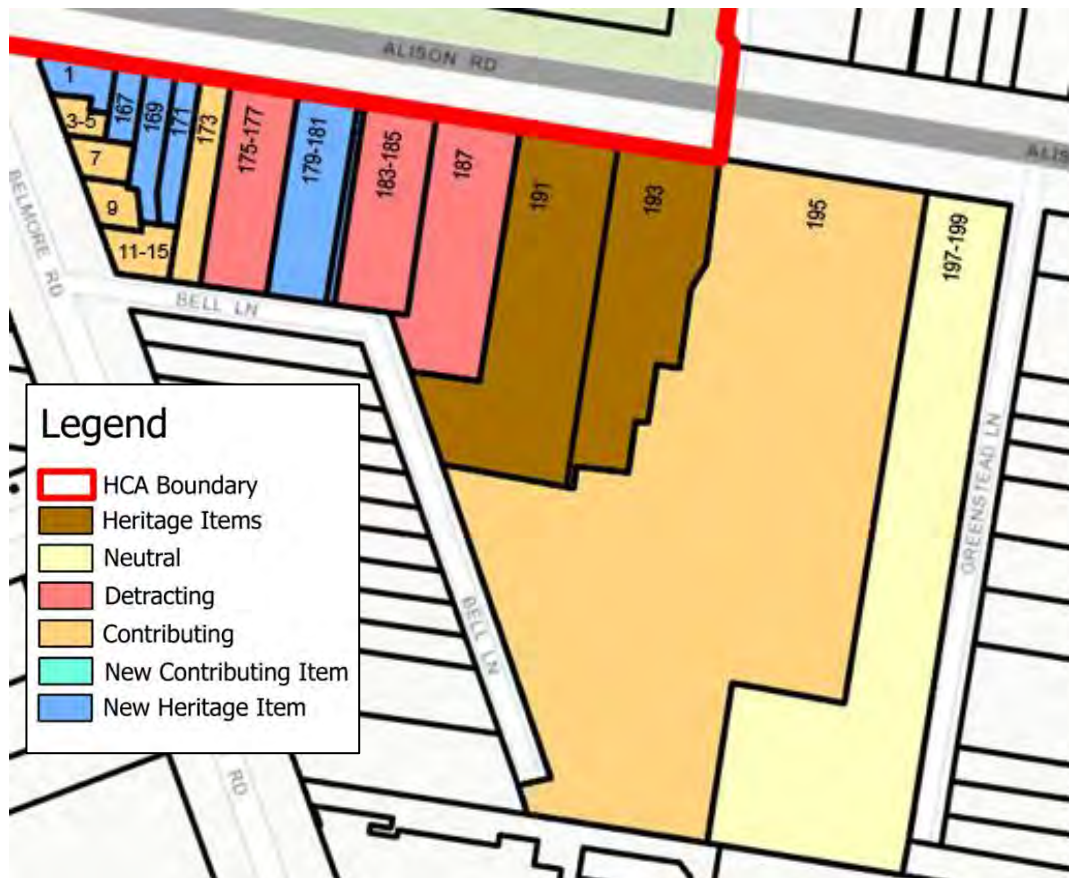
Block 05 is one of three large blocks within the Randwick Junction HCA occupying the majority of the Allison Road boundary of the Area. It is an irregular block bounded by Belmore and Alison Roads, and Bell and Greenstead Lanes adjoining the Royal Randwick Shopping Centre on the south boundary. This Block contains all periods of development that make the Randwick Junction HCA such a special and significant mixed commercial precinct. While the Alison Road frontage is dominated by the Victorian terraces and Inter-War educational buildings of residential scale and style the remainder of the Block presents a two-storey traditional shop-strip with awnings and decorative stepped parapets and well-articulated facades. This block features several detracting buildings scattered amongst Contributing Items. These detracting buildings are relatively recent developments and are readily identifiable by their uncharacteristic wall finishes and/or fenestration above awning level.

Figure 20: Detail of Block 05 showing contributions (Source: City Plan Heritage)

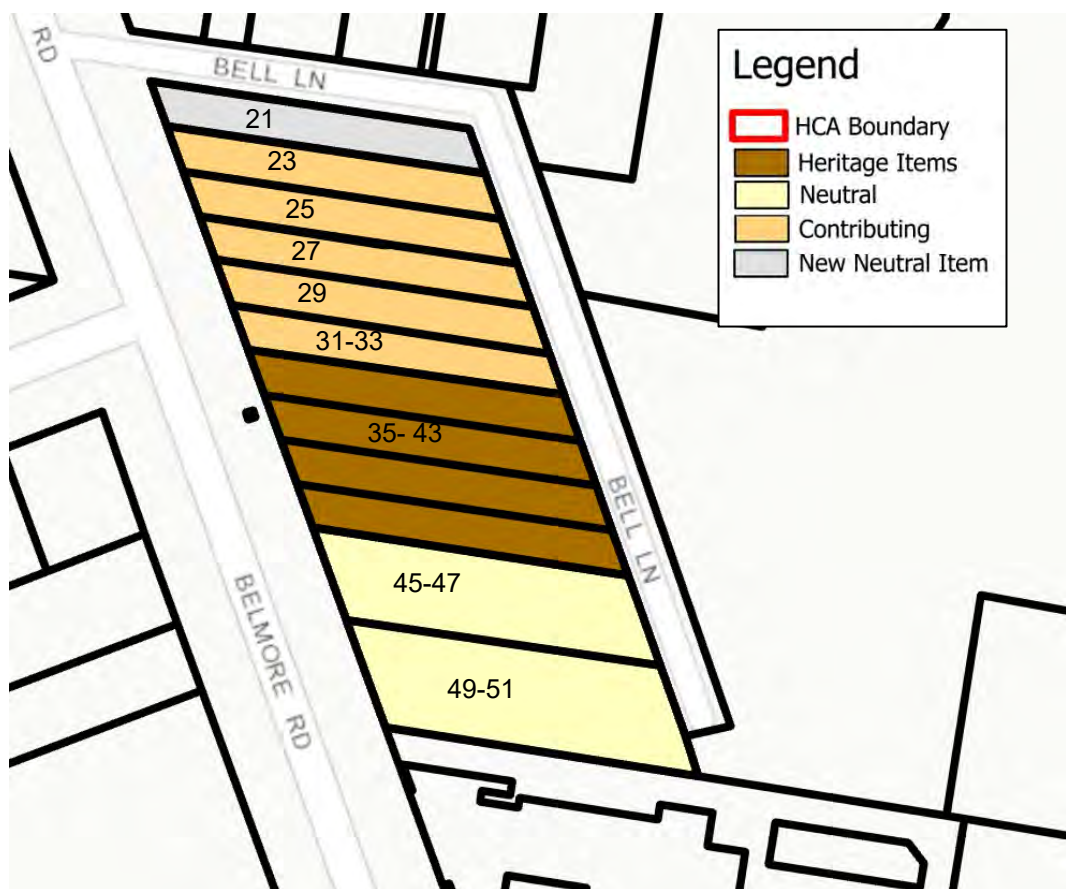
Figure 21: Detail of Block 06 showing contributions (Source: City Plan Heritage)

Block 06 is another small and rectilinear block with Neutral buildings flanking either side of the Heritage Items and Contributing buildings. The Neutral buildings have some intrusive elements attached to them but this does not significantly affect their presentation in terms of scale, finishes and continuing awning along the shopping strip. The contemporary infill building at 49-51 Belmore Road is considered Neutral complementing the overall three-storey scale of the block and matching the dominant horizontal lines of the closest Heritage Item at 35-43 Belmore Road including the awning level with a projecting entrance canopy. The majority of the shops with commercial uses above are two-storey high Edwardian buildings with curvilinear parapets featuring different colour schemes and rendered painted finishes.

Address	Grading	Brief Description	Modifications since 1994 <sup>20</sup>	Image
49-51 Belmore Road	Neutral	3 storey contemporary mixed use building	Previous building demolished, new mixed use development (approved 1994), constructed circa 1996.	 
45-47 Belmore Road	Neutral	Two storey 1970s era two-storey commercial building. Intrusive air conditioning units.	None, minor works only.	 
35-43 Belmore Road	Heritage Item I294	3 Storey Art Deco commercial building	None, minor works only.	 
31-33 Belmore Road	Contributing Item	Edwardian 1900-1920 shop with one Victorian setback residential level above (Edwardian shop built in front of Victorian building).  Detracting signage	None. Minor works only.	 
29 Belmore Road	Contributing Item	Edwardian 1900-1920 shop with one residential level above.	None. Minor works only.	 
27 Belmore Road	Contributing Item	Edwardian 1900-1920 shop with one Victorian setback residential level above. (Edwardian shop built in front of Victorian	None. Minor works only.

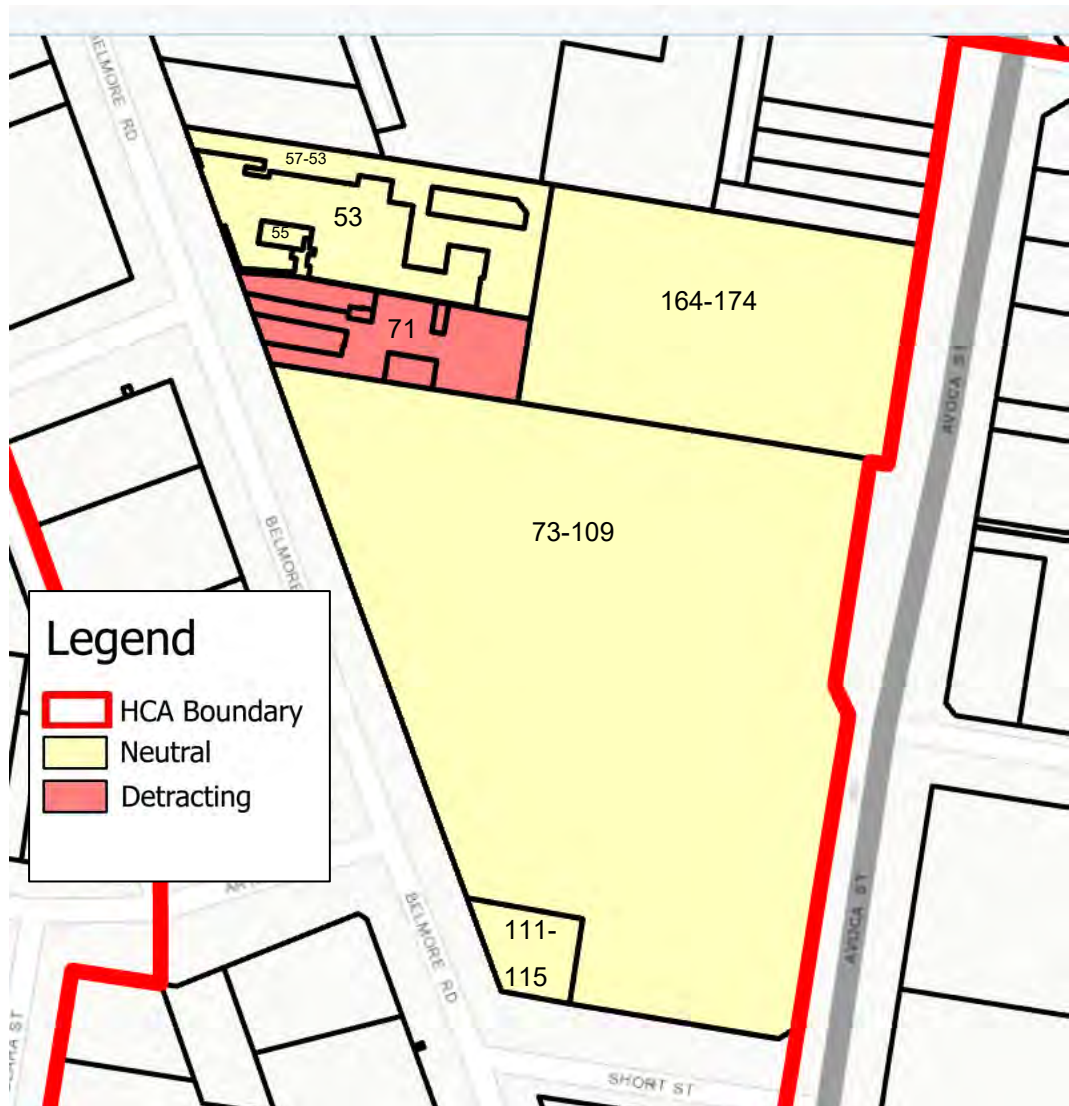
Figure 22: Detail of Block 07 showing contributions (Source: City Plan Heritage)

Block 07 occupies two-third of the Belmore Road frontage of the block between Short Street and Bell Lane. It is comprised mostly of new development including the Royal Randwick Shopping Centre, the former Gemini Hotel (now converted into residential units), and a new four-storey residential/commercial building. The converted Gemini Hotel is notable as an uncharacteristic building within the Randwick Junction HCA. The block is similar to the Randwick Plaza (Block 01) in that it introduces a new type of development within the traditional shopping strip of the Randwick Junction HCA. However, with the exception of the Gemini Hotel, development is generally more appropriate in terms of scale and articulation of parapets than Block 01, making the Block a Neutral element within the Randwick Junction HCA.

Address	Grading	Brief Description	Modifications since 1994 <sup>21</sup>	Image
164-174 Avoca Street	Neutral	Contemporary single storey development, sympathetic. (Marcellin College)	None. 2008 DA approved to remove tree.	 
73-109 Belmore Road (Avoca Street Frontage)	Neutral/ Detracting	Royal Randwick Shopping Centre Development	None, minor changes only.  The Avoca Street Elevation features service entrances to the shopping centre which are uncharacteristic. The loading dock, in particular, is considered intrusive.	 
111-115 Belmore Road	Neutral	Royal Randwick Shopping Centre development	None, minor changes only.	 
73-109 Belmore Road	Neutral	Royal Randwick Shopping Centre development	None, minor changes only.	 
65-71 Belmore Road	Detracting	8 Storey residential development - formerly Gemini Hotel	Converted into residential units with major changes to its interiors and some external elements.	 
57-63 Belmore Road	Neutral/ Detracting	4 storey contemporary residential/commercial building	New build, approved 2000

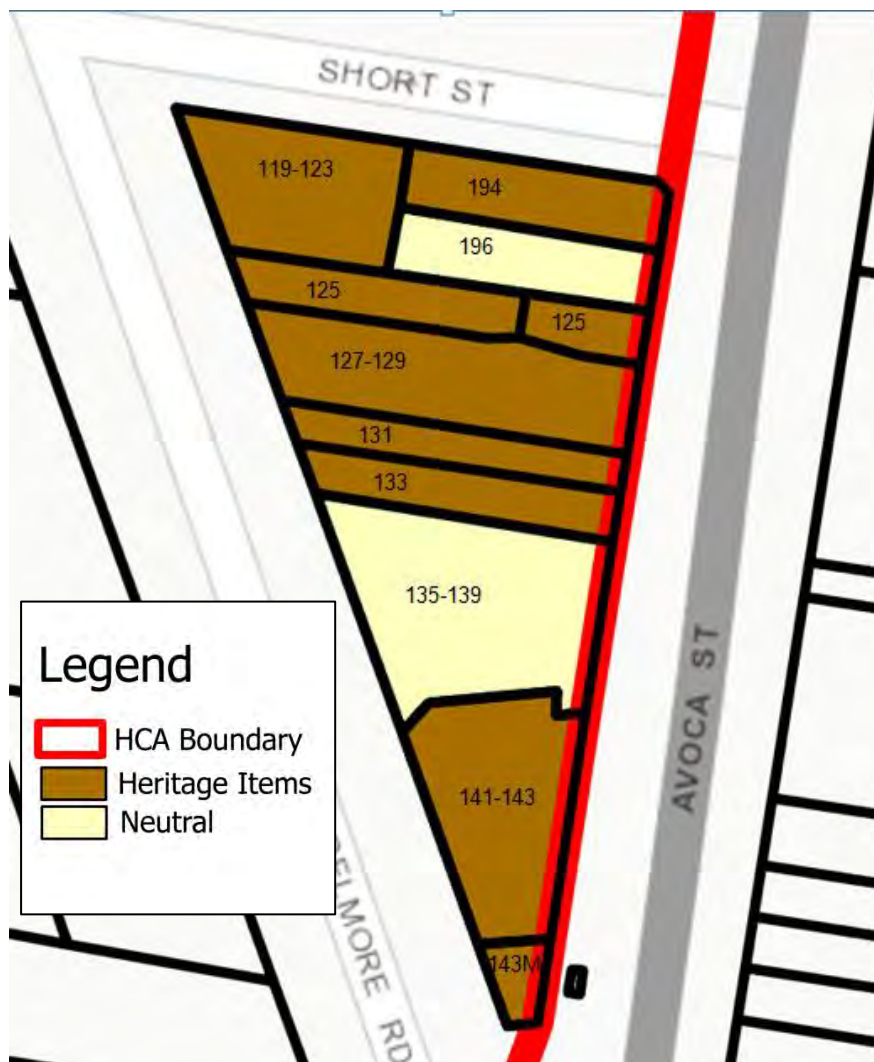
Figure 23: Detail of Block 08 showing contributions (Source: City Plan Heritage)

Block 08 is the southernmost end of the Randwick Junction HCA. It is a triangular block bounded by Belmore Road, Avoca Street and Short Street. The most distinctive feature within this block is the Statue of Captain James Cook. Combined with the Star & Garter Inn, the Heritage Items provide a prominent landmark and gateway to the Randwick Junction HCA. Other notable Heritage Items within the block are the two-storey Victorian commercial buildings which present a very cohesive and architecturally distinctive streetscape. The bright colour schemes of some of the Victorian shops break the consistency but this is a reversible painting finish and can be rectified when the opportunity arises with a more suitable period colour scheme that would highlight the architectural detailing and above awning embellishment of these shops.

Address	Grading	Brief Description	Modifications since 1994 <sup>22</sup>	Image
145M Belmore Road	Heritage Item I303	Statue of Captain James Cook	None.	 
141-143 Belmore Road	Heritage Item I302	The Star and Garter Inn	Refurbishments associated with new restaurant fit outs.	 
135-139 Belmore Road	Neutral	Two storey contemporary commercial building sympathetically designed. Render and colour intrusive. Described as 'Modern Heritage style'	Awning added.	 
133 Belmore Road	Heritage item <i>Group listing I300</i>	Late Victorian commercial building. Intrusive and uncoordinated colour scheme across terrace.	None, minor works only.	 
131 Belmore Road	Heritage item <i>Group listing I300</i>	Late Victorian commercial building. Intrusive and uncoordinated colour scheme across terrace.	None, minor works only.	 
127-129 Belmore Road	Heritage item <i>Group listing I300</i>	Late Victorian commercial building. Intrusive and uncoordinated colour scheme across terrace.	None, minor works only.

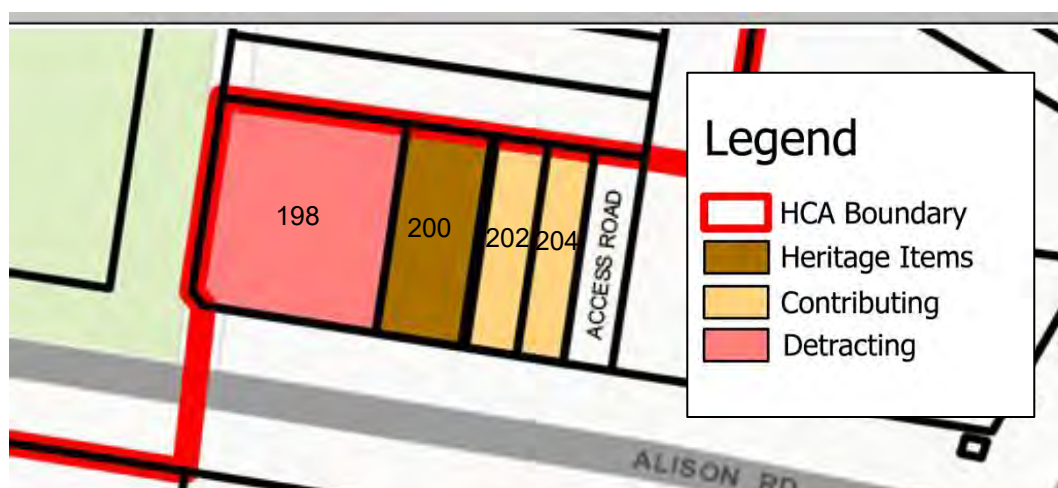
Figure 25: Detail of Block 10 showing contributions (Source: City Plan Heritage)

Block 10 is the smallest block within the Randwick Junction HCA, marking its northwest boundary. The Block has only three buildings - a Heritage item of Edwardian period stone building with high intactness, a Contributing Inter-War commercial shopfront and a Detracting c.1970s commercial building with large horizontal bands of first floor base and parapet with uncharacteristic ground floor window fenestration. The transition from the Randwick Junction commercial precinct in to residential precinct is evident from the changes in the dense street trees along the adjoining The Avenue streetscape.

Address	Grading	Brief Description	Modifications since 1994 <sup>24</sup>	Image
202-204 Alison Road	Contributing Item	1920s single storey shopfront	New paint schemes associated with new tenancies. No significant structural changes.	 
200 Alison Road	Heritage item I260	Edwardian Stone commercial building	Improved streetscape presentation, signs coordinated, awnings and details painted in a more appropriate colour scheme.	 
198 Alison Road	Detracting	1960s.1970s commercial two storey building. Now Randwick Police Station	Formerly Westpac Bank. Painted in unsympathetic blue/white colour scheme. Changes to windows.

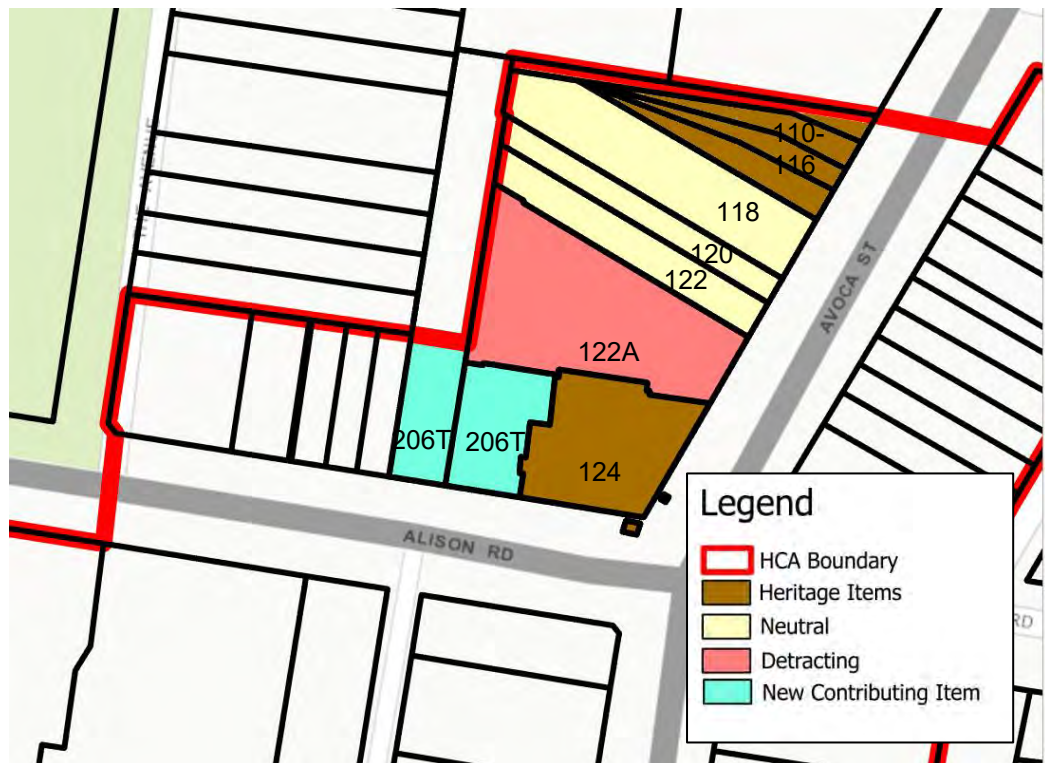
Figure 26: Detail of Block 11 showing contributions (Source: City Plan Heritage)

Block 11 also marks the northern boundary of the Randwick Junction HCA fronting both Alison Road and Avoca Street. It features two Heritage Items, one of which is the first Post office in Randwick, and a number of Contributing buildings dating from Federation and Inter-War periods. While the shopping strip street-edge character continues along Avoca Street frontage, the Alison Road frontage resembles stand-alone buildings in transition to the non-commercial development along the northern side of the Road. A detracting building at 120 Avoca Street features a high and disproportional parapet within the well-articulated and architecturally pleasing buildings of the Block.

Address	Grading	Brief Description	Modifications since 1994 <sup>25</sup>	Image
206T Alison Road	New Contributing Item	1920s commercial building.	Internal refurbishment associated with tenancies. No changes to facade.	 
206 Alison Road (See also 124 Avoca)	New Contributing Item	Modified sandstone three storey building- possibly Edwardian construction. Shopfront with two residential storeys above.	Modifications to windows and doors at street level. Contemporary interiors.	 
124 Avoca Street	Heritage Item I274 Jubilee	Former post office (includes fountain)	Conversion from post office.	 
122A Avoca Street	Detracting	3 storey building - Telephone exchange	None (possibly recorded as a different site)	 
122 Avoca Street	Neutral	1930s shop with one residential level above. Low architectural quality and not a good example of the period.	Minor works only.	 
120 Avoca Street	Neutral	1930s shop with one residential level above. Low architectural quality and not a good example of the period. The sandstone capped piers, however, are considered a contributing element.	Minor works only.

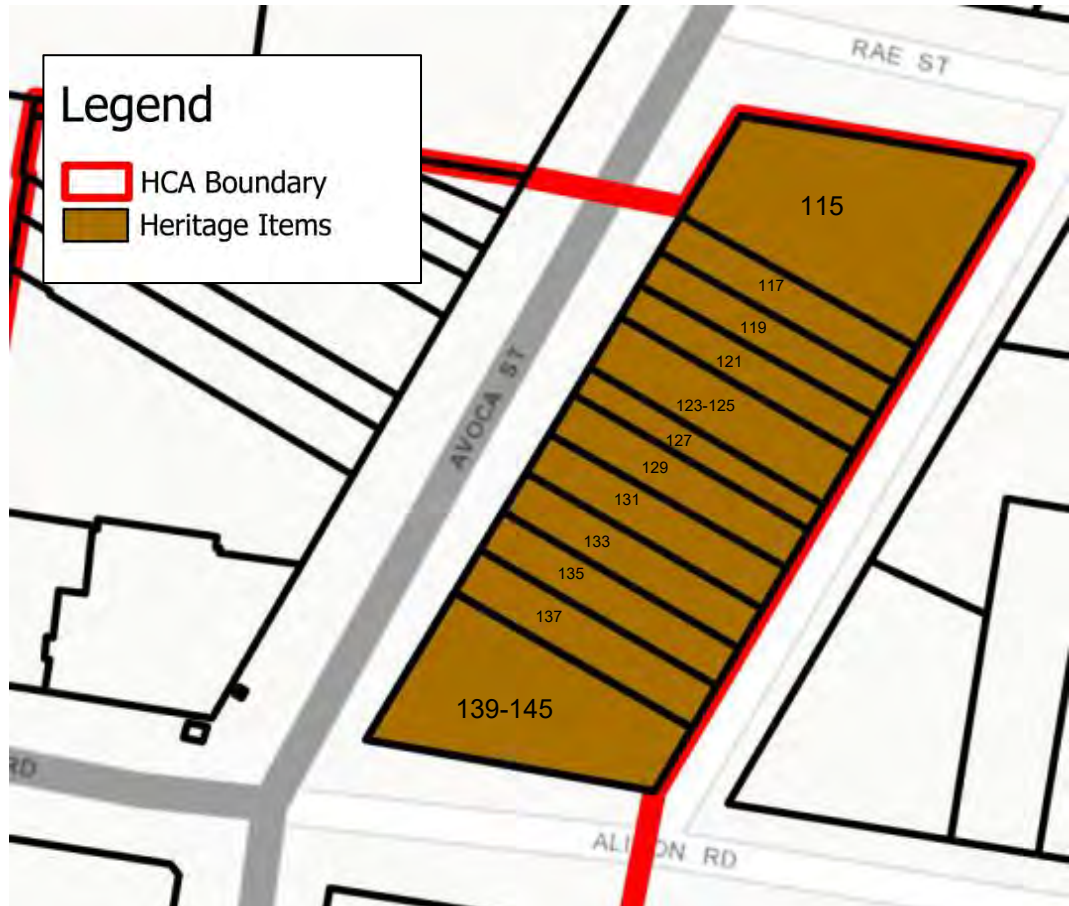
Figure 27: Detail of Block 12 showing contributions (Source: City Plan Heritage)

Block 12 is bounded by Avoca, Rae and Lingard Streets, and Alison Road. This is the only block entirely comprised of Heritage Items. 115-137 is a single Heritage Item consisting of a cohesive group of Victorian and Inter-War shops with residences above, and a warehouse located at the northern end of the group. The streetscape presents a traditional shopping strip with continuing awning with highly decorated and articulated facade fenestrations for each group of shops. This Block marks the northeast boundary of the Randwick Junction HCA and contributes significantly to its primary heritage significance.

Address	Grading	Brief Description	Modifications since 1994 <sup>26</sup>	Image
139-145 Avoca Street	Heritage Item I278	Part of Victorian and inter-war building	Minor works only. Refurbishment of individual residential units.	 
137 Avoca Street	Heritage item Group listing I273	Victorian and inter-war building (shopfronts with residences above)	Works associated with restaurant fit outs.	 
135 Avoca Street	Heritage item Group listing I273	Victorian and inter-war building (shopfronts with residences above)	Works associated with restaurant fit outs.	 
133 Avoca Street	Heritage item Group listing I273	Victorian and inter-war building (shopfronts with residences above)	Works associated with restaurant fit outs.	 
131 Avoca Street	Heritage item Group listing I273	Victorian and inter-war building (shopfronts with residences above)	Works associated with restaurant fit outs.	 
129 Avoca Street	Heritage item Group listing I273	Victorian and inter-war building (shopfronts with residences above)	Works associated with restaurant fit outs

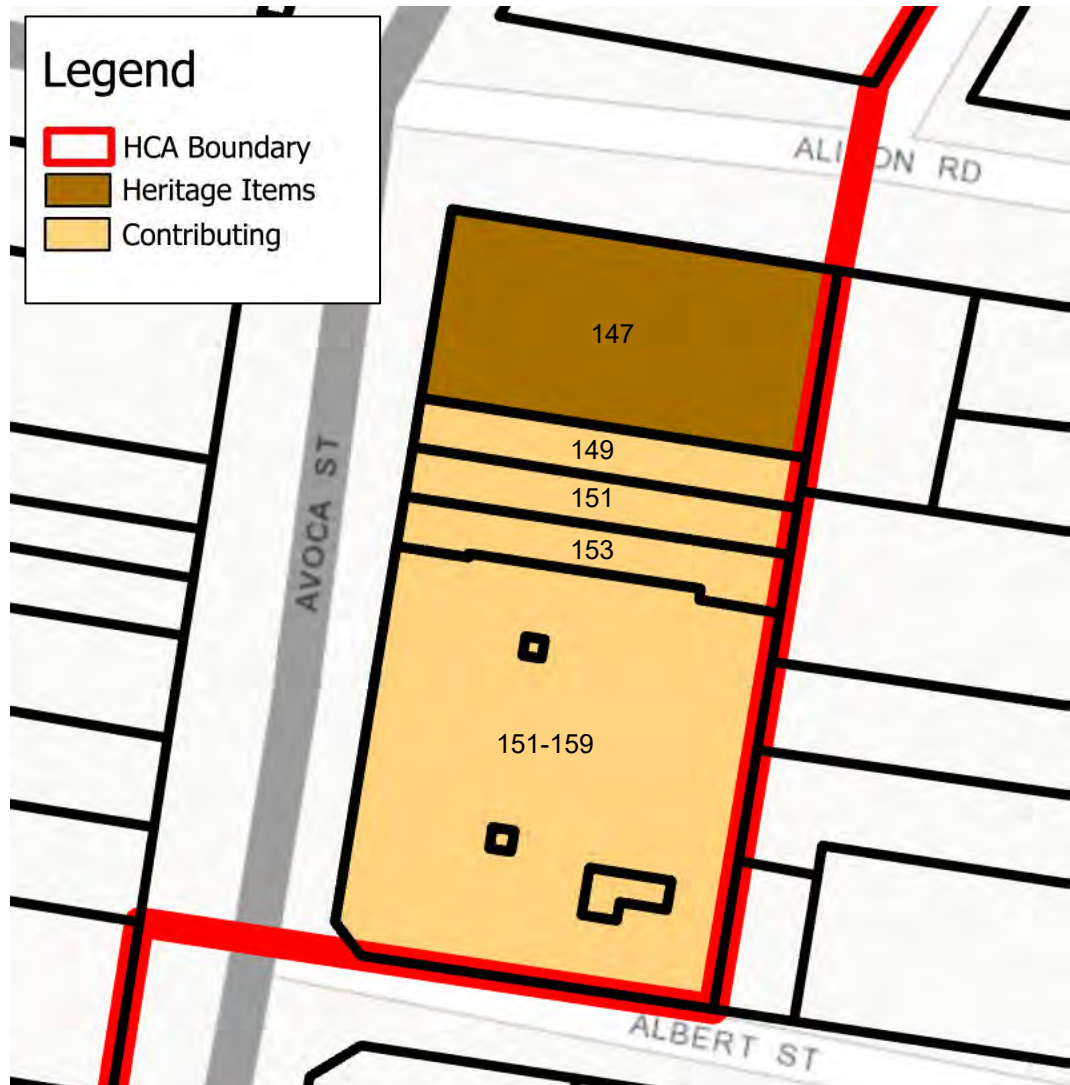
Figure 28: Detail of Block 12 showing contributions (Source: City Plan Heritage)

This Block is also located at the northeast end of the Randwick Junction HCA at the southeast corner of the Alison Road and Avoca Street intersection. It is characterised by the commercial and residential buildings of two to three-storey high building and features the important Coach & Horses Hotel. Although it is at the edge of the Randwick Junction HCA this block is in reality is in the heart of the Randwick Junction providing evidence of the earliest development pattern and activities in the Randwick City.

Address	Grading	Brief Description	Modifications since 1994 <sup>27</sup>	Image
155-159 Avoca Street	Neutral	Sympathetic 3 storey commercial/residential building	Built 2005.

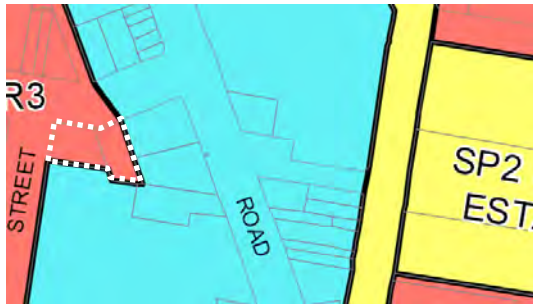
Figure 29: Randwick LEP Zoning Map. 66 and 68 Arthur Street are shown in the white hashed area.

However, given the adjacent property (66 Arthur Street) remains in residential use and the site is also located in close proximity to other residential apartment complexes, it is considered appropriate to retain the current zoning of this area. Rezoning would impede on any future use of 68 as a residential dwelling, which would be preferable in the context of the building's original history and the Randwick Junction HCA.

As such, it is recommended that the current zoning remain in place in order to facilitate the potential conversion of the property back to a residential property. This will ensure the integrity of the site is maintained as well as its contribution to the Randwick Junction HCA with the adjacent 66 Arthur Street.

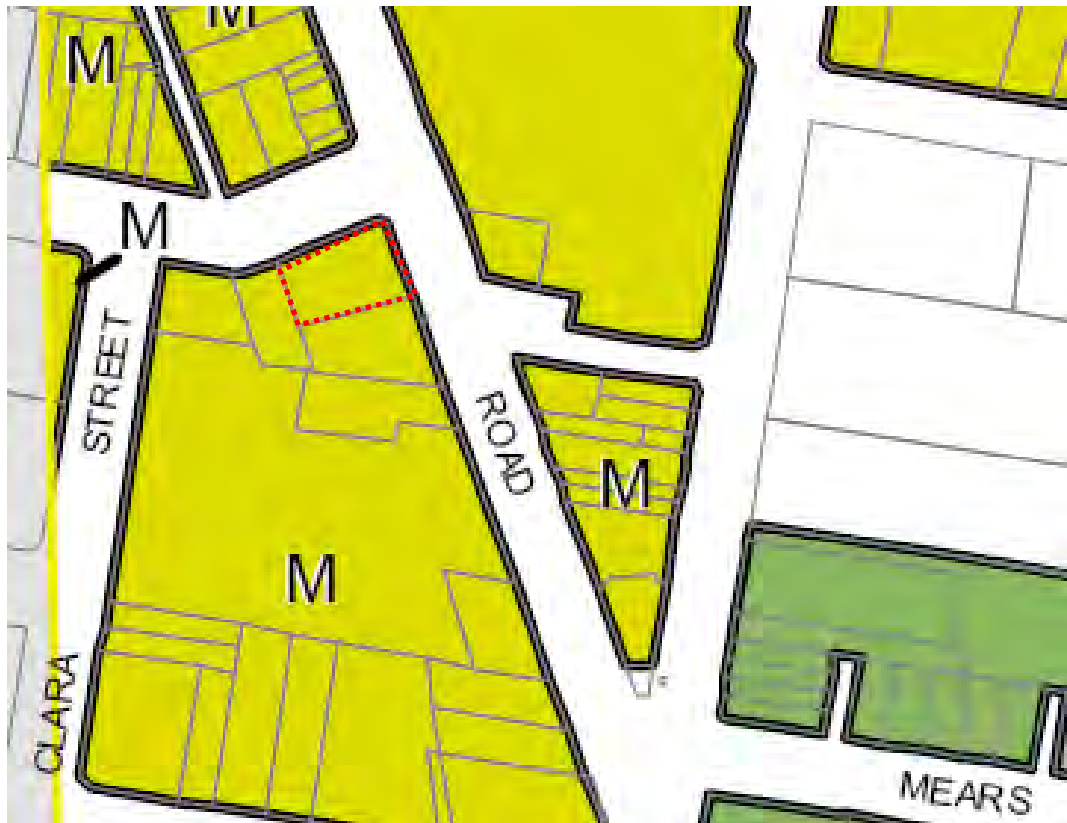
Figure 31: Randwick LEP extract showing current maximum building height (12m)

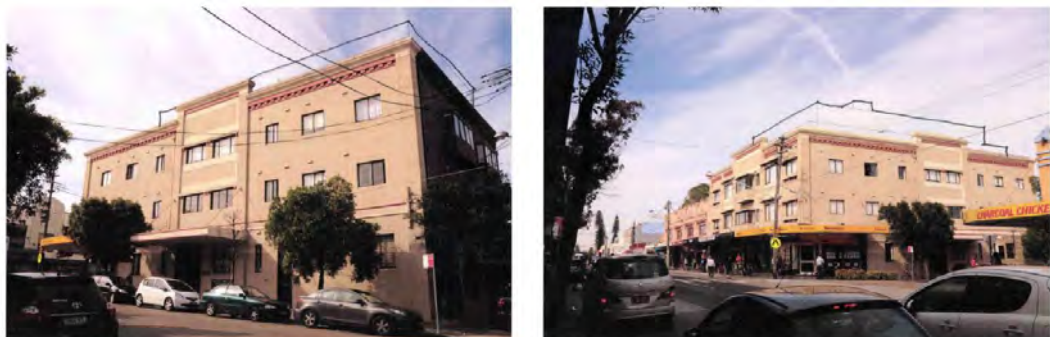
Figure 32: Proposed additional height at 70 Arthur Street (Source: Tribe Studio)
