Air Monitoring Certificate

Report Number: 40-8057-42-AM

Site Address: 1901 Botany Rd

Matraville NSW 2036

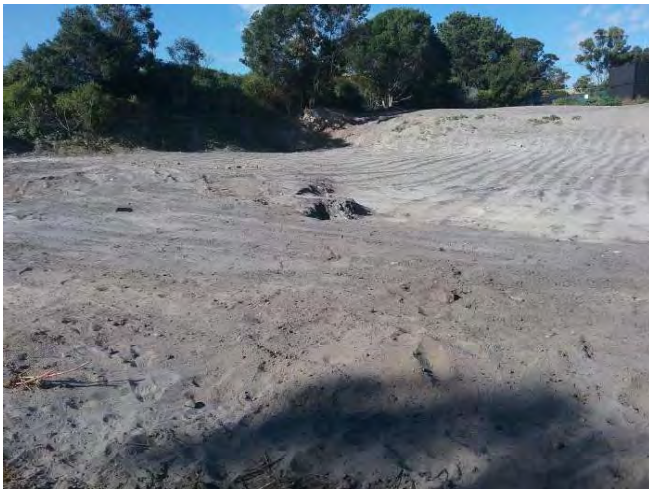
Photograph 2:

Visible and accessible ground surfaces to the south eastern corner of the development site, Lot 1 DP219847, within an area approximately of 50m x 20m, and centrally located at approximate coordinates (WGS84) -33.966569, 151.228492.

Grass / dense vegetation was observed within the area inspected. Grass / dense vegetation can obscure the ground surface and therefore severely limits the accuracy of any visual inspection. For added assurance, remove all ground cover and have the area reinspected.

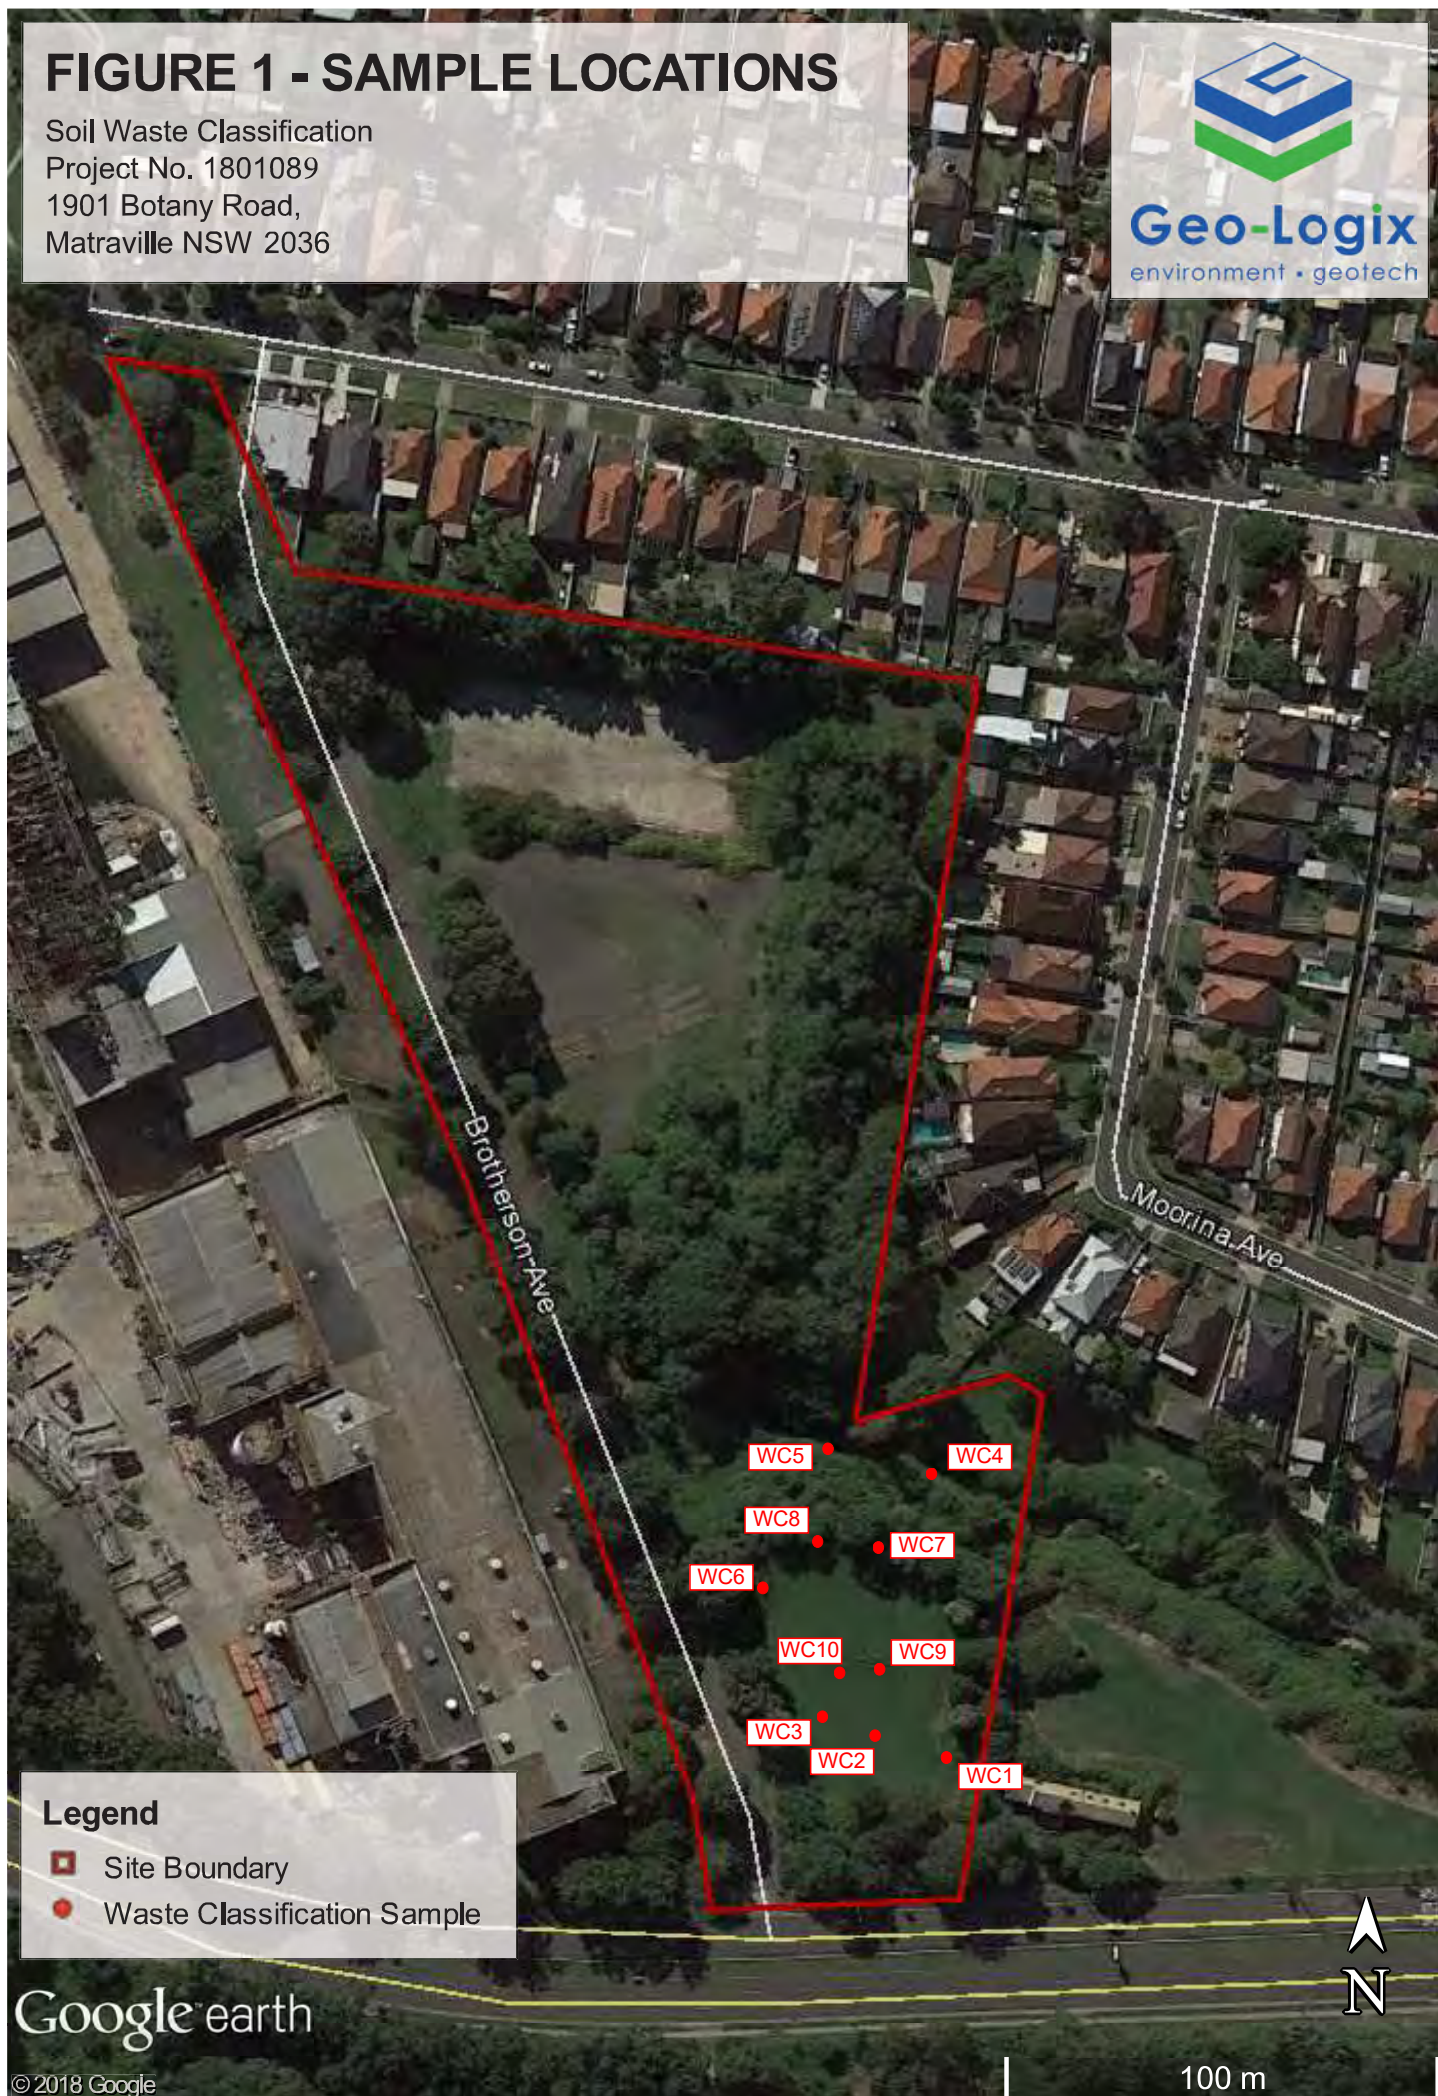
FIGURE 1 - SAMPLE LOCATIONS

Soil Waste Classification
Project No. 1801089
1901 Botany Road,
Matraville NSW 2036
