REMEDIATION AND VALIDATION REPORT

1901 Botany Road (South)
Matraville, NSW 2036

Horme Group Limited – July 2019

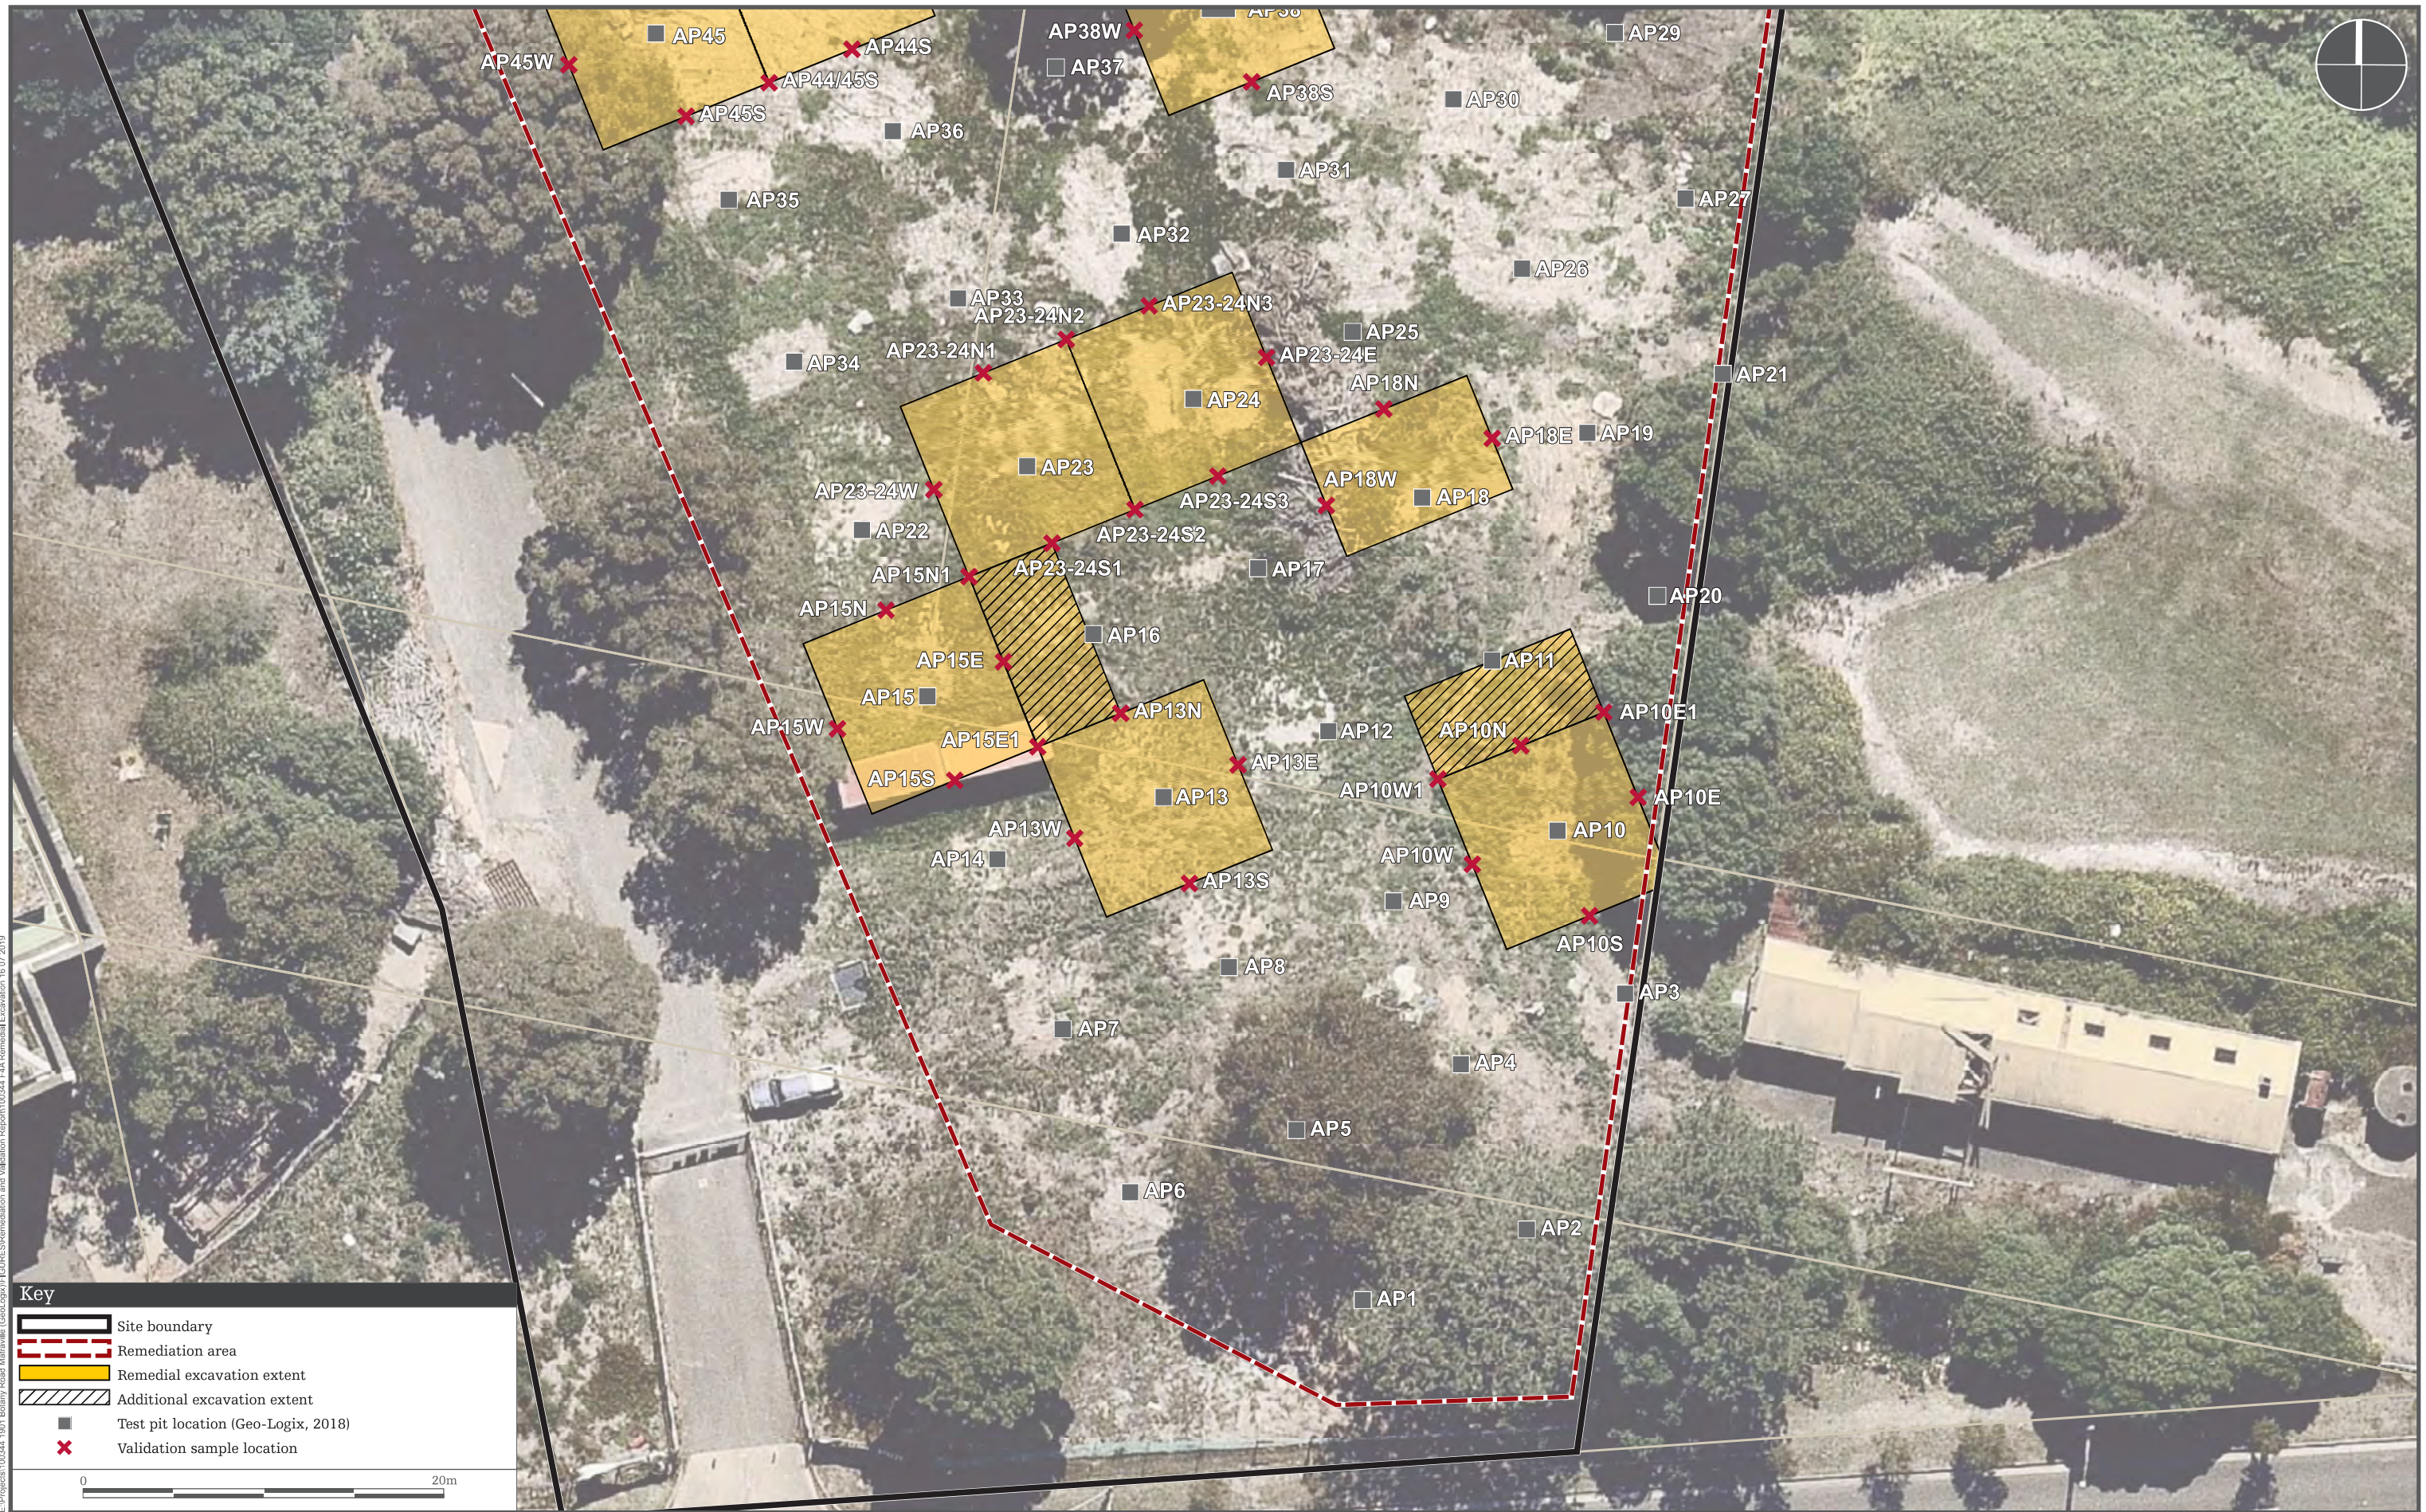
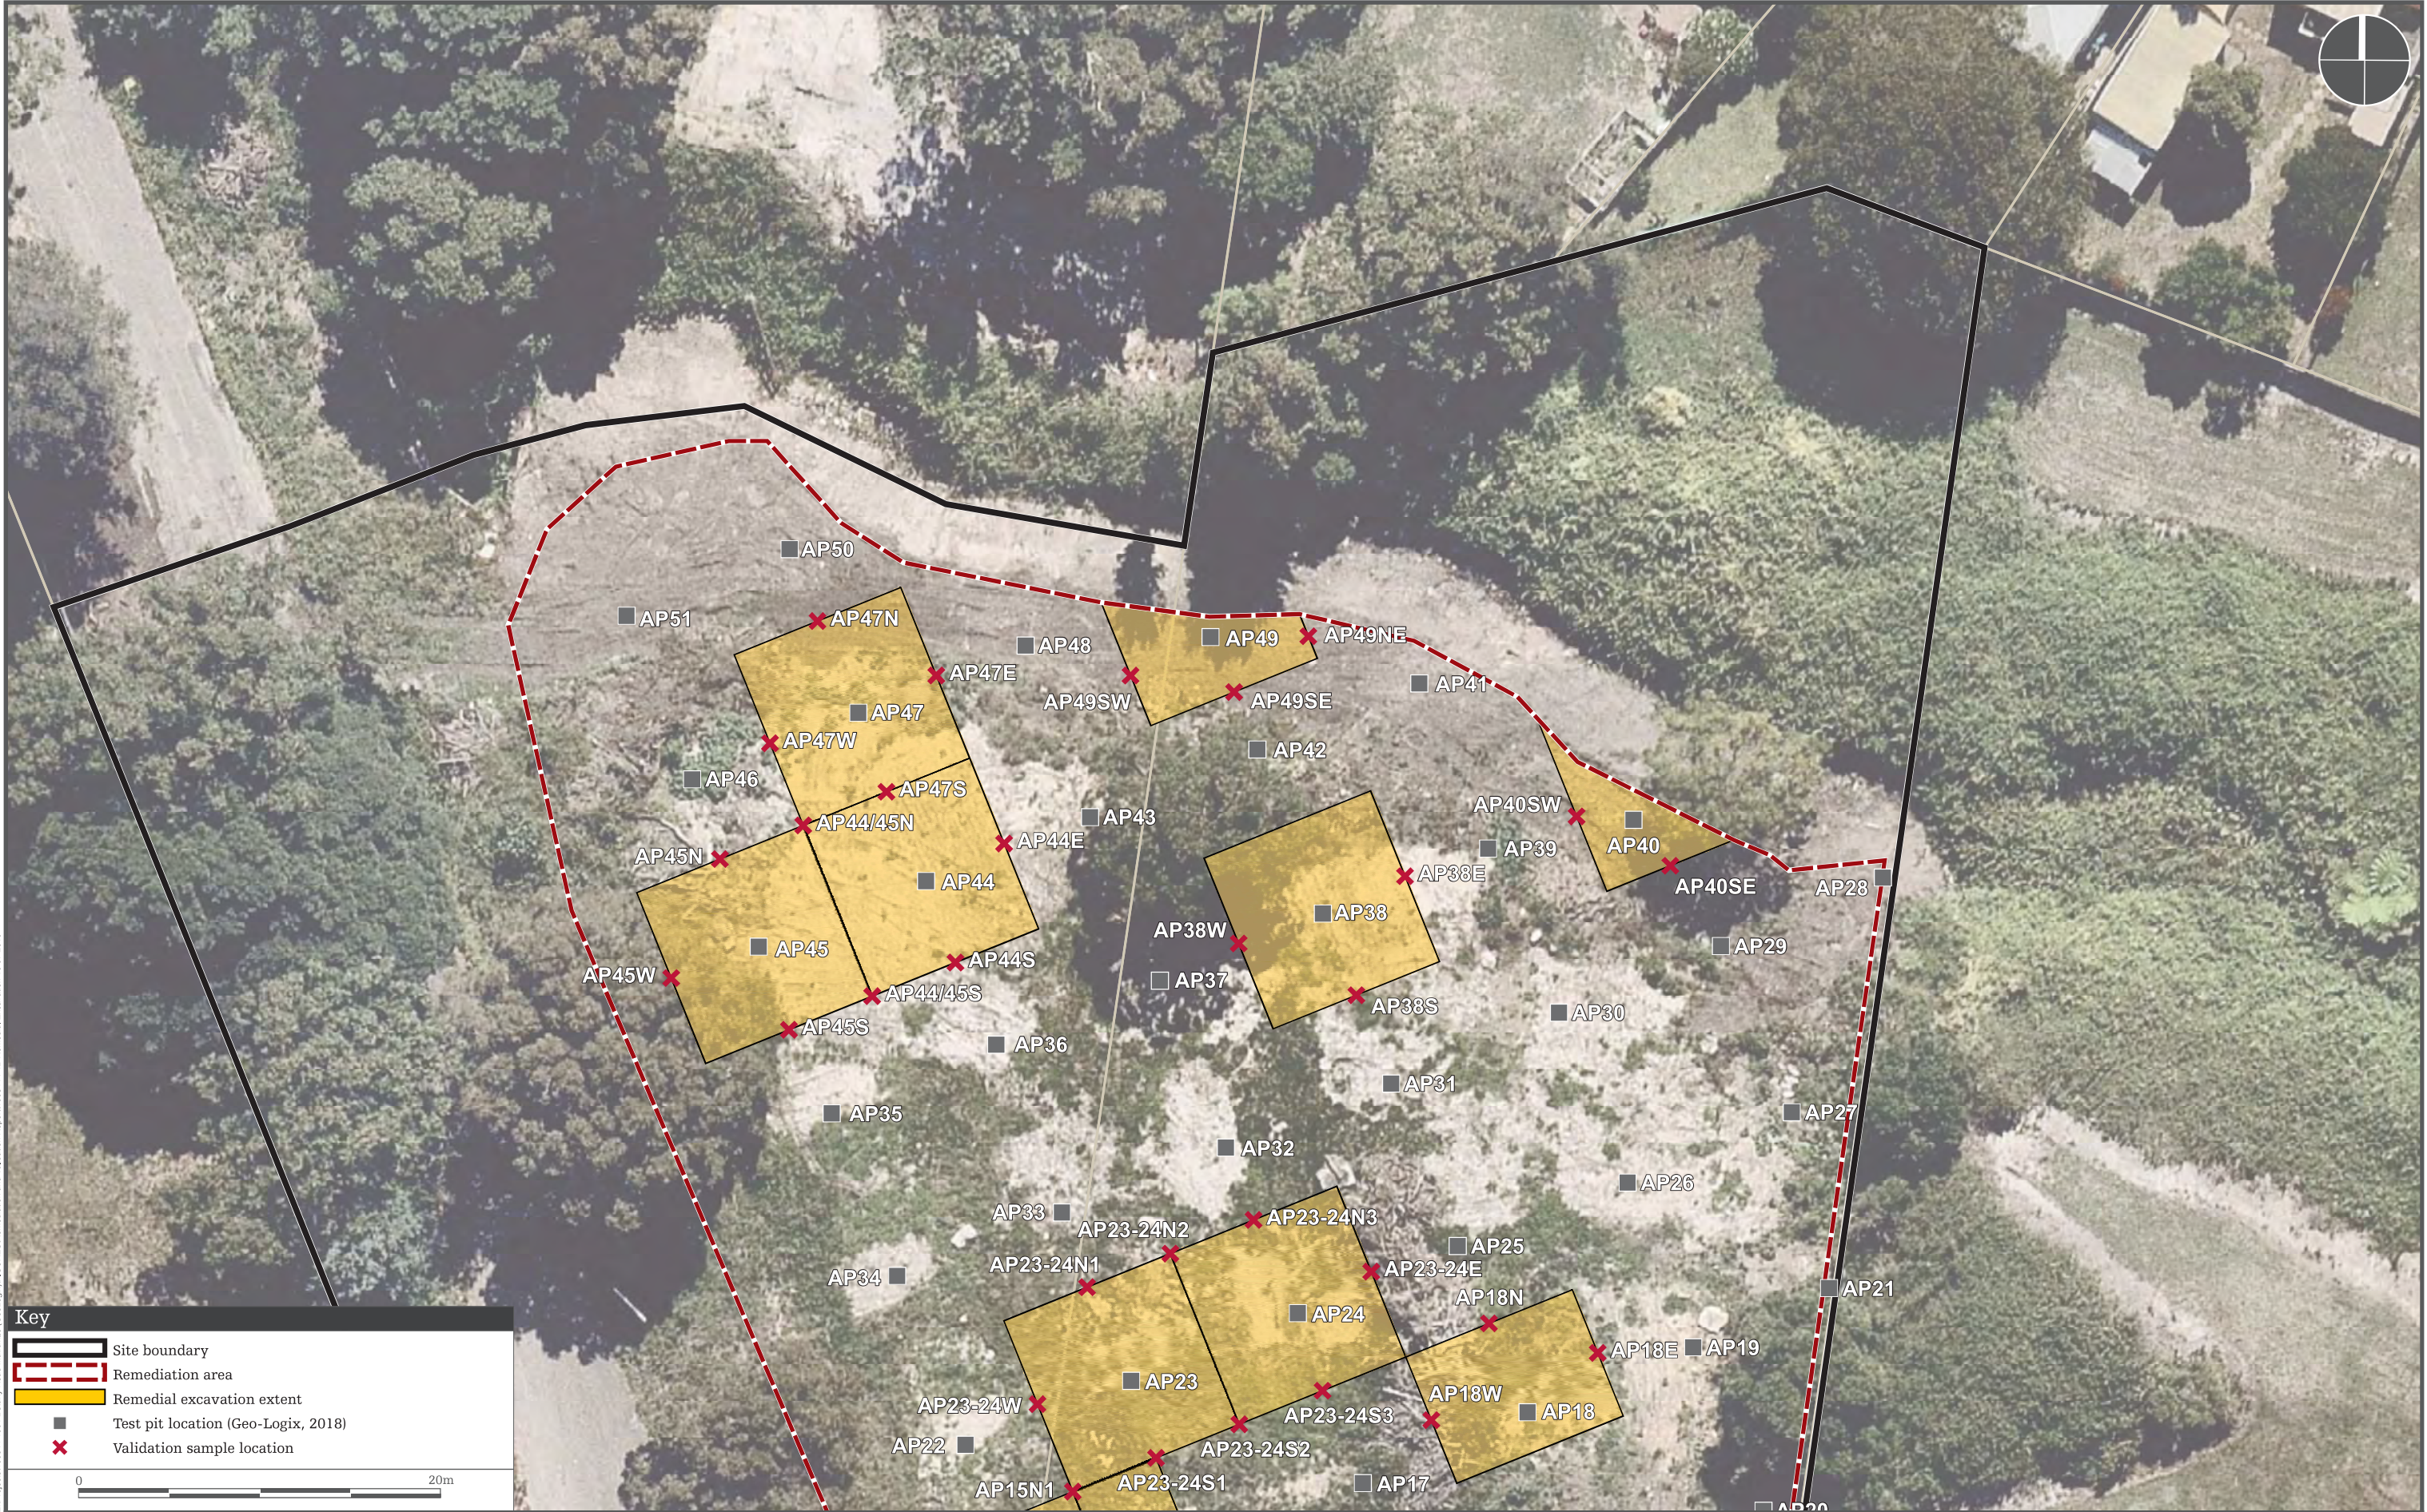
El:\Projects\100344_1901 Botany Road Matraville (Geo-Logix)\FIGURES\Remediation and Validation Report\100344 FAA Remedial Excavation 16.07.2019

- Excavation wall validation soil samples were collected at evenly spaced locations along each wall at 5 m lateral lengths. The validation sample locations are presented in Figure 4A and Figure 4B;
- At each location a 10 L volume soil sample was collected from the 1 m thickness of the excavation wall for visual assessment and measurement of the %w/w bonded ACM in accordance with the NEPM (2013) Gravimetric Sample Method (entailing spreading the sample on a tarpaulin of contrasting colour for inspection for bonded ACM fragments and weighing all fragments found in order to calculate the %w/w bonded ACM in soil); and
- A 500 ml sub-sample collected from each location was submitted to Australian Safer Environment and Technology Pty Ltd (ASET) laboratory for quantitative analysis of AF and FA in fill.

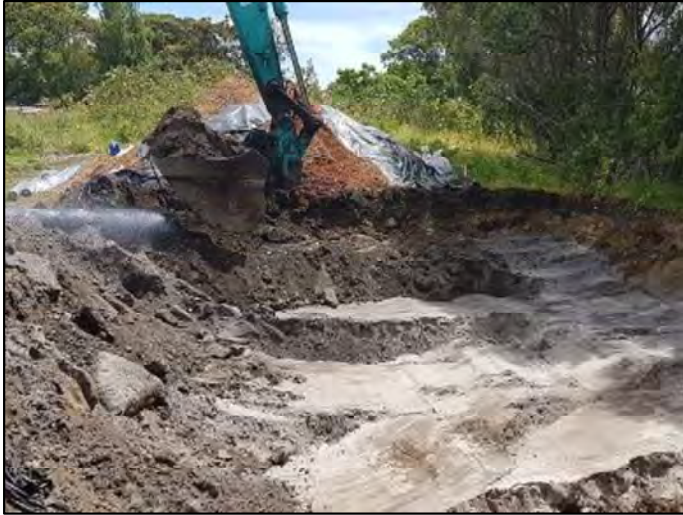
Plate 1: AP10 excavated to the level of natural soil.

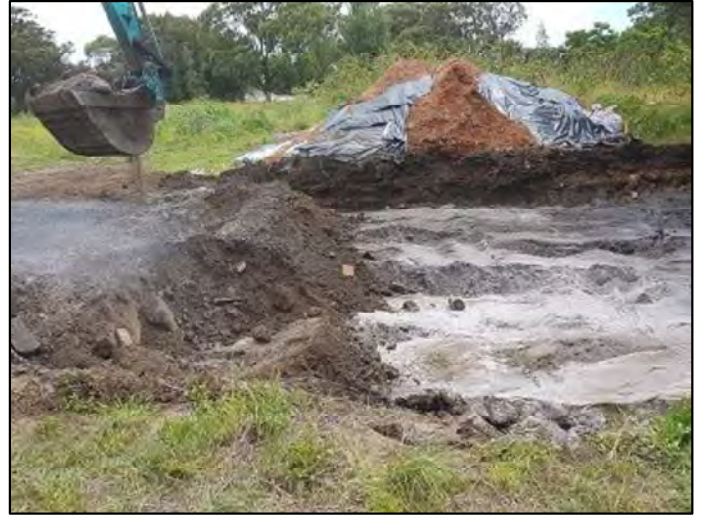
Plate 2: AP18 excavated to the level of natural soil.

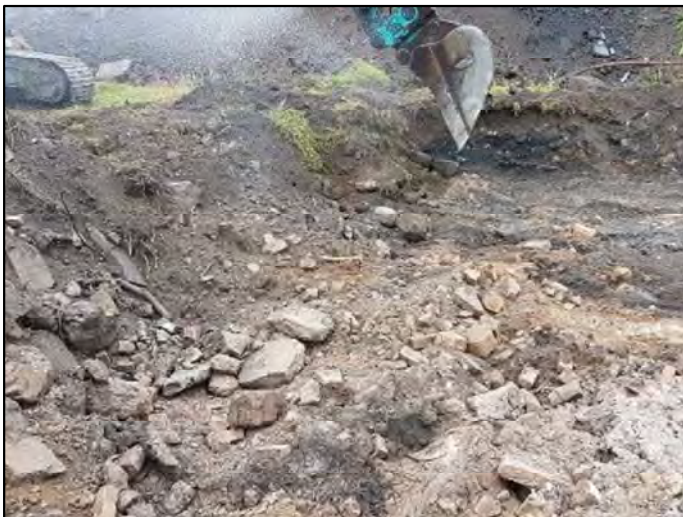
Plate 3: Concrete clocks, bricks, reinforcement bars, bonded ACM, etc. were among the fill materials excavated from AP18.

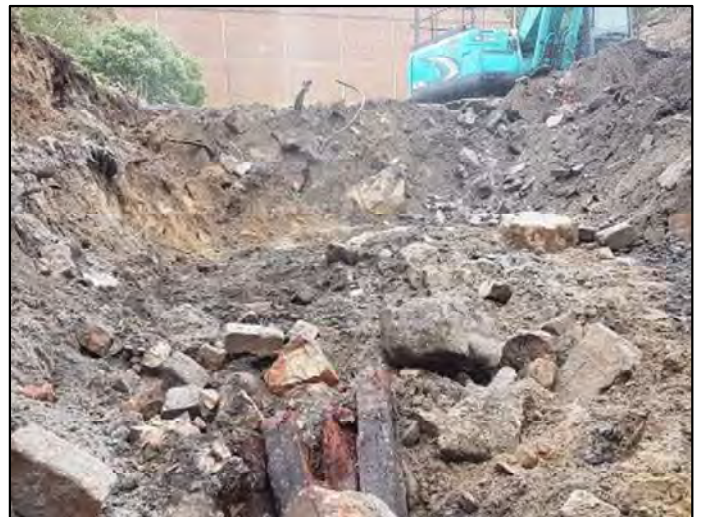
Plate 4: Concrete clocks, bricks, timber, reinforcement bars, bonded ACM, etc. were among the fill materials excavated from AP23.

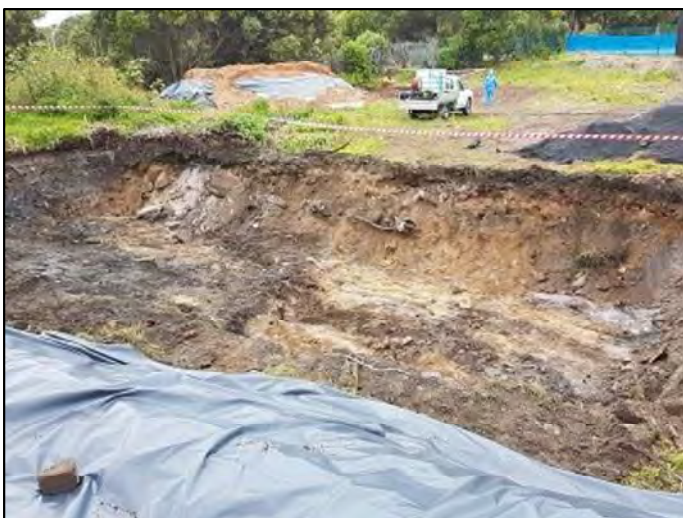
Plate 5: AP24 barricaded after excavation with warning tapes.

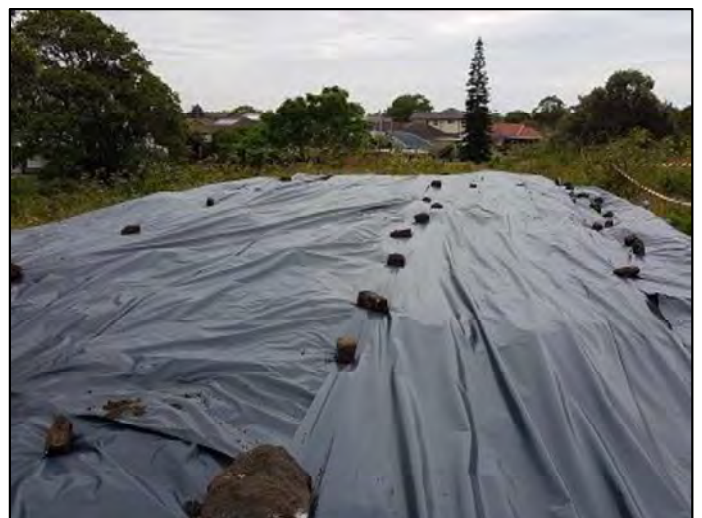
Plate 6: Stockpiles covered with LDPE sheets.

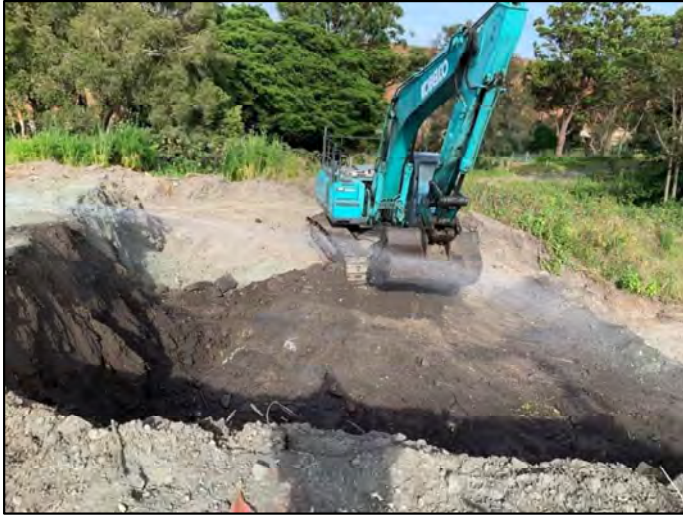
Plate 7: Excavation and removal of soil from AP44. Light water spray used to suppress dust.

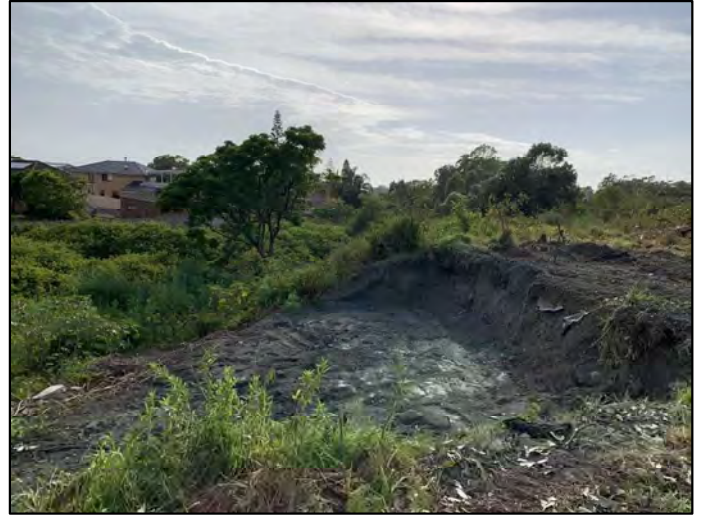
Plate 8: Excavation and removal of soil from AP38. Excavation surfaces were lightly wetted down, sprayed with a soil binding emulsion.

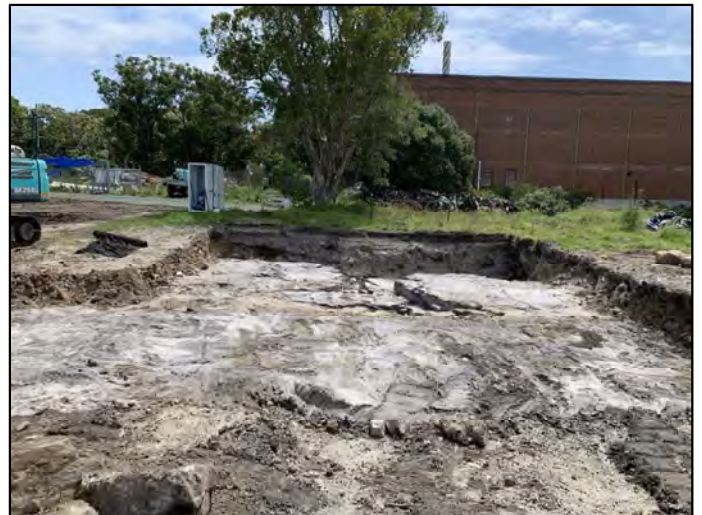
Plate 10: AP15 excavated to native soil.

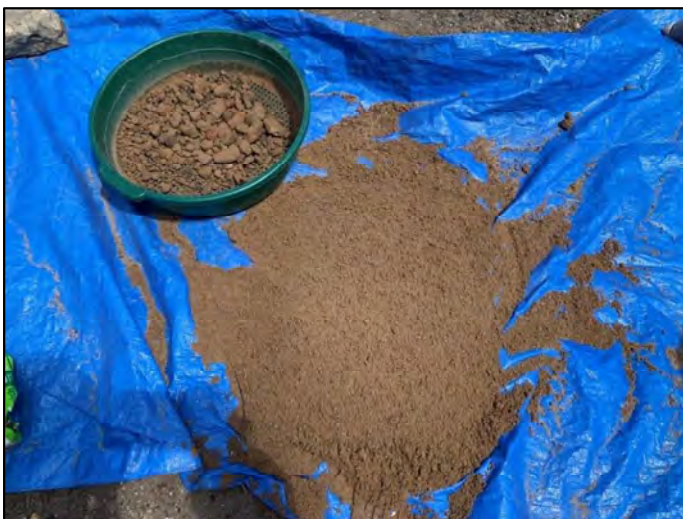
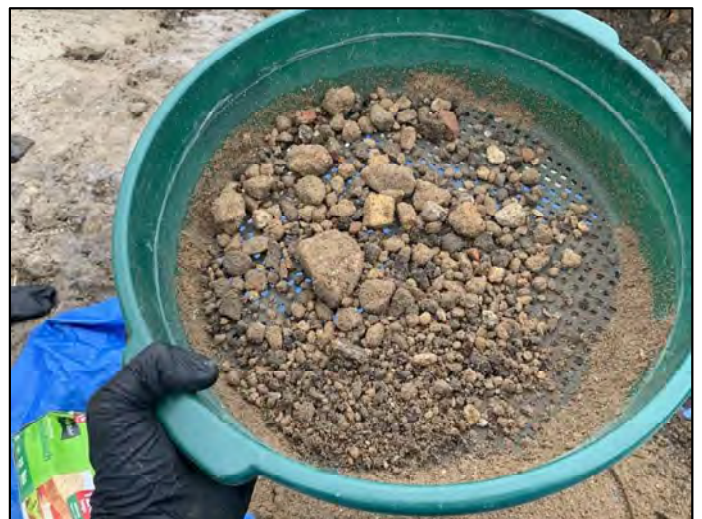
Plate 11: Gravimetric analysis for validation of the excavation walls.

Plate 12: Gravimetric analysis for validation of the excavation walls.

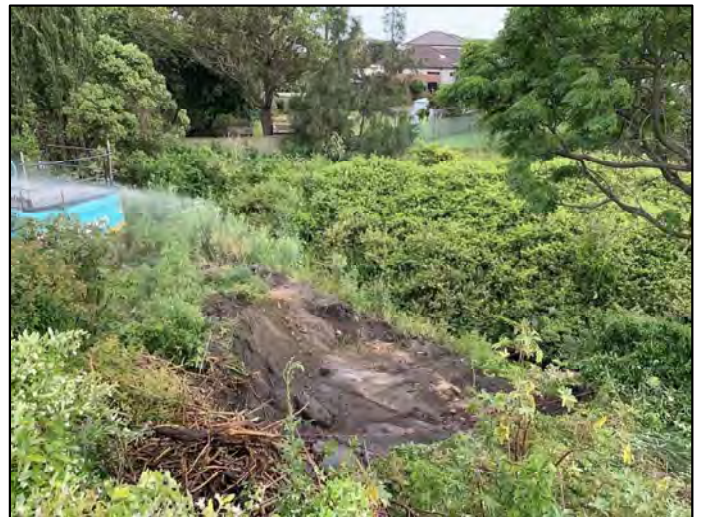
Plate 16: Excavation and removal of soil from AP40 located near Bunnerong Creek.

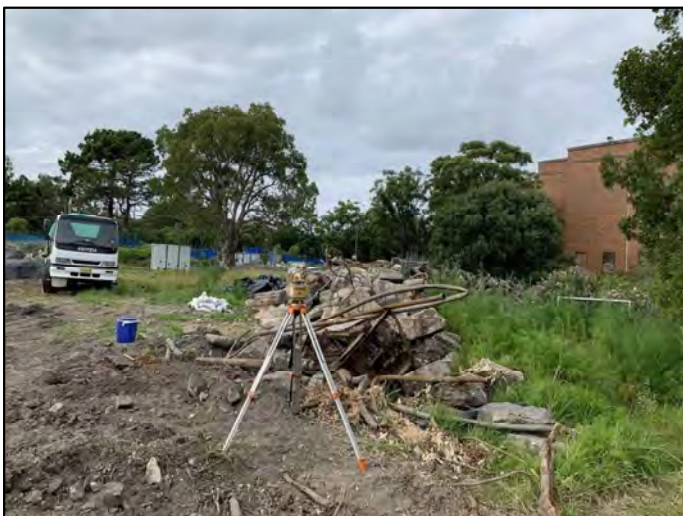
Plate 17: Laser level set up for survey of the excavated areas.

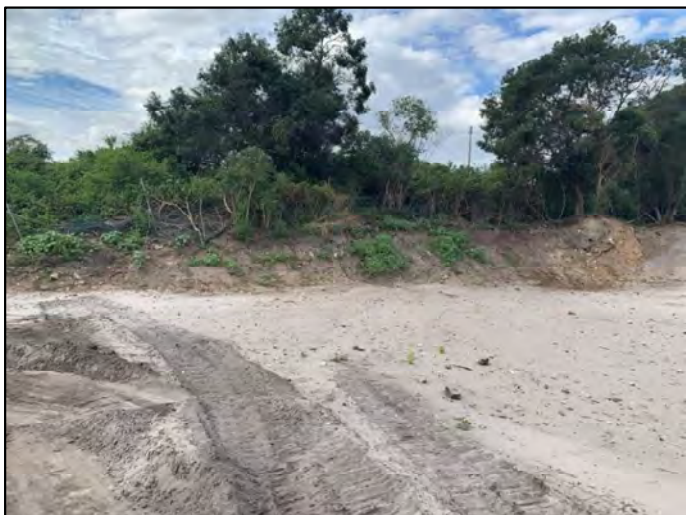
Plate 21: A small quantity of fill material is left near the retaining wall in the east boundary of Lot 1.
