Randwick Heritage Study Volume 1

Heritage Conservation Area Review

Prepared for Randwick City Council

March 2021—Final

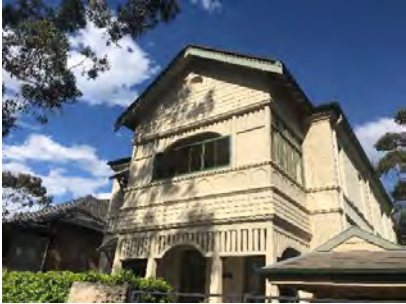
The house is located at 37 Darley Road. The condition of this item is in keeping with its description on the SHI. The balcony enclosure is the most obvious alteration, however overall the item appears otherwise intact and in good condition.
Federation house, c 1915 (I340)	Local

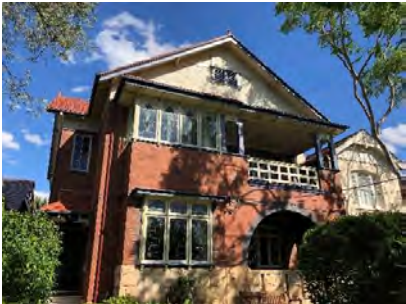
The house is located at 71 Darley Road. The overall condition and integrity match the image on the SHI database. The building appears to be in good condition and with most original details.
Bungalow style dwelling, c 1920s (I341)	Local

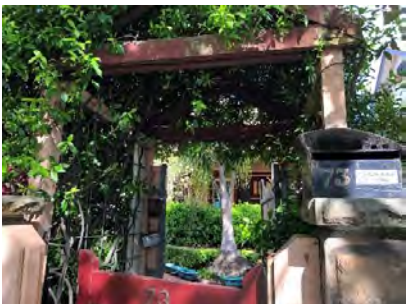
73 Darley Road has a front fence and hedge that makes the property difficult to see from the public domain. For this reason an inspection was unable to be undertaken.
"Shaldon", Queen Anne residence, c 1905 (I342)	Local

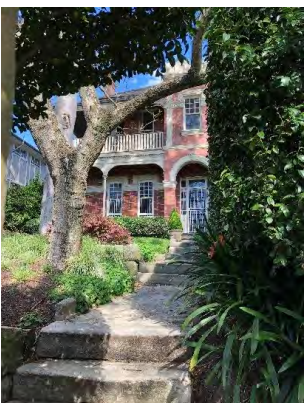
85 Darley Road has a high hedge that makes viewing the property from the public domain difficult, however, the building appears to be in a good condition and intact.

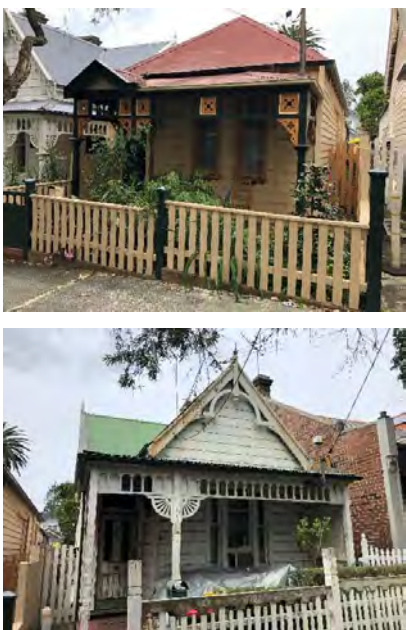
<p>These houses are located at 59 and 61 Earl Street. The item appears to be mostly consistent with the description in the SHI database, with the below exceptions.</p> <p>59 Earl Street is noted in the SHI database as having an unsympathetic decramastic pressed metal roof. This has been replaced with Colourbond roof sheeting.</p> <p>61 Earl Street is similar in style to 55-57 Earl Street, however, is in a poorer condition, with deterioration of timber elements noted during the inspection.</p>
Federation residence, c 1905 (I417)	Local

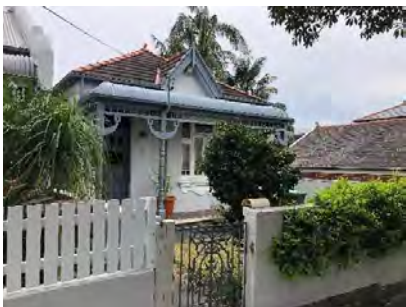
<p>This house is located at 2 Monmouth Street. The item appears to be consistent with the description in the SHI database, apart from painting of the original face brickwork. Otherwise, the item is relatively intact and in a good condition.</p>
Bungalow, c 1931 (I418)	Local

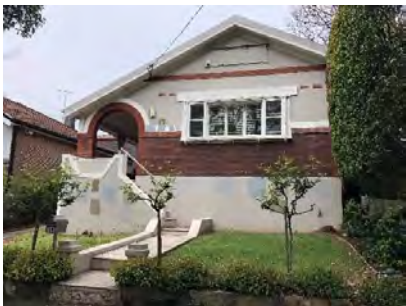
<p>This house is located at 19 Monmouth Street. The item appears to be consistent with the description in the SHI database. At time of inspection sample areas of paint were noted on the render in, suggesting it is soon to be repainted.</p>

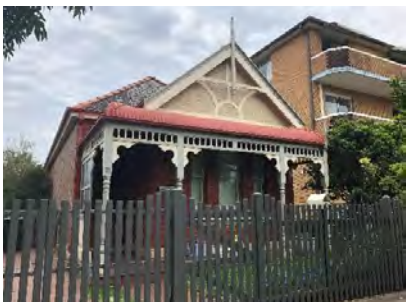
<p>This house is located at 71 Pine Street. The item appears to be consistent with the description in the SHI database, with some original detailing and a replacement fence. There is some corrosion on the verandah roof corners.</p>

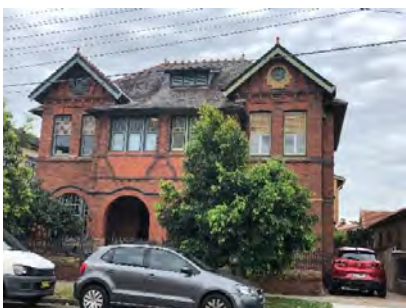
This property is located at 81-83 Pine Street. The item appears to be consistent with the description in the SHI database, with decorative brickwork. 81 and 83 have been painted in different colour schemes. There is a sympathetic extension to the rear of the property.
Pair of late Victorian terraces and Edwardian style corner house (I450)	Local

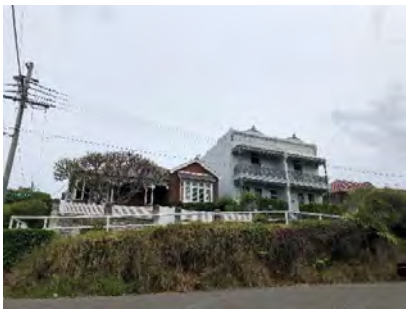
<p>This house and terrace pair are located at 10-14 Stephen Street.</p> <p>The terrace pair at 10-12 appear consistent with the description in the SHI database, with the exception that they have recently been repainted. The SHI database additionally notes the terrace pair as having two mismatched doors, new matching doors have been installed.</p> <p>The house at 14 does not have a physical description included within the SHI listing, however, appears to be in good condition and intact.</p>

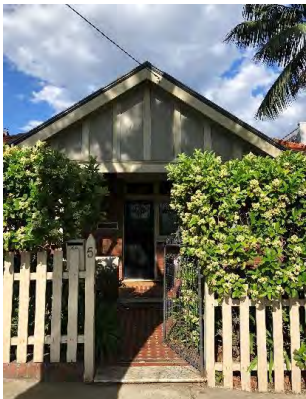
This house is located at 5 Wentworth Street. The item is mostly obscured by a high fence and hedge and is not visible from the public domain. Suggest further inspection.

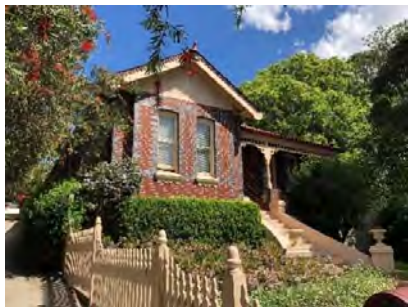
This house is located at 6 Balfour Road. The item appears to be consistent with the description in the SHI database, in good condition and with significant detailing intact. Was unable to see the side addition mentioned due to vegetation.
"Hastings", Federation style dwelling, c 1915 (I135)	Local

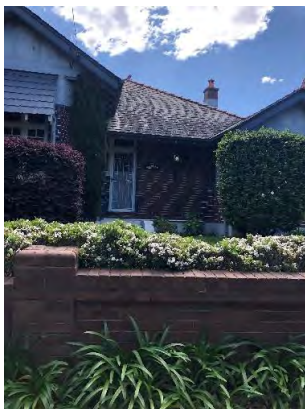
This item is located at 25 Lenthall Street and appears to be in a similar condition to the SHI listing. Fence is a sympathetic replacement, and overall the item is in good condition with many details intact.
Late Federation style dwelling, c 1915 (I136)	Local

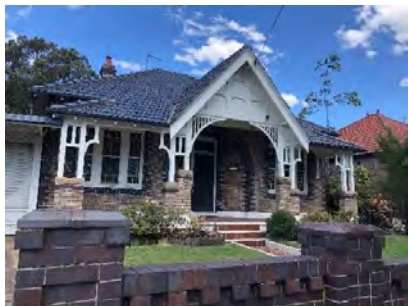
This item is located at 42 Lenthall Street and appears consistent with the description in the SHI database, in good condition and with relatively little modification. The front fence is likely a replacement but is sympathetic.
Federation style house (I137)	Local

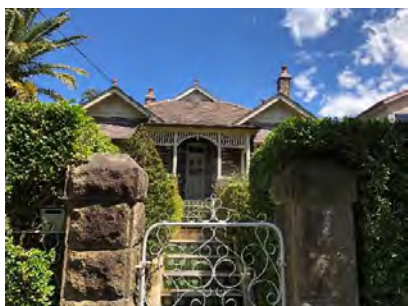
This item is located at 7 McDougall Street and appears to be in good condition, however, is very difficult to see due to the high fence and hedge. Suggest further inspection.

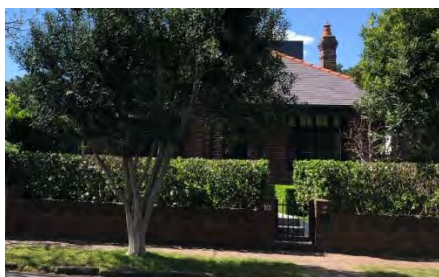
This item is located at 10 McDougall Street and appears to be in good condition, however, is very difficult to see due to the hedge. Appears mostly intact. Suggest further inspection.

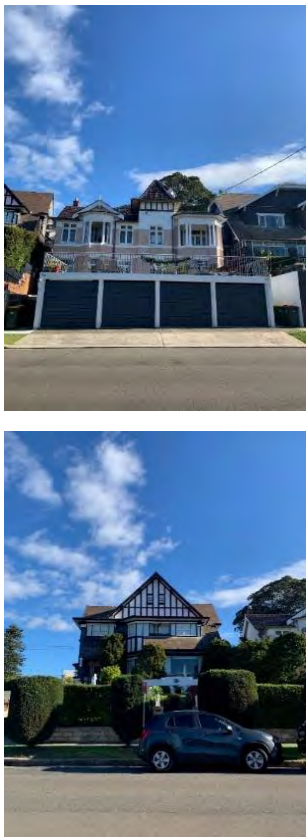
<p>32 -34 Dudley Street is a large 1920's style house with large tower featuring pyramidal roof and a mixture of design influences including Italianate, Classical and Art Nouveau. There is an intrusive garage structure at the street frontage.</p> <p>36 Dudley Street is a highly individual bungalow style mansion constructed on a corner site C.1936. The slate roof is steeply pitched with unusual corner porches with flat roofed balconies.</p> <p>Original stone retaining walls and well planted grounds</p> <p>Alterations have been made to enclosing the balconies.</p>
Inter War Bungalow (I467)	Local

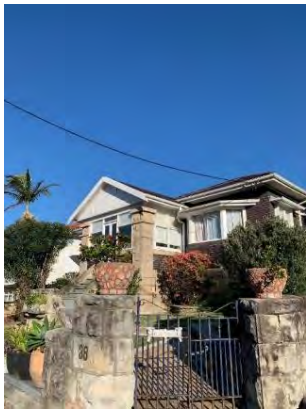
<p>38 Dudley Street is on the corner of Dudley and Byron Street is an example of an interwar freestanding residence C.1929-30. The house has a scale, quality and response to the setting which demonstrates the historic evolution of the Interwar house and the last stages of the suburban consolidation of Coogee. The item appears consistent with the description in the SHI database, and is in good condition.</p>

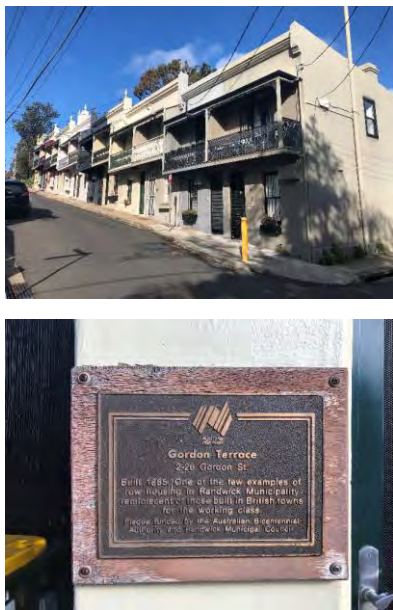
A series of mid-Victorian style terraces dated to 1885 with step-downs to align with the surrounding landscape. This heritage item also has a plaque installed adjacent to 26 Gordon Street. This item appears to be in good condition and relatively intact.

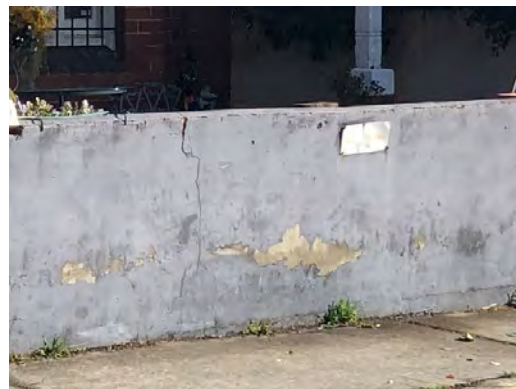
Figure 40. Close up of fence on Gordon Street requiring repair.

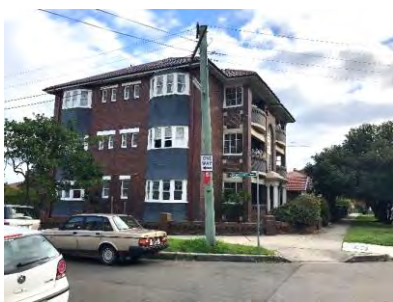
Building appears to be in good condition, viewed from public domain. Materials, features and detailing are in keeping with the physical description outlined in the SHI.
"Romona Hall", Spanish Mission influence flat building, c 1940 (I404)	Local

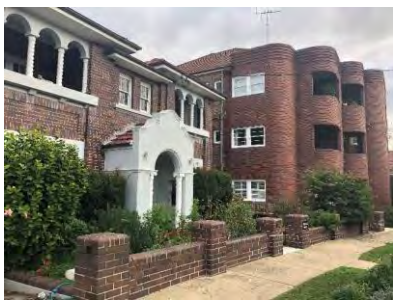
Building appears to be in good condition, viewed from public domain. Materials, features and detailing are in keeping with the physical description outlined in the SHI.

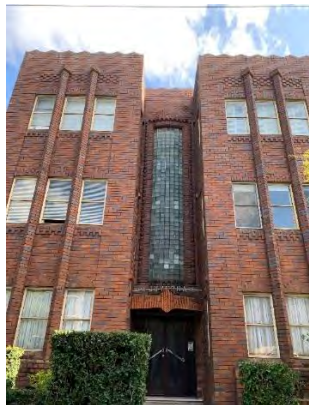
The item at 50 Cook Street is a three level art deco residential flat building in good condition generally as built. It has a deeply recessed central feature stairwell with translucent glass blocks, thematic brickwork, including brick columns, decorative parapet features and herringbone brickwork on the foyer ceiling. The original fence, entry doors and windows have been retained.

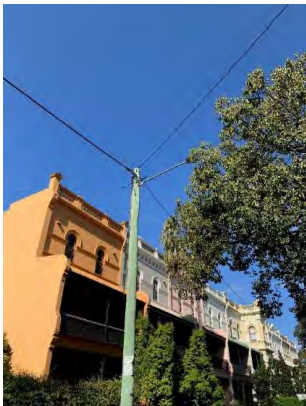
The item at 26-42 The Avenue is one of the finest rows of Victorian terraces in Sydney, in magnificent park setting overlooking a row of large Moreton Bay Figs. Remarkable for high degree of integrity despite alterations to some terraces. All are redeemable. Local historical interest associated with education.

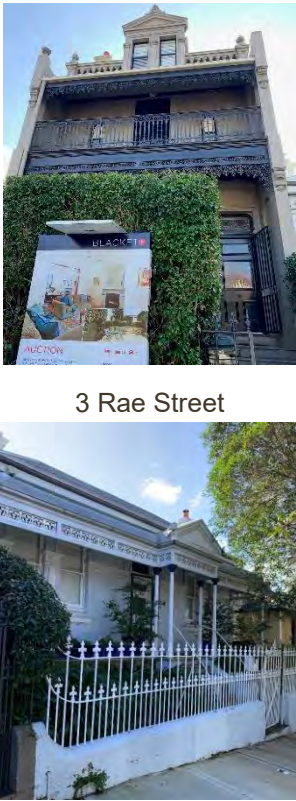
<p>3 Rae Street</p> <p>5 Rae Street</p>	<p>The group of houses at 3,5,7 & 9-11 Rae Street, Randwick are mostly consistent with the description in the SHI database. The item maintains a high integrity and is considered to be in a good condition, particularly No. 3 which has been recently restored.</p>

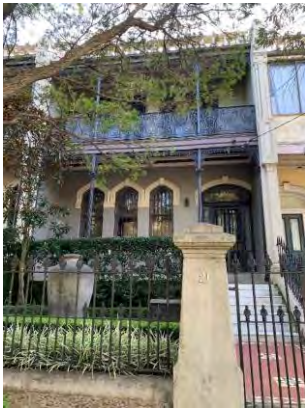
<p>The group of houses at 11A-23 Rae Street, Randwick are mostly consistent with the description in the SHI database although Nos 11 to 21 have been recently restored. The item has a moderate integrity and is considered to be in a good condition. No. 23, however, is in a poor condition and has an enclosed balcony.</p>
Victorian residence, c 1889 (I436)	Local

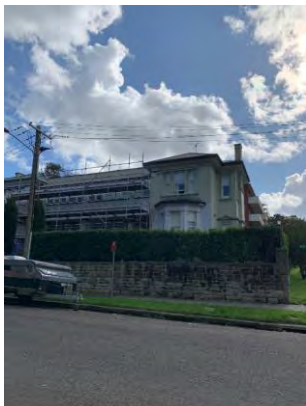
<p>The item is located at 37-39 Rae Street, Randwick. The item is consistent with the description in the SHI database. The item maintains a moderate integrity and is considered to be in a good condition. Currently, there are some works occurring to the enclosed balcony at the front.</p>

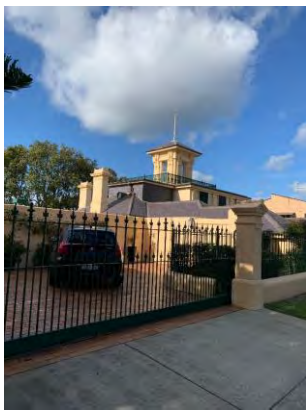
The item is located at 43 St Marks Road, Randwick. The item is consistent with the description in the SHI database. The item maintains a high integrity and is considered to be in a good condition.
Single-storey and two-storey Italianate residences, part of a large and consistent group, c 1884 (I442)	Local

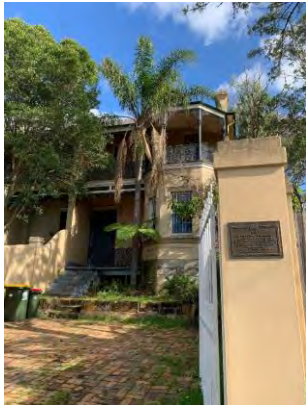
The item is located at 48, 50, 52-56, 58, 60, 62, 64, 66 St Marks Road. The majority of these houses were not visible from the public domain and so were not fully inspected during this study. The item's description should be updated in the SHI database as there is currently no information within this listing sheet.

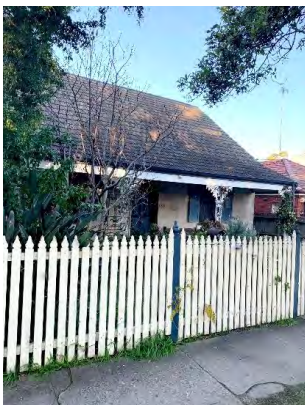
The house is located at 139 Botany Street. The overall condition and integrity match the details provided in the SHI database, the house having been substantially modified and only the original stonework remaining intact. Otherwise, the house is in good condition.

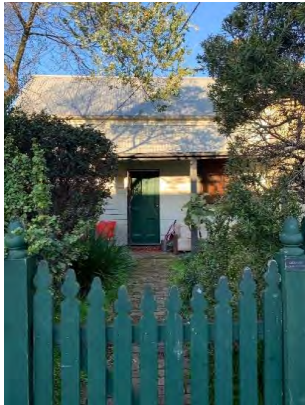
The house is located at 11 Jane Street. The overall condition and integrity match the details provided in the SHI database, having been substantially altered and original materials having been extensively replaced. It is difficult to see from the public domain due to the fence, but this item appears to be in good condition but not particularly intact. Suggest further inspection.
Two-storey sandstone cottage, c 1860s (I393)	Local	 	The house is located at 15 Jane Street. The overall condition and integrity match the details provided in the SHI database, with extensive replacements to original features. The house is however difficult to see over the high fence so further inspection is suggested.
St Jude's Mission Church, c 1885 (I411)	Local	 	The house is located at 84 Middle Street. The overall condition and integrity match the details provided in the SHI database. This dwelling, once a church, is now a private residence. Brickwork has been painted and many original details have been lost. The integrity of the item is low, however it appears to be in fair condition.

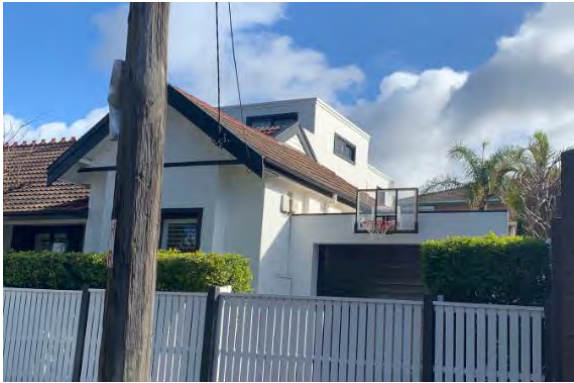
Figure 74. Example of unsympathetic 'pop top' addition above the roofline.

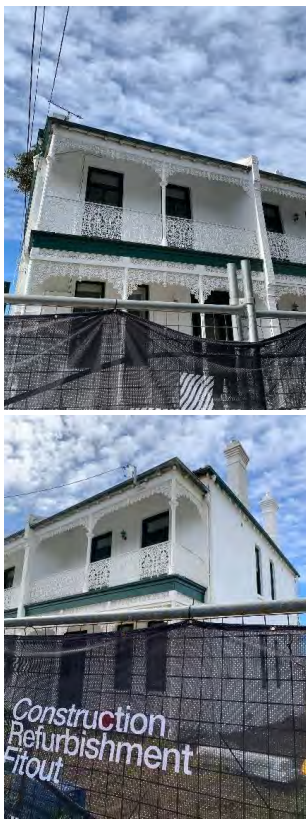
<p>The two-storey pair of terraces are present at 10-12 Doncaster Avenue. The item is consistent with the description in the SHI database, although there is a threat of a reduction in the large curtilage. The item maintains a moderate integrity and is considered to be in a fair condition being in the process of restoration.</p> <p>The surrounding properties have been demolished and a planning proposal has been submitted to incorporate the item into new development. There is a potential risk for insensitive redevelopment of this area.</p>
"Creswell", Victorian terrace, c 1890s (I124)	Local

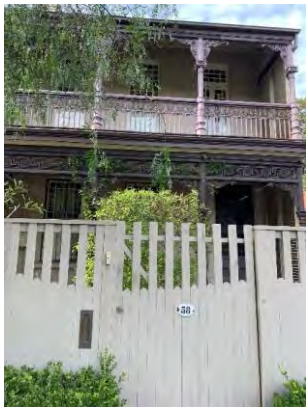
<p>The Victorian Terrace is present at 58 Doncaster Avenue. The item is consistent with the description in the SHI database. It maintains a moderate integrity and is considered to be in a good condition.</p> <p>Notable additions to the property include a rear addition, that is not overly visible from the public domain, an unsympathetic timber panel fence.</p>

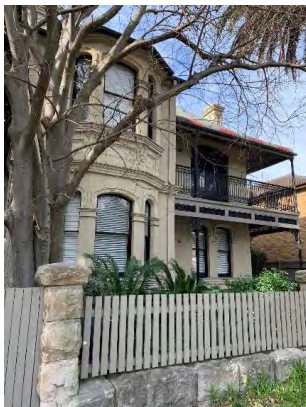
<p>The Victorian mansion is present at 8 Doncaster Avenue. The item is consistent with the description in the SHI database. It maintains a high integrity and is considered to be in a good condition.</p>

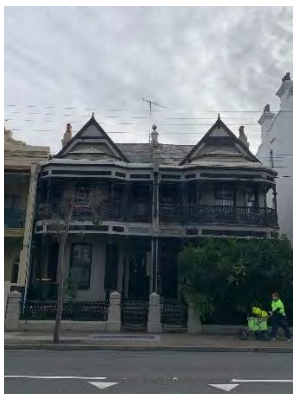
The terraces are located 156-158 Avoca Street, Randwick. The item is mostly consistent with the description in the SHI database although is in a fair condition. There are scratches to the rendered façade, the slate roof tiles are in need of repair, the filigree balustrade to No. 158 is broken and a new unsympathetic screen door has been added to No. 156. The item has moderate integrity.
Two three-storey terraces, c 1885 (I281)	Local

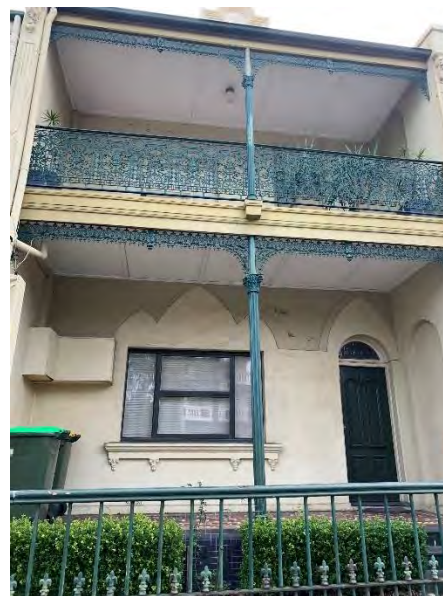
Figure 97. Unsympathetic replacement of windows and removal of moulded architrave at 160 Avoca Street.

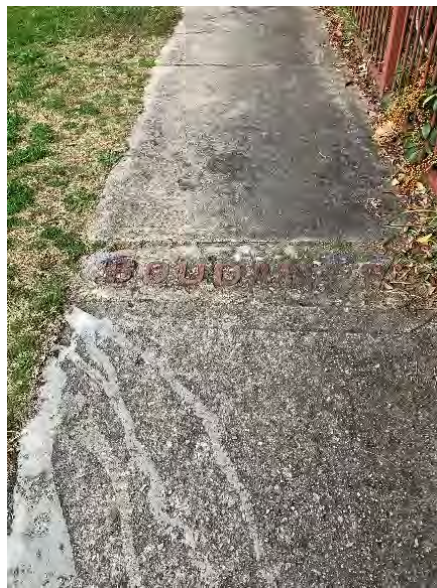
Figure 102. 'Soudan St' laid into the concrete. It is recommended that these are retained as a feature of the Heritage Conservation Area.

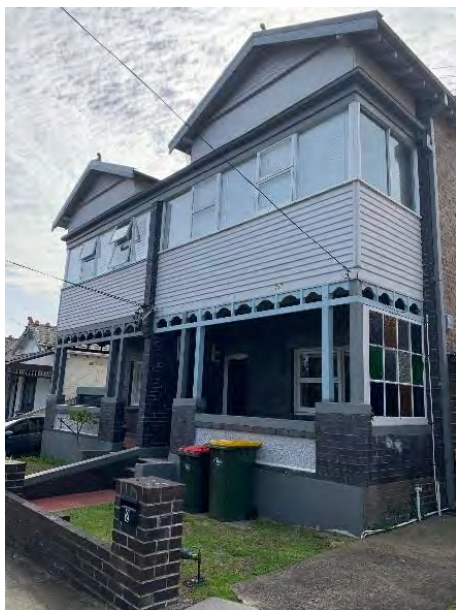
Figure 103. Restored building at 227 Barker Street. Unsympathetic use of materials and infilling of verandah. This property has lost some of its integrity.

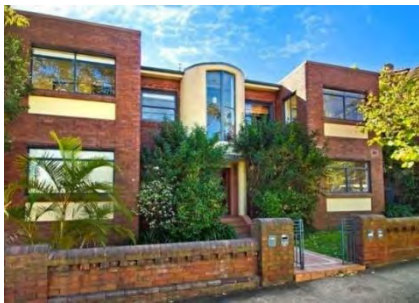
<p>This property is within the Moira Crescent HCA.</p> <p>This is a fairly unusual Art Deco style block of flats, which appears to have mostly intact features.</p> <p>Subject to further detailed assessment, it is recommended this property be listed.</p>
1 Winburn Avenue, Kingsford

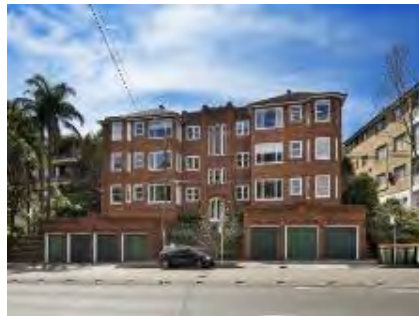
<p>Block of Art Deco flats with interesting Art Deco brickwork and features. The building has been built to a unique plan. Some windows may have been replaced but otherwise appears to be highly intact.</p> <p>Subject to further detailed assessment, it is recommended this property be listed.</p>
122 Brook St, Coogee

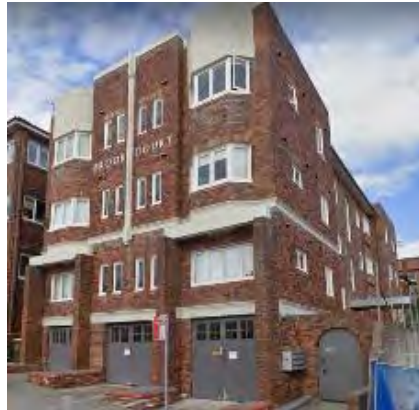
<p>Art Deco apartment which has a good contribution to the streetscape. Unusual features and ground level doors. Further historical research may provide more valuable information.</p> <p>Recommend further research for potential listing.</p>

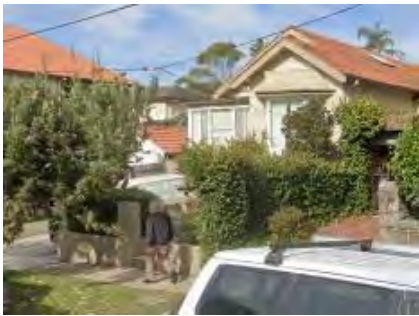
<p>This property is within the Dudley Street HCA.</p> <p>This house is a Federation bungalow, set back from the street and modified at the street frontage.</p> <p>It is not recommended that this property be listed.</p>
9 Frances Street, Randwick	 	<p>This property is within the St Jude's HCA.</p> <p>The property is a block of mid-century four-storey walk up flats. This type of dwelling is very common in the area and does not exhibit any remarkable features.</p> <p>It is not recommended that this property be listed.</p>

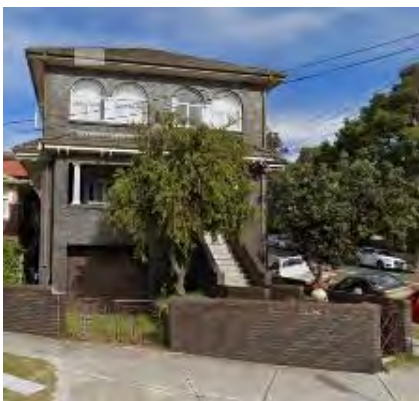
<p>No 1 Berwick Street was approved by council in 1925 and built 1926. A three-storey flat building with interesting Art Deco features. It is highly intact and has an interesting corner block sitting, however it is not considered to be the most interesting or best example within the LGA.</p> <p>Not recommended for listing.</p>

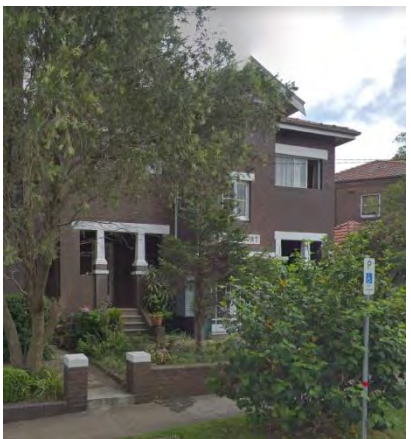
A two storey Art-Deco flat building with some interesting features. While highly intact, this building is afforded adequate protection as a part of the Moira Crescent HCA. It is not recommended that this property be individually listed.
12 St Luke St, Randwick

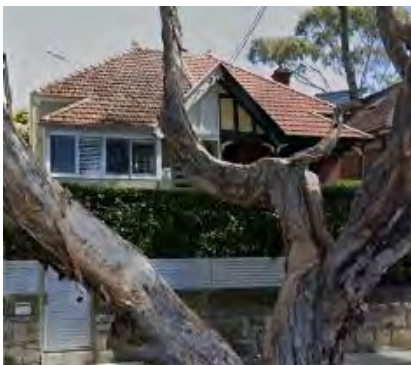
One half of a semi-detached Federation house. Only No. 12 would be considered intact with No. 14 being highly modified. This would only be recommended for listing if both halves of the semi were highly intact. It is not recommended that this property be listed.
125 Mount St, Coogee
