## Urban Capability Assessment

## **EDGEWORTH LOCAL ENVIRONMENT PLAN**

**RE: EDGEWORTH LOCAL ENVIRONMENT PLAN  
GEORGE BOOTH DRIVE, EDGEWORTH  
URBAN CAPABILITY ASSESSMENT - FINAL REPORT**

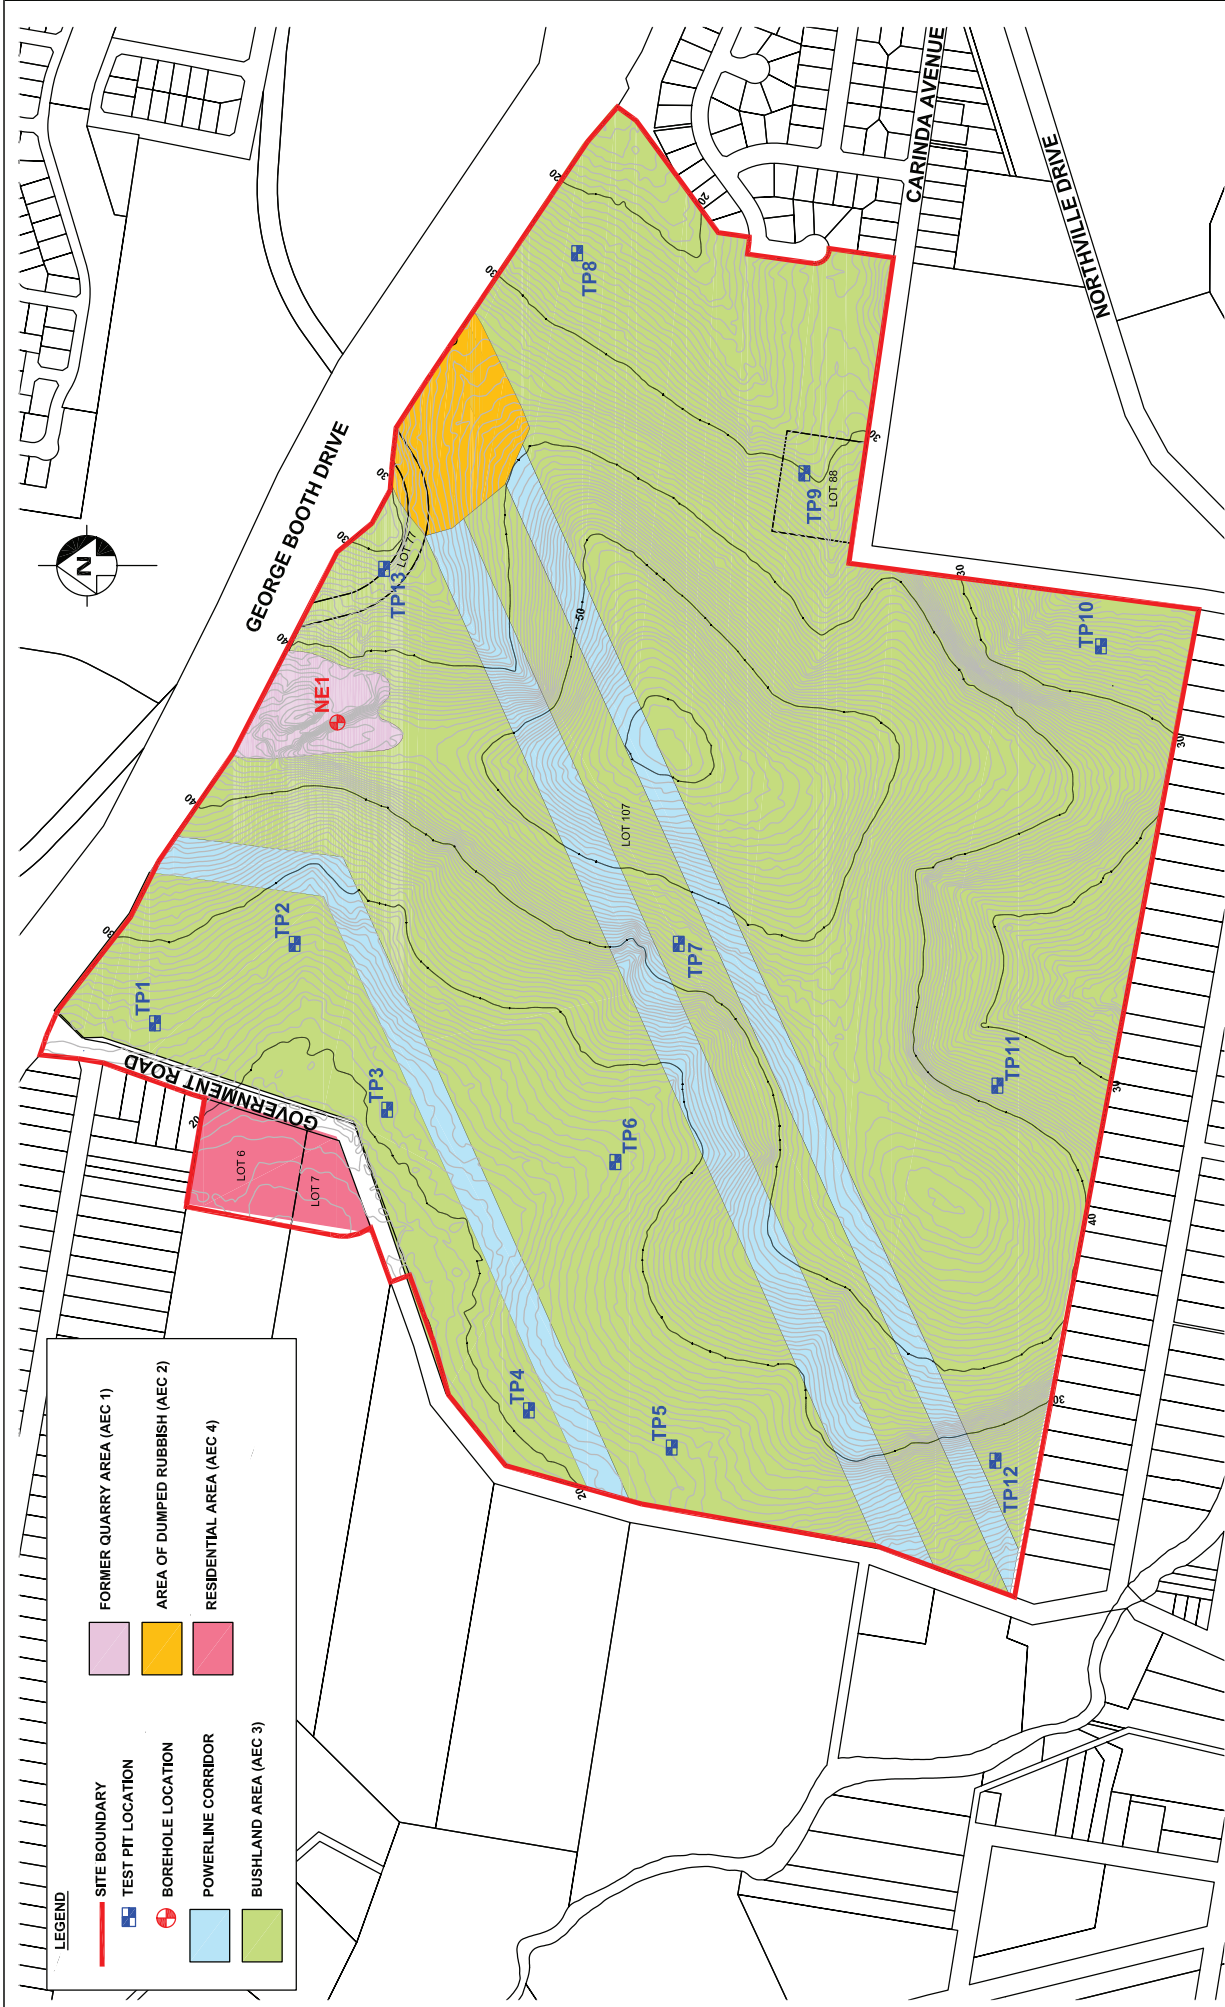
The proposed development has been divided into a series of geotechnical domains based on the limited subsurface investigation and likely surface and subsurface conditions. Due to the size of the site, the classification into geotechnical domains are broad and based on the extent that conditions will impact on potential development. The geotechnical units are defined in Table 3 and delineated over the site as shown in Figure 2.
