STAGE 1 ENVIRONMENTAL SITE ASSESSMENT

PROPOSED WAREHOUSE DEVELOPMENT

**LOTS 33 AND 34 IN DP243029
CORNER OF SAPPHIRE COAST DRIVE AND TURA BEACH
DRIVE, TURA BEACH, NSW**

25 SEPTEMBER 2015

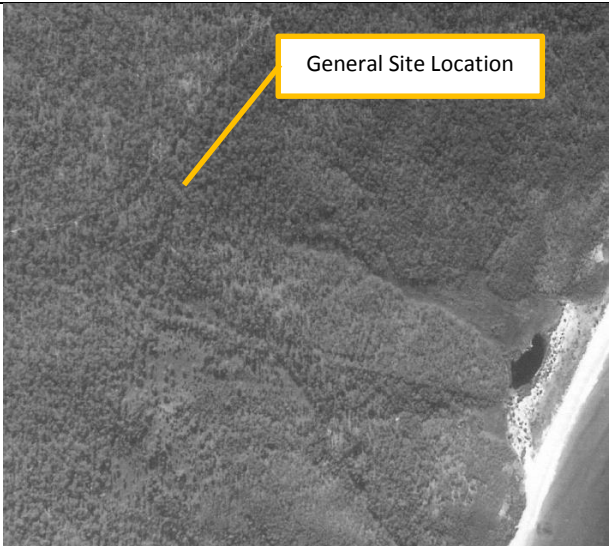
Year	Details
1957

<p>The site formed part of wider bushland which generally extended from the coast.</p>
1962	The site appeared generally similar to the 1957 photograph. Some clearing of vegetation had occurred in the generally vicinity of the site.
1971	Large sections of bushland in the vicinity of the site had been cleared. Dirt tracks were visible in the immediate vicinity of the site.
1989	<p>The site was generally vacant and formed part of a wider vacant property which extended to the south, east and west. Scattered trees and bushes were located at the site. Sapphire Coast Drive and Tura Beach Drive had been developed.</p> <p>The area further to the east of the site had been developed and occupied by residences. A large pond/dam was located on a property to the west of the site.</p>
1994	The site and immediate surrounds appeared similar to the 1989 photograph.
2003	The site generally appeared similar to the present layout. Development was underway to the south-east of the site.

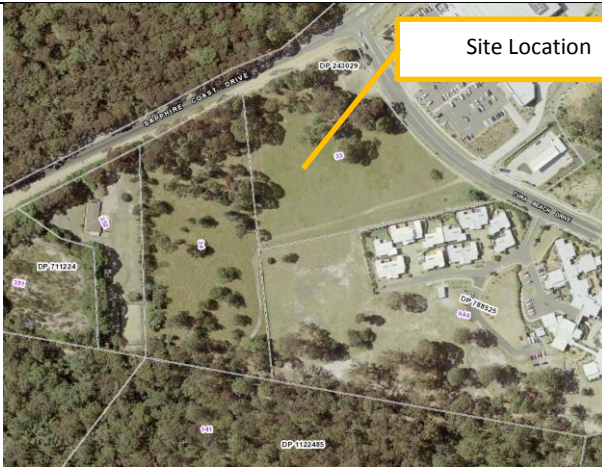
Year	Details
2014 ¹² (SIX Maps)

<p>The site generally appeared similar to the present layout. The shopping village development was to the east of the site.</p>
