**REPORT  
ON  
PRELIMINARY GEOTECHNICAL AND  
CONTAMINATION ASSESSMENT**

**PROPOSED LOCAL ENVIRONMENT PLAN  
WYEE LAND RELEASE**

**Prepared for  
CONICS PTY LTD**

**PROJECT 41810  
JULY 2009**

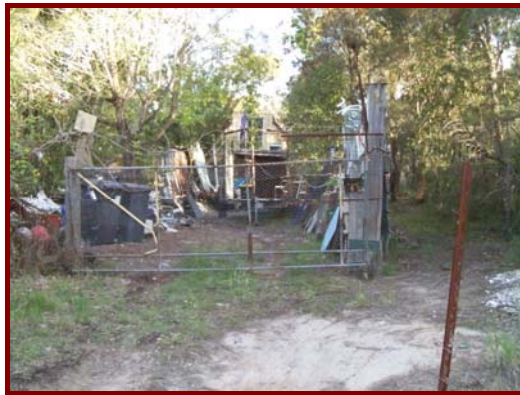
**Photo 1 – Dwelling in the “paper” subdivision**

The south-western area of the site comprised a “paper” subdivision with at least 100 approved and unapproved low cost houses (refer Photo 1). Numerous areas affected by illegal dumping were identified throughout the “paper” subdivision area (refer Photo 2).

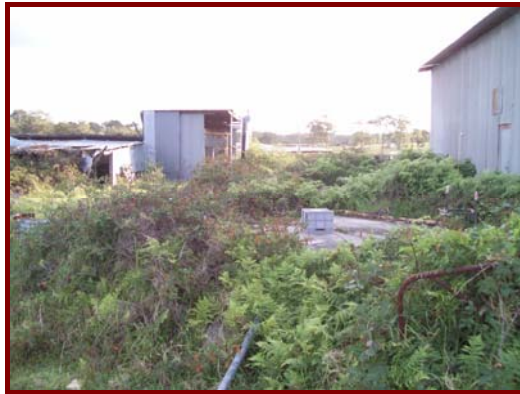
**Photo 3 – Former chicken shed and filling**

A former chicken farm is located in the north-western corner of the site (refer Drawing 3). Evidence of extensive cut and fill was noted in this area (refer Photos 3 to 5)

- significant areas of cutting and filling are present in the area of the former chicken farm in the north-west corner of the site (refer Drawing 3 and photos 3 to 5)

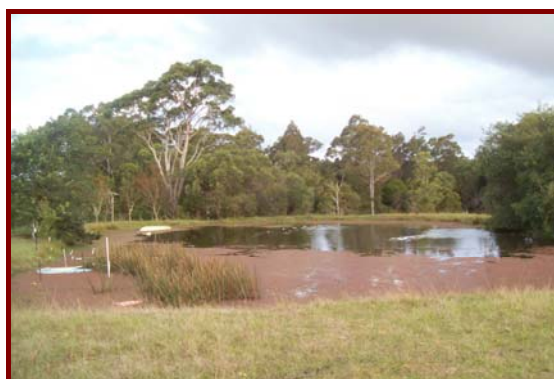
**Photo 6 – Existing dam to the south of former chicken farm**

Numerous dams are scattered across the site, predominantly in the south-western corner and also in the north-western corner.

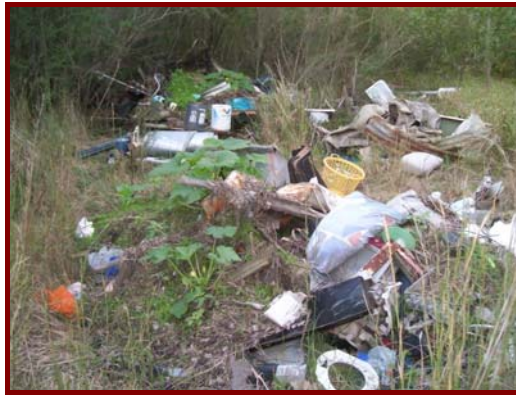
**Photo 7 – Illegally dumped rubbish near former cricket oval in eastern area of site**

In between the existing low cost houses in the south-east corner of the site, there are many deposits of dumped materials, such as timber, whitegoods, car bodies and generally rubbish (refer Photo 7)

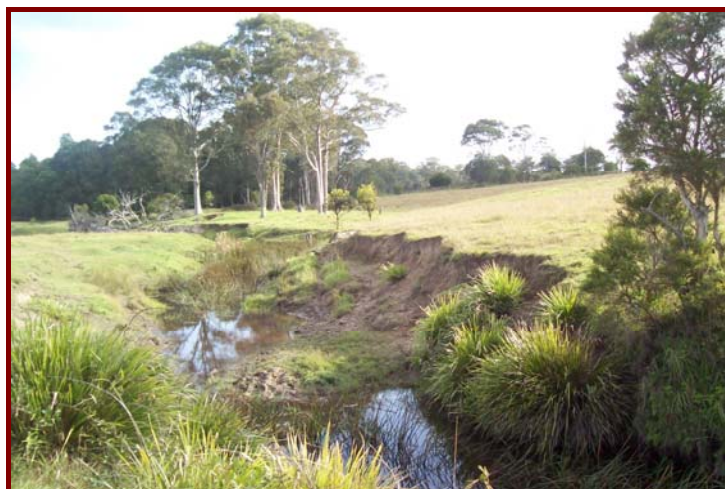
**Photo 10 - Erosion in Mannering Creek**

- no rock outcrops were observed within the site.
- erosion along the banks of Mannering Creek and the unnamed creek running south to north through the site (refer Drawing 3). Erosion depths ranged from 0.3 m to 2.5 m.

- most of the banks are devoid of trees and hence there is little protection against erosion and associated slumping of undercut sections.
- some slumping of creek banks has occurred in Mannering Creek (refer Photo 10 above).
- waterlogged soils are present in areas around the unnamed creek and also within the north-eastern area of the site (refer Drawing 3 for approximate extent).
- the near surface soils in these wet areas are generally weak and do not allow passage of vehicles (refer Photo 11)

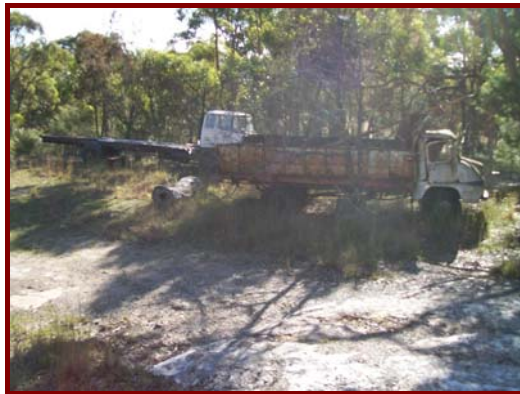
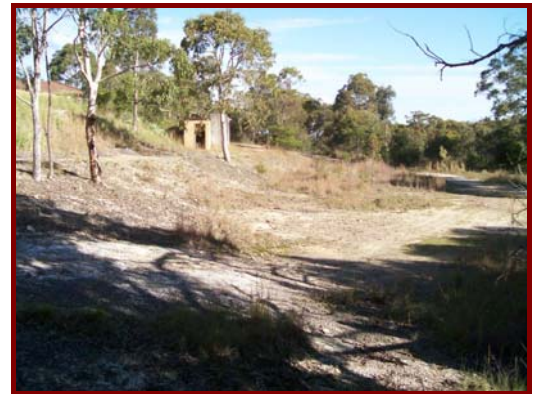
Photo 12 & 13 – Former Quarry Land Use Area

- **Lot 212 DP866437** (located off Bushells Ridge Road) – Anecdotal information suggested that the area currently occupied by Lot 212 was formerly used as a quarry. This information was supported by review of the aerial photographs which indicated bare areas stripped of vegetation in the 1954 and 1965 photographs.

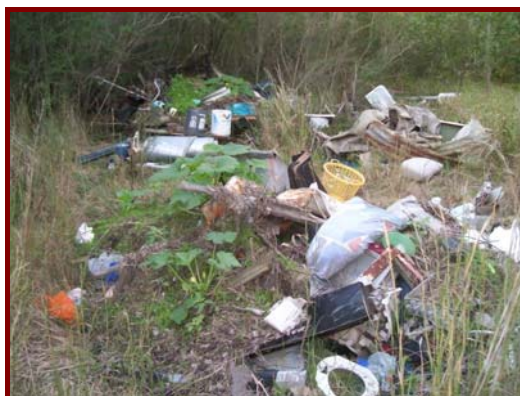
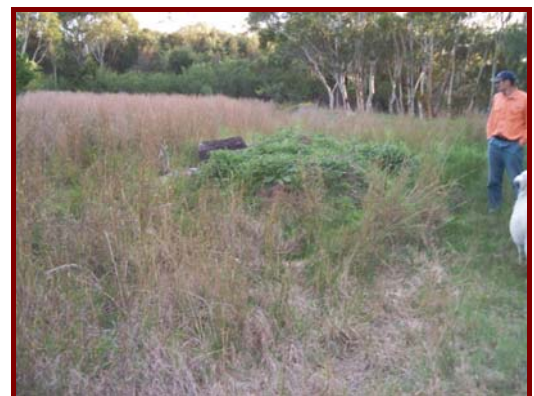
Photo 14 & 15 – Example of Illegal Dumping in Former Cricket Pitch Area

- **Lots 245 to 262 & 273 to 283 DP 7506** (located off Gorokan Road) – Review of the aerial photographs indicates that the area currently occupied by these lots had a historical orchard land use from around 1965. These lots are now part of the “paper” subdivision site area.
- **Lot 430, 188 & 189 DP 755242** (located off Gorokan Road) – Review of the 1954 aerial photograph identified a circular cleared area in the 1954 and 1965 aerial photographs. Anecdotal information confirmed that this cleared area was historically a cricket pitch. Visual inspection of this area identified mounds of illegal dumping waste materials.

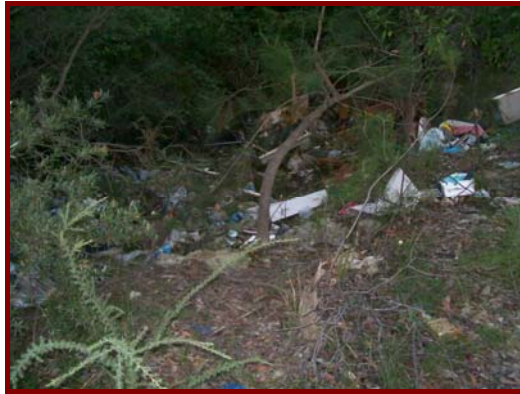
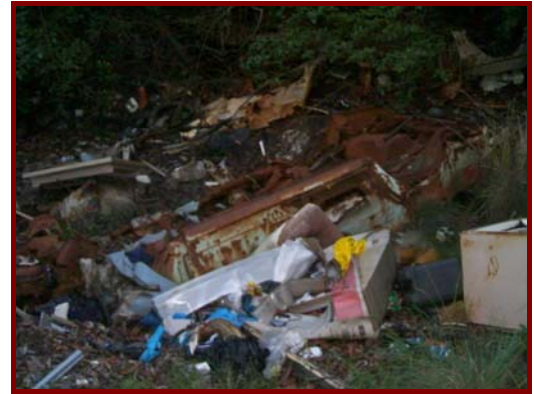
Photo 16 & 17 – Example of Illegal Dumping

- **Lot 1582 DP 1121660** (located off Gorokan Road) – Review of the 1954 and 1965 aerial photographs identified a cleared area with dam. Anecdotal information indicated that this area was possible used as a quarry or as a water storage area supplying water to steam trains on the nearby Main Northern Railway Line. Visual inspection identified significant quantities of illegally dumped waste.

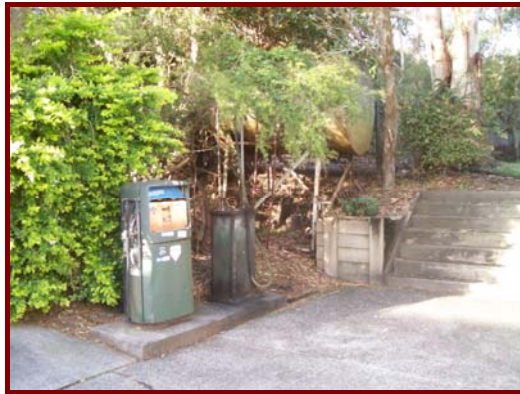
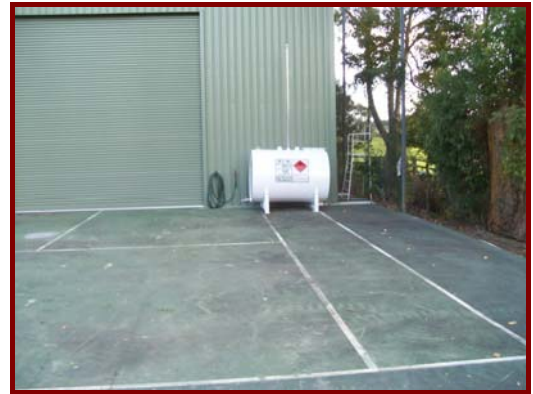
**Photo 18 & 19 – Identified Above Ground Fuel Storage Tanks & Bowzers**

- **Lot 472 DP 755242** (accessed from Gorokan Road) – Visual inspection identified large sheds that were currently used as vehicle and farm machinery workshops and storage areas. In the locality of the sheds was an above ground diesel fuel storage tank and bowser. A separate shed had also been constructed on a former tennis court for storage of a helicopter. A separate above ground aviation (A1) fuel storage tank and bowser was also identified in this area of the site. In both cases the refuelling infrastructure appeared well maintained, with only minor visible signs of contamination around the diesel refuelling infrastructure. Anecdotal information indicated that the shade structures located within the site was operated as a commercial nursery, ceasing operations in the 1990's.

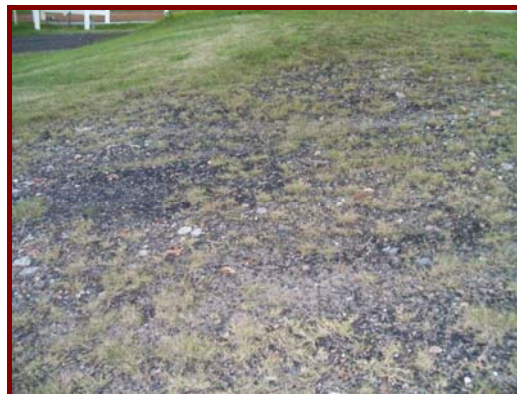
**Photo 21 – Anthropogenic Inclusions with Filling (Lot 8)**

- **Lot 8 DP 1020857** (located off Gorokan Road) – Visual inspection mound of filling towards the Gorokan Road boundary. Close inspection identified anthropogenic inclusions within the filling.

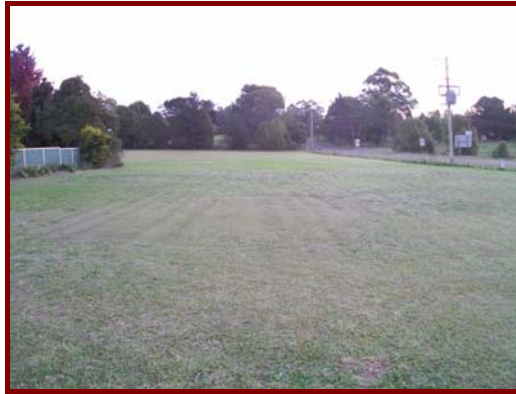
Photo 22 – Current condition of Lot 323

- **Lot 323 & 324 DP 755242** (located off Hue Hue Road) – Review of the historical aerial photographs indicated that the majority of the area currently occupied by these lots had a historical orchard land use from around 1954 to 1965. Debris was identified from the 2007 aerial photograph within the Lot 323, although the property could not be accessed during the site walkover.

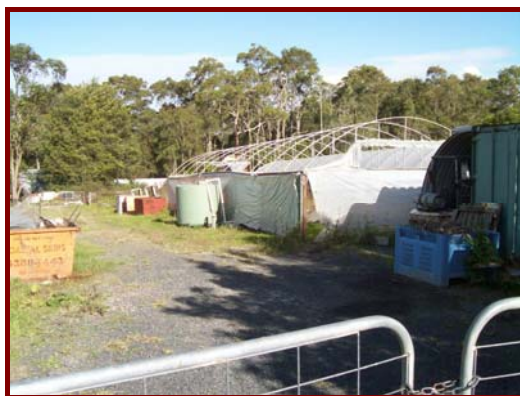
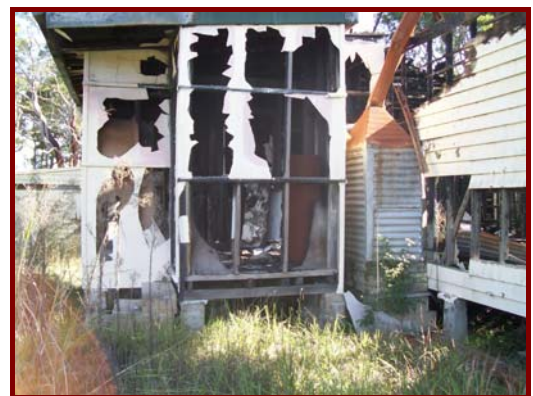
Photo 23 & 24 – Current condition of Lot 442 and 443 (respectively)

- **Lot 442 & 443 DP 755242** (located off Hue Hue Road) – Review of the historical aerial photographs indicated that the majority of the area currently occupied by these lots had a historical orchard land use from around 1954 to 1965. Elongated buildings likely to be for hydroponic activities in green houses were identified in the 2007 aerial photograph. This land use was confirmed during the site walkover, although no detailed inspection was possible. The aerial photograph also identified workshop facilities within Lot 442. The site walkover indicated that the derelict dwelling within Lot 443 was significantly damaged by fire and vandalism. The building appeared to be constructed from fibreboard building materials that may contain asbestos.

The walkover assessment identified various potential sources of asbestos contamination to the surface soils, filling or waste disposal areas on-site. This walkover assessment does not constitute a hazardous building materials assessment. Further, a hazardous building materials assessment would be recommended prior to demolishing the any buildings at the site.

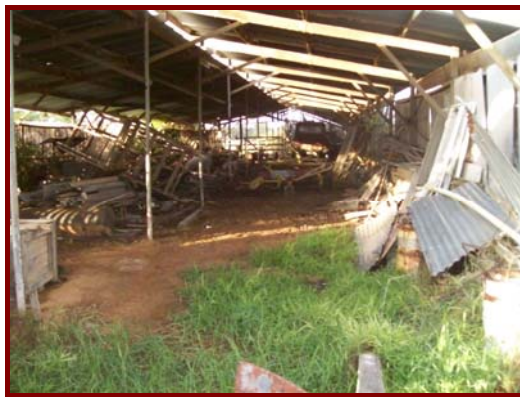
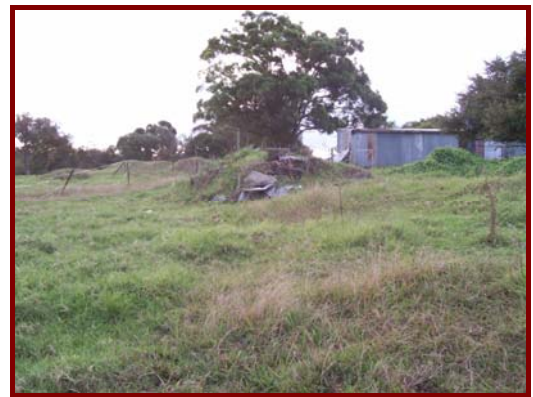
Photo 25 & 26 – Former poultry sheds & waste materials within Lot 17 (respectively)

- **Lot 1 DP 785709 & Lot 17 DP 870597** (located off Hue Hue Road) – Review of the historical aerial photographs indicated that the part of the area currently occupied by these lots had a historical orchard land use from around 1954 to 1965. This portion of the site is currently grass covered.
- **Lot 17 DP 870597** (located off Hue Hue Road) – Review of the historical aerial photographs indicated that the part of the area currently occupied by this lot had a historical poultry farm land use from around 1975. This land use may have encroached onto Lot 16 DP 870597. Visual inspection of the site identified that significant disturbance, including cutting and filling and possibly stockpiling of waste materials, had occurred within this area of the site in the past. No former chicken burial pits were identified within this area of the site, although their presence is to be expected.

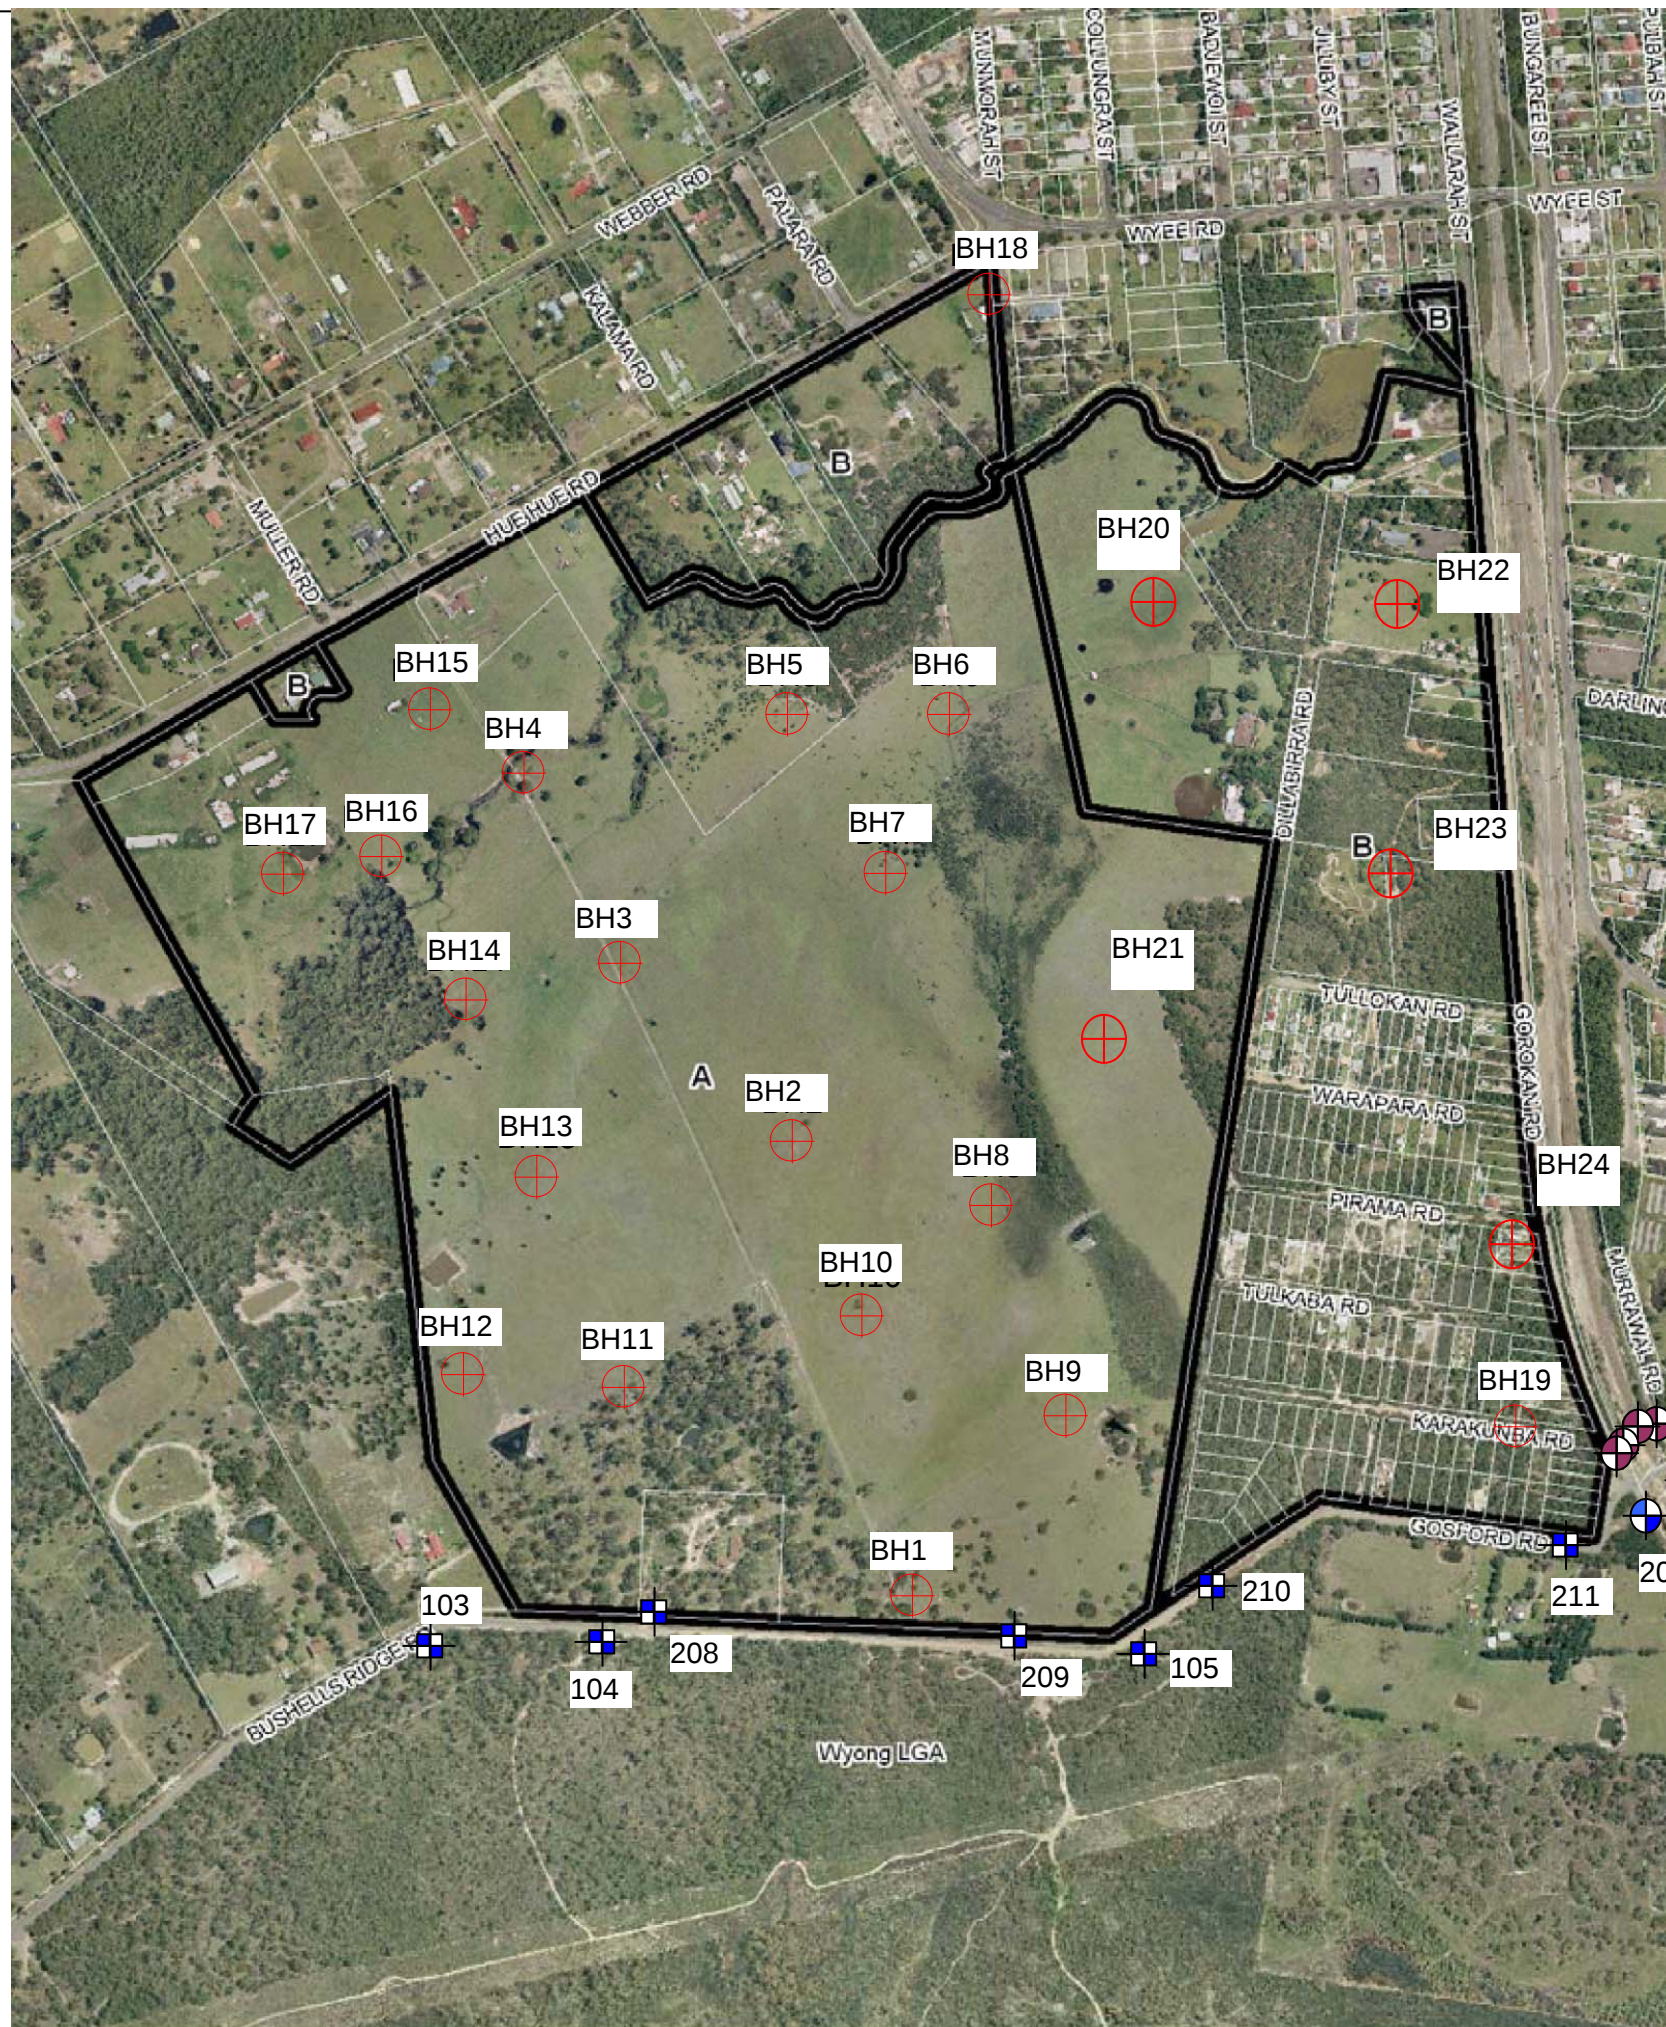
**6**

- ⊕ Test Bore location and number
- ⊕ Test Bore Location and Number (Previous Investigation 41533/2)
- ⊕ Test Pit Location and Number (Previous Investigation 41533/2)
- ⊕ Test Bore Location and Number (Previous Investigation 41533/1)
