PLANNING PROPOSAL – PP036

Shoalhaven Local Environmental Plan 2014 2019 Heritage Housekeeping Amendment

Prepared by
Planning, Environment & Development Group
Shoalhaven City Council

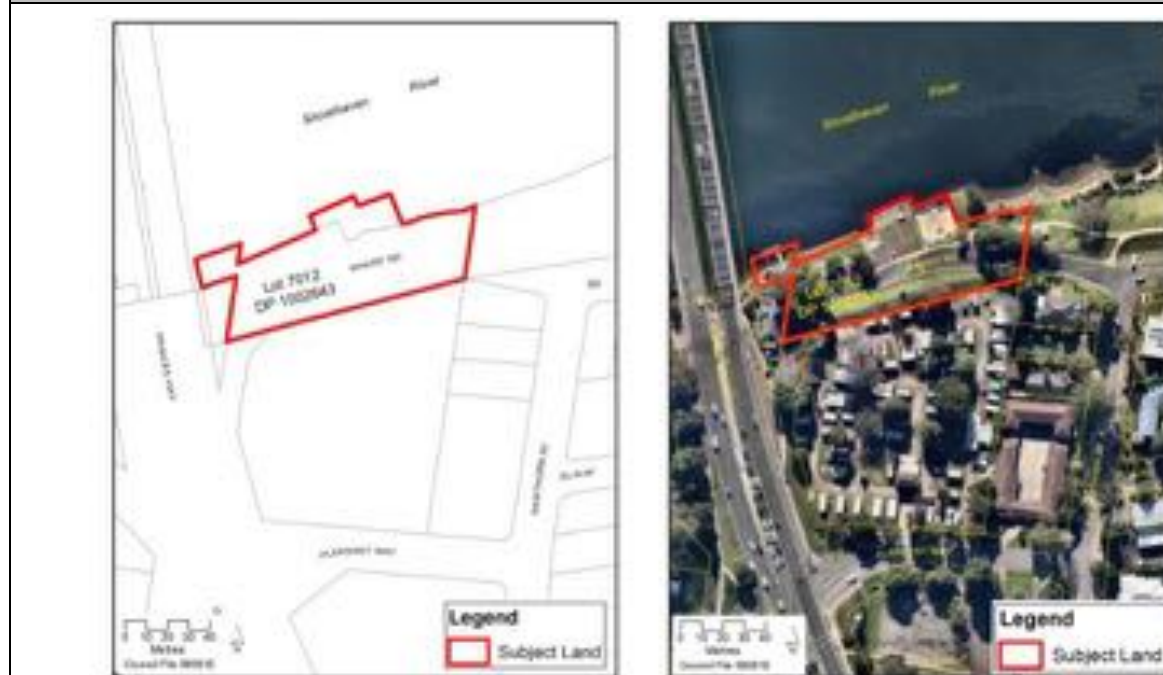
161. Item No. 407: Inter-war Weatherboard Building and Timber Wharf

Issue: A part of the item, the Nowra Sailing Club weatherboard building, was burnt in a fire and subsequently removed. As a result the item name is now incorrect. The item address, property description and heritage mapping are incomplete.

Proposed change: Update the item name to reference the removal of the Nowra Sailing Club weatherboard building. Update the item address to include a street number. Update the property description and Heritage Map (Sheet HER_013E) to include the portion of the wharf that extends over the adjacent waterway.

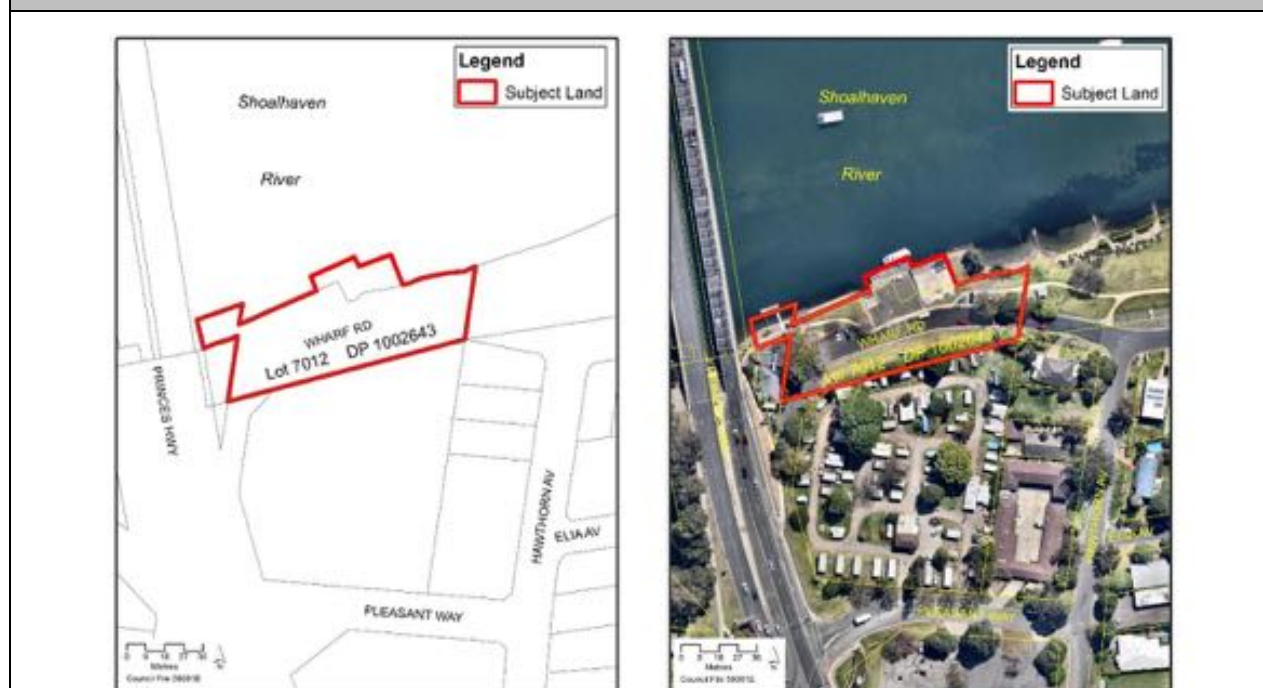
172. Item No. A8: Nowra Wharf

Rationale: A Heritage Assessment of the Nowra Sailing Club identified the Nowra Wharf site to possess potential archaeological significance. It is noted the wharf is intended to be removed as it poses a public safety concern, however the early footing in-situ is recommended to be retained. These remains are proposed to form the archaeological site, as supported by the Statement of Heritage Impact located in **Attachment G**.

Mapping Changes: Update the Heritage Map (Sheet HER_013E) to include an archaeological mapping layer over the proposed item (Lot 7012 and adjacent waterway)

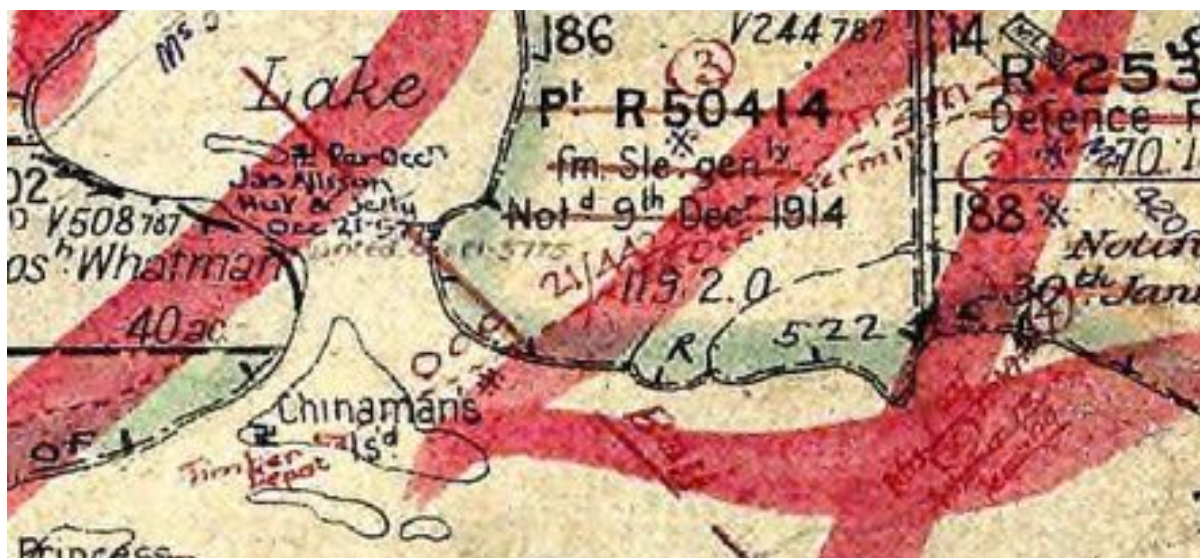
Figure 5 Parish Map showing Occupation Permit for Timber Tramway and location of timber depot on Chinamans Island. (OccPer 21/4422) (National Library of Australia, n.d.)

In the 1920s Kirton and Earnshaw Timber Company, trading as the Red Mill Timber co. used Chinamans Island to assist in the export of timber across Conjola Lake. Bullocks or horses were used to drag sawn logs to certain areas around the lake such as Roberts Point or Leaning Oak Point. A paddle wheel vessel is said to have been used to move these logs up the lake to Chinamans Island. From here the logs were then hauled from one side of the island to the other and then across the water along a timber framed tramway to the north side of the lake. The Parish Map 1919-1924 shows the timber depot on the island and the route of the timber railway (Figure 6). From there wagons of timber were rolled along a tramway across to Red head/ Bendalong Boat Harbour. A photograph in McAndrews book shows a picture of a team of horses dragging a skip with a large log across a jetty like structure. The railway was still extant in the 1940s. There are remains of a timber structure evident in the waters on the northern side of Chinamans Island which are possibly surviving physical evidence of the timber railway.

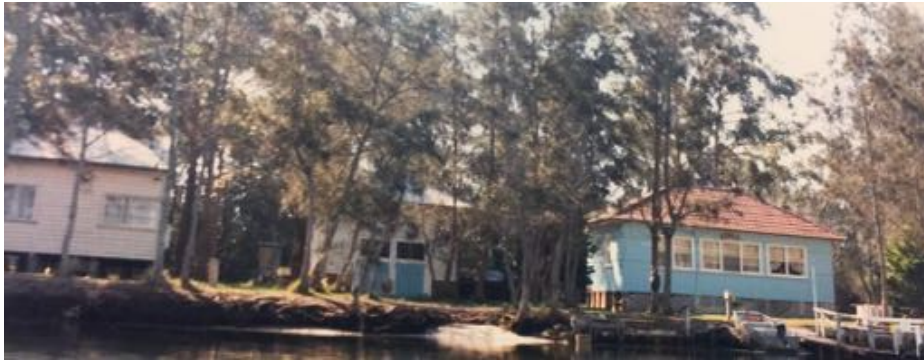
Figure 9. Lot 3 and Lot 4. The building in the middle is the boat shed belonging to Lot 3. (NSW Department of Industry, Lands & Water Division))

The Cottage, shed and jetty shown in Figure 9 was originally owned by Wilson and may have been built by Allison. It was transferred to T.M. Hambly, and has since been removed. The property was described by a report to the Department of lands in the 1990s as a weekend dwelling and jetty – total area 695.6m².

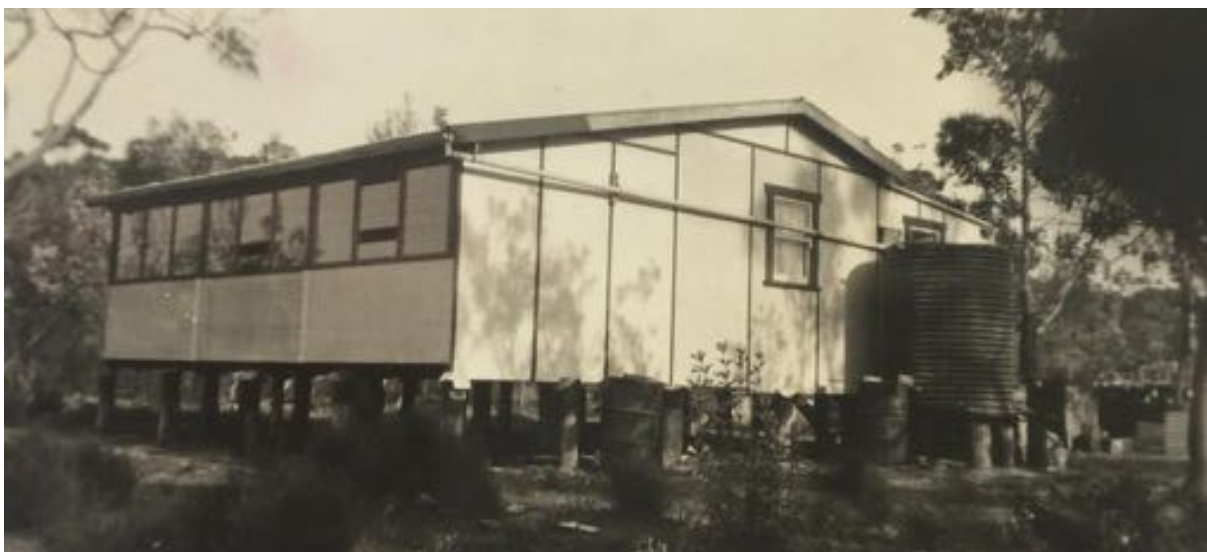
Figure 13. The Smith Cottage at Lot 7 before it was extended. Note the two tone colour scheme with the moulded fibro cover strips picked out in a dark colour to match the windows. (Milham)

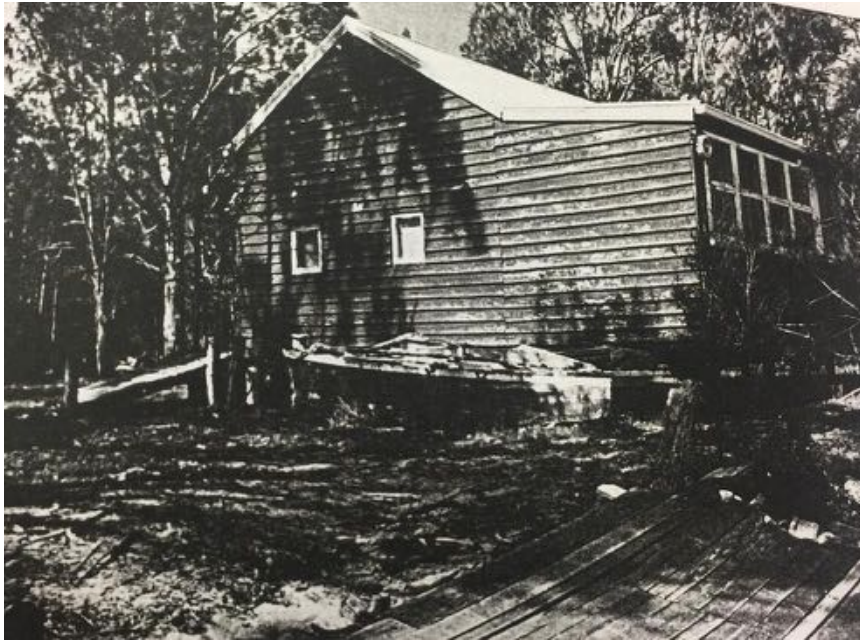
Figure 17. Lot 11 – Original dwelling constructed by Southwell and purchased by R.G Henley (Photo date 15/10/1991 (NSW Department of Industry, Lands & Water Division))

Lot 11 (PO 56/16) The original weatherboard cottage was built by the Southwells. Mr Henley purchased the dwelling from Mrs Southwell and then constructed a laundry, shower, storeroom, workshop and boatshed, retaining the dwelling. The Henley family used the property as a weekend- cottage.

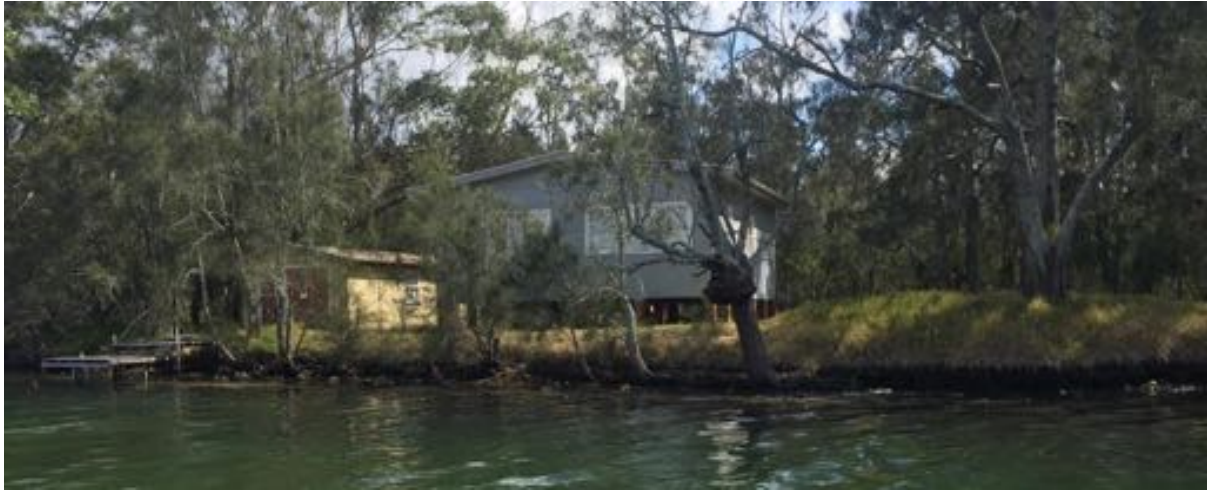
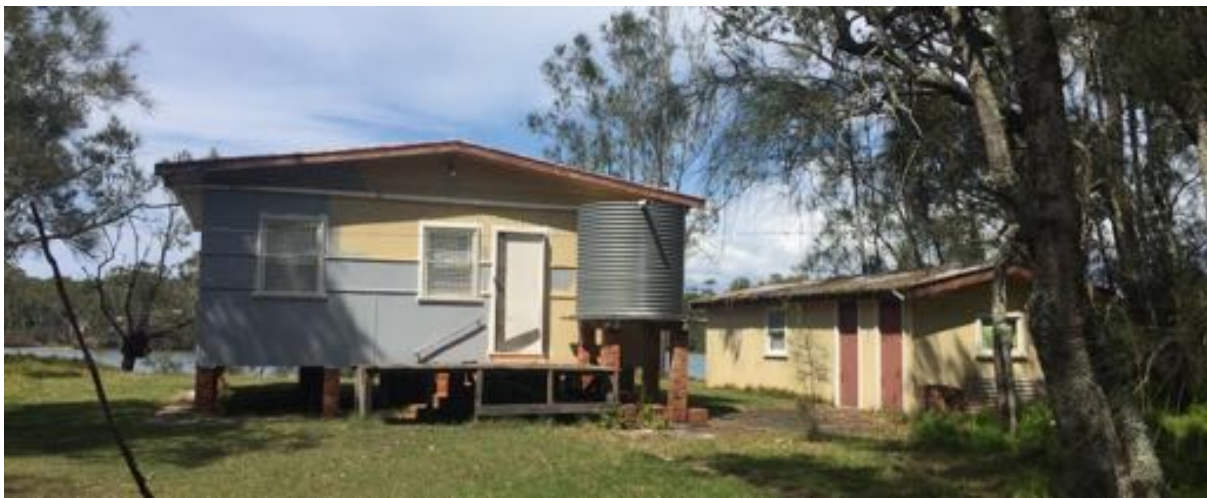
Figure 29. Ryan, the eastern most cottage Lot M.

Figure 30. Lot M - Ryan. Rear view looking south towards Lake Conjola

This cottage is located on the site of the original home of Mick Glanville whose Cottage was removed and replaced by the existing Ryan Cottage. The Cottage has a roughly square plan form with fibro asbestos cladding with moulded fibro cover strips and timber framed double hung sash windows. A larger pair of fixed pane and twin sash windows face south and Conjola Lake. The Cottage is constructed on brick piers and has a shallow pitched gable roof. The entry door is located on the northern side of the Cottage and there is a chimney on the western elevation that does not extend through the roof. A water tank is located at the rear steps. Adjacent to the Cottage is a long rectangular boat shed with a shallow gable roof and fibro cladding. It also has timber framed windows and two entry doors which suggests it may have been constructed as a temporary residence prior to the Cottage being built. There

is a fibro clad outdoor toilet located away from the dwelling. The lot upon which Ryan's Cottage is located is at the narrower end of the island and therefore has access and views through to Conjola Lake on both sides of the Island.

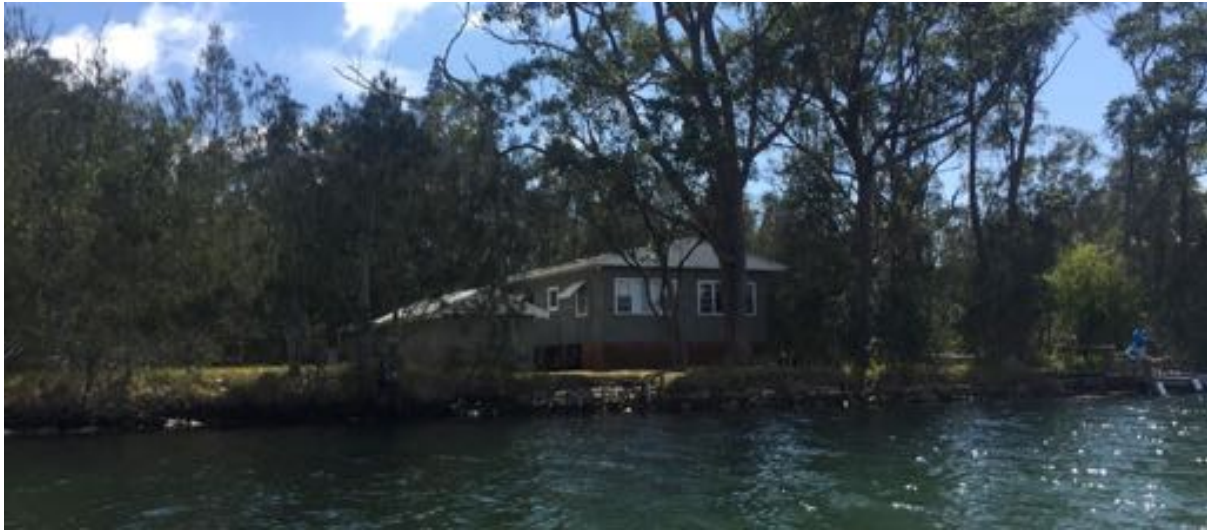
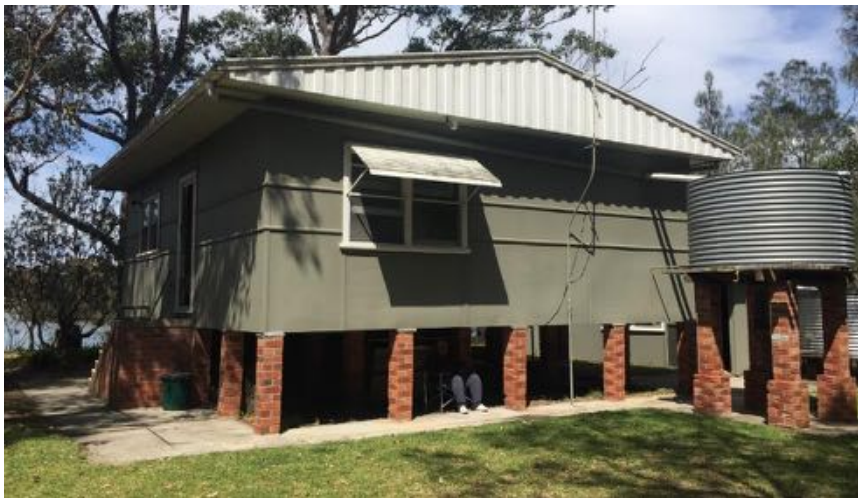
Figure 31. Vacant lot and then King Lot K.

Figure 32. The rear of the King Cottage

This Cottage is very similar to the Ryan Cottage however the gable ends of the roof project and are boxed in by cladding and the entrance to the Cottage is from the side. The Cottage is constructed on brick piers and has a strip brick footing around the front. As at the Ryan Cottage there are two timber framed double sash and fixed glazing windows at the front facing Conjola Lake and all the windows are timber framed. There is also a water tank on a stand at the rear and a fibro asbestos clad boatshed. In addition to the fibro clad toilet there is also a smaller clad structure.

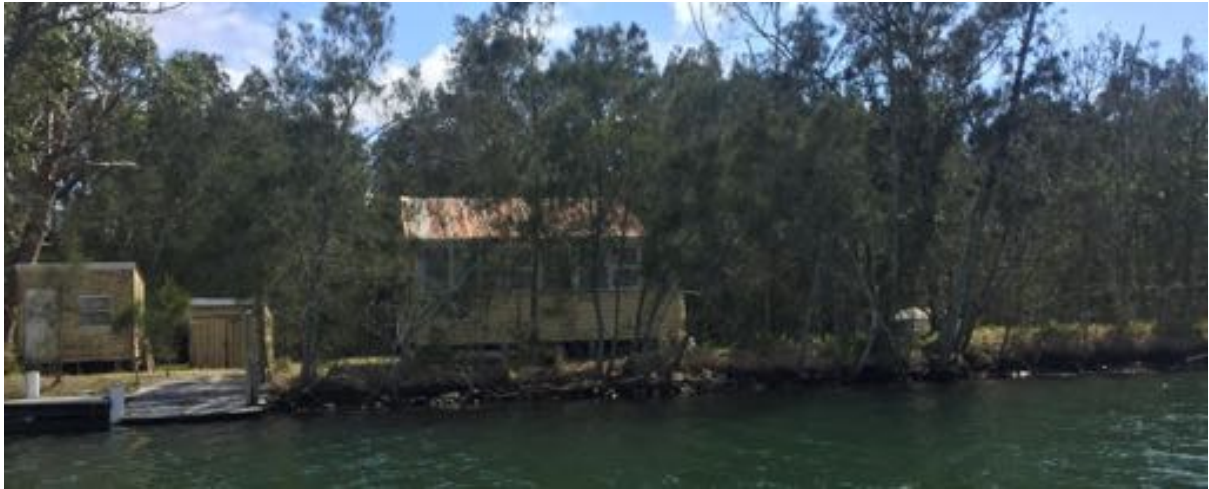
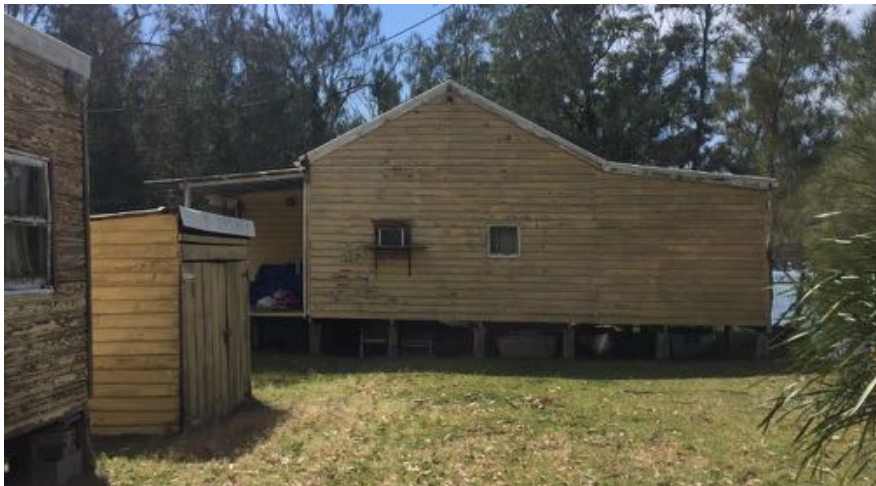
Figure 33. Henley – Lot J with a vacant lot to the right

Figure 34. Henley Cottage and out buildings. Lot J

The building at Lot J is most likely the earliest and most intact Cottage remaining on the Island. The building is timber framed on timber stumps and is clad in sawn boards that have been lapped to use as cladding with a corrugated galvanised steel roof. The building appears to have had a front verandah which has been enclosed and a rear verandah which is partially enclosed.

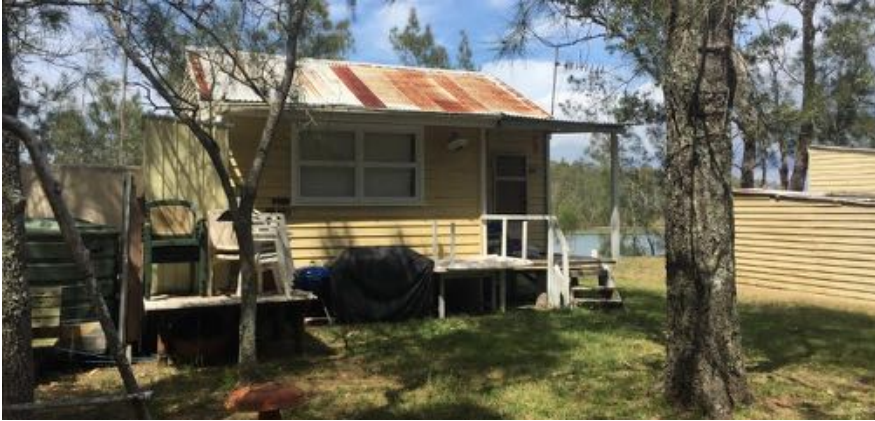
Figure 35. Rear of Henley Cottage with partially enclosed rear verandah

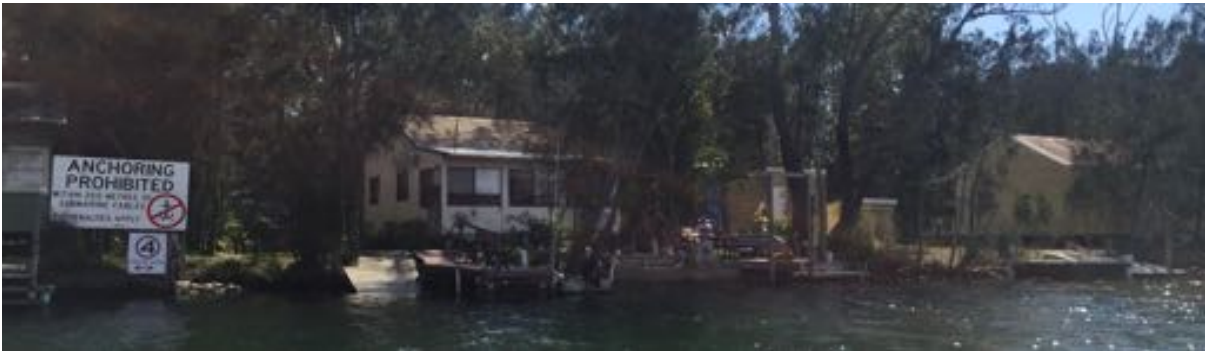
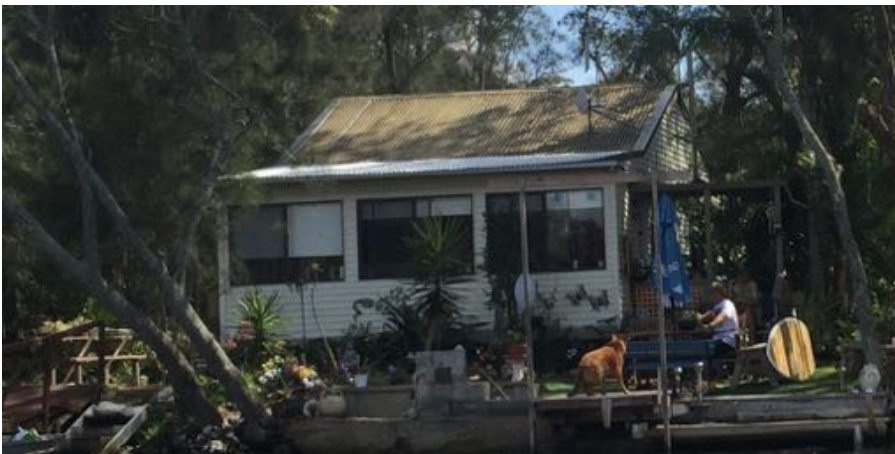
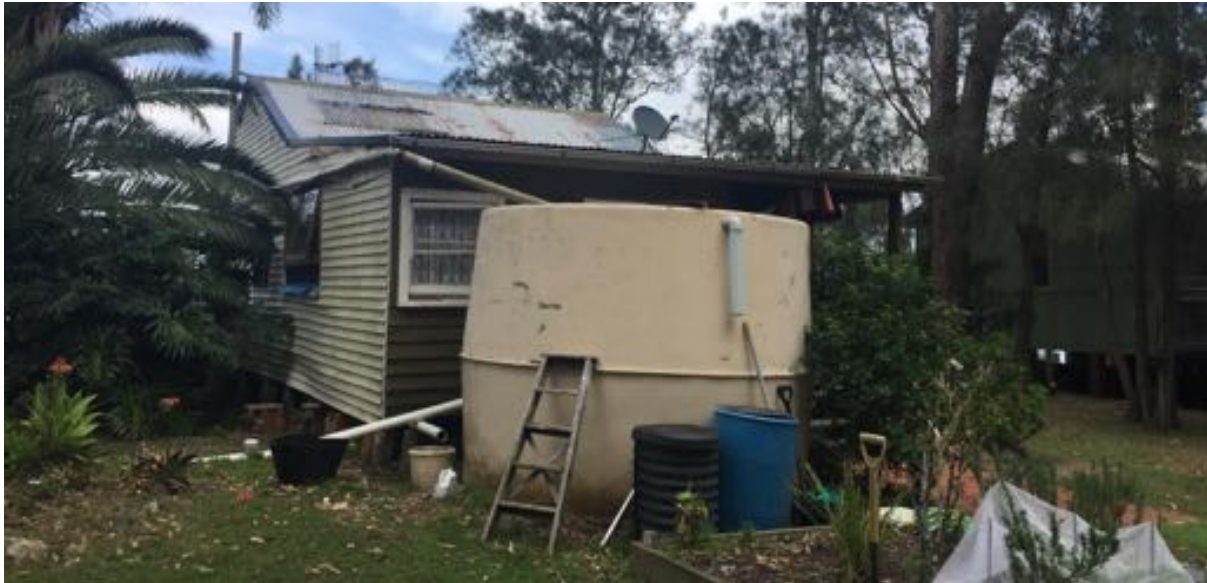
Figure 36. Butler Lot H in the centre and Henley to the right.

Figure 37. Butler Cottage, the only permanently occupied Cottage on the island.

Figure 38. Rear of the Butler Cottage

The Butler Cottage is a timber framed weatherboard Cottage resting on timber stumps. On the eastern and western elevations the original timber framed windows have been replaced by aluminium framed windows. Some of the stumps have been repaired with brick piers. The design of the Cottage is the same as the Henley Cottage with a small gable roof and skillion roofs over verandahs front and back that have been fully or partially enclosed. There are outbuildings to the rear.

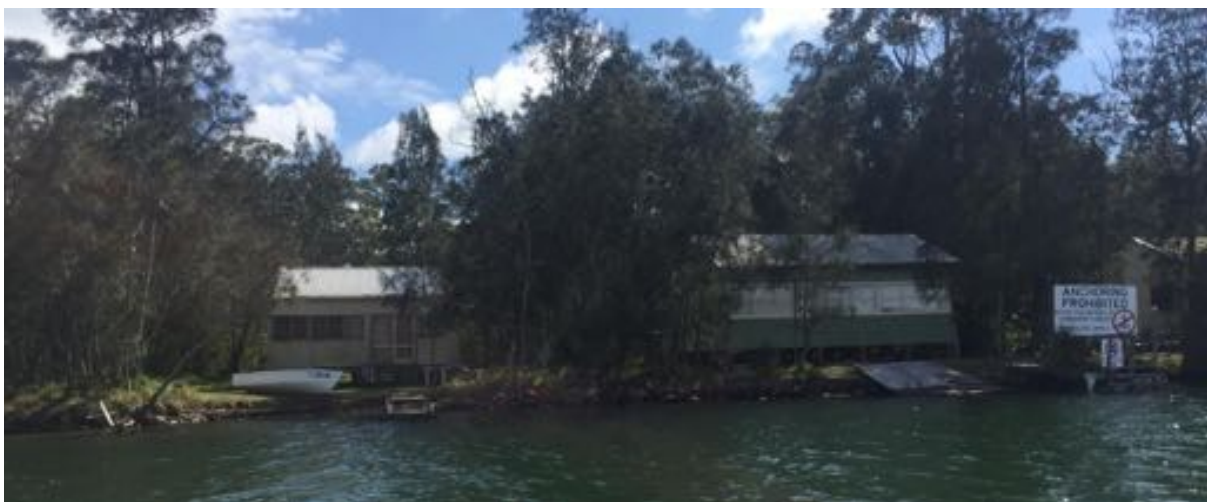
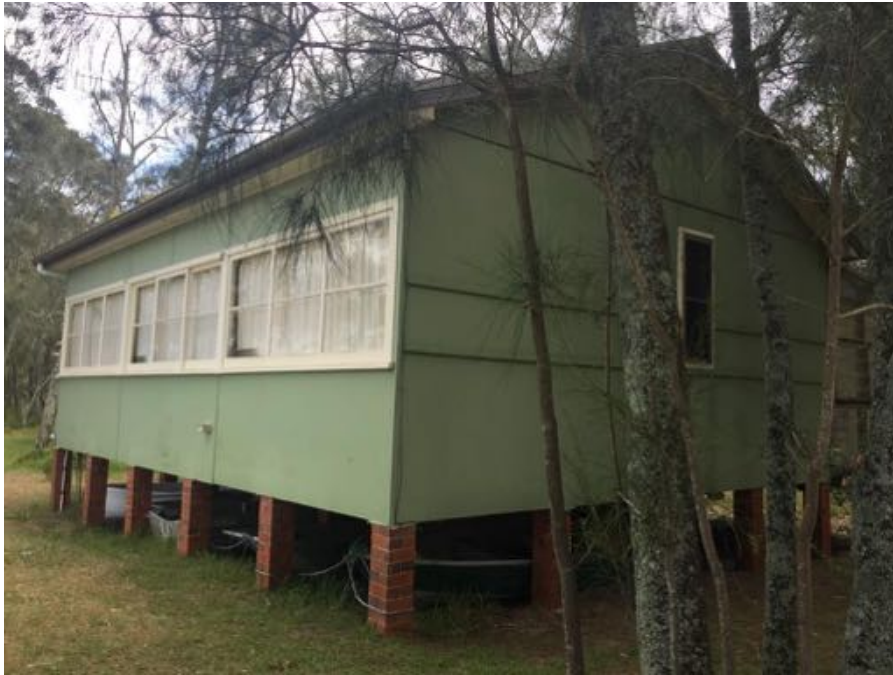
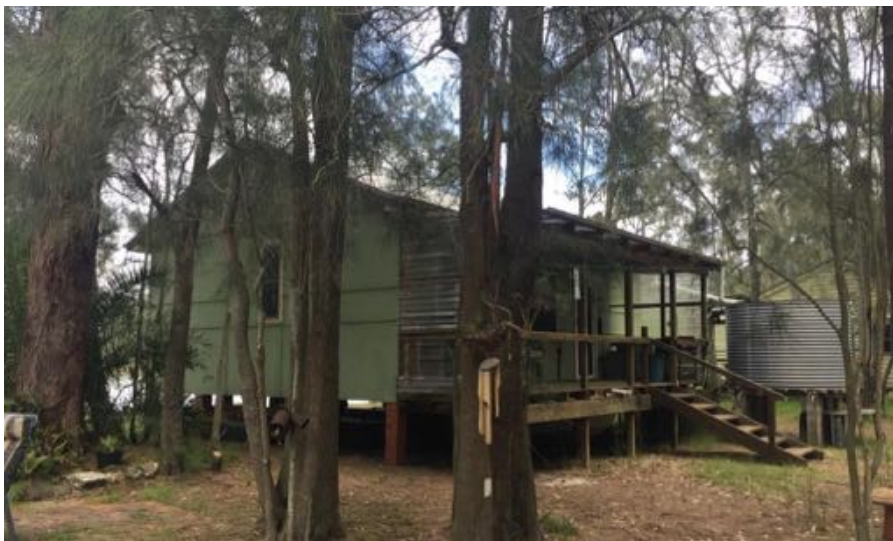
Figure 39. Falcon – Lot F on the left and Hicks – Lot G on the right.

Figure 40. Hick's Cottage from front

Figure 41. Hick's Cottage from rear

The Hick's Cottage is a variation on the fibro Cottage design of Ryan and King. It is a smaller design with a gable roof that has a ridge running east to west. At the rear is a skillion roofed verandah that appears to be of later construction to the original Cottage. The building is clad in asbestos fibro with asbestos fibro moulding cover strips and timber framed windows. The building is supported on brick piers. There are fibro clad out buildings at the side and rear.

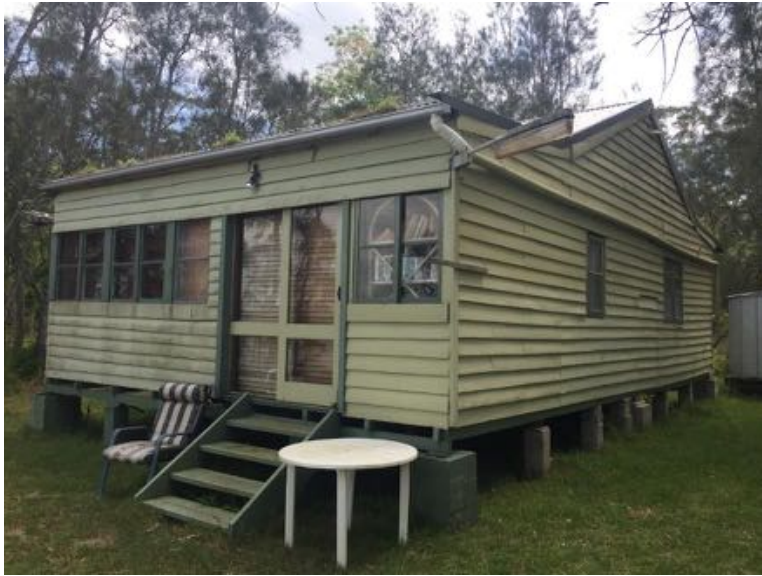
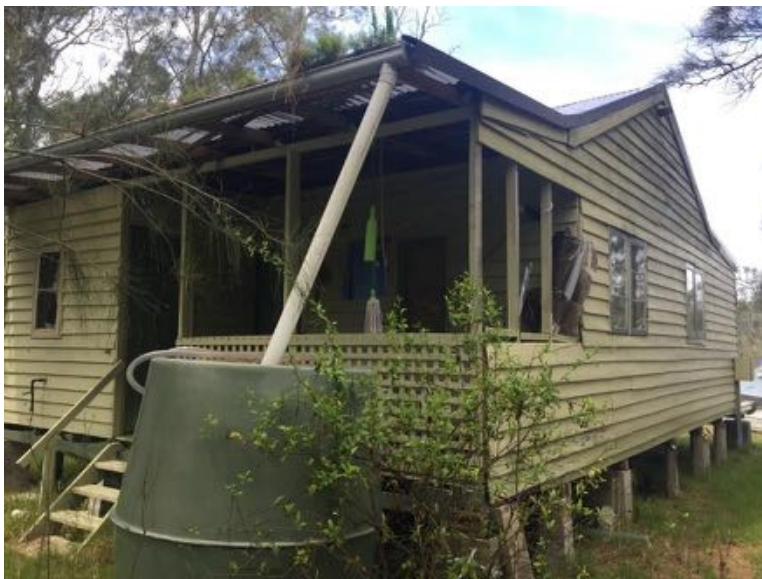
Figure 42. Front of Falson Cottage

Figure 43. Rear of Falson Cottage

The Falson Cottage is of the weatherboard type with the same design as the Henley and Butler Cottages. It is largely intact with only minor modifications since it was built.

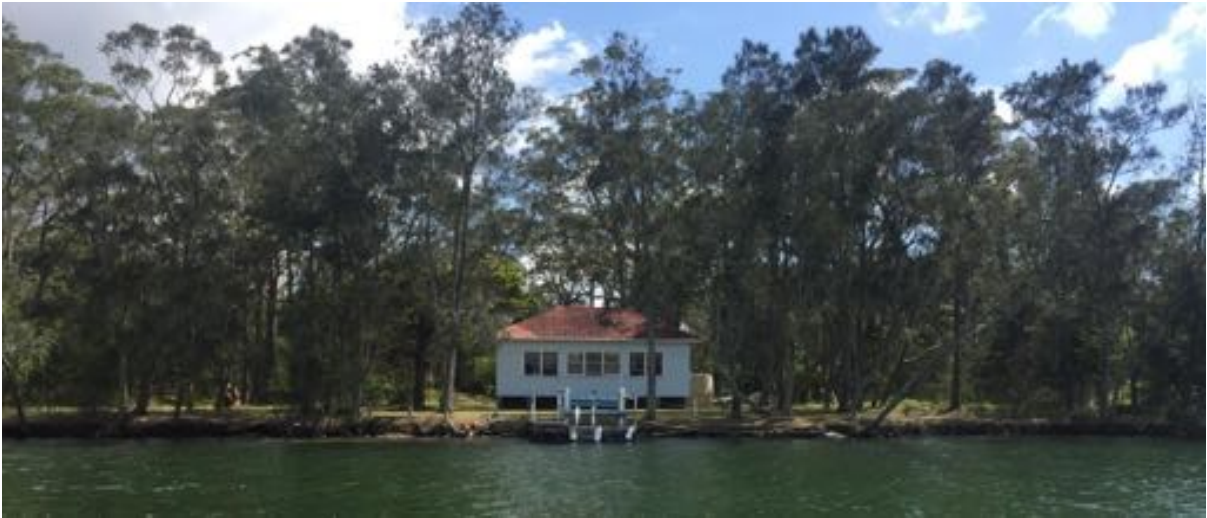
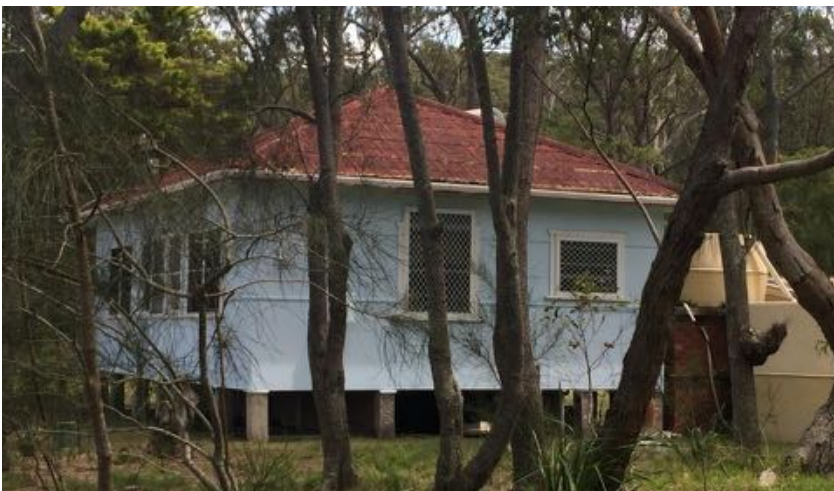
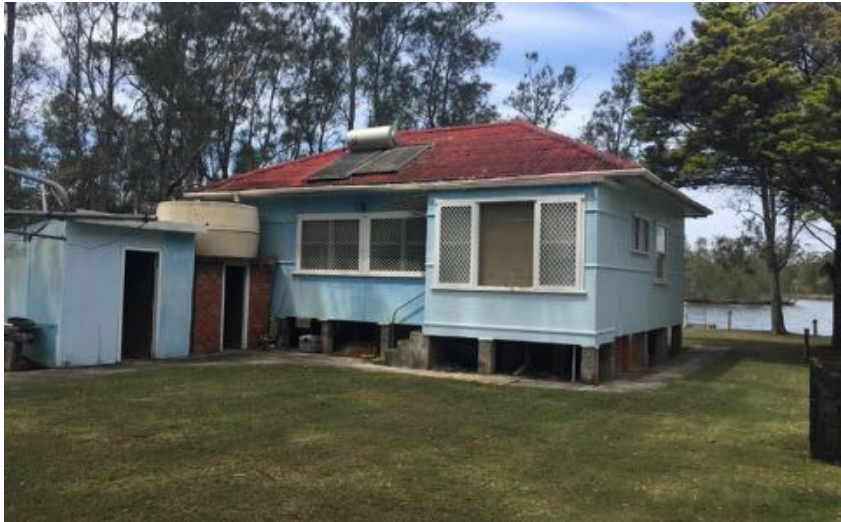
Figure 44. Milham Lot B - located on western end of island

The Milham Cottage is largely intact. It is of the fibro type and has a number of out buildings. It is the only building left at the western end of the island.

Figure 45. Side of Milham Cottage on Lot B

Figure 46. Rear of Milham Cottage on Lot B

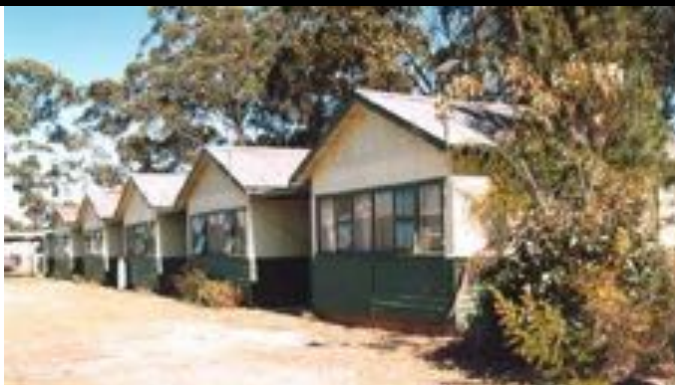
Physical description: Typical 1940's period cabins illustrating the type of dwelling & their construction and materials, erected in the inter-war years. The cabins utilise local construction techniques in the stud framed construction with a combination of external weatherboards and fibro above. The gabled roof, open eaves is clad with galvanised iron sheet.

Figure 49. Greentree's - Holiday Cabins³²

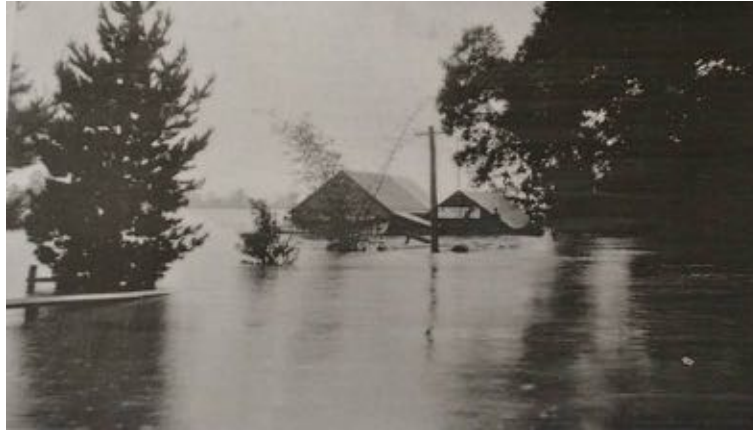
Figure 3: 1916 flood with the 1902-1904 building.¹⁰

Flooding was a continuous issue for Nowra and the ISNC wharf and building on the riverfront was often used as a measure for the river height in newspaper reports. Flooding occurred in 1896 as mentioned above and later references to the goods shed was found in reports of flooding from: 1899, 1900, 1904, 1916, 1920, 1922, 1925, 1948, 1949, 1955, 1958 and 1959 (Figure 3).

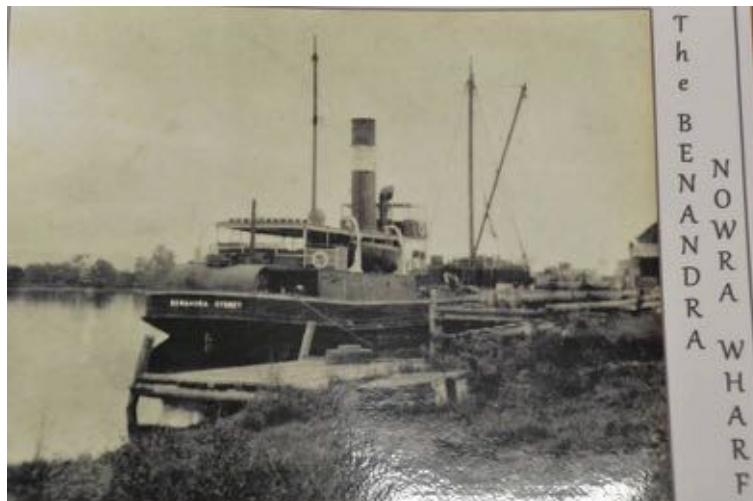
In 1913 improvements were made to Nowra wharf by Nowra Council with the financial assistance of ISNC. The wharf was extended to 56 feet (17.07 m) in length with a depth of 26 feet (7.92 m) so as to serve steamers, with a total cost of £250.¹¹ There is an undated image of the wharf with the vessel *Benandra* moored alongside (Figure 4). *Benandra* was a 345-ton wooden screw steamer built in Balmain, Sydney Harbour by Morron and Sinclair in 1914 and owned by ISNC, functioning as a coastal transport for cargo. It was wrecked on 25 March 1924 when it hit a sandspit near the bar at Moruya Heads.¹² While this picture has no date, the history of the vessel indicates that it was taken between 1914 and 1925, after Nowra council extended the jetty. The photograph shows the vessel moored against the higher main part of the wharf (with the building just visible on the right-hand side) with a lower wharf protruding along the bank to the west and connected by timber stairs. It is likely that the lower part represents part of the extension constructed by Nowra Council.

Figure 4: ISNC vessel Benandra moored at Nowra wharf.¹³

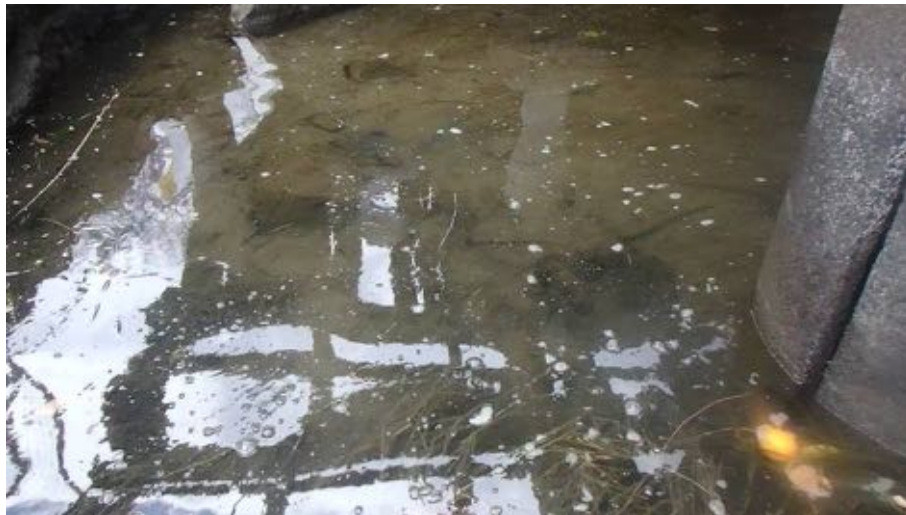
Conditions on site were optimal for an inspection. The water visibility was 100% with a clear view of the seabed beneath its surface (Figure 7). Water depth was approximately 0.3 m at the northern edge of the wharf, gradually sloping down for another metre or so to about 0.5 m before sharply dropping to about 1.5 m at the floating pontoon. One limitation to visibility was a patch of seagrass in the shallower part of the site (Figure 8). Here, the archaeologist made use of a scale rod to pass through the seagrass and identify any protrusions that may be cultural material. Part of the river edge, extending within the area of the wharf, was covered in large irregular rock which also obscured the seabed. The seabed for the majority of the site consisted of a firmly packed sand with occasional scattered rock. Probing the sediment could not penetrate the sand to any degree above the water line, while below the water line (near the northern-most line of piles) the probe could only enter 150 mm. The bank was scattered with natural debris and modern litter.

Figure 7: View of the seabed beneath the water line, facing S. (Video Nowra Wharf 001, still image taken at 00:22)

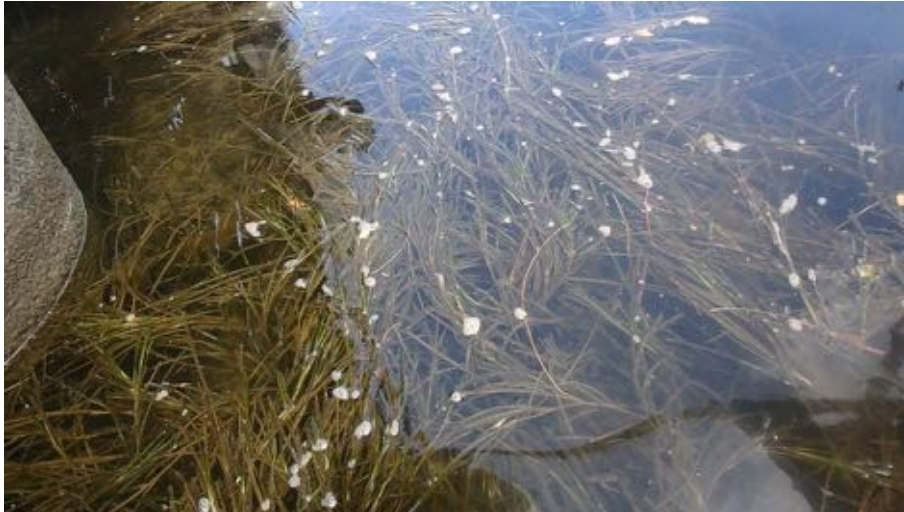
Figure 8: Seagrass covering part of the site, facing W. (Video Nowra Wharf 005, still image taken at 00:00)

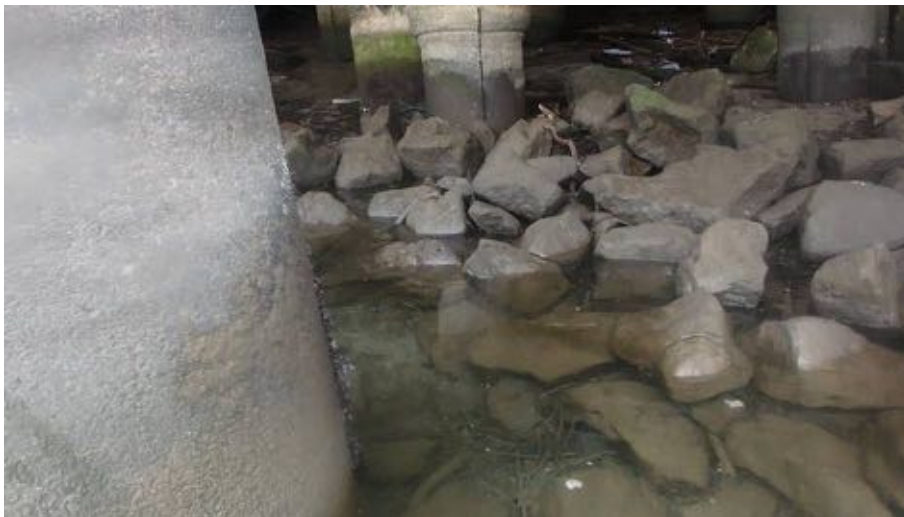
Figure 9: Area with large rock, obscuring the seabed, facing S. (Video Nowra Wharf 009, still image taken at 00:27)

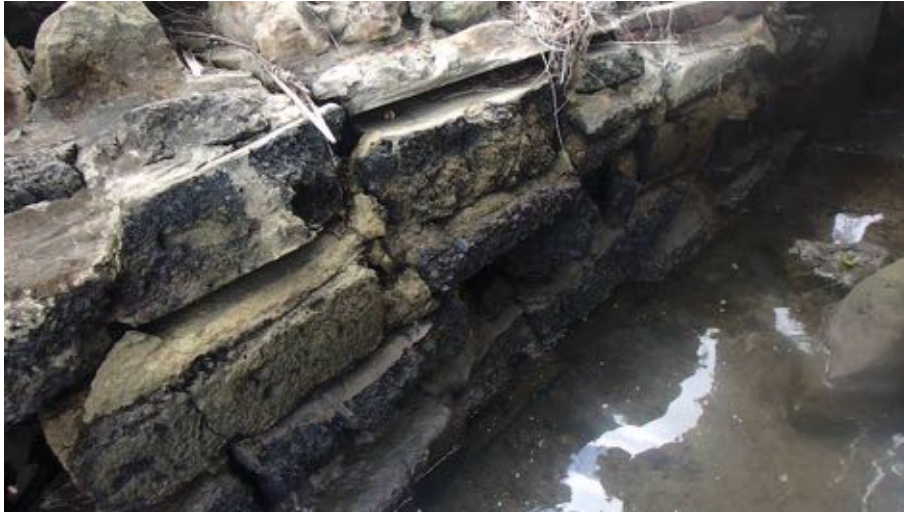
Figure 10: Roughly-shaped rock forming the wall on the eastern side of the wharf, facing SE. (Video Nowra Wharf 001, still image taken at 00:31)

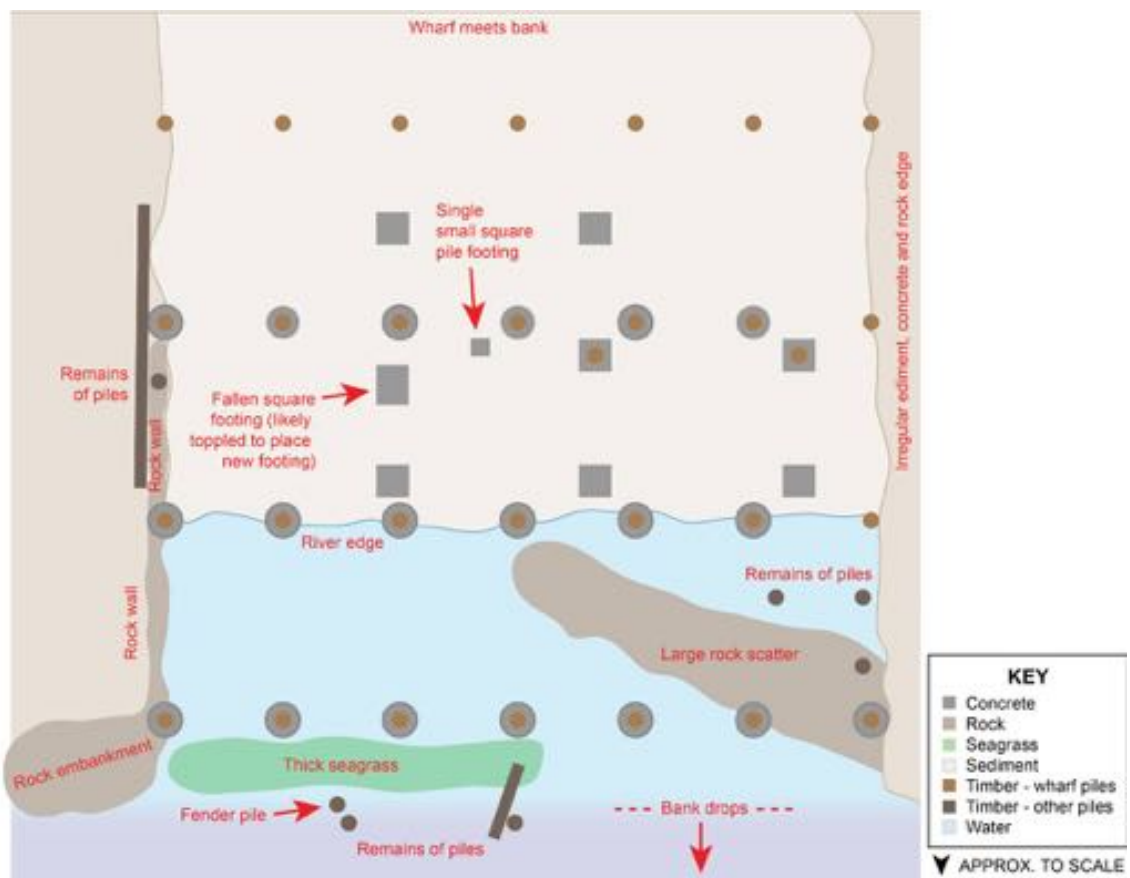
Figure 11: Plan of the findings from the site inspection.

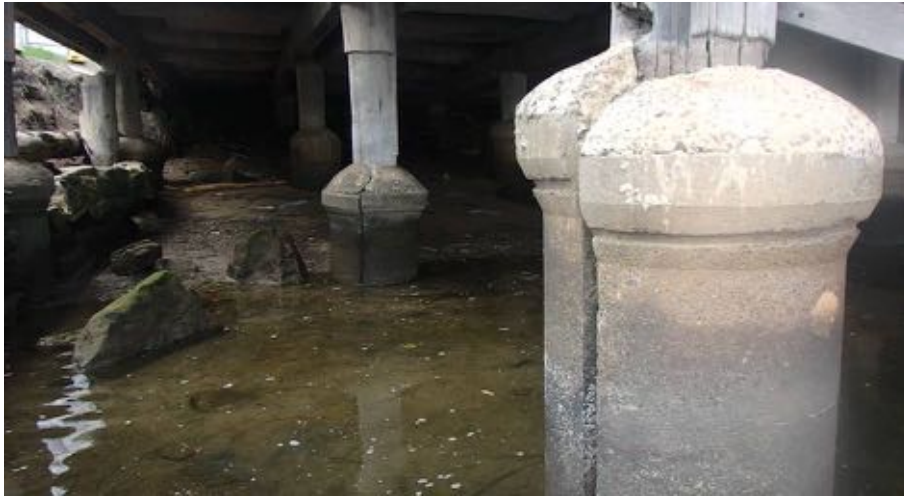
Figure 12: Round concrete pile jackets, showing the split and sliding which likely indicates damage, facing SSW. (Video Nowra Wharf 001, still image taken at 00:14)

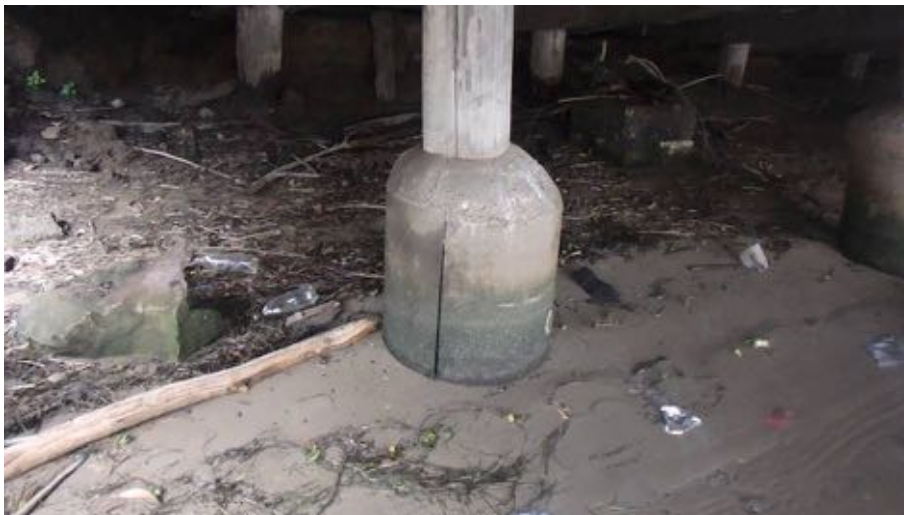
Figure 13: Round concrete jackets without shaping at the top, possibly indicating that they are newer additions, facing SSW. (Video Nowra Wharf 001, still image taken at 01:33)

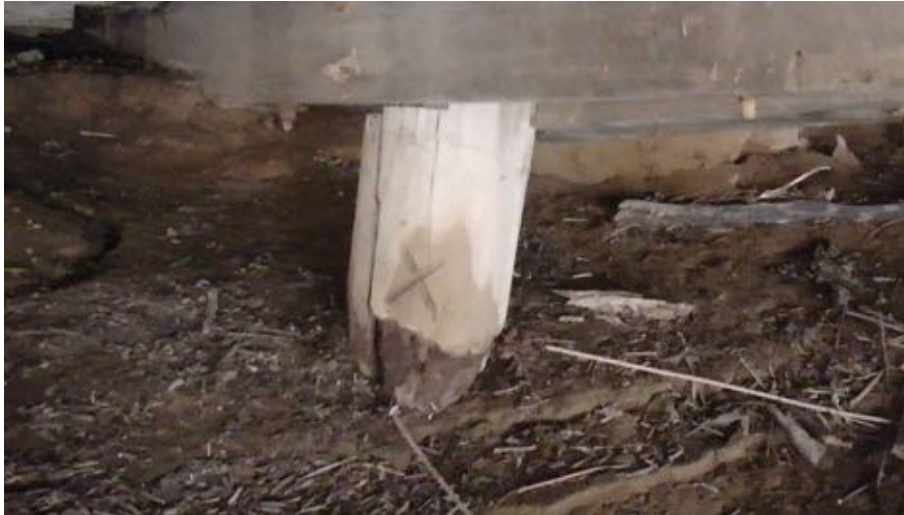
Figure 14: One of the piles showing evidence of a split, facing SSW.
(Video Nowra Wharf 005, still image taken at 01:49)

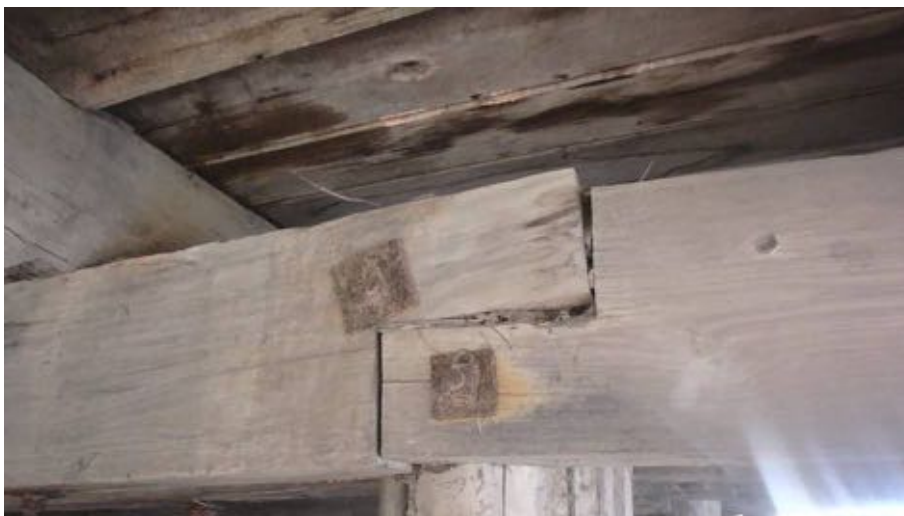
On either side of the piles, near the top, are rectangular timber beams running in a north-south orientation. Each beam extends from one pile to the next where it is joined to a second beam with a half-lap scarf joint (Figure 15). The beams appear to be untreated timber. Above the beams, at irregular but approximately 1 to 1.5 m apart, were timber headstocks running in an east-west orientation. The scarf joints and beams themselves all appear to be attached with iron bolts. Some of the joints appear to be coming apart due to strain on the beams, and some of the beams show evidence of extensive splitting (Figure 16).

Figure 15: Rectangular beam with half-lap scarf joint with bolts, facing WSW. (Video Nowra Wharf 002, still image taken at 01:11)

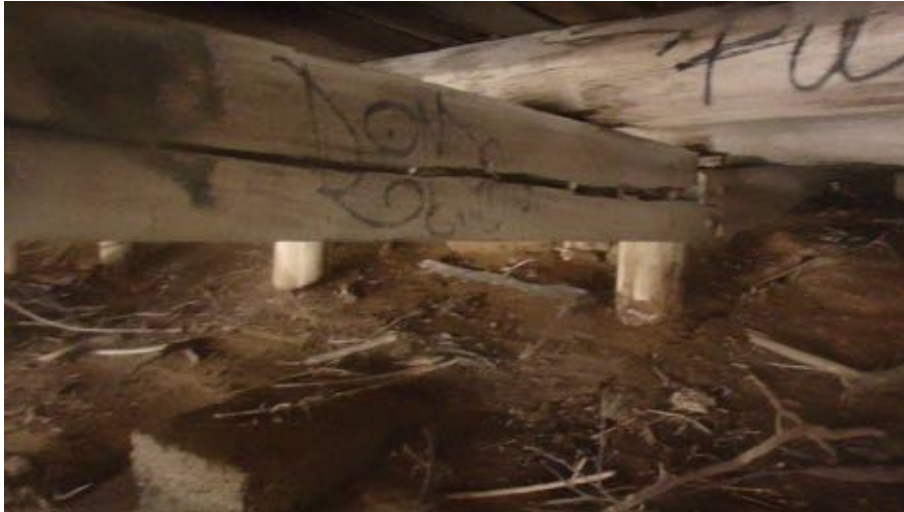
Figure 16: Split along the centre of a beam. (Video Nowra Wharf 10, still image taken at 00:53)
