PLANNING PROPOSAL – PP036

Shoalhaven Local Environmental Plan 2014 2019 Heritage Housekeeping Amendment

Prepared by
Planning, Environment & Development Group
Shoalhaven City Council

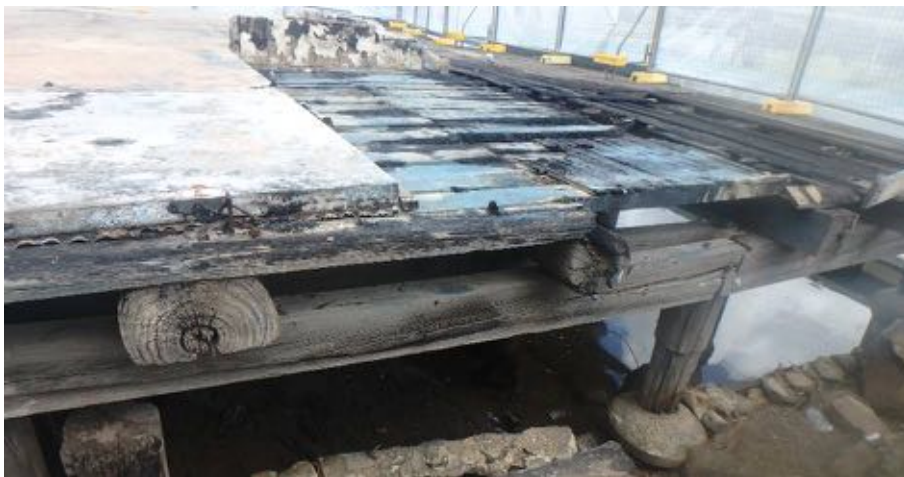
The headstocks are formed of long, irregularly shaped timbers that appear much longer than the beams and may extend the entire width of the wharf. Any joins are hidden above the beams. Some of the headstocks are square in profile with others round or crescent-shaped. The ones with rounded edges showed a rough-hewn surface with possible bark and knotted protrusions in the wood (Figure 17). Depending on the diameter, the headstocks had rough rectangular recesses cut into them where they sat upon the beams to ensure that the height above the beam was consistent throughout the wharf, creating a flat plane for the transverse planks (Figure 18). These thicker planks ran north-south above the headstocks, closely abutting each other. It was to these that the top and much smaller deck planking was attached, running east-west, and forming the top surface of the wharf (Figure 19).

Figure 17: View of the ends of three timber headstocks – from left to right there is one crescent-shaped, one round and one square headstock, facing WNW. (Cosmos Archaeology Pty Ltd, 29th November 2017)

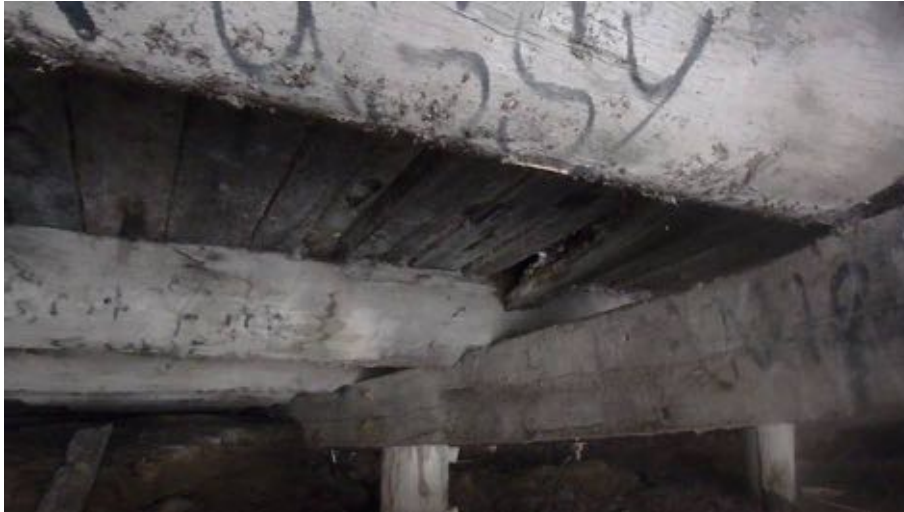
Figure 18: View of the round piles, rectangular beams, round headstocks and transverse planks, facing SSW. (Video Nowra Wharf 004, still image taken at 01:06)

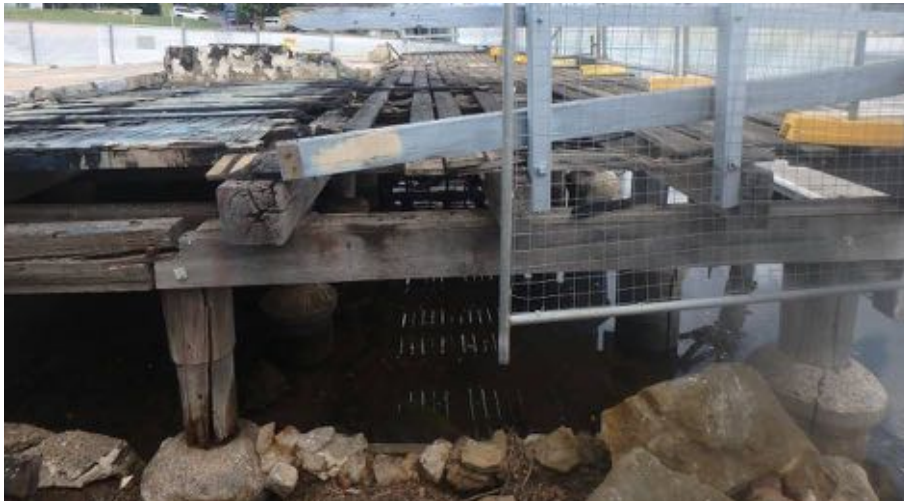
Figure 19: View of piles, beams, square headstocks, transverse planks (just visible to LHS) and deck planking, facing W. (Cosmos Archaeology Pty Ltd, 29th November 2017)

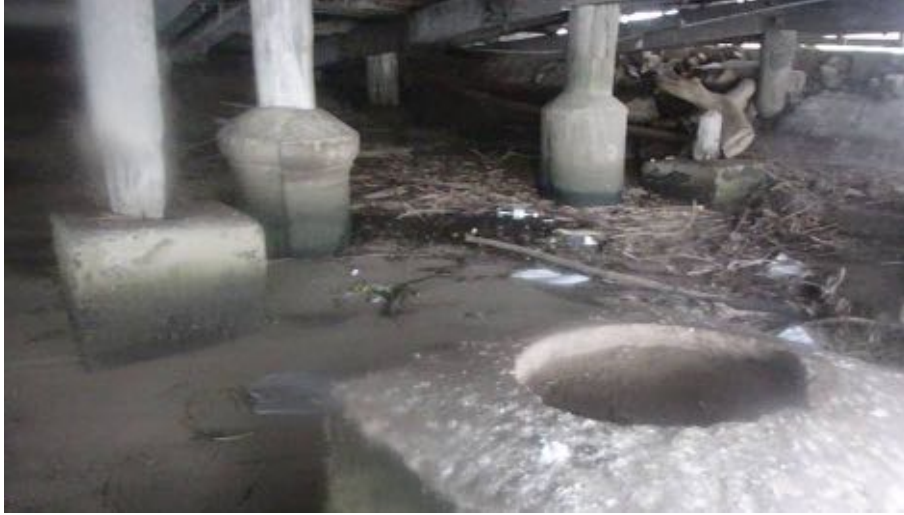
Figure 20: Three square concrete footings, two with cut piles and one without, in contrast to the round concrete jackets, facing SW. (Video Nowra Wharf 007, still image taken at 01:12)

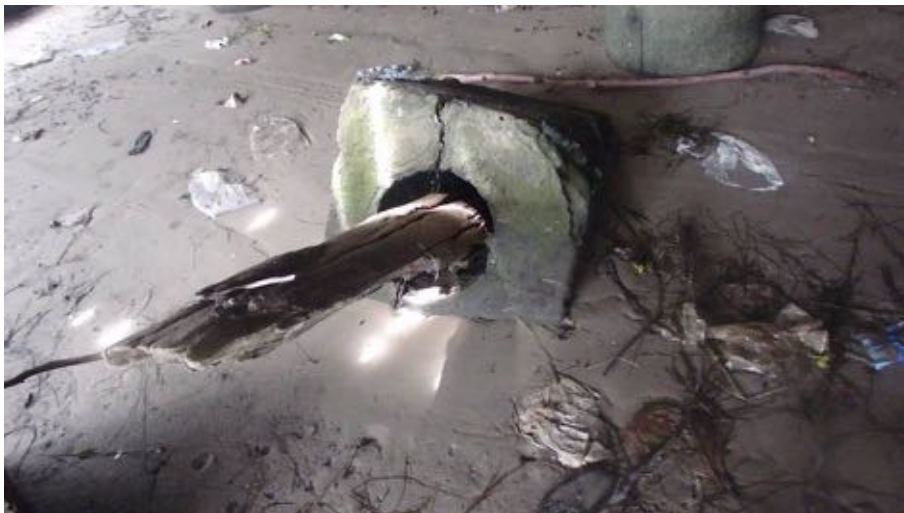
Figure 21: Toppled square concrete footing with degraded pile remains and round footing in background, facing SSE. (Video Nowra Wharf 005, still image taken at 01:21).

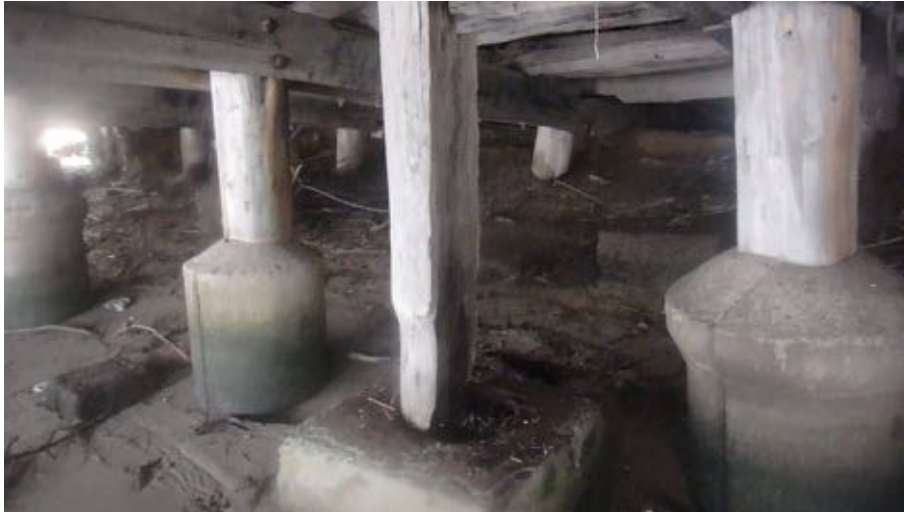
Figure 22: Standing pile in square footing that has snapped along its length, facing SSE. (Video Nowra Wharf 010, still image taken at 00:26)

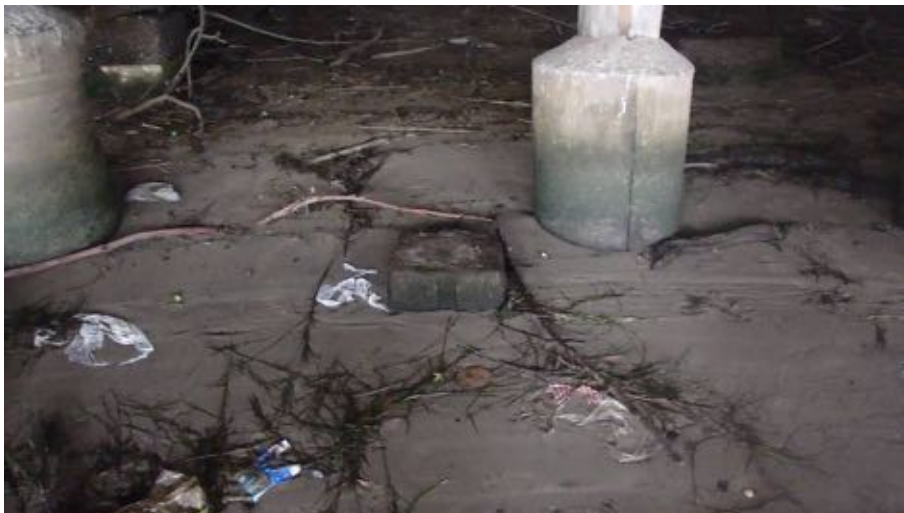
A third type of potential footing was also identified, being square in profile and considerably smaller measuring 480 mm by 440 mm with an exposed height of 160 mm (Figure 23). Only one of these were identified during the survey. It had a clearly marked rectangular groove in the centre of the northern face.

Figure 23: Small square concrete timber footing with groove, facing S. (Video Nowra Wharf 005, still image taken at 01:17).

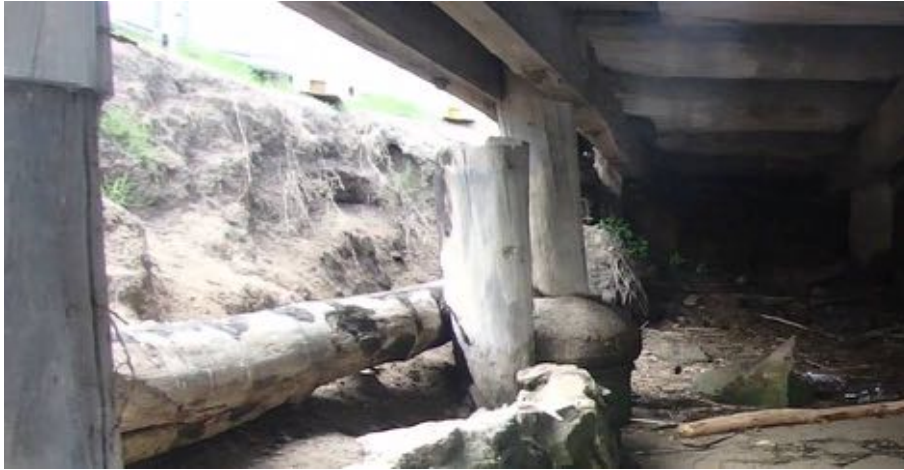
Figure 24: Standing pile stump of relatively good condition on eastern side of the wharf, facing SSE. (Video Nowra Wharf 001, still image taken at 00:49)

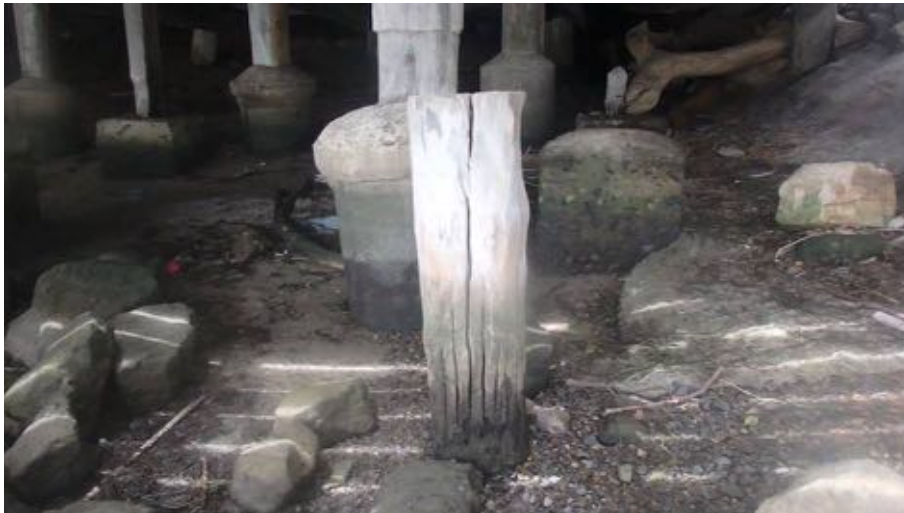
Figure 25: Standing pile stump of relatively good condition towards western side of the wharf, facing S. (Video Nowra Wharf 014, still image taken at 00:13).

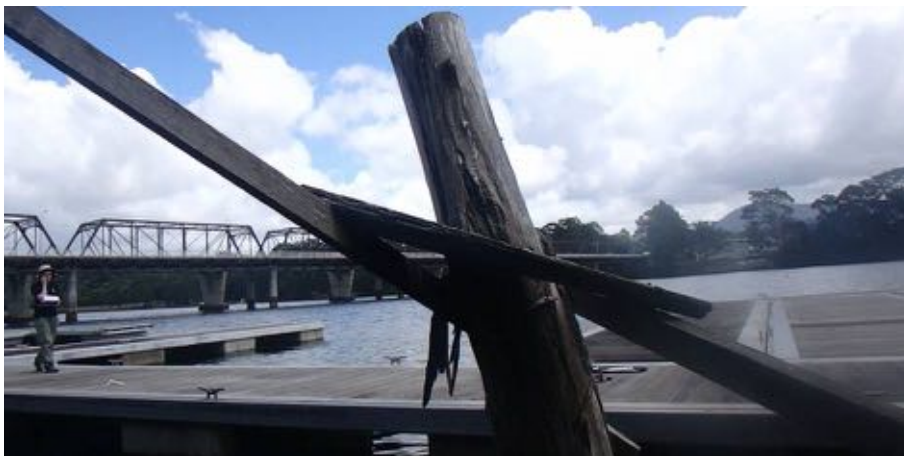
Figure 26: Standing fender pile to the north of the wharf, facing NNW. (Video Nowra Wharf 004, still image taken at 01:58)

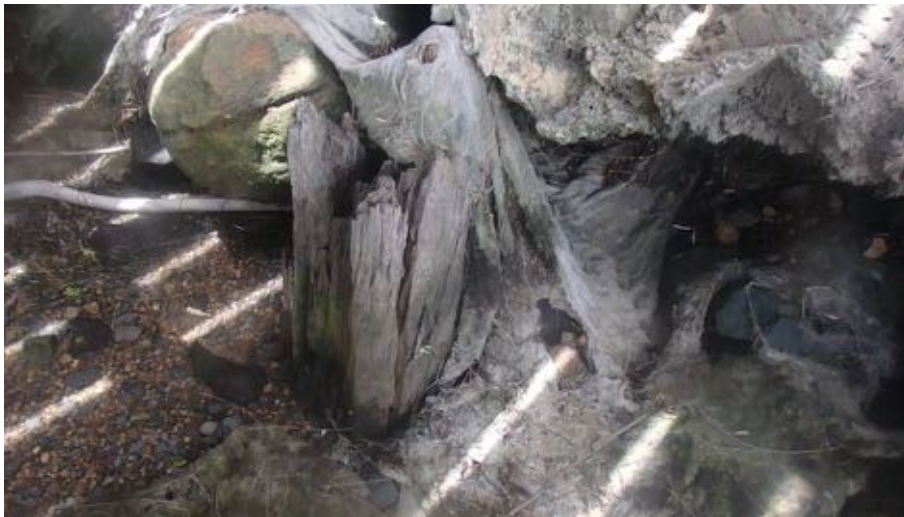
Figure 27: Degraded pile stump, being the larger identified on the western side of the wharf, facing SW. (Video Nowra Wharf 014, still image taken at 00:30)

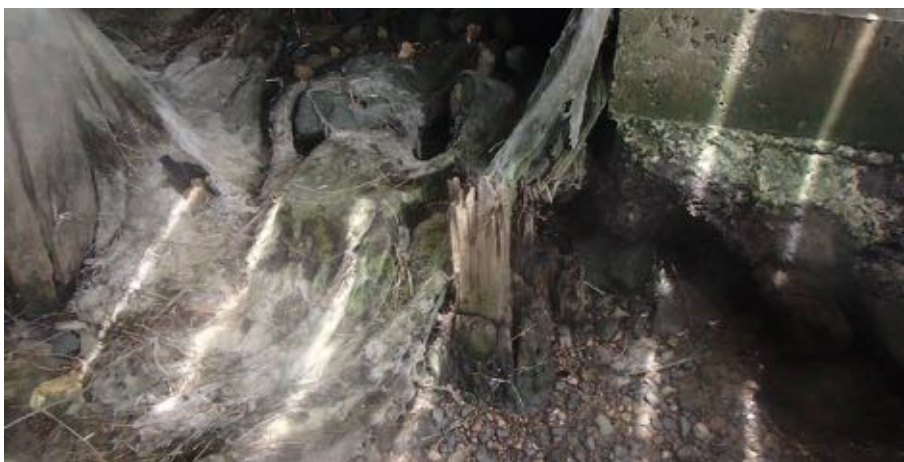
Figure 28: Degraded pile stump, being the smaller identified on the western side of the wharf, facing WSW. The larger of the two piles is visible on the RHS of the image. (Video Nowra Wharf 014, still image taken at 00:25)

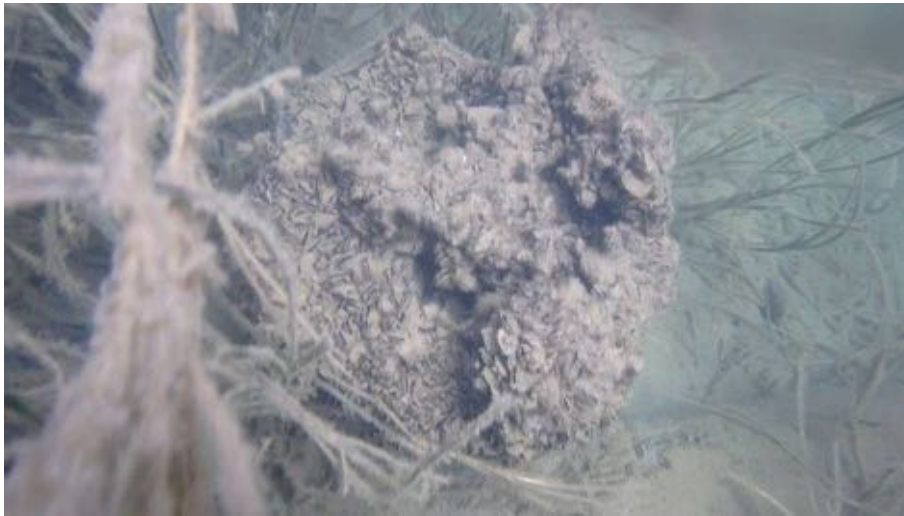
Figure 29: Submerged pile stump adjacent to the fender pile. (Video Nowra Wharf 007, still image taken at 00:07)

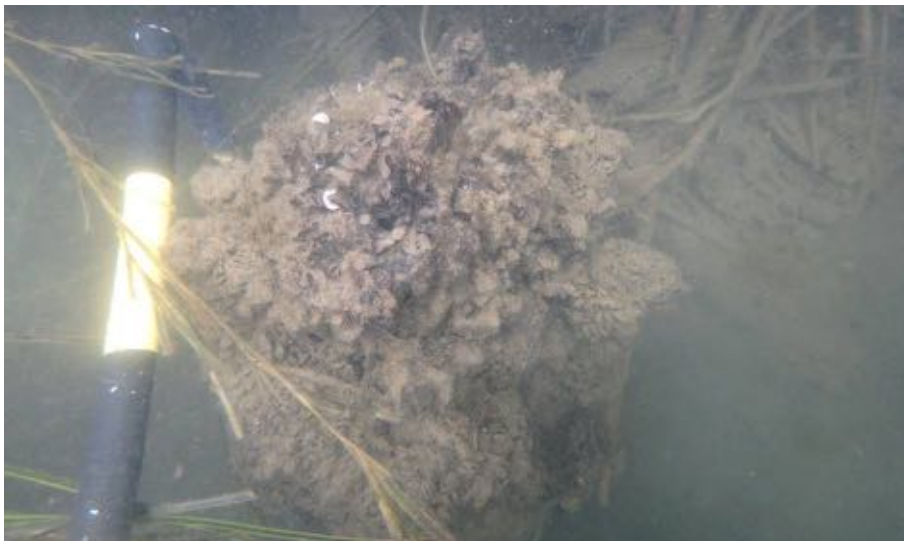
Four degraded pile stumps were also identified. Two of these were located along the western side of the wharf, between the first two lines of piles, and were located in alignment with each other. One had a surviving height of 0.6 m with a snapped end and a maximum surviving diameter of about 360 mm (Figure 27). The other had less surviving material, with a 0.50 m height and surviving diameter of 400 mm at the base (Figure 28). Of the two in the water, one was located near the standing fender pile and the other against the relatively intact pile lying in the water. The first, located where the bank drops away to the north of the wharf, had an exposed height of 1.08 m and a surviving diameter of 270 mm (Figure 29). The second had a 0.45 m surviving height and surviving diameter of 300 mm (Figure 30).

Figure 30: Submerged pile stump near the pile lying on the seabed. (Cosmos Archaeology Pty Ltd, 29th November 2017)

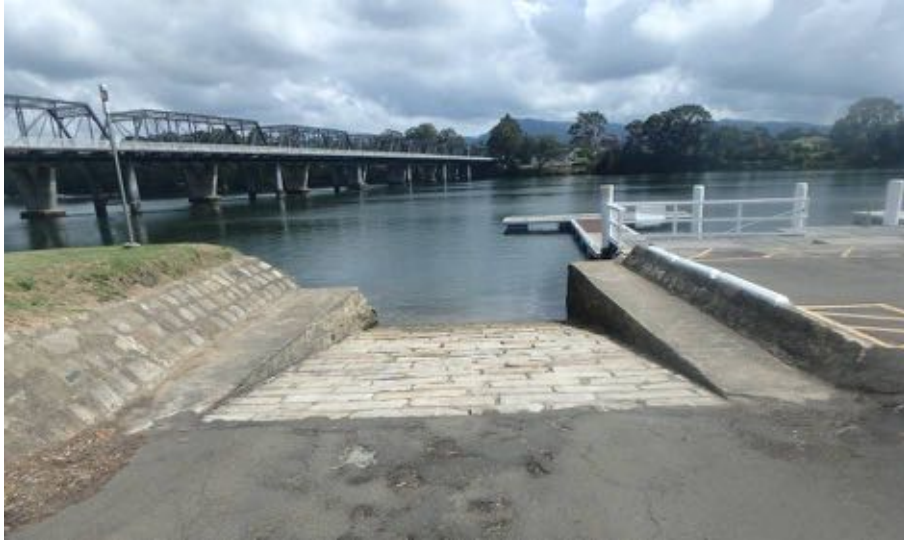
Figure 31: Sandstone boat ramp, facing N, with Princes Highway to west.
(Cosmos Archaeology Pty Ltd, 29th November 2017)

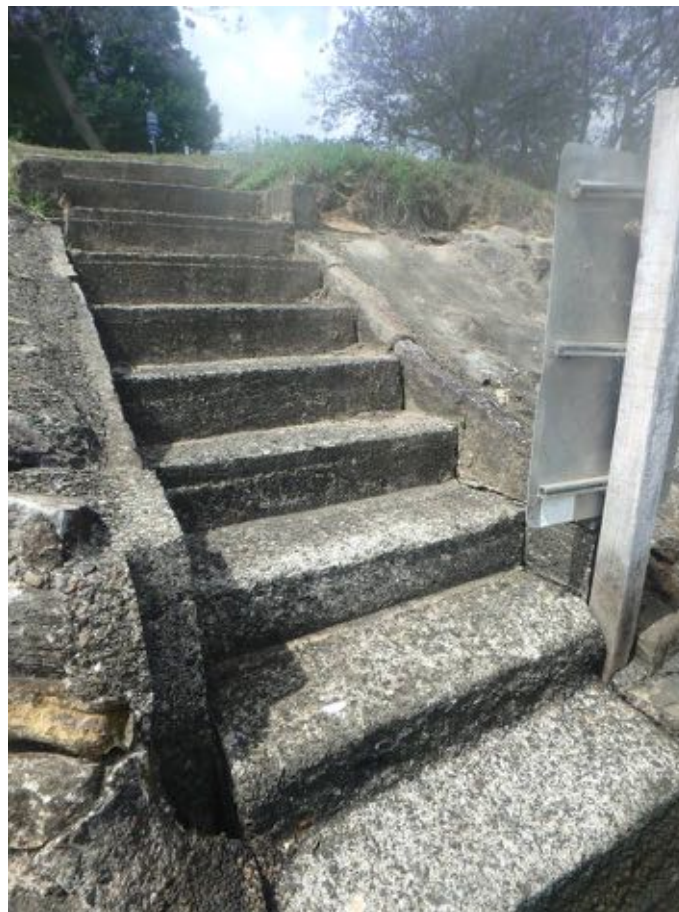
sandstone wall continued adjacent to the river where it met the concrete staircase leading from the grass above to a small sandy patch beside the boat ramp (Figure 32).

Figure 32: Concrete stairs to west of boat ramp, facing SW. (Cosmos Archaeology Pty Ltd, 29th November 2017)

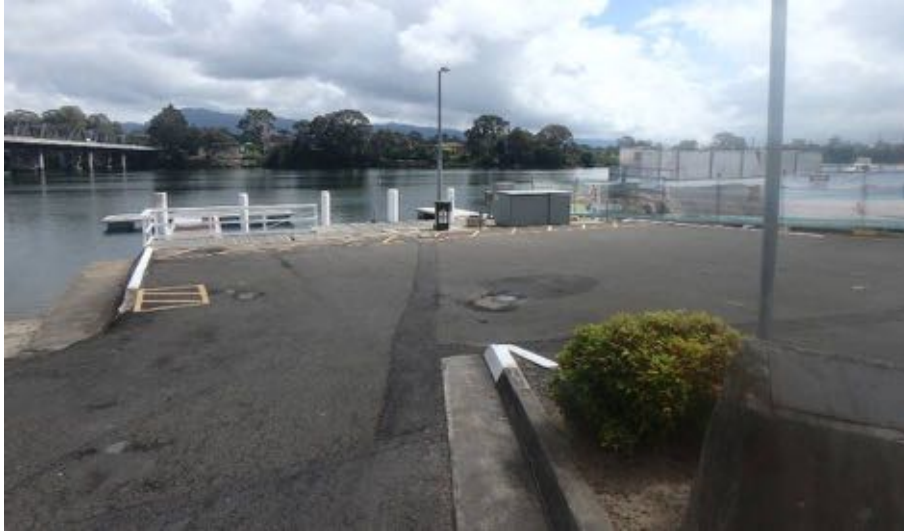
The carpark also appeared to be of serviceable condition, with the public wharf on the northern side easily accessible by timber ramps (Figure 33). The public wharf was in excellent condition, with tidy timber decking and white-painted fender posts (Figure 34). Wide steel-grill stairs led to the floating walkway and pontoons below (Figure 35). It appears that the pontoons are a recent addition to the site to facilitate access to a larger number of recreational craft. No evidence of the pontoons can be seen in aerial photography (available through Google Earth) until at least 2016.

Figure 33: Car park between boat ramp and ISNC wharf, with public wharf to north, facing N. (Cosmos Archaeology Pty Ltd, 29th November 2017)

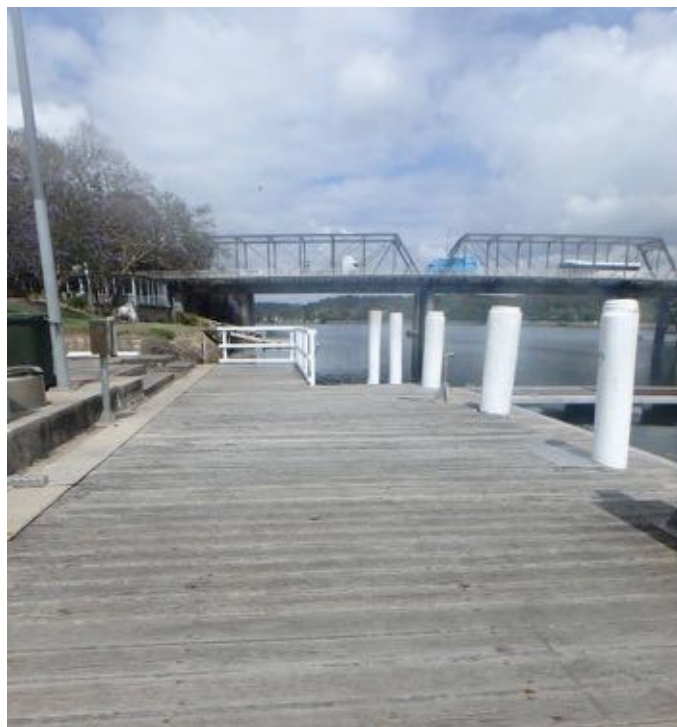
Figure 34: View along public wharf, facing W, with Princes Highway in the background. (Cosmos Archaeology Pty Ltd, 29th November 2017)

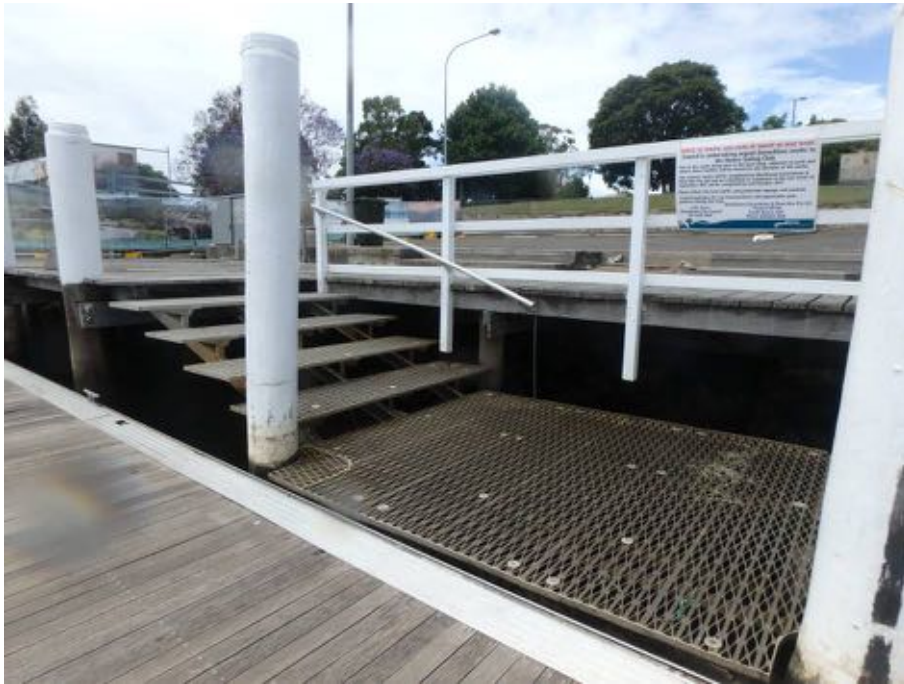
Figure 35: Wide steel grill stairs from the wharf to floating pontoons, facing SE. (Cosmos Archaeology Pty Ltd, 29th November 2017)

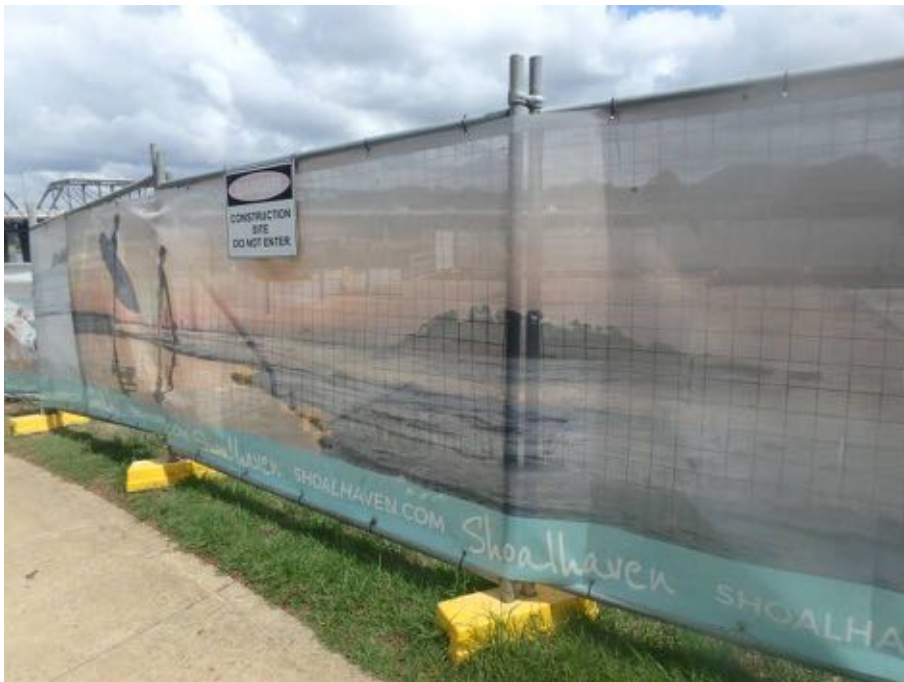
The wharf site itself is currently blocked by fencing on all four sides to restrict access to the hazardous remains of the wharf (Figure 36). This fencing very visible from the road, water, and Princes Highway (Figure 37). It forms a large, imposing and unattractive part of the site.

Figure 36: Fencing around the ISNC wharf, facing NE. (Cosmos Archaeology Pty Ltd, 29th November 2017)

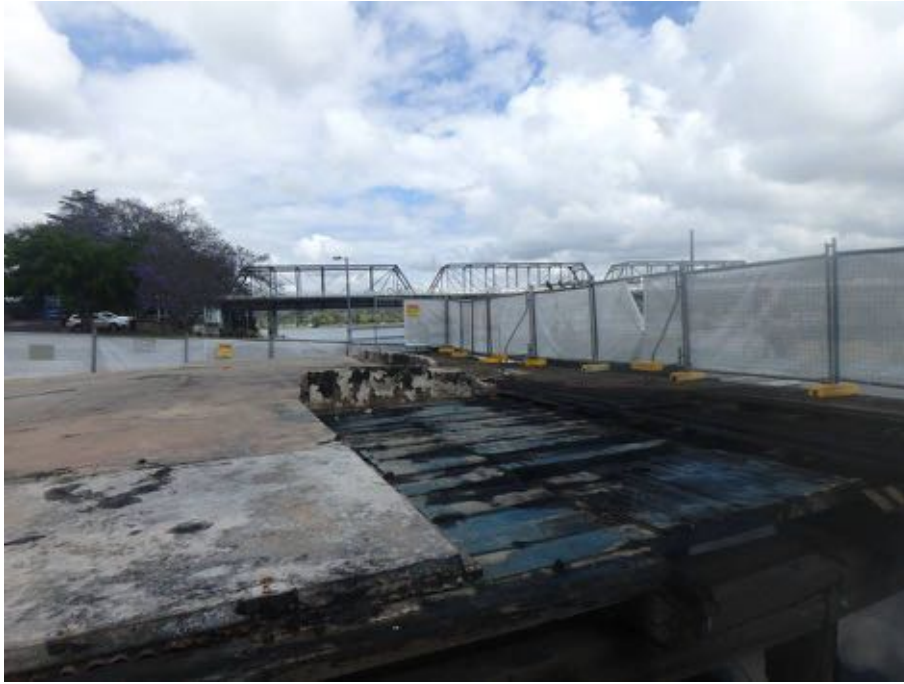
Figure 37: Glimpse of the wharf through a small gap in the fencing, facing W with Princes Highway in the background. (Cosmos Archaeology Pty Ltd, 29th November 2017)

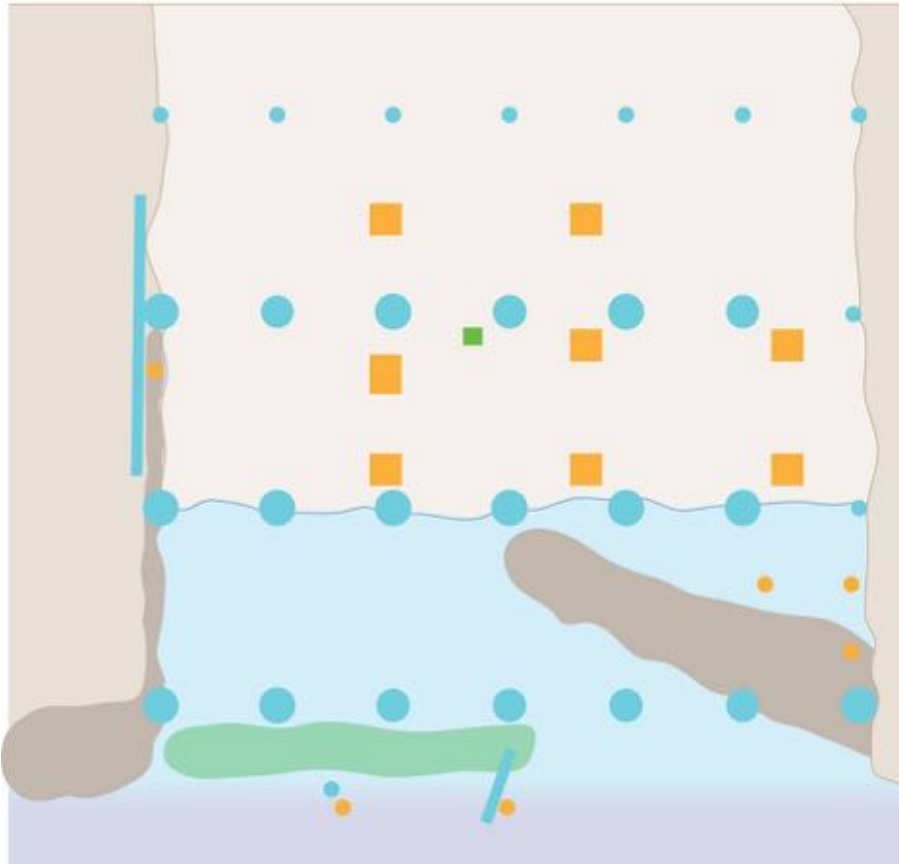
Figure 38: Features possibly associated with each stage of development.

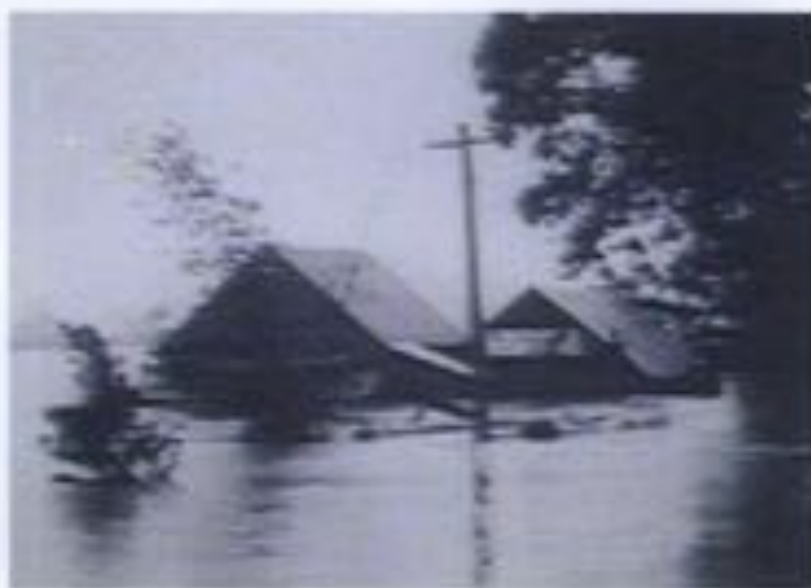
Figure 2.4 View to the wharf during the flood of 1918

The photograph of the flooded wharf in 1915 (Figure 2.4) shows two buildings with the rear building being a small addition to the building at the river. Both have steeper roof pitches than the current building.

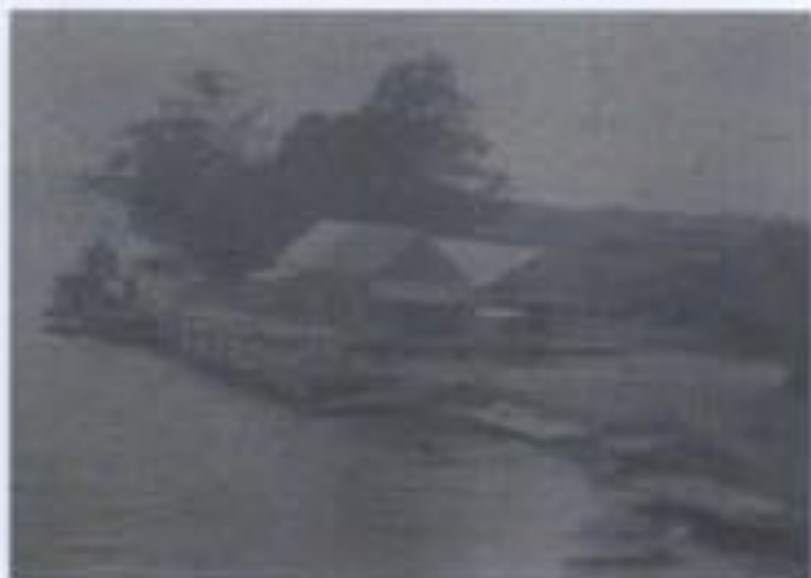
Figure 2.5 Undated view to the wharf. The front building appears to have an extension at the rear. The building at the rear appears to be replacement to the building shown in Figure 2.4

The current buildings do not appear to correspond with any of the early photographs of the buildings and wharf (Figures 2.1-2.5) both in form or footprint.

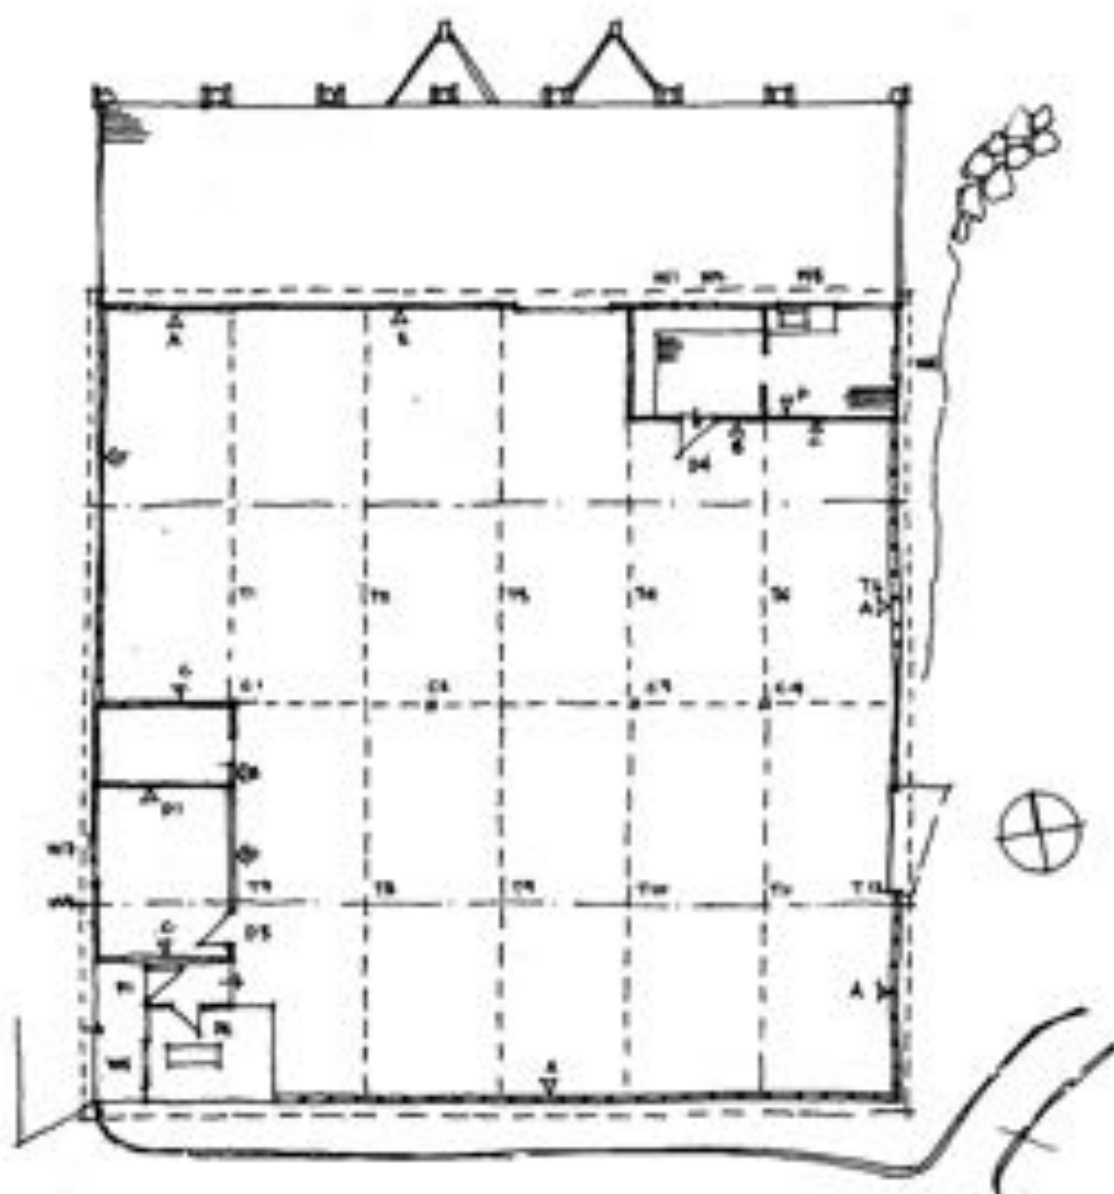
KEY			
ITEM		ITEM	
A	SAWN TIMBER WEATHERBOARDS ON SAWN TIMBER FRAMING	T1	SAWN TIMBER KINGPOST TRUSS WITH STOP CHAMFERED DETAIL TO THE KING POST
B	VERTICAL SAWN TIMBER BOARDS ON SAWN TIMBER FRAMING	T2-T5	SAWN TIMBER TRUSS
C	EXPOSED SAWN TIMBER FRAME	T6	SAWN TIMBER KINGPOST TRUSS WITH STOP CHAMFERED DETAIL TO THE KING POST
D	MASONITE ON SAWN TIMBER FRAMING	T7-T12	SAWN TIMBER TRUSS
E	MASONITE ON SECONDARY FRAMING		
F	SAWN TIMBER WEATHERBOARDS ON FIBRO ON SAWN TIMBER FRAMING

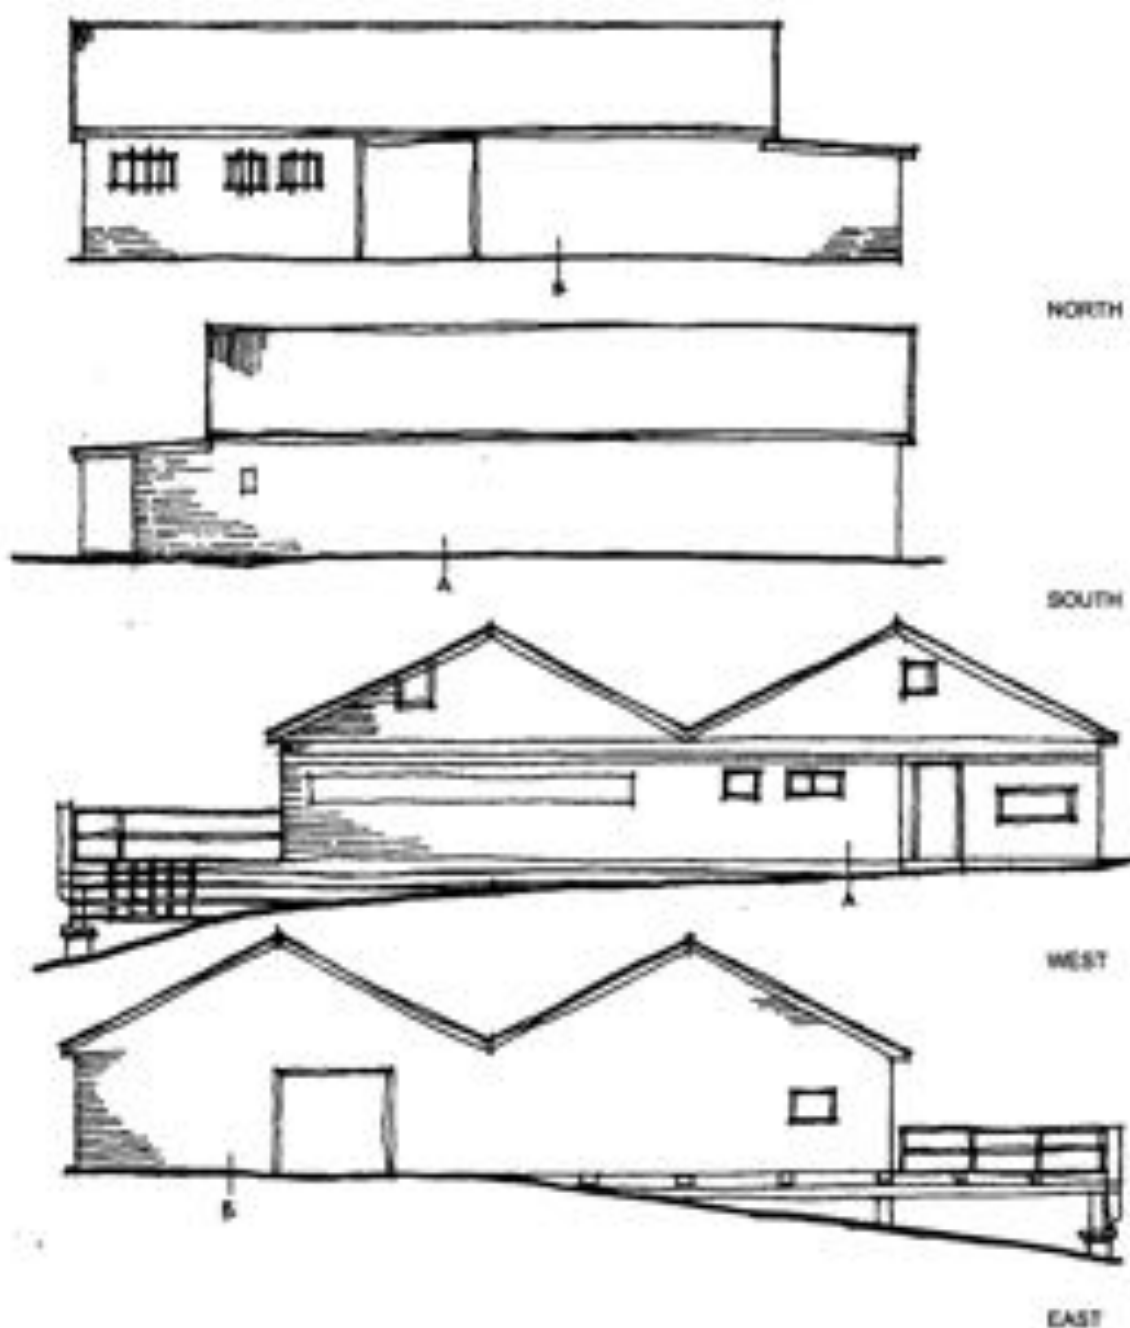
KEY	
ITEM	
A	SAWN TIMBER WEATHERBOARDS WITH ABRIS REMOVED
B	SAWN TIMBER WEATHERBOARDS

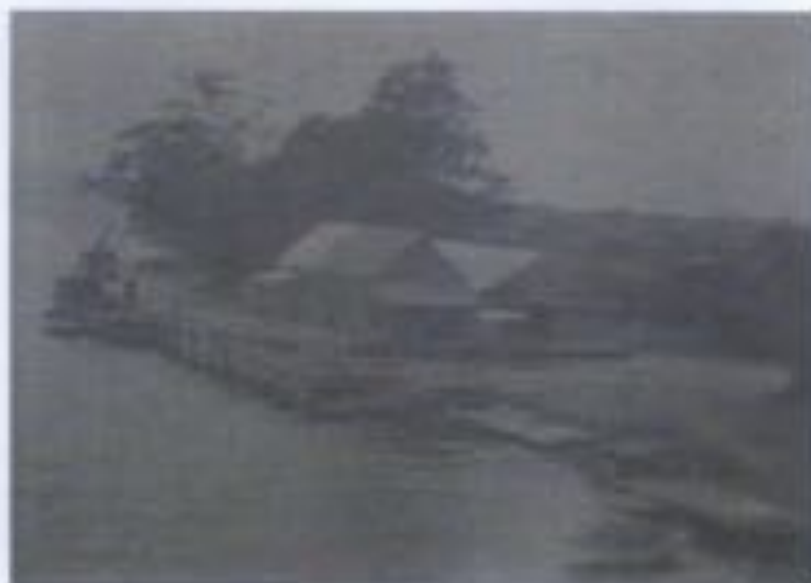
Figure 4.1 Undated photograph of the wharf

What is probably a later photograph (Figure 4.1) shows the waterside building extended with a larger building to the rear that more resembles the current form of the rear section of the Sailing Club. However, there is little evidence in the fabric of earlier structures apart from the substructure that is likely to be (in part) original. The wharf structure has been cut back to its current line. The superstructure appears to have been replaced wholesale apart from the two decorated kingpost trusses and (possibly) any extant timber flooring.
