Item name: Merriwa Conservation Area revised

Location: Merriwa 2329

Item type: Conservation Area

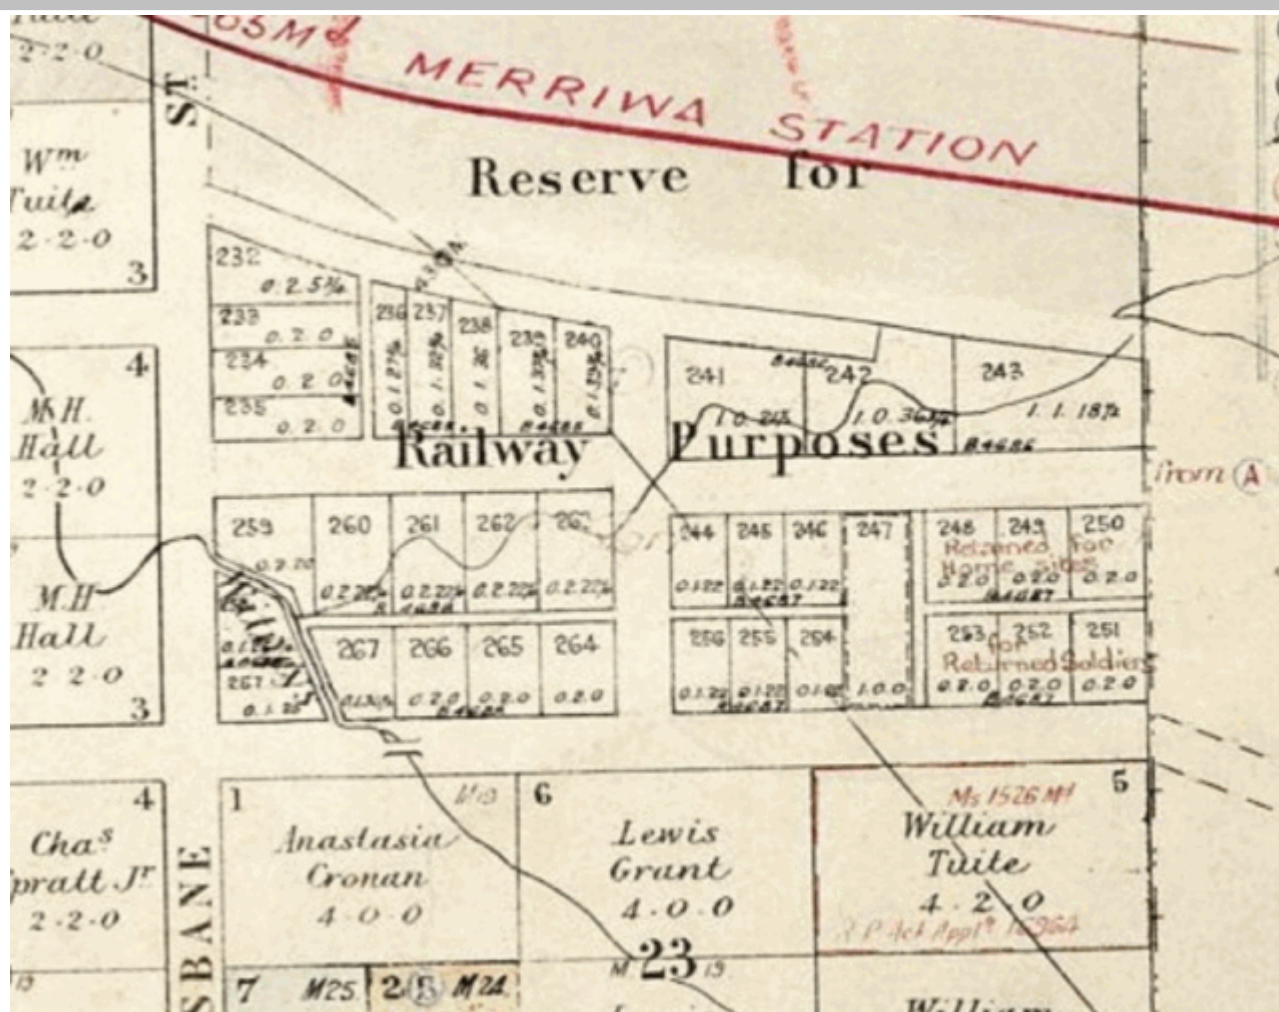
Map dated 1891 showing "retained for returned soldiers"

Caption: Figure 3: 1891 map showing "retained for returned soldiers"

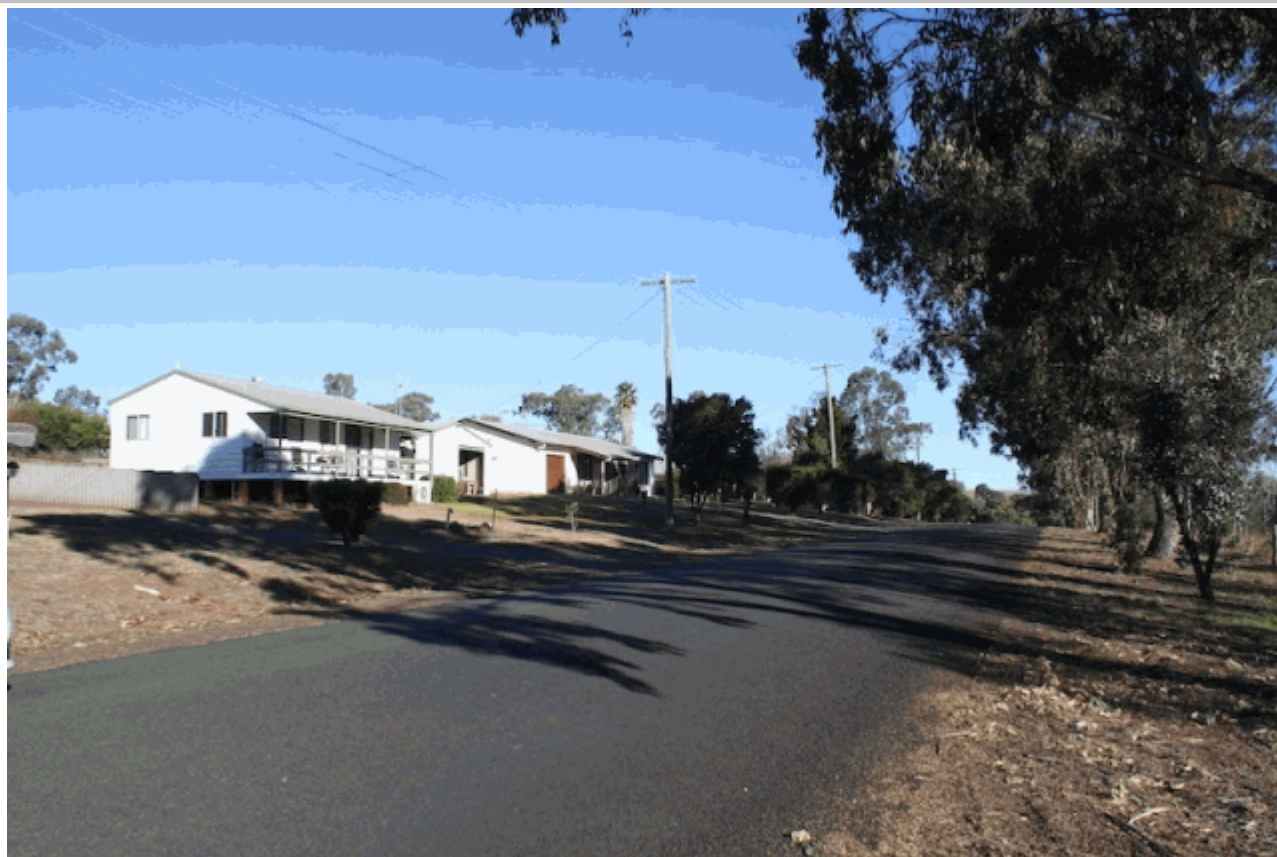
Caption: Streetscape view of Flaggs Road showing buildings assessed as non-contributory

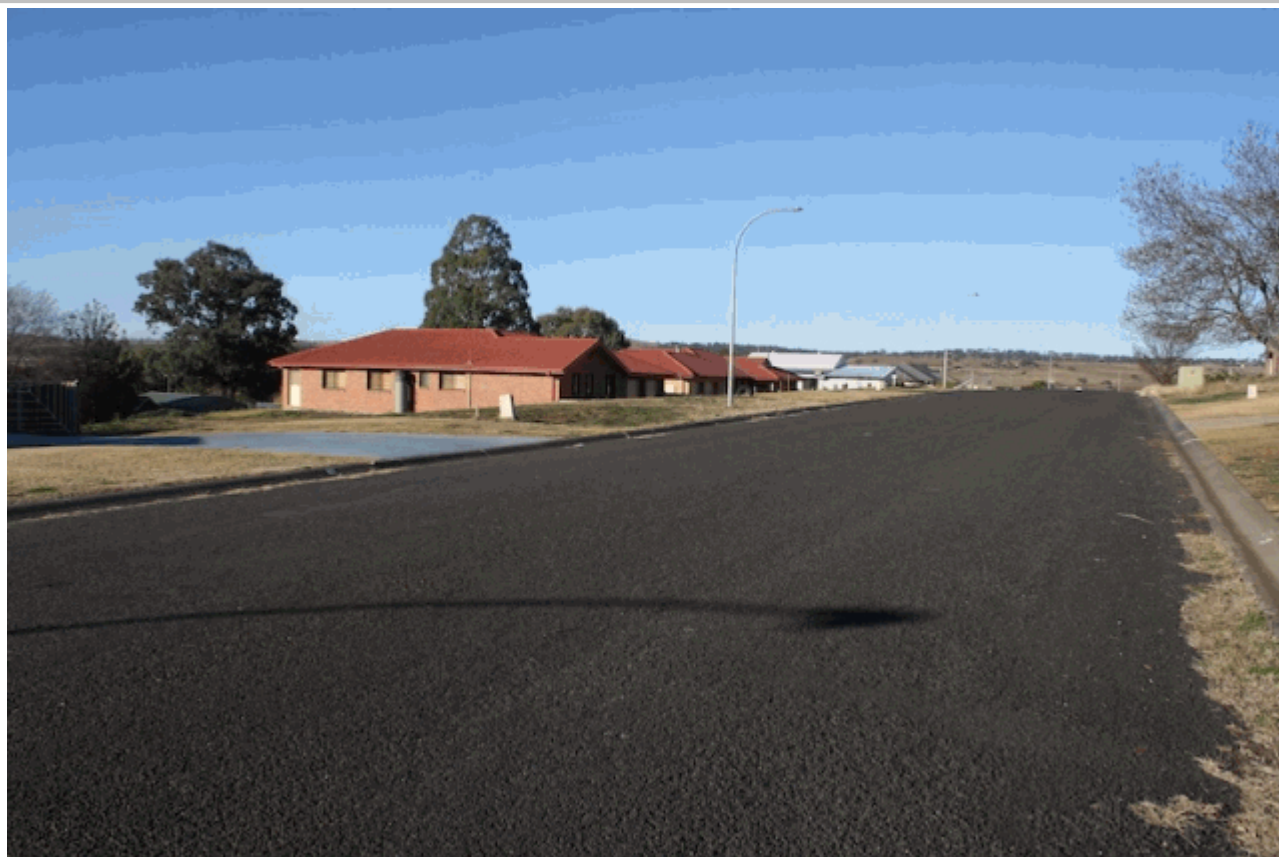
The streets to the south of the eastern precinct (south-eastern precinct), including Collins and Hall Street are predominantly recent houses dating from the late 20th and early 21st century.

Caption: Streetscape view of Collins Street showing example of buildings assessed as non-contributory

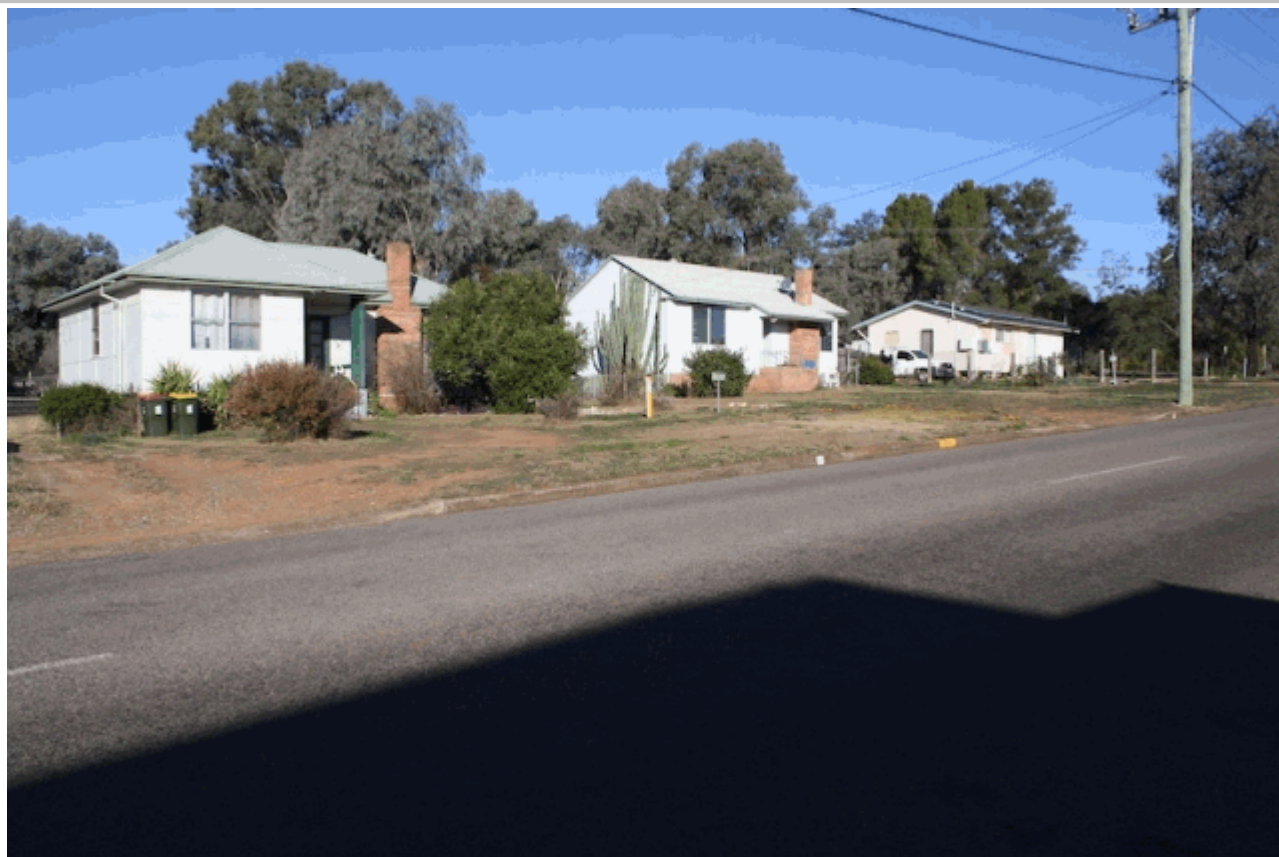
Caption: Example of post-war buildings in Marquet Street Lot A,B,C, DP36072

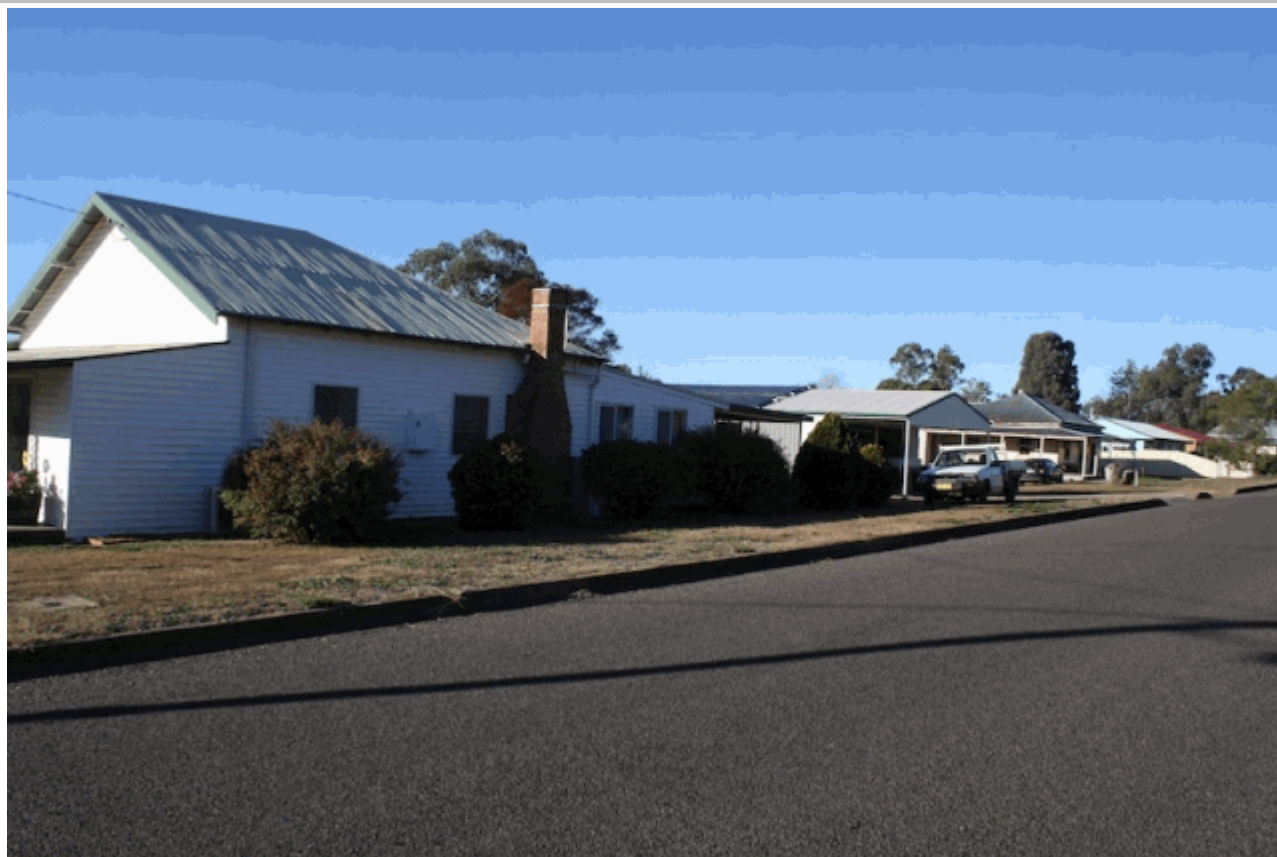
Caption: Streetscape view of William Street showing contributory buildings within conservation area

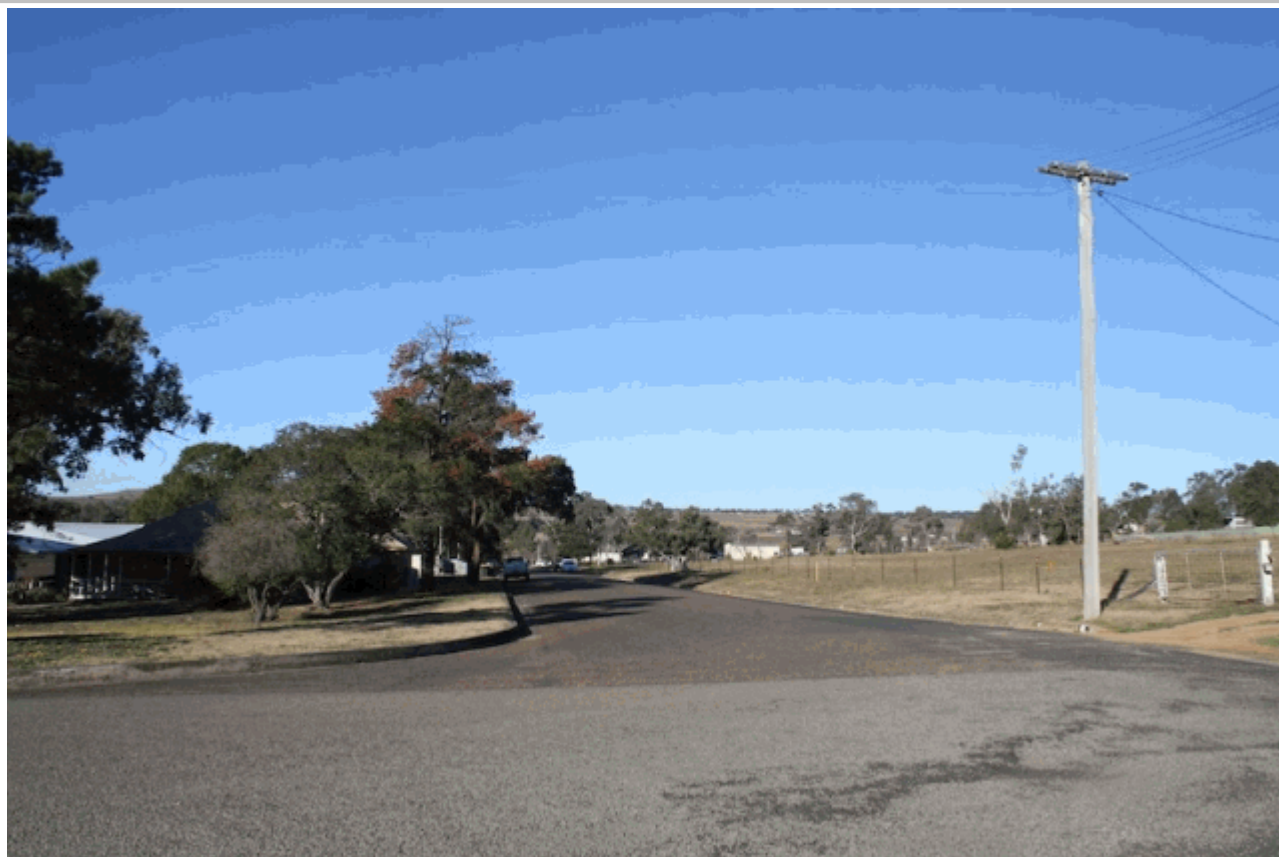
The land for the current hospital site was dedicated in 1886, though there is no obvious built evidence of early buildings with the current buildings all 20th century.

Caption: Hospital McRae Street assessed as non-contributory

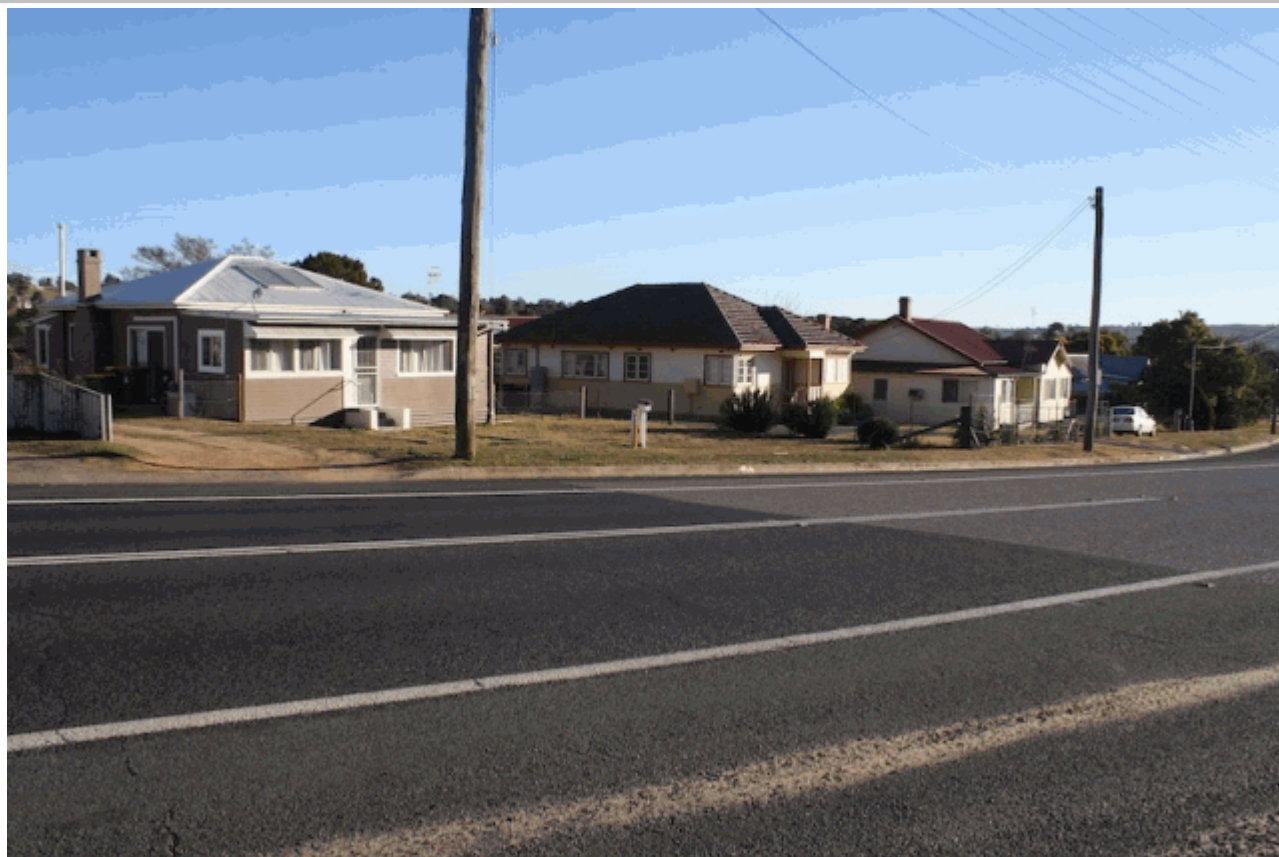
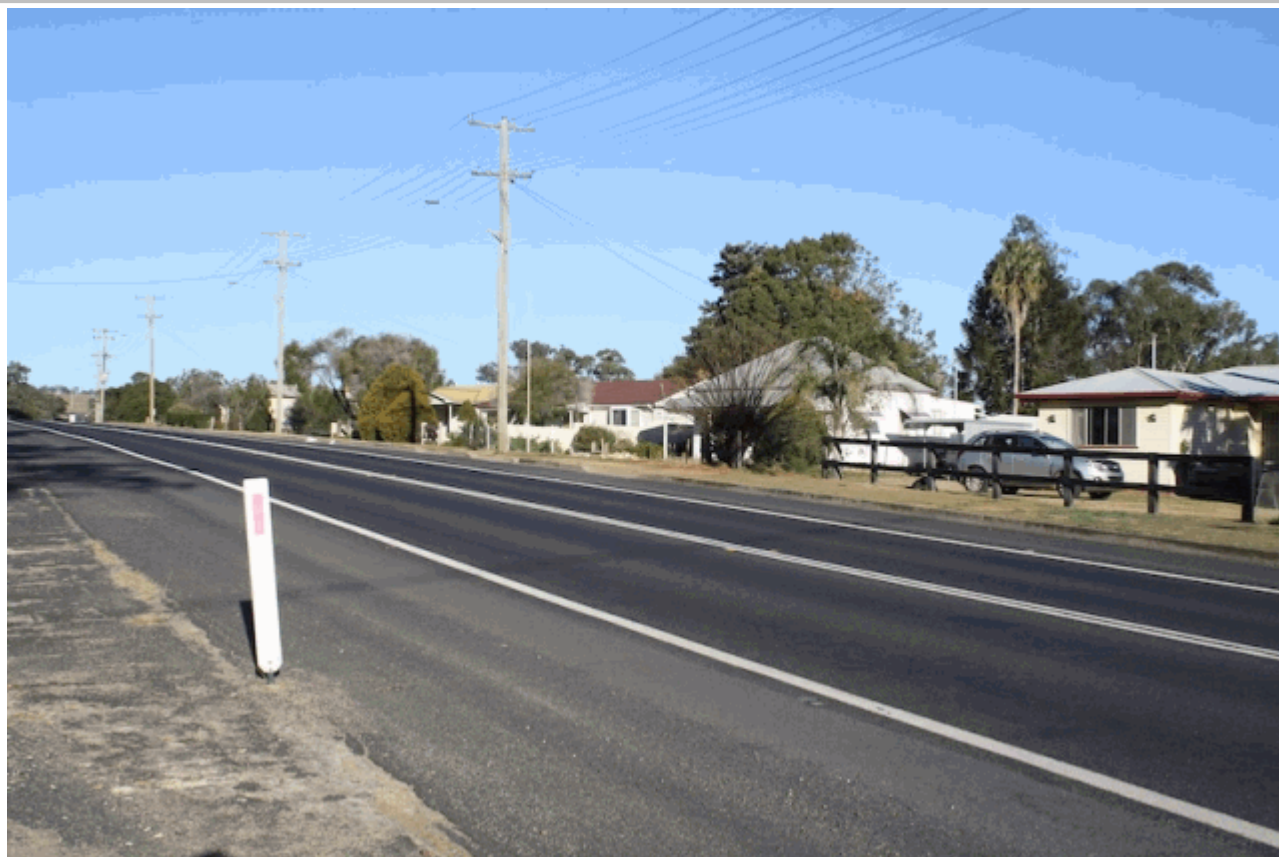
The streetscape of King George V Avenue include a number of early to mid-20th century houses that are assessed as contributing in style and scale.

Caption: King George V Avenue - proposed to be retained as conservation area

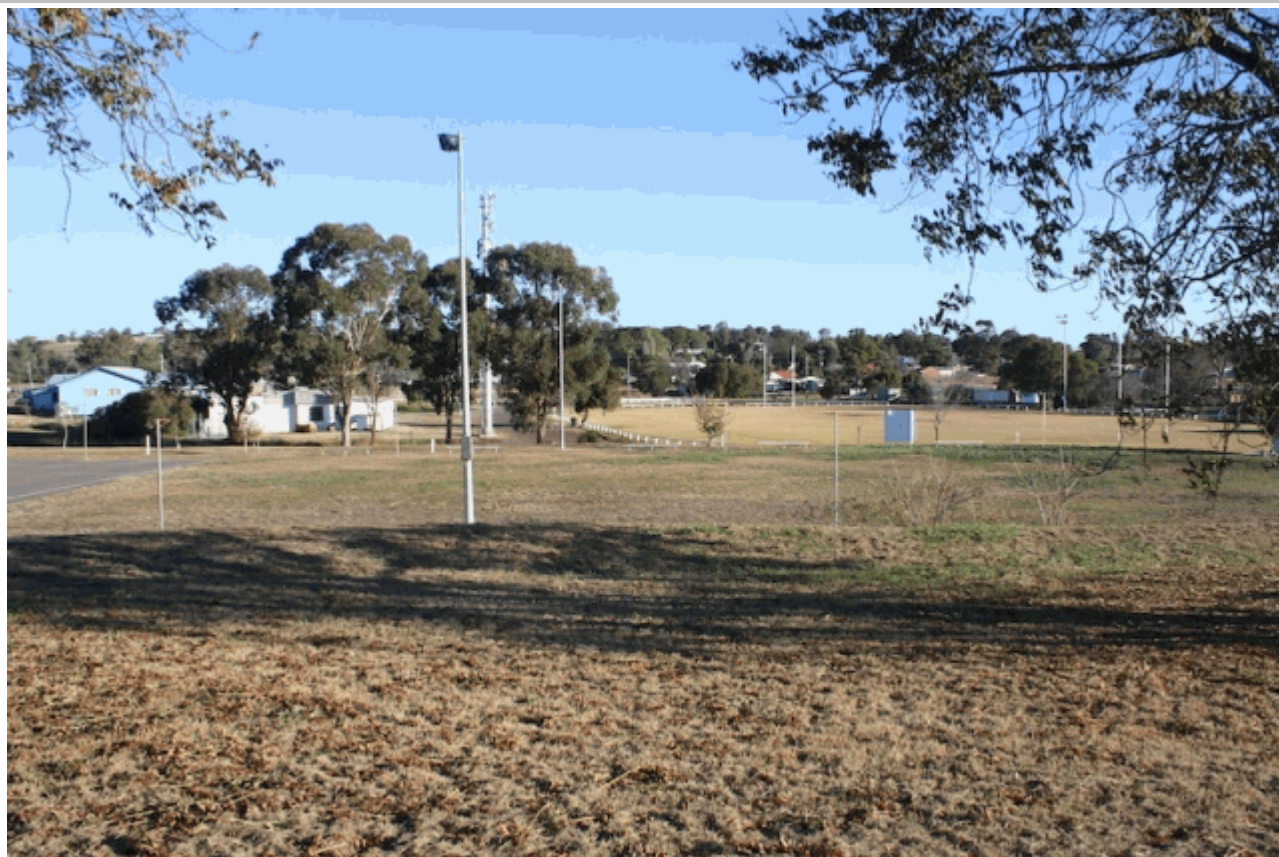
The area to the north-east of the town and to the east of Brisbane Street is indicated as "reserve for public recreation" extending to the later railway area to the north of Macartney Street. This land is still used as public recreation and includes sports fields and a sports club.

Caption: Public Recreation Area east of Brisbane St proposed to be retained as conservation area

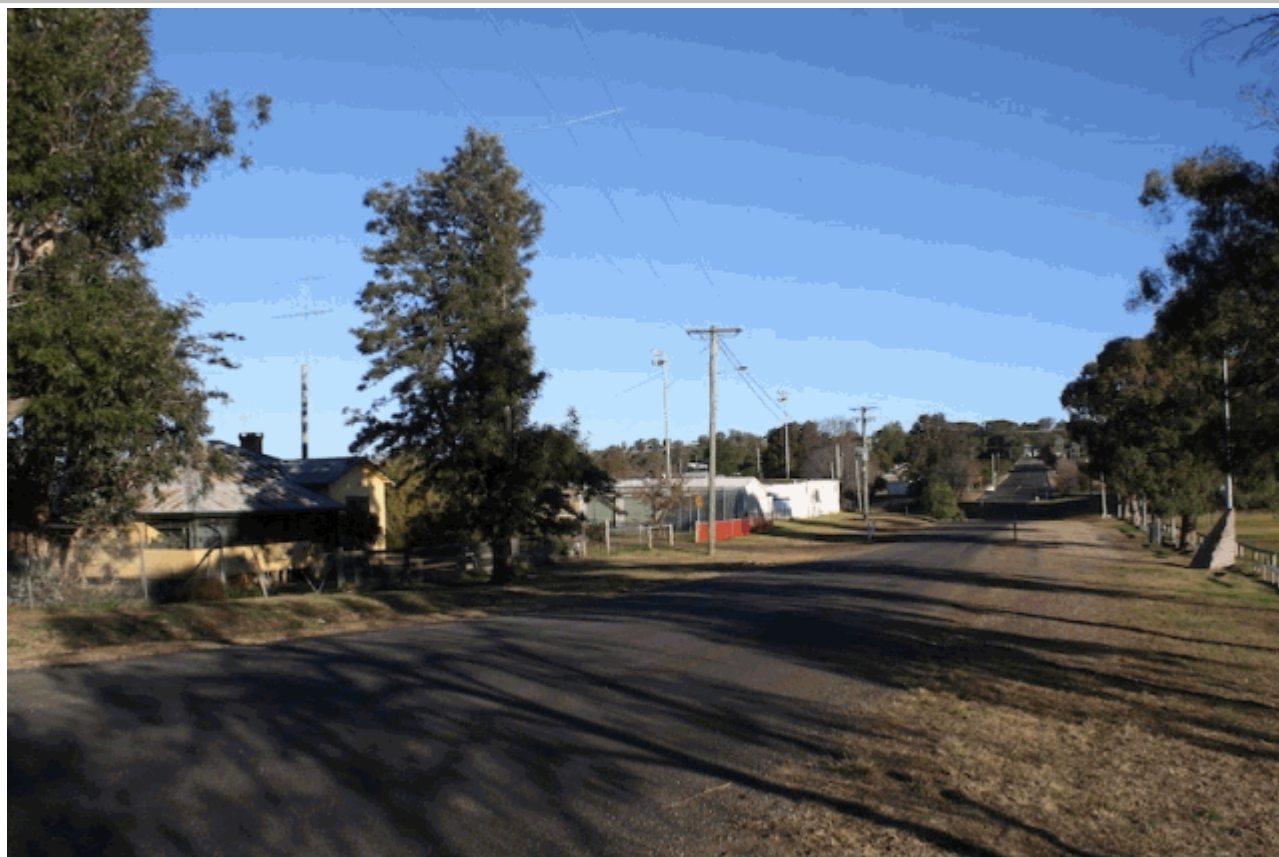
Caption: Streetscape view of Brisbane Streetscape Brisbane St showing contributory building in foreground

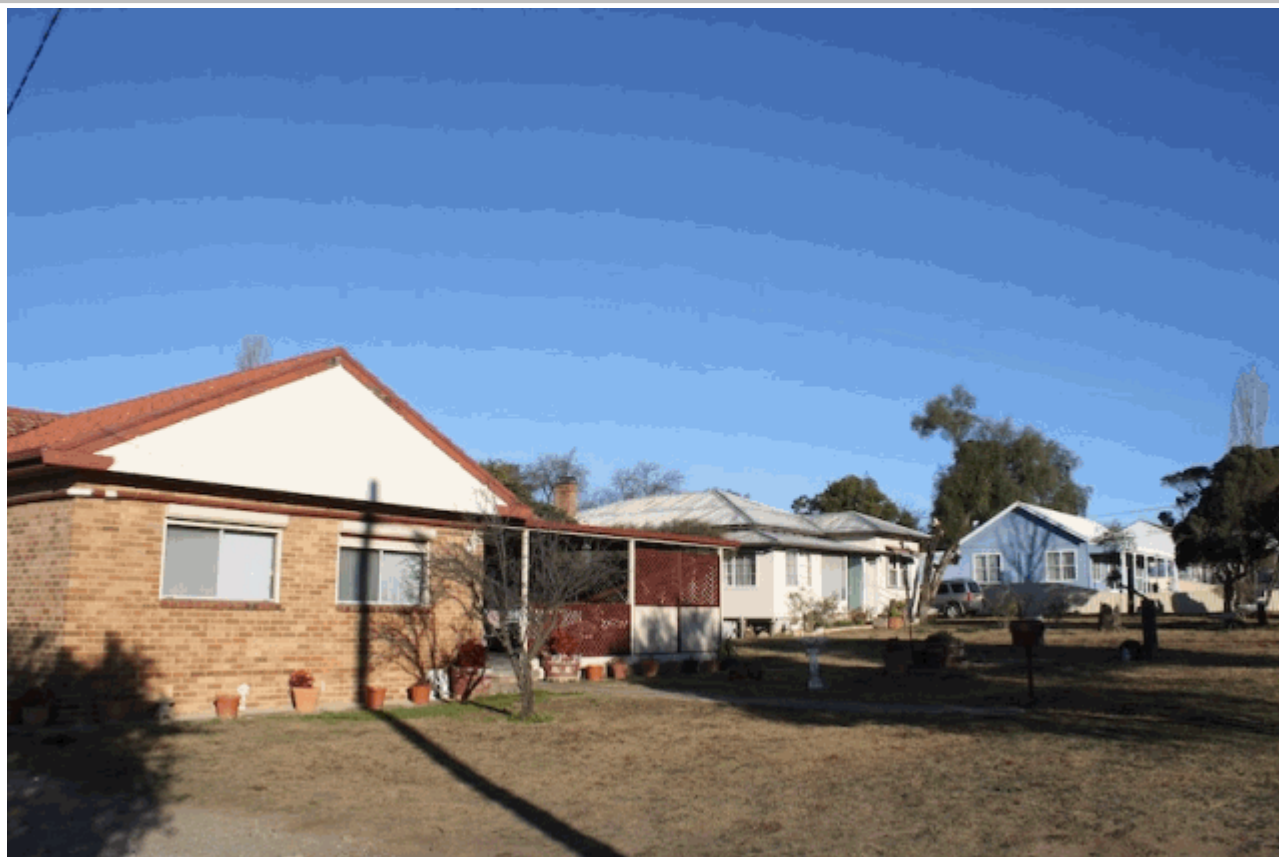
Caption: Streetscape Brisbane Street showing post-war non-contributory buildings

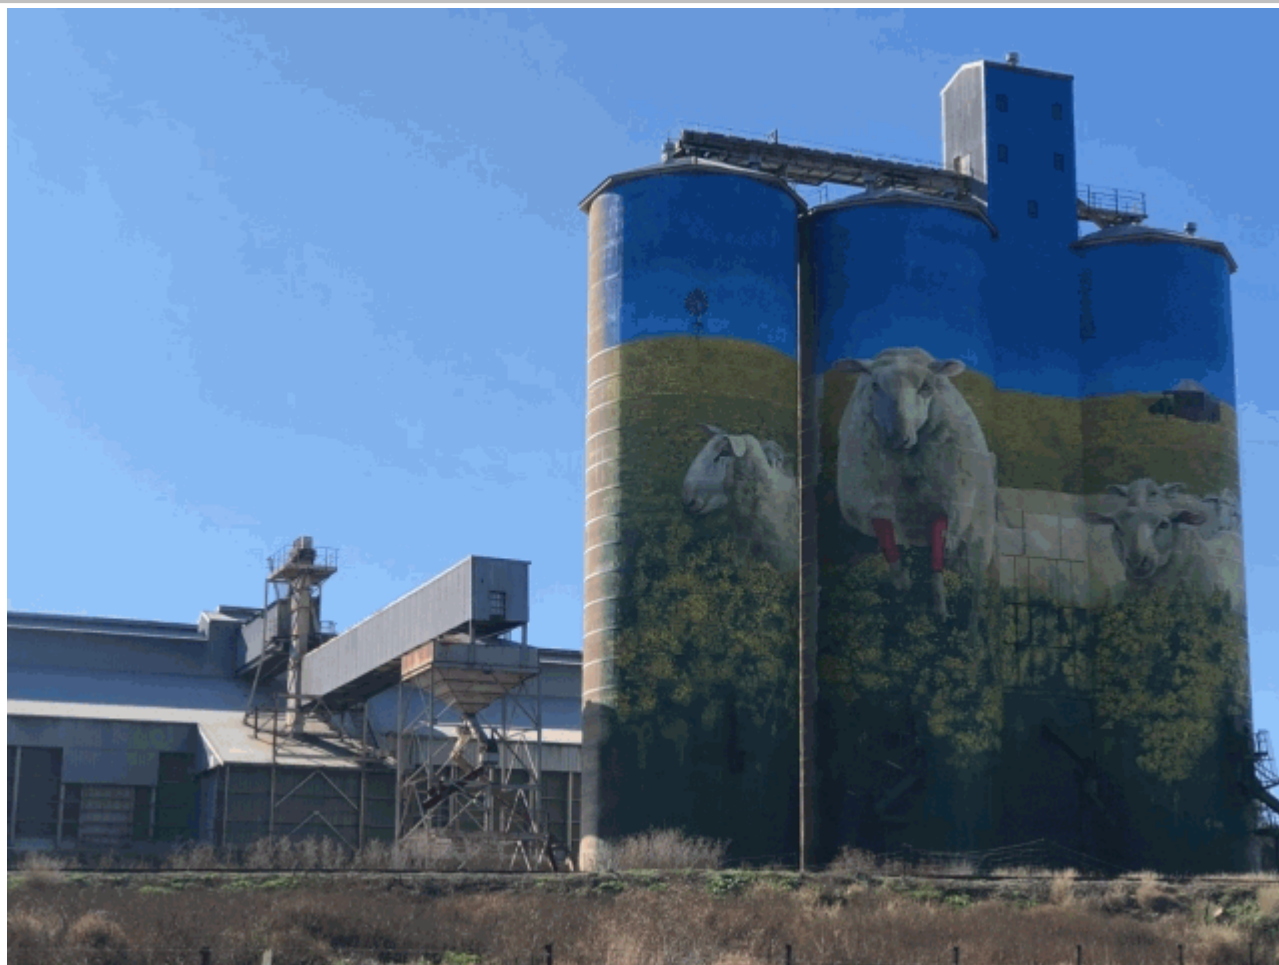
The railway and associated infrastructure including the silos are a record of the development of the town of Merriwa from the opening of the line in 1917. It also records the town's function as a centre for agriculture and the transport of wool and crops.

Caption: Lot1 DP818800 Silos potential heritage item

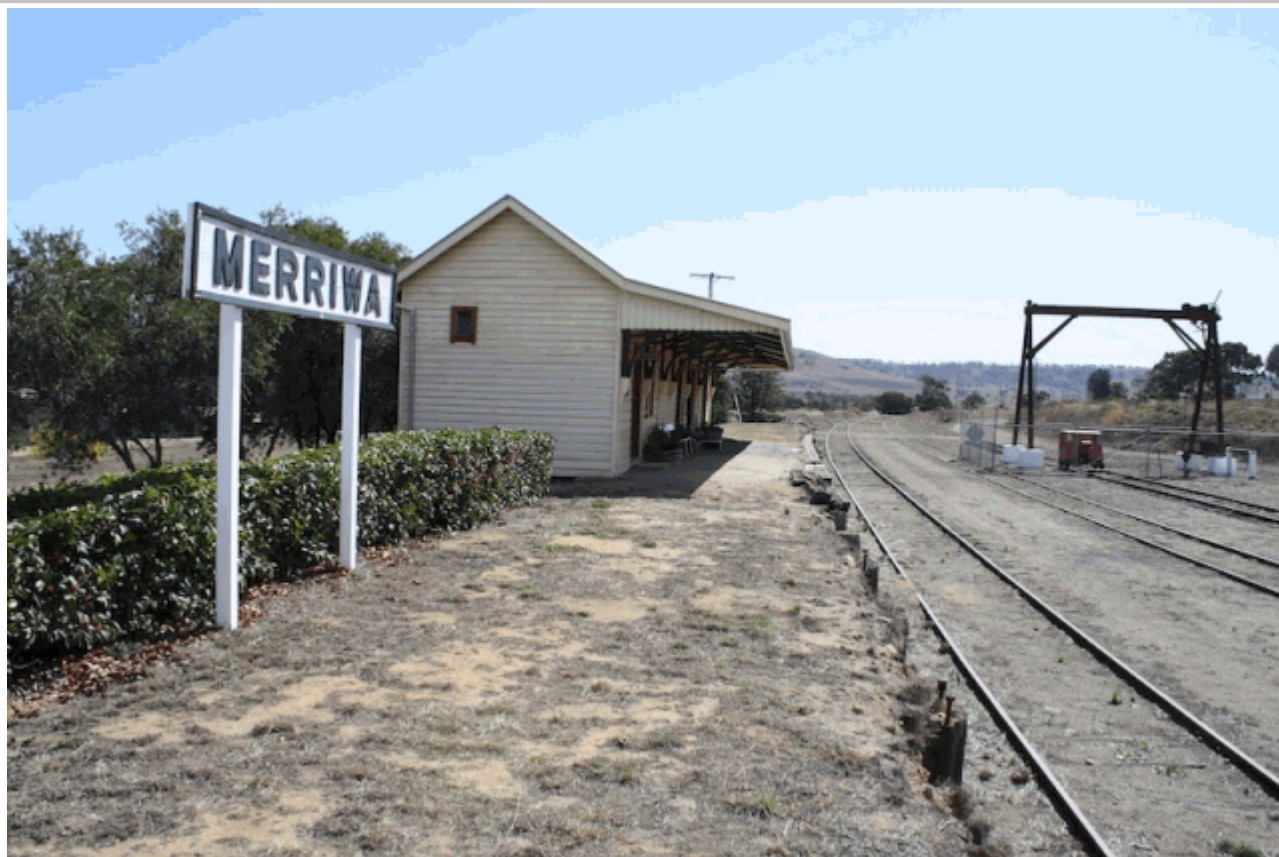
The railway station complex is important as a representative example of an early 20th century station complex and includes the station building, goods shed, gantry, water tower, turntable, rail lines, embankment and platforms.

Criteria e): The railway turntable has technical significance as a mechanical turntable requiring two men to operate.
[Research
significance]

Criteria f): The railway turntable is likely to be a rare example of its type in NSW requiring two men to operate.
[Rarity]

Caption: Lot 1702 DP1175204 Lot 1 DP724472 Merriwa Railway Complex - Potential Heritage Item
